GEOTECHNICAL ISSUES ASSOCIATED WITH THE DESIGN AND CONSTRUCTION OF THE MIDDLE RIVER BRIDGE

Vishnu Diyaljee, Ph.D, P.Eng, F.ASCE
Managing Director, GAEA Engineering Ltd
33 Ashby Field Road, Brampton, Ontario
Canada, L6X 0R4

ABSTRACT

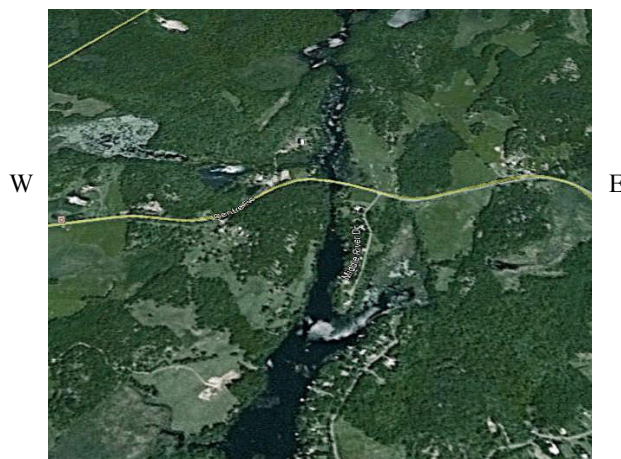
Fig.1. Aerial Photograph of Site

As shown in the aerial photograph of the site taken from Google Maps, Fig.1, the river was constricted from both abutments with a larger constriction from the east abutment.

This river constriction was likely done to reduce the span of the existing bridge. Whether this constriction was undertaken during the initial construction or the construction in 1930 is unknown.

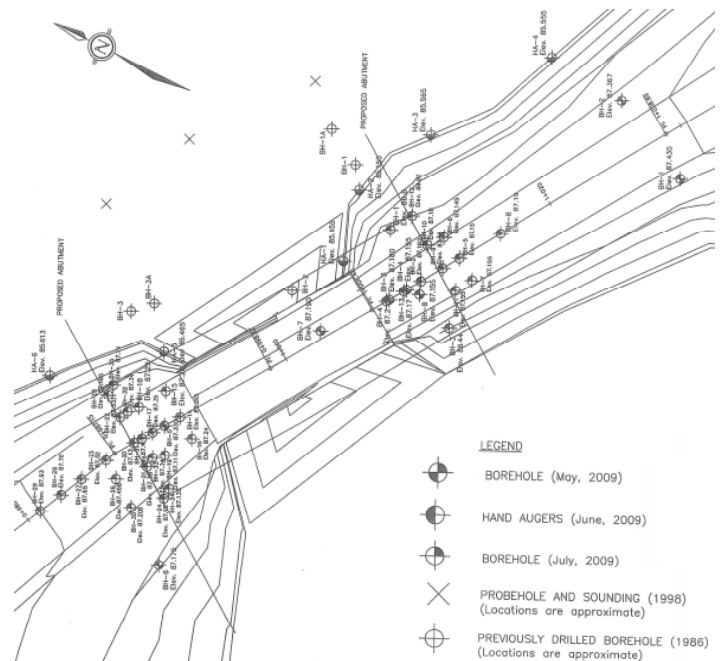
Fig.2. Locations of Boreholes (1986 and 2009)

To be able to investigate closer to the existing bridge abutments, arrangements were made with the Town of McKellar for closure of the roadway for 2 days. An additional six (6) boreholes BH’s 3 - 8 were undertaken between May 11 and May 12. These boreholes were located closer to the existing bridge abutment and near to the locations anticipated for the proposed abutments of the new bridge. Except for BH 7 which was drilled around the middle of the river from the existing bridge deck through a hole in the deck, the remaining holes were drilled on either side of the existing bridge abutments. The locations of the boreholes are shown in Fig.2.

A total of thirty-two (32) probes were undertaken on both sides of the existing bridge abutments at locations shown in Fig.2. The only setback in using the air track rig was that samples of soils could not be obtained except that soils and materials that were blown out of the hole were visually observed as the probe was advanced. Materials encountered were also identified by the rig operator based on his experience and examination of the cuttings as the drilling advanced with depth. Figure 3 shows the air track rig in operation.

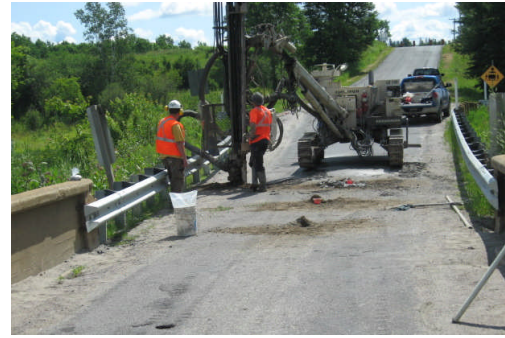
Fig.3. Air Track Rig Drilling Probe/Boreholes

The only alternative left was to engage the advice of owners of Air track drilling equipment since these were capable of rapid penetrating most materials overlying bedrock, and in fact these rigs are often used in proofing the location and depth of bedrock. This type of rig uses compressed air for advancing a percussion type drill bit with depth.

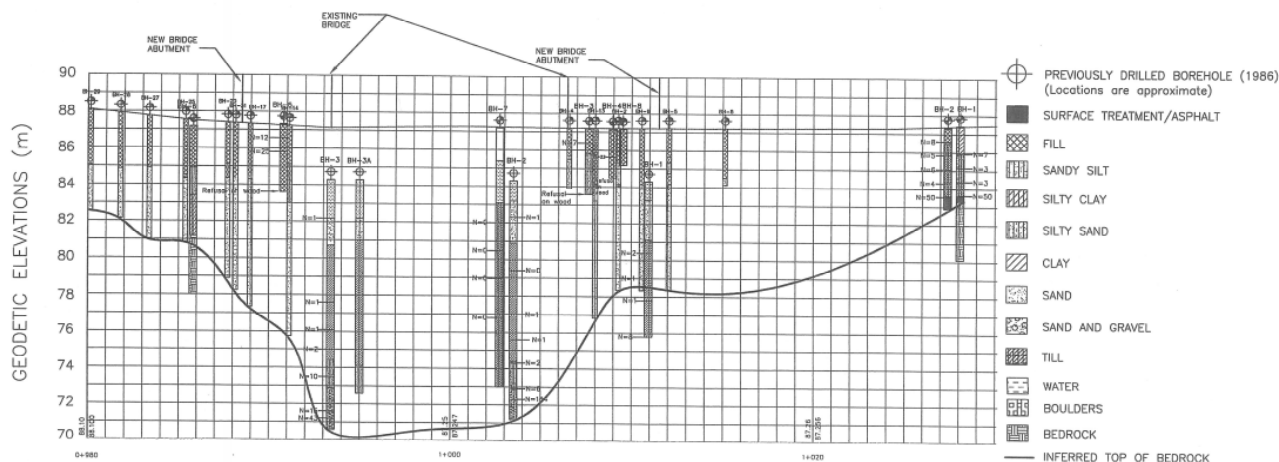
Fig.4. Longitudinal Stratigraphic Profile

Several stratigraphic cross-sections and a longitudinal stratigraphic profile were evaluated. The longitudinal profile is shown in Fig. 4. These results were used to set the locations of the new bridge abutments. These locations are shown on the longitudinal profile. Also shown on the longitudinal profile is the bedrock line which also played an important role in the decision of where the abutment was to be located. As can be seen, the bedrock profile is steep on the west side beyond the existing abutment with the slope at almost 45 degrees while on the east side the slope is slightly flatter.
