International Conference on Case Histories in Geotechnical Engineering (2008) - Sixth International Conference on Case Histories in Geotechnical Engineering

Application of Screening Analyses for the Stability of Landslide in Seymareh Dam Project

APPLICATION OF SCREENING ANALYSES FOR THE STABILITY OF LANDSLIDE IN SEYMAREH DAM PROJECT

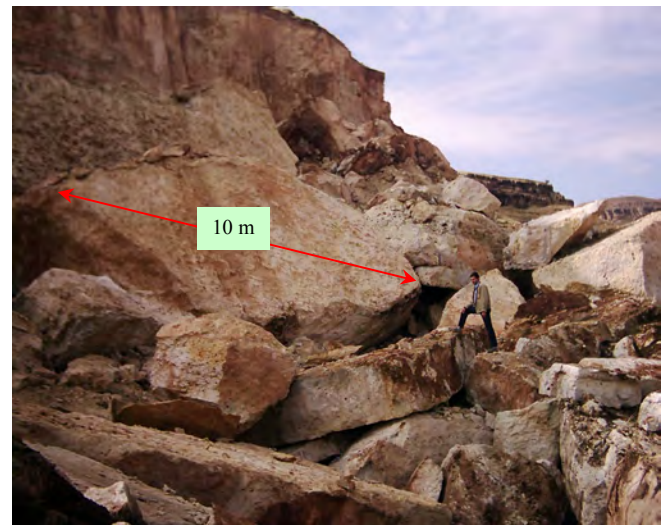
The landslide completed in November 10th 2003 few hours after an intensive rainfall. The event created a huge mass of debris by 300000 m³, in which the size of some rock pieces could exceed 10 m (Fig. 2). The scope of area before and after final collapse is displayed in Fig. 3. The sliding mass can be defined by a tension crack of 20 m height and 200 m long in the above and a sliding planar surface of 26° dip and with about 100 meters horizontal lengths. In the west part of failure zone, where the power tunnel entrance is located in the bottom, many large blocks were stopped unstably. Because of the future location

Fig. 2 The large blocks left by landslide

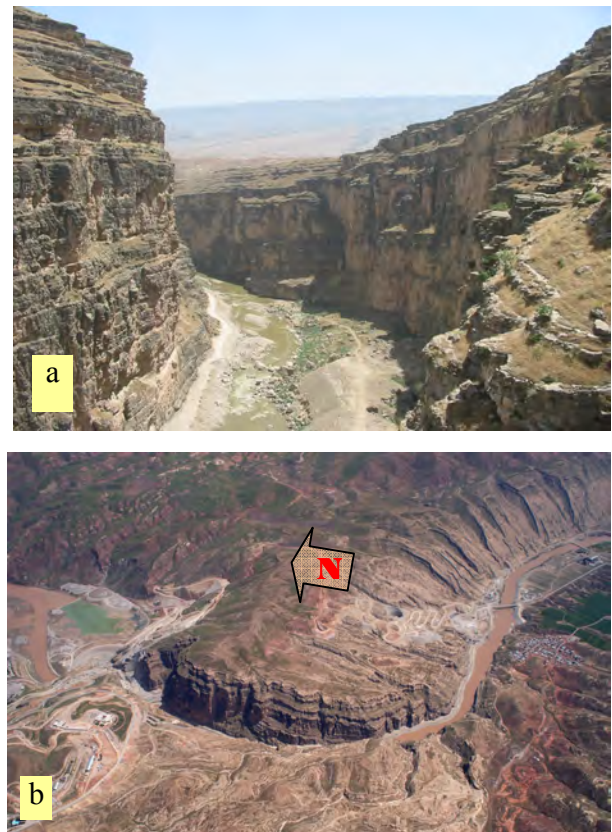
The morphology of the site includes a U shaped nearly symmetrical valley with steep and someplace negative slopes at abutments, crossing the bedding strike perpendicularly. At the gorge of dam site the width of river varies from 40 to 50 m and its trend varies from NW-SE to NE-SW. To the downstream direction, beyond the anticline axis and its southern limb, the river again adopts a NW-SE trend and flows in to the Talkhab plain and finally joins Karkheh River (Fig. 4).

Fig. 4. The morphology of Seymareh site, a) U shaped valley, b) Ravandi anticline

4b. This situation has caused more abundant fracturing & crushing relative to that of the northern limb in which the dam body will be situated. The emergence of a great number of springs in the southern limb of the Ravandi anticline can be attributed to this.

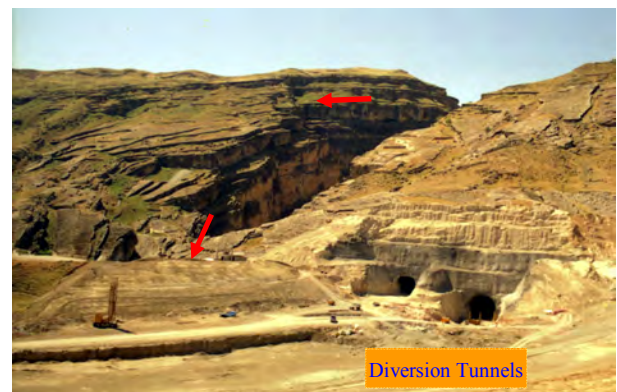
The northern limb of Ravandi anticline, where the dam will be constructed, consists of slopes with varying dips, ranging from 45-50 degrees at the start of gorge, to 10-15 degrees at the downstream of dam (Fig. 5). At dam abutments there are small gullies with steep walls formed along the bedding planes and fractures. Lack of vegetation around the dam site has made a rocky nature with a surface showing resistance against erosive factors. The overburden materials in Seymareh dam site include alluvial deposits, Lacustrine deposits, Talus and Old alluvial deposits. The main part of the materials is Lacustrine deposits, which have a 35 m thickness. This deposit consists of greenish gray silty clay with high plasticity & sandy intercalations resulted from the formation of natural lake due to the huge Kabir Kuh landslide. The well-known Kabir Kuh landslide, sometimes so called as Great Seymareh landslide is the largest in the world located 50 km far from the dam site.

Fig. 5. Dramatic variation of bedding dips at the northern limb of Ravandi anticline

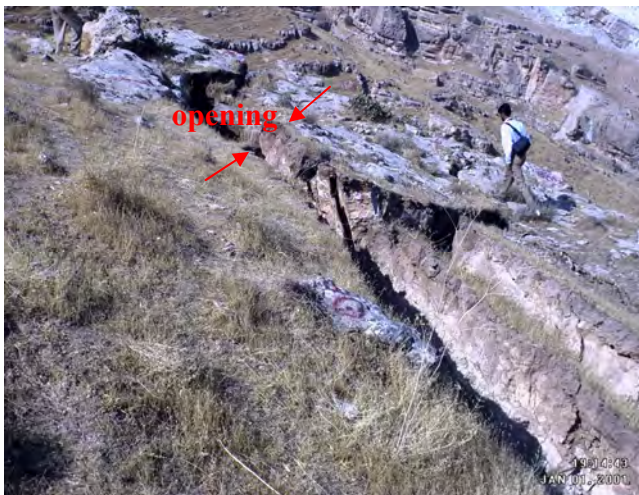
Fig. 9. The appearance of vertical joints in the southern wall of affected area and on the ground surface

The total displacement of sliding mass before the global collapse happened reached approximately to 4m on the main joint location. Figure. 9 illustrates the trace of main tension joint on the ground surface and the resulting large scarp. In the last hours of November 9th, 2003 an intensive rainfall caused the total mass to be saturated. Finally, at the midday of November 10th the whole mass collapsed totally and remained a huge mass of debris estimated by 300000 m³ as shown in Fig. 2 and Fig. 3b. After this final failure, the fault F12 wall was clearly seen in a length of some 200 m with variable elevation from 20 to 40 m (refer to Fig. 3b). It was also observed that a clay filling material by 50 cm thickness is pasted to the most parts of fault F12 face. This indicated that the fault F12 was an old tension crack filled during a long history. After the total collapse of sliding zone some of the big dislocated blocks moved towards the power tunnel intake and stopped unstably on the above of this area as illustrated in Fig. 10.
