## Case Study of Landslides in Kabylia Region, Algeria

## CASE STUDY OF LANDSLIDES IN KABYLIA REGION, ALGERIA

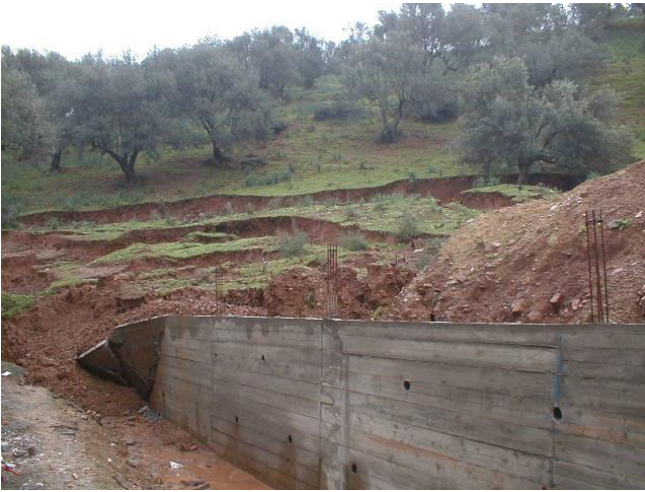
*Fig. 1. Landslide at Beni Amrane , Department of Boumerdes, causing damage to retaining wall, January 2003.*

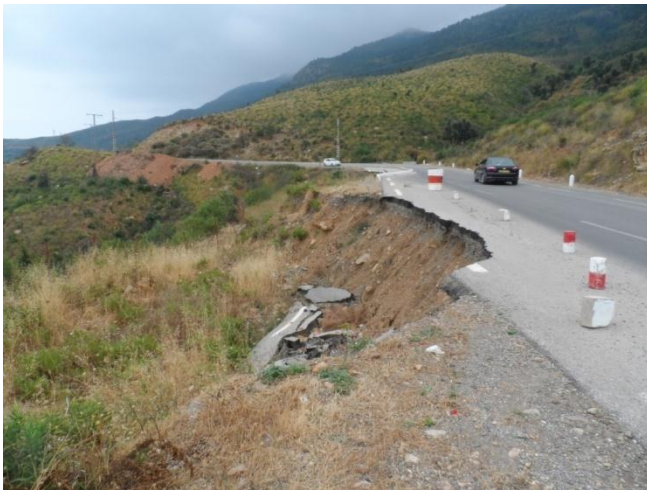
*Fig. 2. Landslide at PK 227+110, RN 24, Bejaia, 2011.*

In general, training colluviums overcome dips direction (North-South) of schistose marl and marly limestone very hard and impermeable (Fig. 6b). The interface between the scree slope and marl consists of greenish clay and plastic very sensitive to water; it loses the mechanical characteristics and becomes slippery. Saturated colluviums slip at the interface with the marl under the effect of dip angle and increased hydrostatic pressure (Fig. 6b). This results in deflection of roads, slope failure, longitudinal crevice (Fig. 2). These instabilities are observed on several sections of the road RN24 especially after periods of rain (Fig. 2).

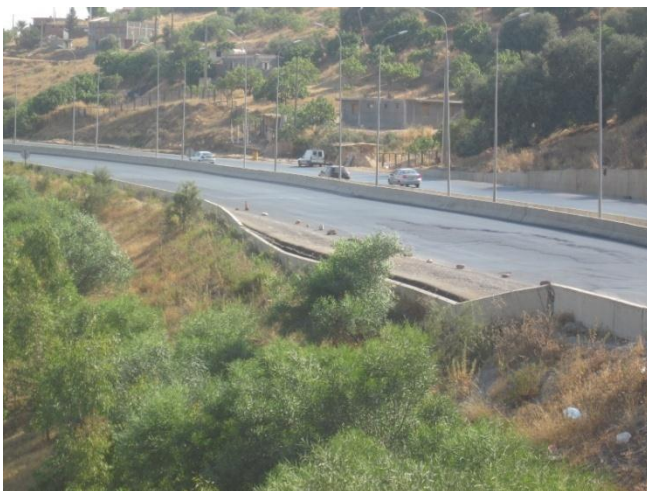
*Fig. 3. Landslide at Ain -Tork, Department of Bouira, East-West highway A1, April 2012.*

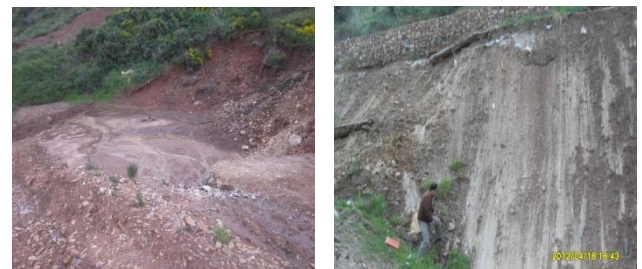
a) Saturated colluviums

b) Marly limestone dip (slip surface)

Fig. 6. Site lithology at PK 226+300, RN24.

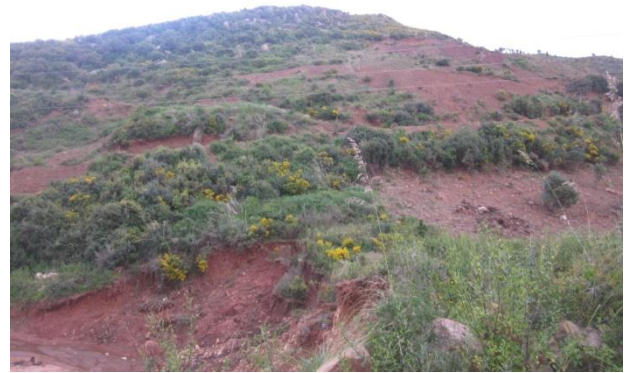
*Fig. 7. Deforestation hillside.*

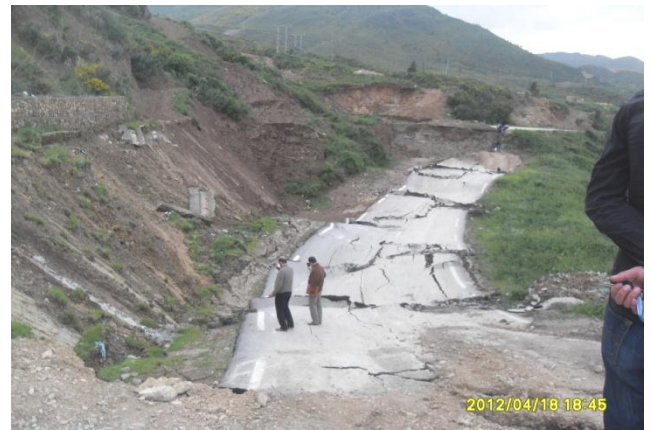
*Fig. 8. Overview of landslide Assoumeth RN24, PK 226+300.*

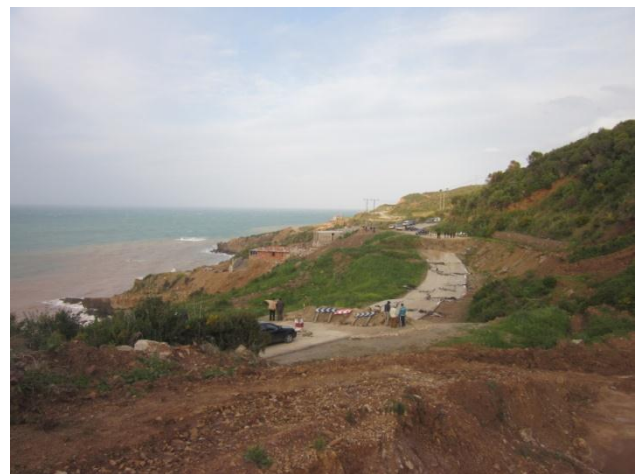
*Fig.9. Overview of landslide Assoumeth RN24 PK 226+ 300*

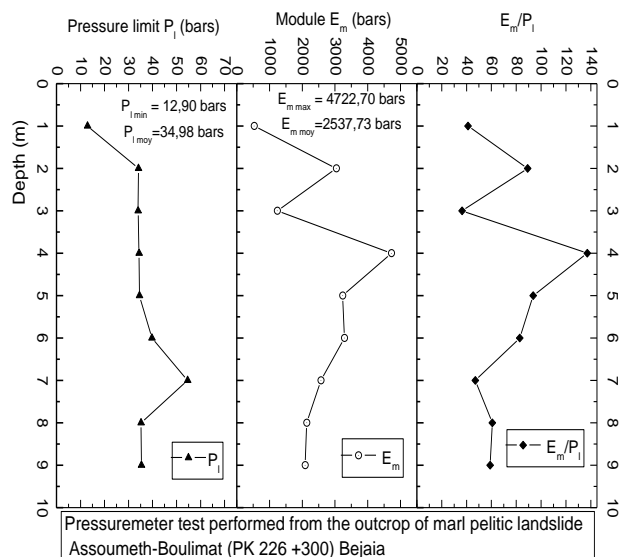
Fig. 11. Pressuremeter test results.

The physical and mechanical parameters measured in the laboratory are summarized in Table 1. The specific density of marly limestone is  $25.6 \text{ kN/m}^3$ , indicating a very hard soil. The shear test performed on a sample colluviums clay component provides low shear parameters ( $c_u=20 \text{ kPa}$  and  $\phi_u=7^\circ$ ). The pressuremeter test results reveal that the pelitic marl is very hard, it has a limit pressure  $p_l=3.5 \text{ MPa}$  and a pressuremeter modulus  $E_m=253.8 \text{ MPa}$  (Fig. 11). The Young's modulus of this marl is in order of  $280 \text{ MPa}$ .

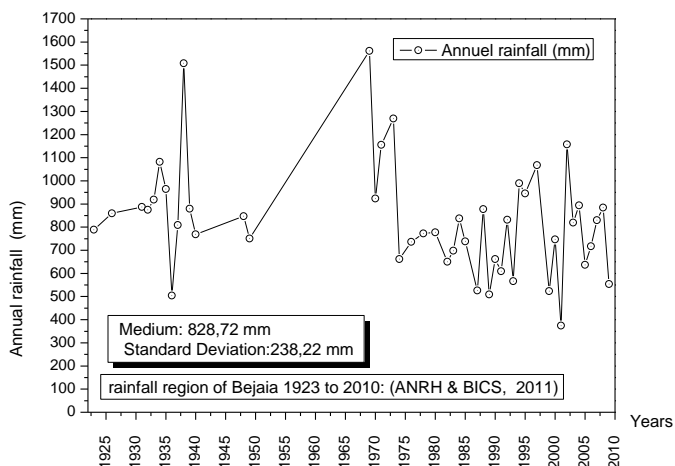
Fig.12. Rainfall region of Bejaia 1923 to 2010 for pluviometry station of Tifra (ANRH, 2011)

Figures 12 show annual records covering periods from 1923 to 2010 (ANRH, 2011). Figure 13 shows the monthly variation of rainfall of the rainy year. These data show that the average rainfall along the cycles recorded is 831 mm. The last two decades are characterized by an average rainfall of 750 mm. The representation of rainfall is characterized by irregularities inter-seasonal and inter-annual. As a general, the relative distribution of 28.94% from September to November, 39.96% from December to February, 27.30% from March to May and 3.8% from June to August.

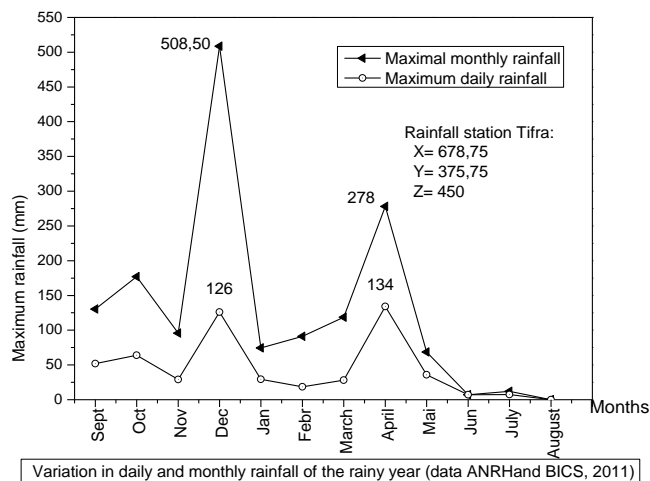
Fig. 13. Variation in daily and monthly rainfall of the rainy year (ANRH, 2011)

Almost all rainfall is concentrated over a period ranging from November to March, not exceeding five (05) months: two-thirds (2/3) of the total rainfall is recorded during this period. In addition, according to the data, a peak rainfall was recorded in April with a maximum monthly rainfall of 278 mm (Fig. 13), which justifies the initiation of the majority of landslides in the Kabylia region during the spring period. In April, the hillsides were in a saturated condition following a relatively wet spell during the preceding weeks.

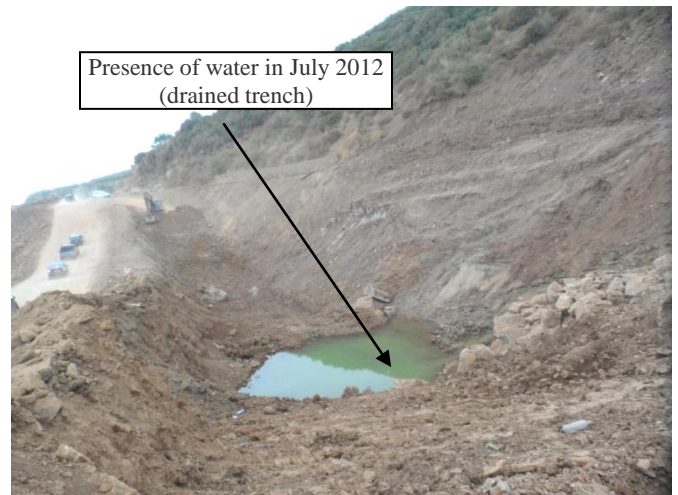
Fig. 17. A typical cross section of trench drain.

- Securing perimeters impact of landslides and setting up adequate signage of the road,
- Deviation of all water from the site, a drainage nozzle is recommended. Achieve water nozzle ditches outside the landslide (Fig. 16),
- Realization of ramps with maximum slope of 5% either side of the collapsed area to access the purge,
- Earthwork total disturbed masses up to the consistency calcareous marl layer.
- Creation of a trench drain in pebble and nozzles for PVC dry zone of accumulation of groundwater seepage in the vicinity of profile n° 2 and its connection to the outlet (Fig. 14 and 17).
- Substitution materials should be performed by well compacted layers of 30 cm thick.

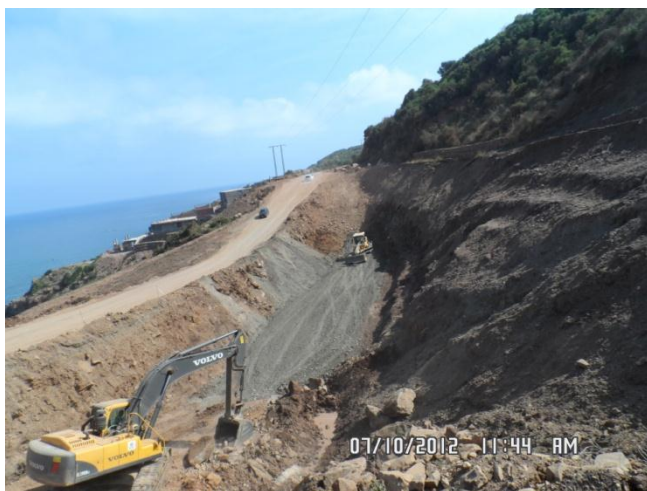
Fig. 18. During emergency work.

Figure 18 shows the temporary road and the state during the preliminary work started in July 2012. Figure 19 shows a long cross section profile of landslide area for three states: initial state before landslide, landslide triggering and after emergency solution work.

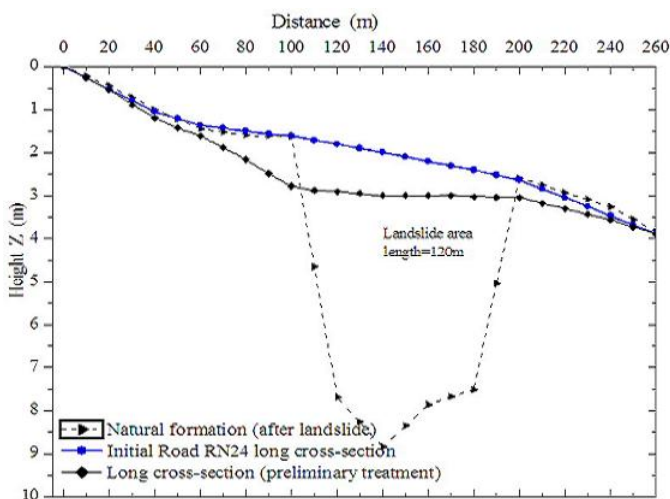
Fig. 19. Long section profile of landslide area for three states: initial state before landslide, landslide triggering and after emergency solution work.

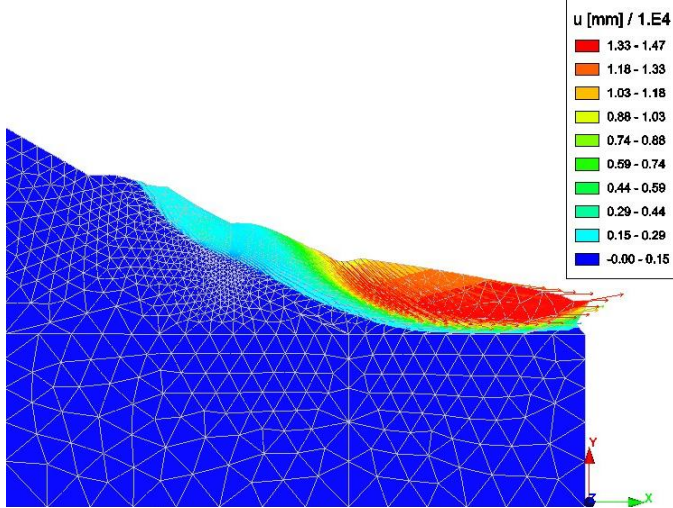
Fig. 20. Displacement vectors at the state landslide triggering.

The finite element code LCPC-CESAR (ITECH-LCPC, 2004) was used to analyze the stability of the landslide. The standard elastoplastic Mohr-Coulomb was used for soil behavior. Stability calculations were conducted for two stages; the state at landslide triggering and the state with nailing reinforcement. According to the geological survey, the residual soil parameters considered for the moved mass (colluviums) are  $c=20$  kPa,  $\phi=7^\circ$ ,  $E=10$  MPa and  $\nu = 0.35$ ). Fig. 20 shows the results of stability calculations of the state at landslide triggering. This figure shows the instability of the slope, the safety factor  $F$  is equal to 0.85. Large displacements, about 1.4 m, of the basin are noted. The results indicate clearly that the

state remains unstable after sliding. Hence, the importance of the emergency work proposed to stabilize the ground and the road by a soil reconstitution by compacted granular material.
