Permanent Tieback Retention System

SYNOPSIS This paper describes the design, construction, and monitoring of a permanent tieback retention system which permitted a 55-foot-deep excavation for an 16-story addition to the existing Good Samaritan Hospital in Cincinnati, Ohio. Tieback anchor capacity is developed in moderate-to-low-strength shale bedrock with intermittent thin limestone layers. The retention system provides temporary and permanent support for adjacent 5- and 10-story buildings and unbalanced lateral earth pressures due to sloping site topography. A permanently tiedback wall also supports a 17-to-33-foot-deep cut adjacent to the 8-story parking structure in lieu of a conventional retaining wall.

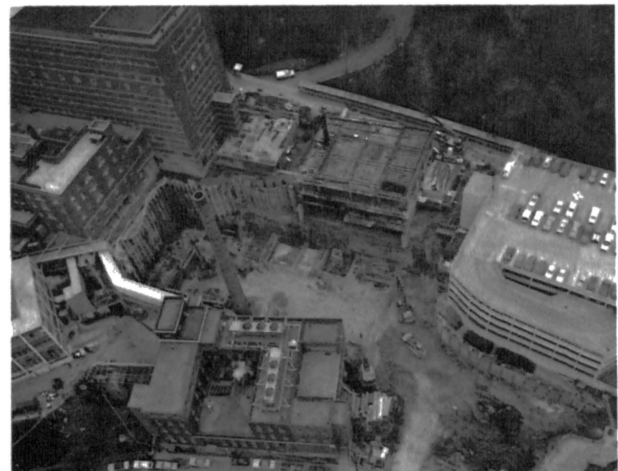
Figure 1. Aerial View of Project During Early Construction Phase

The 16-story hospital addition was situated within a congested structure area, such that six existing buildings bordered the addition (see Figure 1). Surface grades, prior to construction, varied in elevation as much as 40 to 45 feet falling southeast to northwest. The slab-on-grade elevation of the addition was 15 to 55 feet below preconstruction grades.

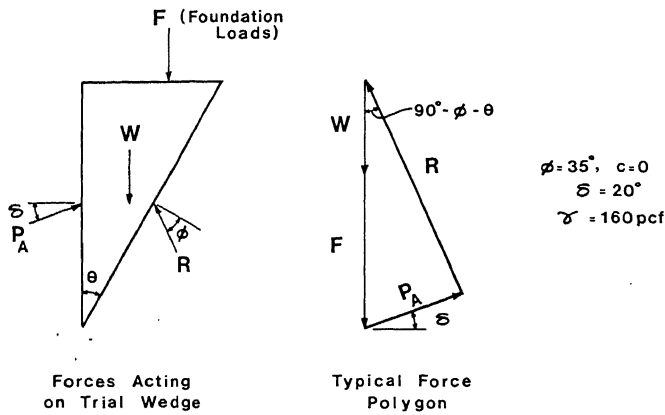
Figure 4 shows the forces acting on the trial wedge, as well as a typical force polygon. The resulting design pressure diagrams for Sections 1-1 and 2-2 are shown in Figures 5 and 6, respectively.

Figure 4. Limit Equilibrium Trial Wedge Analysis

For the design of the retention system, a limit equilibrium trial wedge analysis was utilized assuming the rock behaves as a soil mass with a friction angle of 35 degrees. This analysis incorporated the effects of the adjacent foundation loads. Once the maximum stabilizing force (P_A) was determined from the resultant force polygon, this force was divided by the height of excavation and distributed on the base of the wall as a uniform pressure.

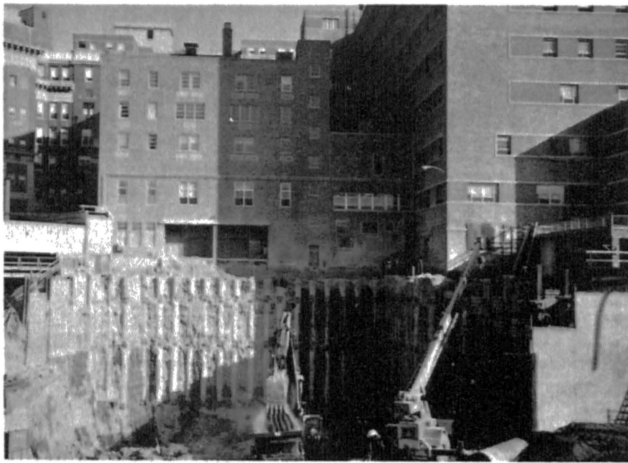
Figure 7. Hospital Area During Construction

For the existing hospital-area wall, a 6-inch-thick shotcrete facing with one layer of wire mesh was placed against the cut face and anchored to the piers comprising the soldier piles. Wall drainage behind the shotcrete facing consisted of a 2-inch minimum thickness of porous filter material against the rock face between the piers held in place by diamond mesh and visqueen anchored to the piers. The final wall facing for the parking structure area consisted of 15-inch-thick reinforced concrete anchored to the soldier piles by shear stud connectors welded to the steel beams. Drainage behind the wall facing was provided by installing 2-inch-thick Geotech drainage board with filter fabric on the back side against the cut face. Photos taken during the construction of the retention systems for the existing hospital and parking structure areas, respectively, are shown in Figures 7 and 8.
