## Ground Failure and Remedial Measures at a Block of Flats

**SYNOPSIS :** The ground failure presented in the paper, occurred in 1986, in the foundation ground, of a ten storied block of flats, consisting of Bahlui structured dilatant clay, normally consolidated. The foundation ground rupture, by plastic yielding, began shortly after an accidental drowing of the basement. Before this accident, the building had not presented any signs of evolutive settlements processes. The paper presents the consolidation measures taken to stop the progressive yielding of the ground beneath the foundations. Results of tests pointed out the dilatant behaviour and the sensitivity to moistening of the Bahlui clays, during the shear process.

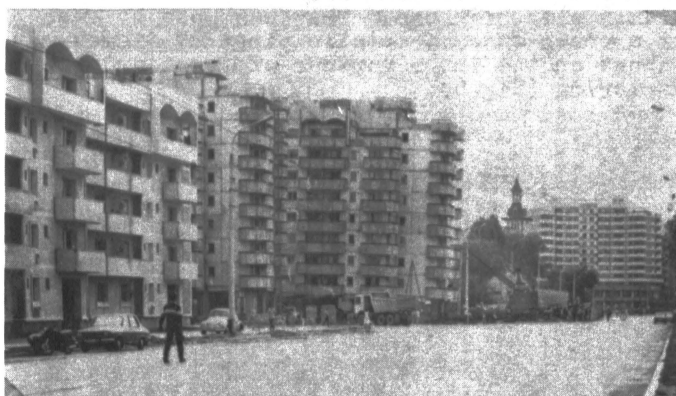
In 1986, a block of flats located in Bahlui river plain, near the railway station of Iassy town, suffered a rather peculiar process of foundation ground failure. The construction, consisting of basement, ground floor and 8 floors, having a total weight of about 50,000 kN, was in the final after an accidental drowing of the basement due to the defective installations, presented nonuniform evolutive settlements without any tendency of amortisation. The maximum settlement velocities, established immediately after the start of the movement, were of the order of 5+7 mm/hour. As a consequence of the nonuniform settlement the construction began to incline visibly (fig.1).

Fig.1 Uneven settlements of the block of flats

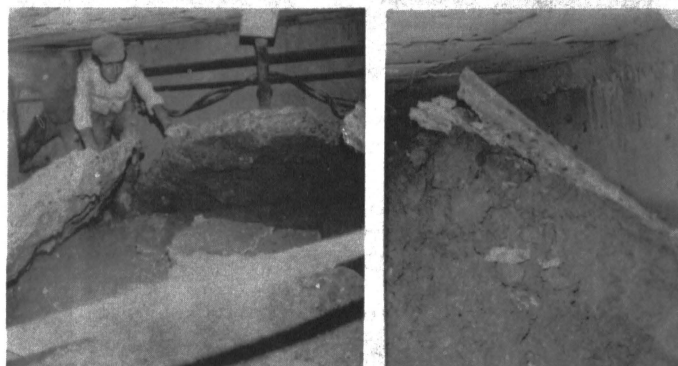
On examining the basement rooms in the zone with maximum settlements it was established that the soil under the continuous foundations of the construction was rejected (fig.2).

The concrete slabs of the floor broke and they were dislodged, the soil raised in the rooms from the large settlement area and, almost, reached the ceiling. The plan arrangement and the shape in vertical section of the foundations are shown on figure 3. The antisymmetric shape

Fig.2 The rejected soil in the basement rooms toward the large settlements area

The rejected soil in the basement rooms was formed of black clay fragments with dimensions of order of 3 ÷ 5 cm and shiny lateral surfaces with striations caused by shearing (fig.5).

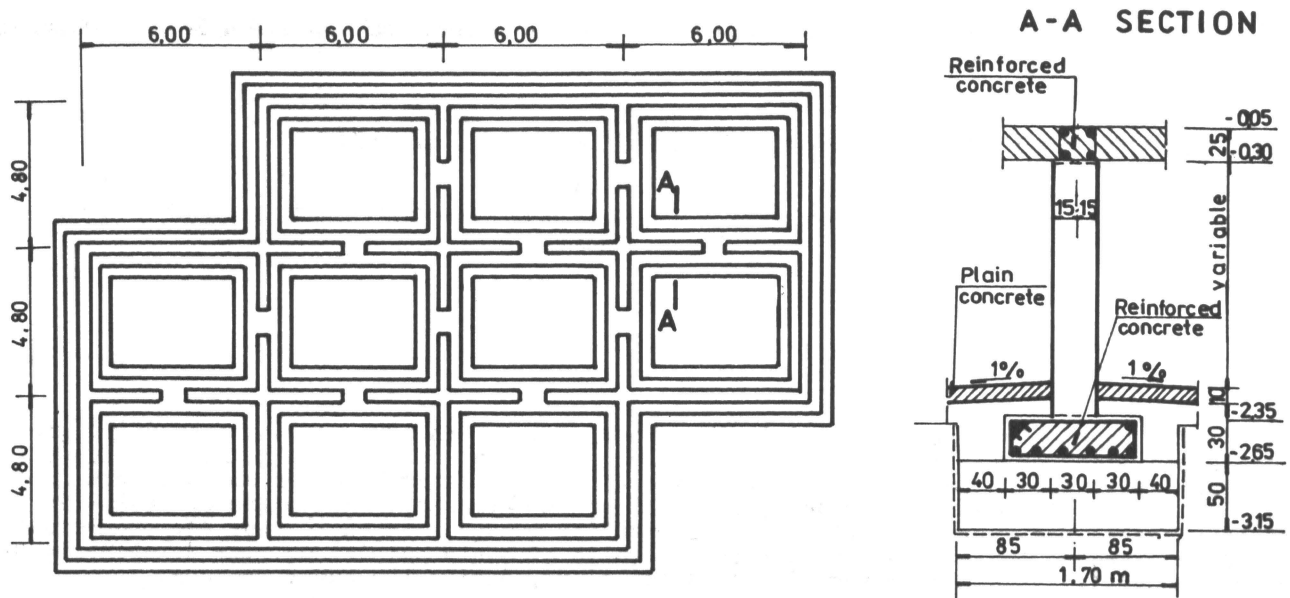
of the foundations plan as against the central inertial axis parallel to the construction sides can be noticed. In an open pit situated in the part opposite to the inclination from the non-uniform settlement, it was noticed that the reinforced concrete bearing was detached from the plain concrete foundation (fig.4).

Fig. 3 Plan arrangement and shape of the foundations

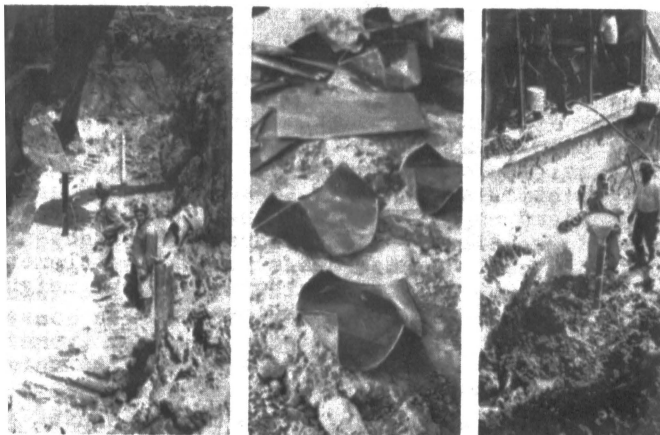
Fig.7 Thrust of vertical pipes used to introduce quick lime in the foundation ground (a). Metal sheet bent at corners (b)

from the weight of the active substance. The foundation ground was treated as follows :  
The ground was excavated following the construction perimeter till the surface of the black clay layer in which the foundations were performed. At the limit of those foundations, metal pipes of 100 mm diameter were thrust vertically into the earth by pushing with the shovel of an excavator (fig.7,a). The peak of the pipe reached 3.00 m below the foundation surface. To prevent the soil from entering the

pipe, its lower end was covered by a metal sheet, bent at its corners (fig.7,b). The quick lime was finely crushed in the ball mill and then put into plastic bags. Through a funnel the finely crushed lime was introduced into the pipe. After filling the pipe, it was extracted by pulling it out using also the ex-

cavator shovel. A treatment cycle was achieved for one point in about 3+4 minutes. A total of 520 drillings spaced at 20+30 cm on three parallel rows were performed on the outer perimeter of the foundations. In the first row of drillings, only quick lime was introduced in the second, lime with cement in equal quantities to insure the mix hardening and in the third row, lime with cement and fine gravel (3-7 mm). The two parallel outer rows served to deform the lime columns by thrust and to increase their surface of contact with the ground. During the treatment period, ground temperature was noticed to grow in the zone. The work was completed in about 48 hours and its result was the reduction of the maximum settlement rate to about 1 mm/day. The continuation of displacements by the rejection of the ground below the foundation came to put into contact the floor over the basement with the ground entering in the three rooms at the maximum settlement zone. Thus it was necessary to block up the nonuniform settlement. After eliminating some solutions of unilateral supporting of the structure on the marly clay layer, by piles or cast in place diaphragm concrete walls, the adopted solution was that of straightening the inclined construction by a controlled settlement to the opposite side of the inclination and by step by step construction of a general reinforced concrete mat.
