## FOUNDATIONS REINFORCEMENT OF OLD ALA BUILDING

Paper No.1.47

In Northern Tehran, a 100 - years old residential masonry building is being renovated into a public library.

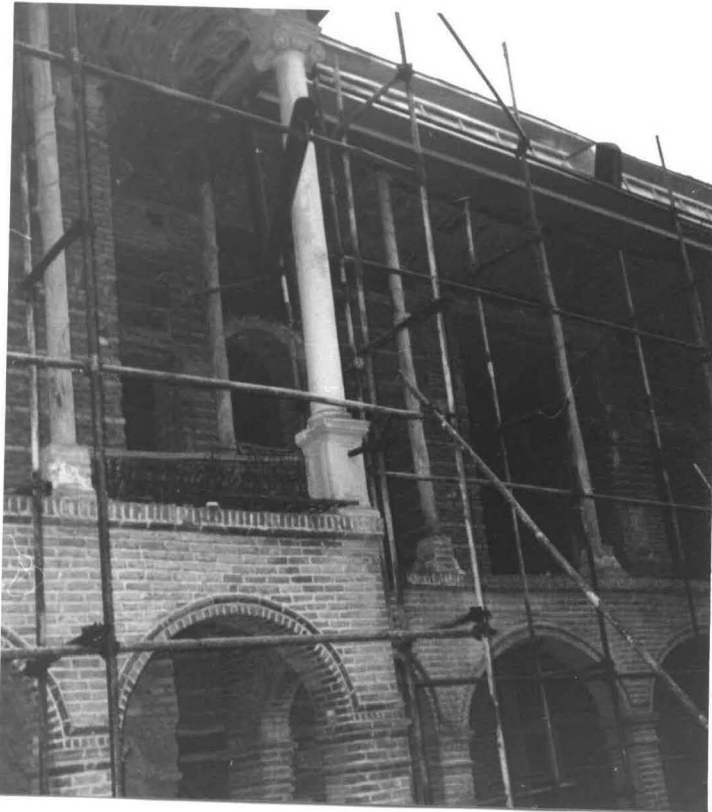
Timber is used as first floor beams and wood trusses are used for roof members. There are a few brick columns with wooden cores on the north side of this building which have added to the looks of the building, Fig (1).

*Fig. 1 North elevation*

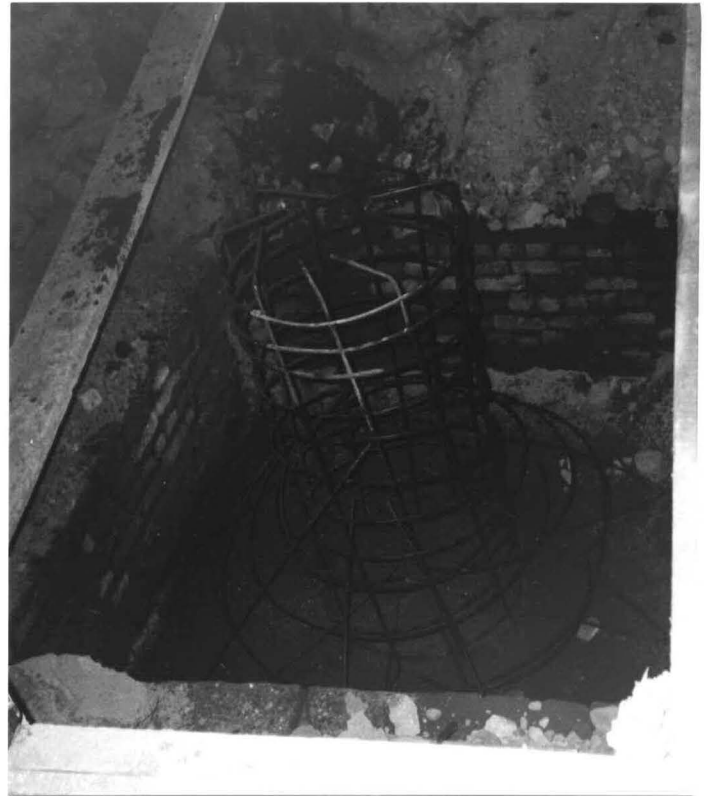
For settlement prevention of old bearing walls, the columns load are supported by end bearing piles with 3<sup>m</sup> embedment lengths, Fig (2).

*Fig. 2 End bearing pile reinforcement*

At corners of each room or corridor, four double INP sections are used as columns with an axial service load of about 50 kn.

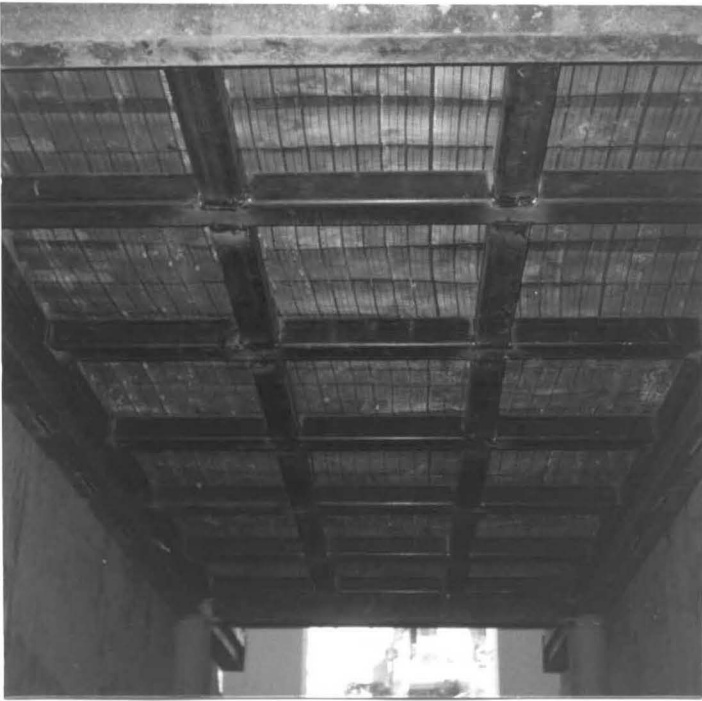
The new load bearing system consists of a steel grid system which is made from tube sections and are attached to the underneath of the timber members.

*Fig. 3 Grid system under wooden floor*

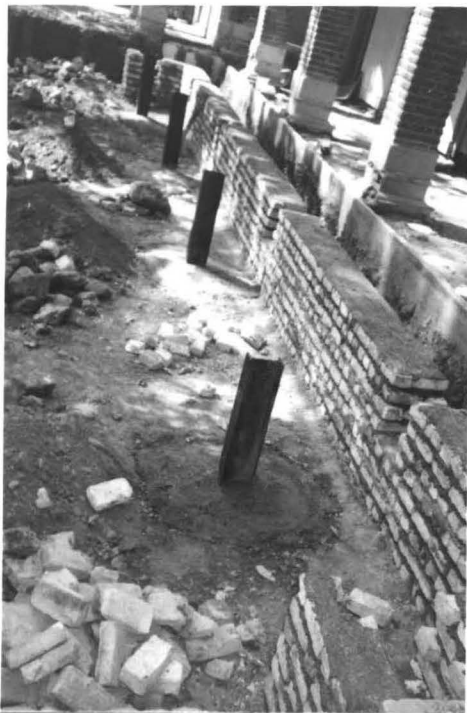
In this new design, a reflective pool is considered very close to the building. But after excavation and during its construction, a number of mortar foundations under the brick columns of the main facade began to slide.

*Fig. 4 Short INP columns*

For damage prevention to the building in this area, holes with 1<sup>m</sup> diameter were dug about 1<sup>m</sup> away from the said columns and steel INP columns encased in concrete were installed in them, Fig (4).

Fortunately this rigid short columns created sufficient vertical support against soil sliding and also created as appropriate area for further loading of the area.

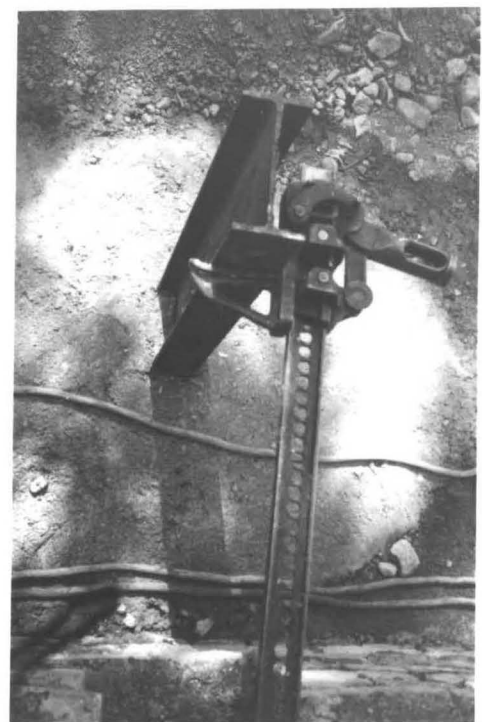
*Fig. 5 Jacking force for the stiffener*

Utilizing cross shape stiffeners from INP sections which were fixed in front of the said short columns a jacking force of 15kn were applied to each stiffener. After this stage the cross shape stiffeners and INP columns were connected with rizontal INP sections to each other and the jacks were removed, Fig(5).

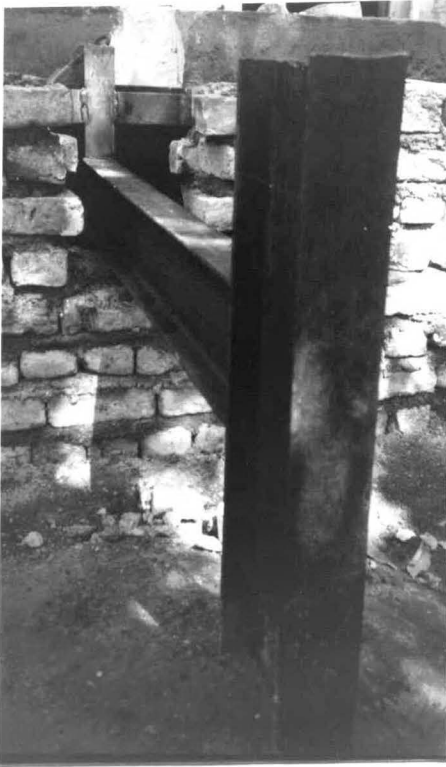
*Fig. 6 Connection between stiffener and column*

- 1- Drilling the holes in front of the brick columns.
- 2- Installing short INP sections (columns) and encasing them in concrete.
- 3- Utilizing jacking force for the cross shape INP stiffeners.
- 4- Making connections between stiffeners and short INP columns and removing the jack, Fig (6).
- 5- Constructing a massive 0.5<sup>m</sup> brick and concrete wall behind the previous vertical hard layer.

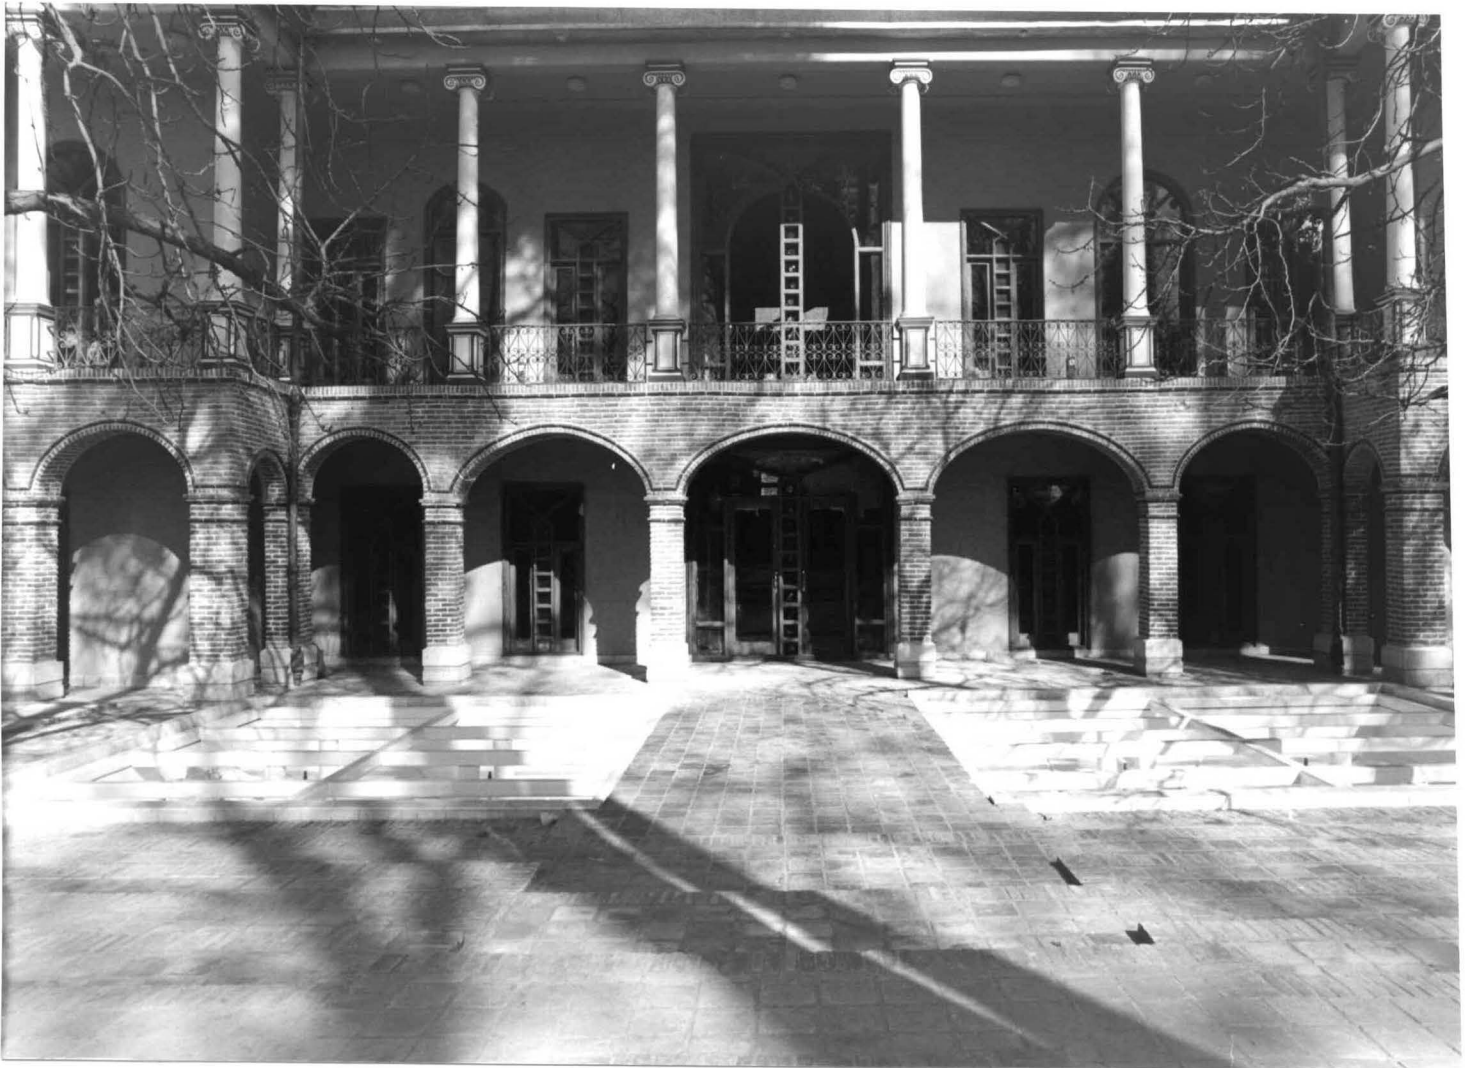
*Fig. 7 Renovated building and reflective pool*

Finally, the control of the load bearing capacity of the brick columns on the north side of the building, a surcharge of  $3 \text{ kn/m}^2$  was used as a load test for 48 hours and no deflections

were created. The renovated building and reflective pool is shown in, Fig(7).
