International Conference on Case Histories in Geotechnical Engineering (2008) - Sixth International Conference on Case Histories in Geotechnical Engineering

Evaluation and Stabilisation of an Embankment at Sebastopol, South Wales, UK

EVALUATION AND STABILISATION OF AN EMBANKMENT AT SEBASTOPOL, SOUTH WALES, UK

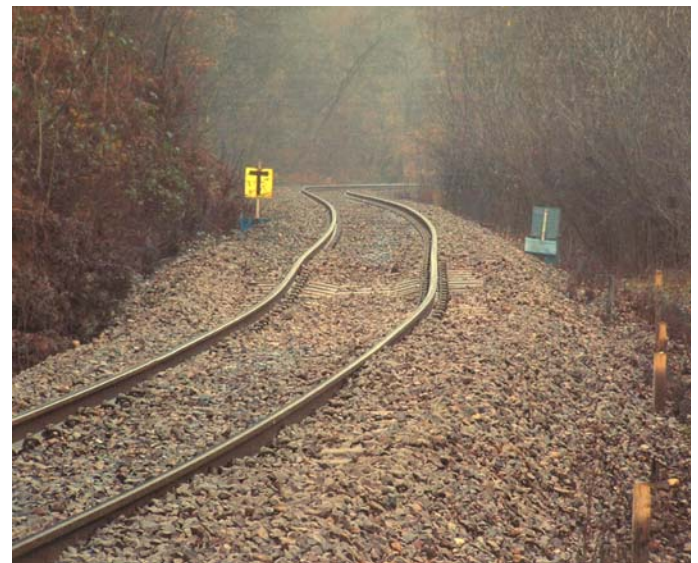
Fig. 3 View of track looking north, November 2004

There has been a history of movement which has affected both the line and an over-bridge on the line at Sebastopol. The track problems at the site were seen as a continuation of a long history of movement which is complex in its origin. Given the sidelong location of the railway on 'founded' ground it is likely that there is local movement of the railway embankment itself together with an underlying general down-slope movement of the valley slopes at least from the A469 to the river. In November 2004 the continued track movement over a distance of about 150 m necessitated the introduction of a temporary speed restriction of 10 mph (16 kph) at the site (see Fig. 3).

There has been steady movement recorded in the inclinometers on defined shear surfaces at between about 5 and 15 m depth in the main slope but less movement has been recorded in the railway embankment where the Grundomat piles are installed. The depth of the movement is often coincides with the rock-head or a short distance into the mudstones but this is not exclusively the situation with some shear zones being within the drift deposits. The tentative trajectory surfaces obtained from inclinometers are shown in Fig. 3 (movement zones are denoted with an 'M').

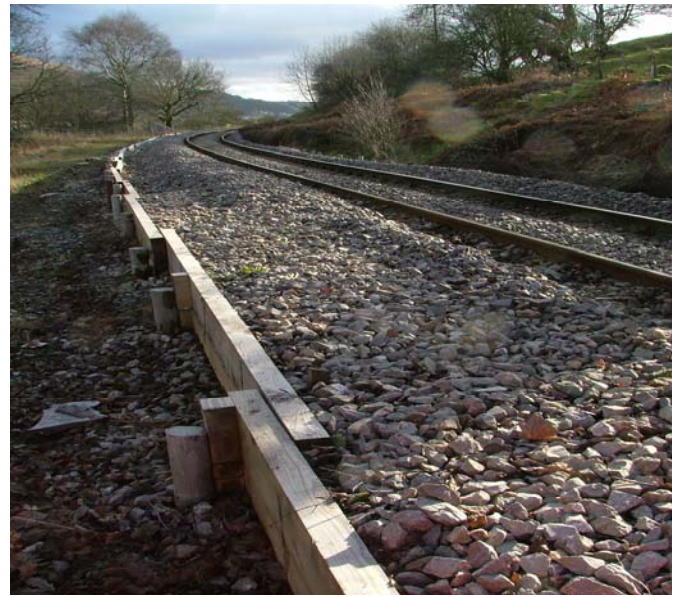
Fig. 9 View of finished Grundomat piles

Approximately 100 Grundomat piles were installed, six of which were fitted with inclinometers. At the time the Grundomats were installed the opportunity was taken to

improve the ballast shoulders of the railway with ballast boards retained by the piles. Fig. 9 shows the finished Grundomat piles.

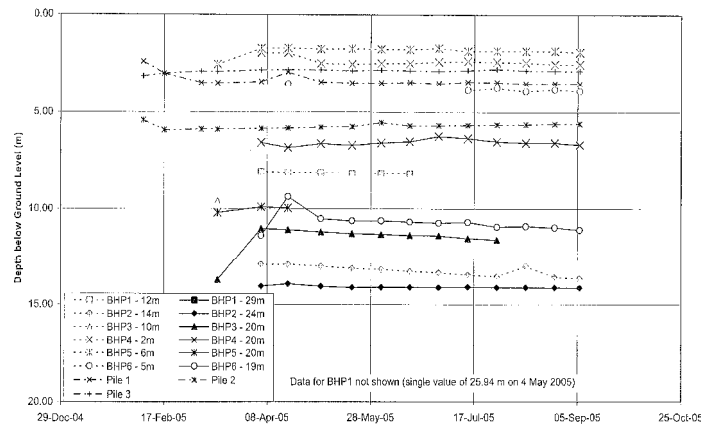
Fig. 11 Piezometric levels over 8 month period (Courtesy of Network Rail)

At the same time however, the reduction in rainfall over the summer months led to a lowering in the groundwater levels. Fig. 11 presents the piezometric levels against time. Monitoring of the piezometers shows a relatively small reduction in groundwater level eg the water level recorded in the upper instrument in Borehole 4P fell by only about 50 mm from May to August 2005. A similar trend is present in the deeper piezometers. It may also be noted from Fig. 11 that there is sufficient distinction between the readings from the shallow and deep piezometers to indicate that the drift and bedrock strata are not in full hydraulic continuity.

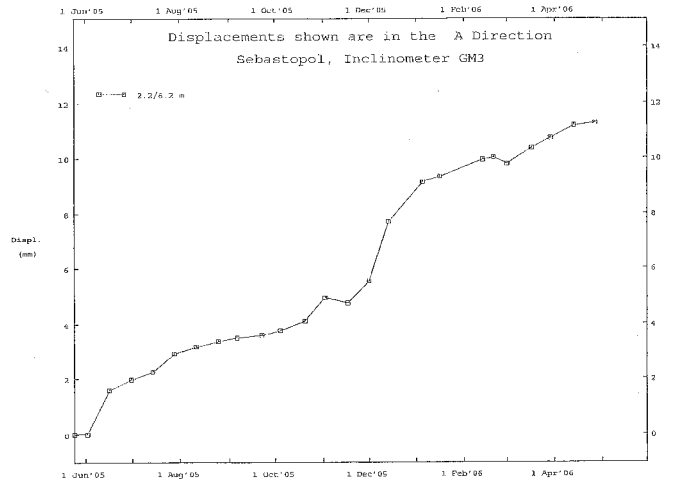
Fig. 12 Displacement against time GM3 (Jun 05 – Apr.06) (Courtesy of Network Rail)

From mid November to mid December 2005 the railway embankment movement accelerated to approximately 6 mm over this four week period. Fig. 12 shows the movement of inclinometer GM3 in the railway embankment at that period.

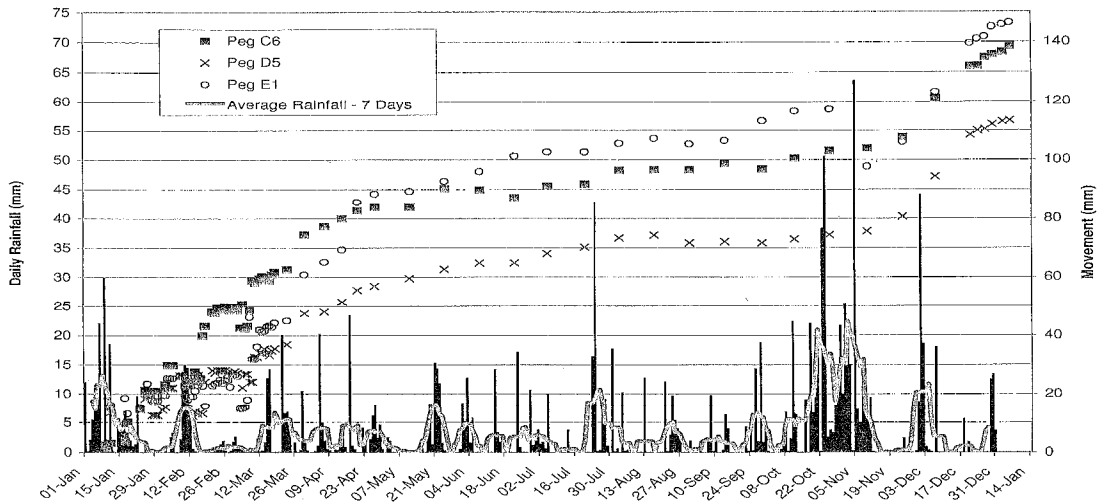
Fig. 14 Rainfall data and slope movement January to December 2005 (Courtesy of Network Rail)

Fig. 14 shows the rainfall data for the period January 2005 to May 2006. The variation of rainfall data has been compared with movements of three of the monitoring pegs (C6, D5 and E1 installed in the upper slope). The rainfall data shows a clear increase from mid November to mid December 2005. The increase in the piezometric levels reflects the increase in rainfall.

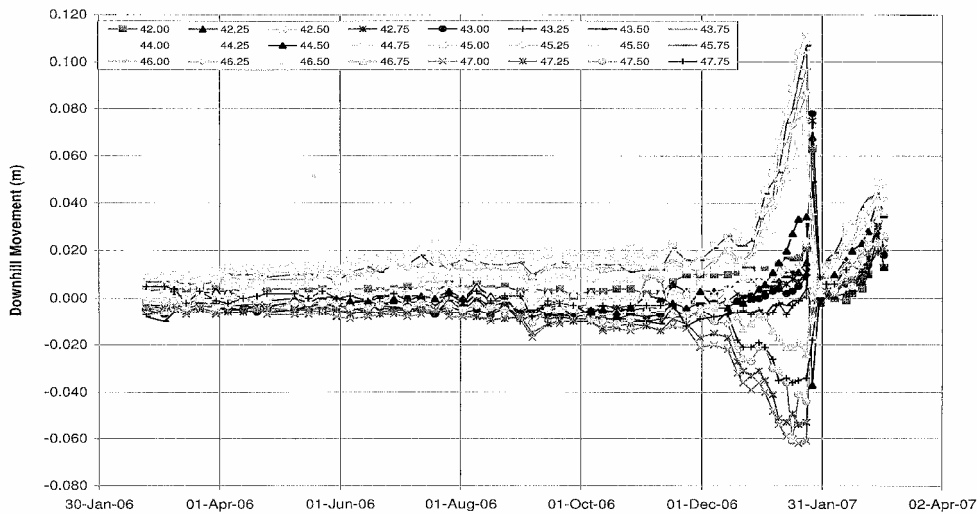
Fig. 15 Track horizontal movement of upslope rail monitoring from January 2006 to February 2007 (Courtesy of Network Rail)

Whilst there was some slow creep of a few mm per month in the railway embankment, the movement accelerated abruptly in December 2006 due to the heavy rain at that time. Fig. 15 shows the horizontal track movement of upslope rail during that period. The large movements suggested that some of the Grundomat piles were over-stressed in bending or had become detached at rockhead. Therefore the continued ability of the Grundomats to stabilise the embankment was considered to be of limited duration, perhaps 1 or 2 years.

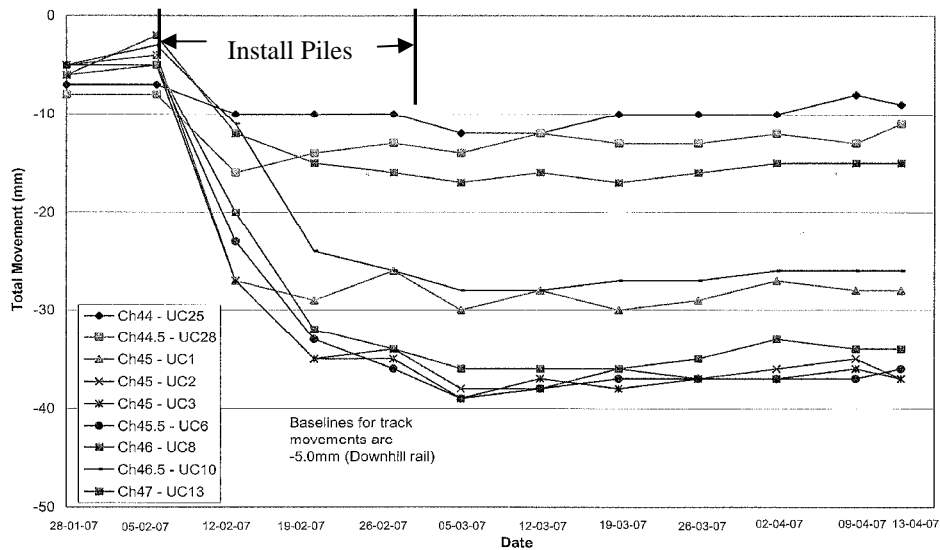
Fig. 17 Down-slope track horizontal movement against elapsed time

Fig. 17 presents the down-slope track lateral movement against elapsed time. The track movements before the installation of the Grundomat piles are clearly large, but the rate of movement slowed down after the installation of the micro-piles in February 2007 and line speed has again been restored.
