Crack Damage and Treatment of Low House on Expansive-Contractive Red Clay

SYNOPSIS : Red clay distributes widely in China, it can be classified into two kinds: swell-shrinking and non-swell-shrinking red clay. According to the strong strength and low compressibility features of the Expansive-contractive Red Clay (ECRC), it can be used as an excellent natural ground. Sometimes its swell-shrinkage property may cause crack damage to the low house which based on the ECRC. this rupture is quite common and serious, the crack house became dangerous and had to be rebuilt. In China, the main preventive measures against the crack damage are: moisture holding, deep embedment, soil replacement method (sand cushion), sand surrounding and heat insulation, etc.

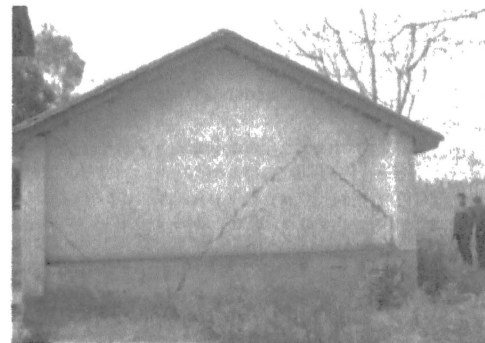
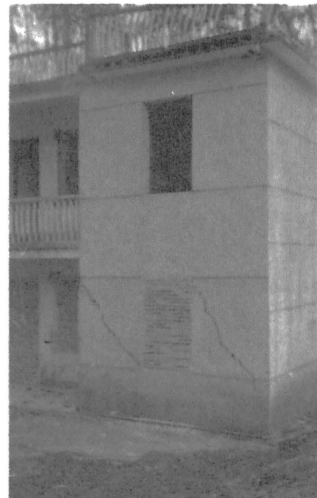
Fig 4. Crack Failure of Lower Houses on The ECRC

The main damage to the house on the ECRC is crack damage in the wall of the low house (no more than three storeys), see Fig.4. Form of the cracks are vertical or horizontal, but oblique in most case. The width of the cracks, some reach 10 cm, some even more than 20 cm.

As to the crack damage to the house on the ECRC, on one hand, it was caused by the excessive vertical swell-shrinkage, however, in the climate condition of southern China, the crack damage were generally caused by the subsidence of shrinking.

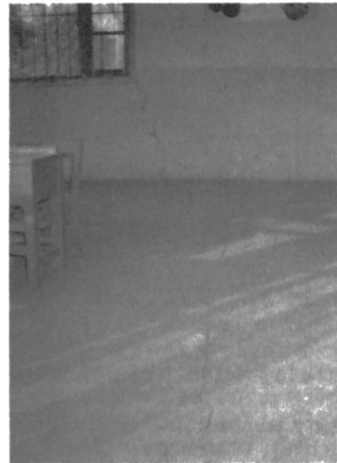
Fig 8. Crack Damage To A Single-storey House Caused By Ground Crack

Fig.8 showed that the crack occurred in the wall and floor of a single-storey house when a ground crack occurred below this house.

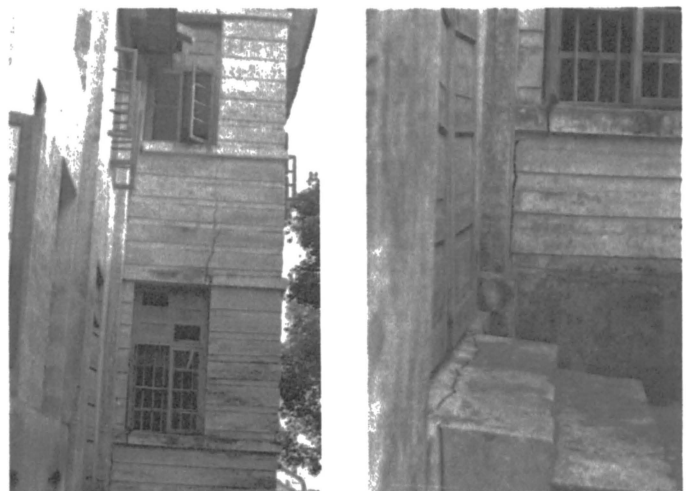
Fig 9. Crack Damage To A Two-storey House Caused By Ground Crack.

Fig.9 showed that the crack was occurred in the wall of a two-storey house when a ground crack occurred below this house.
