Geotechnical Problems in a Bridge over Corinth Canal

SYNOPSIS The railroad bridge of Corinth Canal was founded in a stable tectonic block (horst) consisting of neogene marly limestones, marls and sands. After the last strong earthquake of 24th February 1981 an extension of existed subvertical joints, directed E-W, was observed close to the northern bridge abutment. A geotechnical study was carried out for the detection of the causes which created these phenomena and for the design of probable reinforcing measures. From the results of site investigations and laboratory tests and after considering the slope stability, it was concluded that the only risk for the abutment is the progressive change of joints apperture and their erosion due to rain water. To minimize this risk, the installation of inclined untensioned grouted dowels was proposed and the continuous monitor of joints apperture especially during future strong earthquakes.

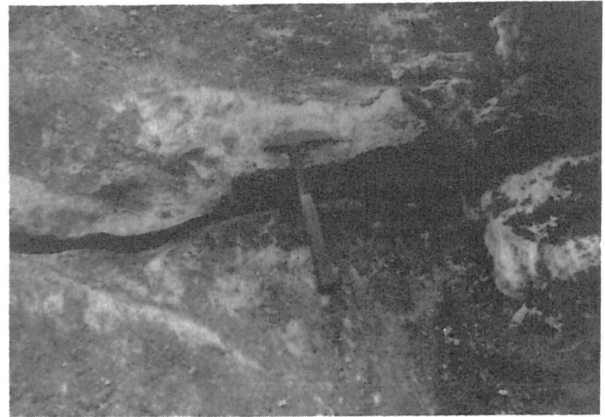
Fig. 4. Characteristic joint in marly limestone

In Figure 4, a characteristic joint is shown, having a dip direction of 8° and a dip of 88°.

Its maximum apperture was 5 cm filled with loose sandy clay. The joint walls were smooth, undulated with a wave-length of 2.5 m and an amplitude of 20 cm, without the appearance of any slickenside or other lineation of mechanical origin.

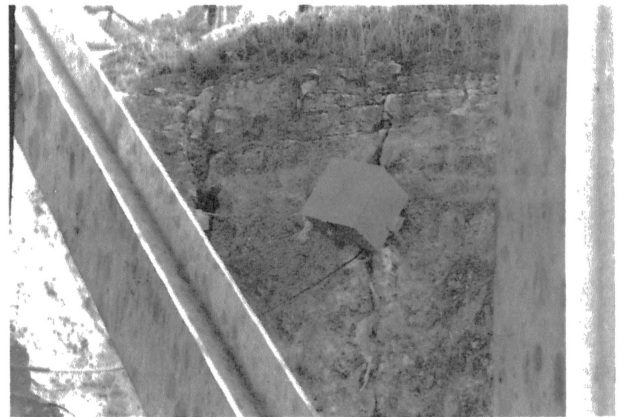
Fig. 5. Installation of a crack displacement transducer on joint walls

In order to measure probable movements of different rock blocks limited by existing joints, five crack displacement transducers were installed on the walls of joints close to the abutment. These transducers were connected with the portable measuring instrument through a 12-channels switch box.

In Figure 5 a transducer, covered for protection with a metallic box, installed on the walls of a joint is shown. The relative movements of joint walls started to be monitored immediately after the installation of the measuring system and the recorded values in certain dates are presented in Figure 6. As the figure illustrates, the deviations from the initial readings are very small (max. value 0.285 mm). Also there was not any continuous opening or closing of joints walls observed, but only an alternating increase and decrease of the initial apertures.
