Seismic Stability of Hillslopes in Greater Cincinnati Area

SYNOPSIS: Slope stability problems involving colluvia on shale bedrock are common in the Greater Cincinnati Area. The behavior of these hillslopes during earthquakes is, however, not known. This gives cause to speculation whether they are vulnerable to earthquake vibrations. In order to verify the response of these slopes to earthquake induced ground motions, representative composite clay-shale samples obtained from a typical colluvial hillside in Cincinnati were tested in a cyclic direct shear apparatus which was attached to a load cell from the MTS piston actuator. The samples were initially consolidated under a selected normal pressure and then sheared until residual strength was developed. Pulsating strains were then superimposed simulating seismic excitation and the response was recorded by digital equipment. The results from the laboratory experiments were used in the analysis of "infinite colluvial slopes" for a wide variety of assumed conditions.

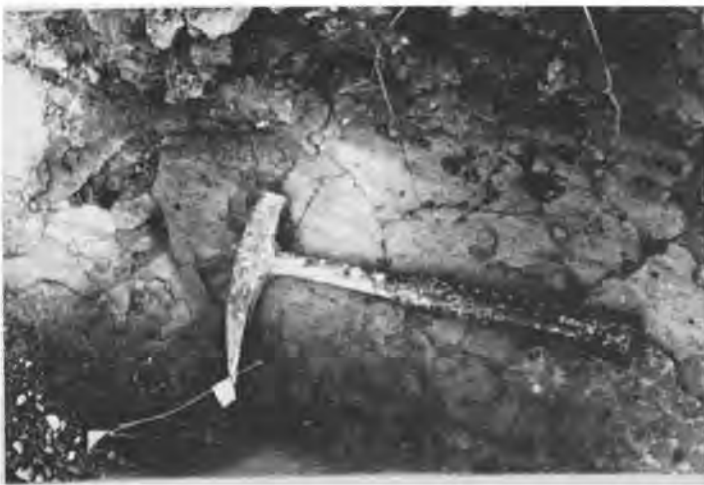
Figure 3a. Exposed Slickenside Surface.

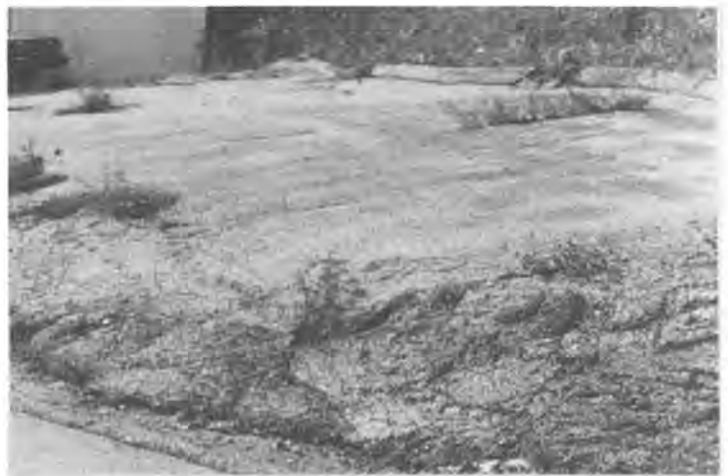
Figure 3b. Creep at Toe of a Sensitive Slope.
