Recent Advances in Geotechnical Earthquake Engineering and Soil Dynamics and Symposium in Honor of Professor I.M. Idriss

MACHINE FOUNDATIONS AND BLAST ENGINEERING VIBRATIONS CASE STUDIES

Ion Vlad

Romanian National Center for Earthquake
Engineering and Vibrations (R.N.C.E.E.V.)
within T.U.C.E. Bucharest, 020396 Romania

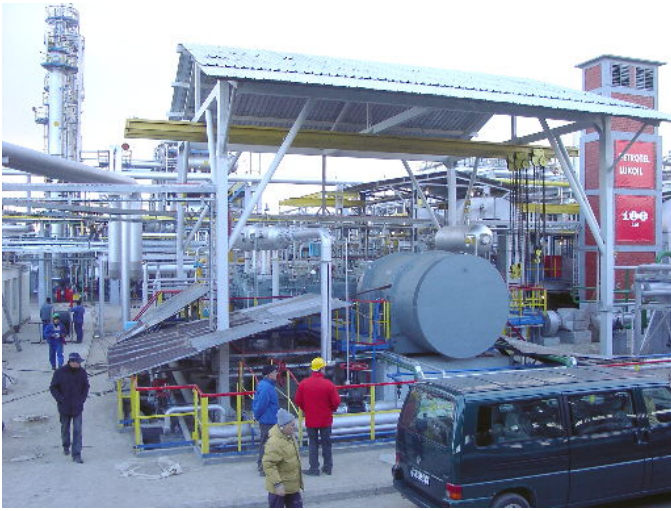
Fig. 1. General view of the compressor.

A compressor (type 06-NK3, Fig. 1) that was installed in an oil refinery was supported on a concrete block foundation that has been built to match the dimensions suggested by the supplier of the machine. The manufacturer of the compressor also imposed the requirement that the foundation should be designed in such a manner that the “peak-to-peak” displacement amplitudes at operating speed, at the top of the foundation, do not exceed 63.5 μm (microns), which is an extremely severe condition.

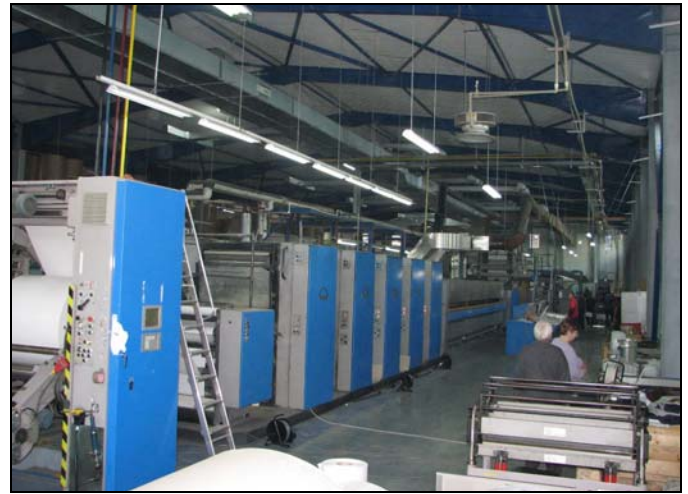
Fig. 16. General view of the printing press.

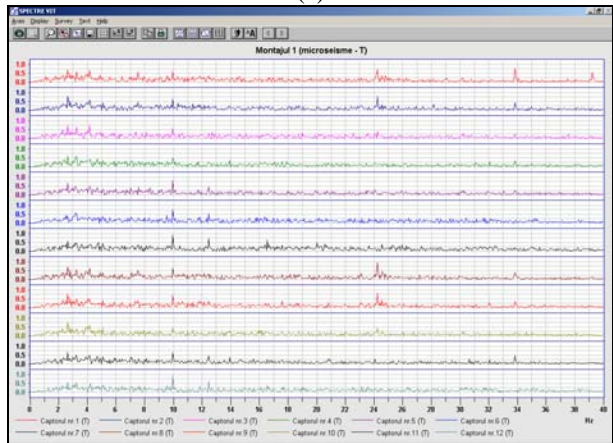
Fig. 20. Ambient vibration data acquisition; velocities. (a) time domain; (b) amplitude Fourier spectra.

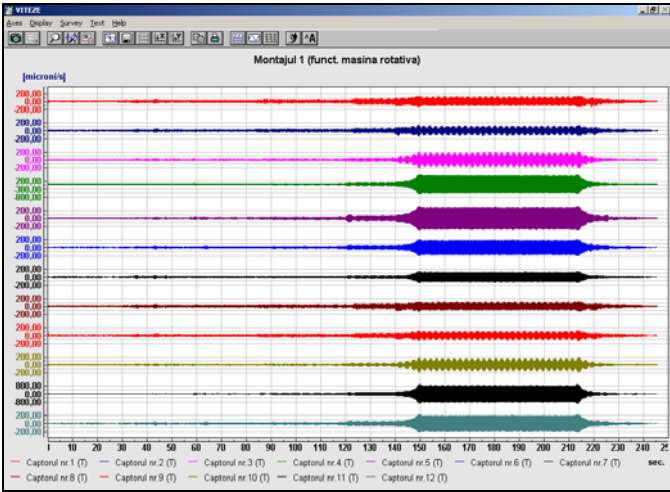
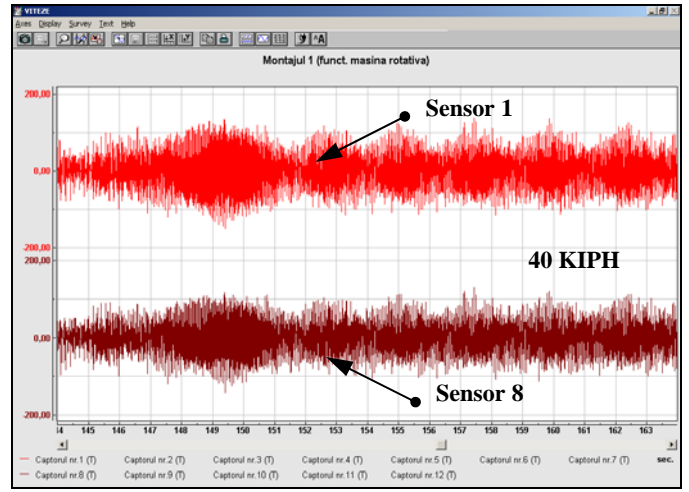
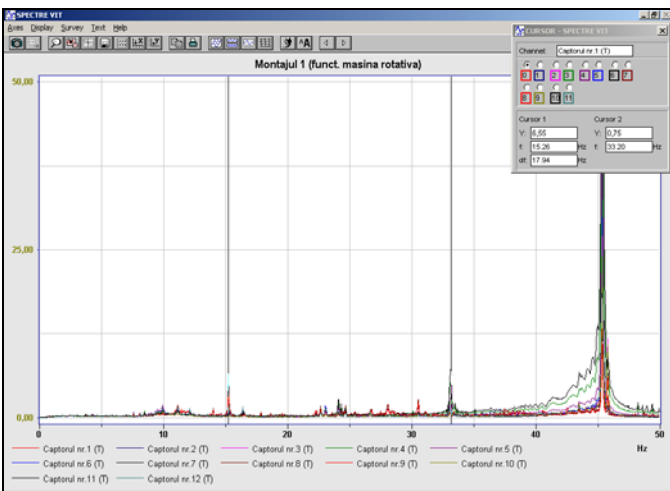
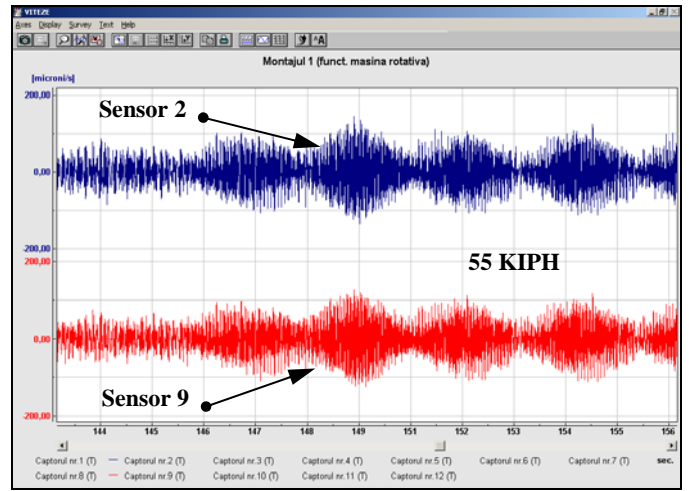
Fig. 21. Printing press operating from 5 to 55 KIPH; velocities. (a) time domain; (b) amplitude Fourier spectra.

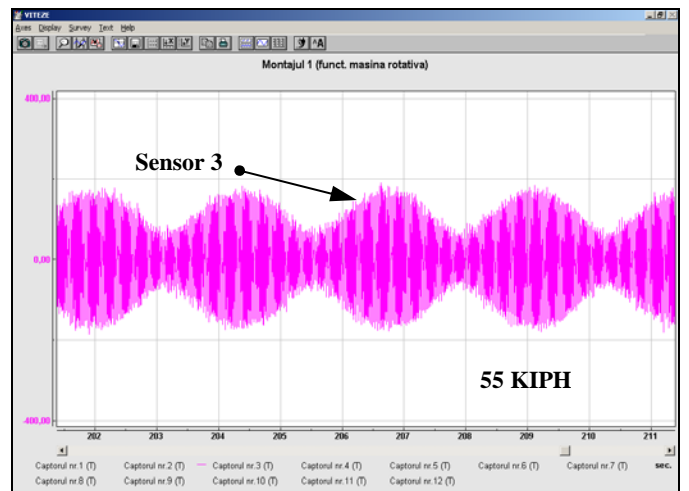
Fig. 22. (a)-(d). Printing press operating at 30...50 KIPH. Time domain; transversal direction; velocities.

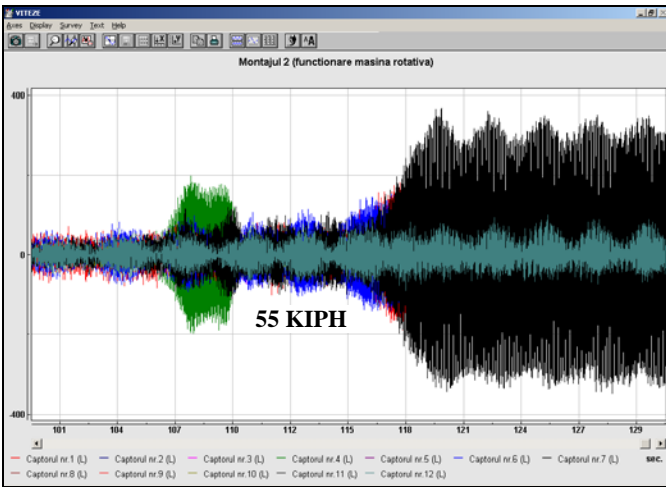
Fig. 23. Printing press operating at 55 KIPH; velocities; longitudinal directions.
(a) time domain; (b) amplitude Fourier spectra.

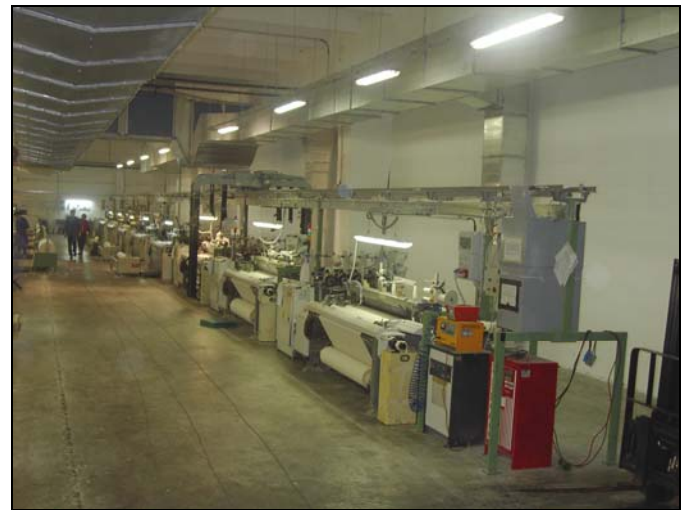
Fig. 30. General view of the rapier type weaving looms.

The *office building* is of square shape in plane, consisting of three spans and three bays, 5.40 m each. From the architectural point of view the building has 5 levels (no basement). The first floor is 4.00 m high, the next three levels are 3.30 m high and the last one is 3.70 m high. The structural system of the building is of reinforced concrete moment resisting frame type. In Fig. 29 the horizontal plane section of the industrial complex which is subject of the present paper is presented. Fig. 30 shows a general view of the weaving shed.

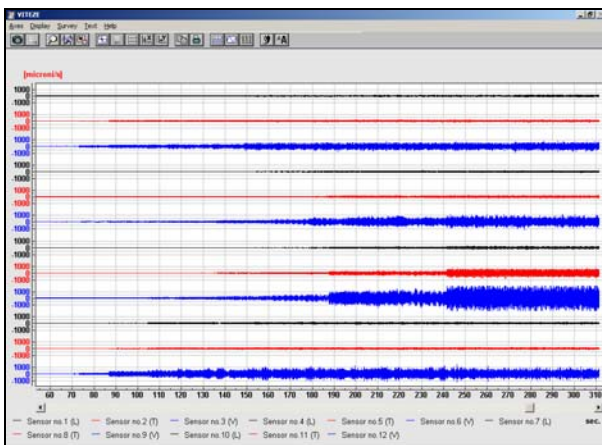
Fig. 35. Weaving shed. Normal operation of all weaving looms; .velocities [$\mu\text{m/s}$].

(a) - time domain; (b) - amplitude Fourier spectra.

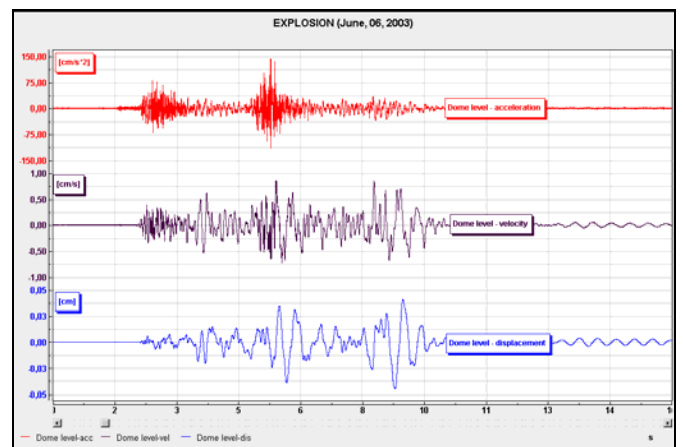
Fig. 49. June 6th, 2003. Dome level: maximum recorded values during the demolition of “Body C”.

Other samples of the outcome of the numerical process are shown in Fig. 48 and Fig. 49 as follows.
