International Conferences on Recent Advances
in Geotechnical Earthquake Engineering and
Soil Dynamics

Mechanical and Acoustical Vibrations of a Building Generated by Weaving Looms

MECHANICAL AND ACOUSTICAL VIBRATIONS OF A BUILDING GENERATED BY WEAVING LOOMS

Dynamic excitations and the resulting stresses in a weaving mill can affect its functioning in many different ways. Possible consequences of service vibrations include emission of acoustic waves, reduction of product quality, damage of non-structural elements (especially partition walls and cladding) and the disturbance of the activity in buildings placed in close vicinity. It is difficult to identify the influence of the vibrations on the production, on the weaving shed and on the neighborhoods. In 2004, an Italian company has rented in Romania 6000 square meters in a huge, one level industrial building, in order to lay out a weaving mill. Connected to this building there is a small five level office building having 256 square meters in plane. Two categories of weaving looms were installed, air-jet based type and rapier based type. One may say that it was another well-known classical result of the acquisition of second hand

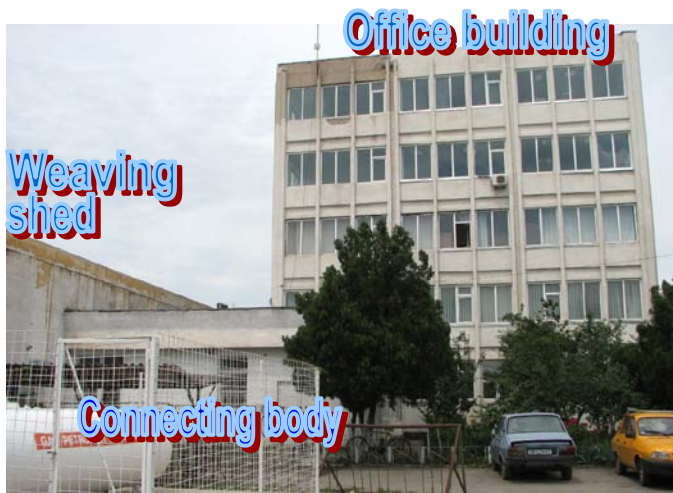
The *weaving shed* is of rectangular shape in plane, consisting of four spans of 18 m and seven bays of 12 m. No partition walls existed in the rented area. Between the two buildings there is a small “*connecting body*” (Fig. 1).

Fig. 1. General view of the complex of three buildings.

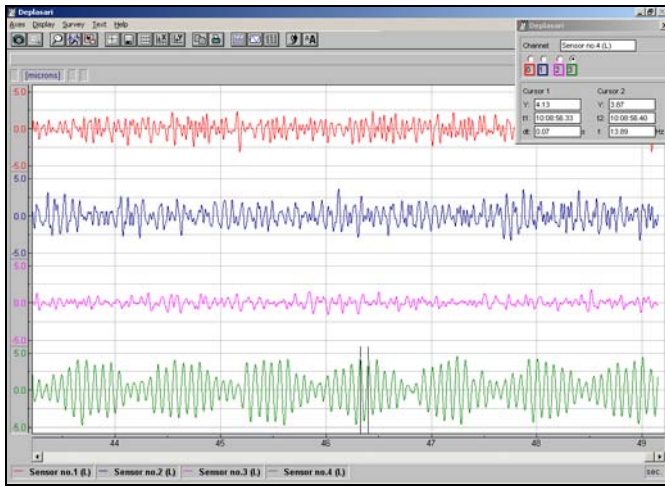
Samples of the results of the numerical processing of the instrumental data, recorded during the first stage, are shown in Fig. 11 and Fig. 12, as follows:

Fig. 12. Flat roof of the weaving shed - third configuration. Normal operation of all the weaving looms). Velocities [$\mu\text{m/s}$]. (a) - time domain; (b) - amplitude Fourier spectra.

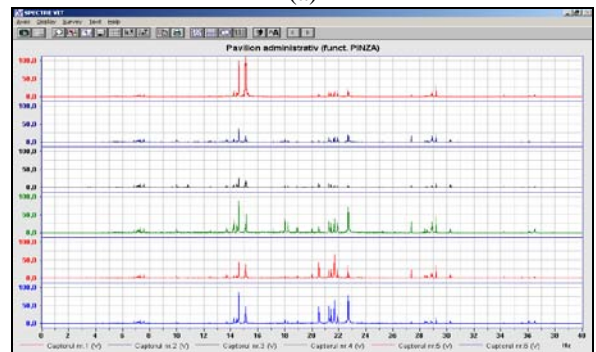
Typical time domain velocities and the corresponding amplitude Fourier spectra are shown in Fig. 14 and Fig. 15.

Fig. 15 . Office building. Normal operation of 11 rapier type weaving looms. Velocities [$\mu\text{m/s}$].
(a) - time domain; (b) - amplitude Fourier spectra.

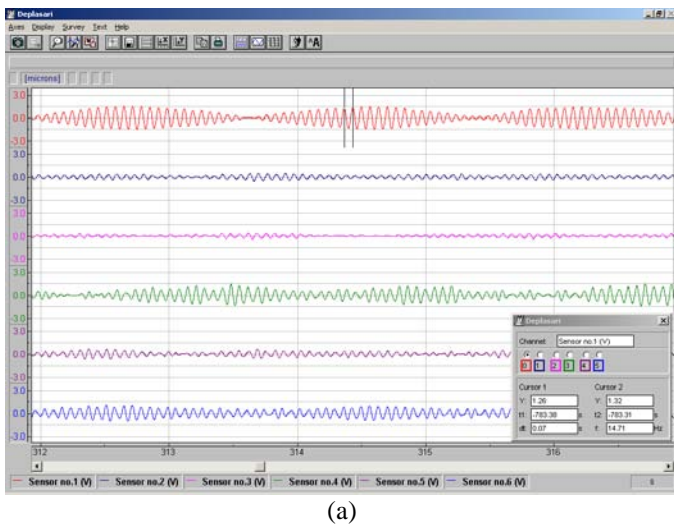
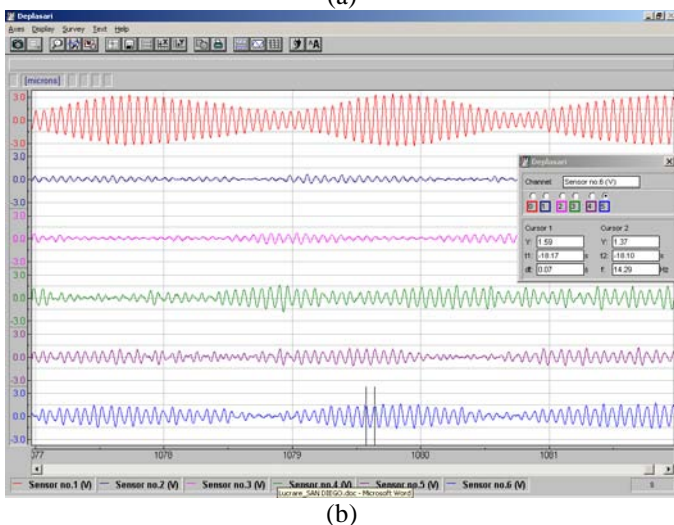
- the examination of strongly filtered records in the frequency intervals 14 Hz÷14.9 Hz and 15 Hz÷15.5 Hz pointed out some supplementary aspects (Fig.16 and Fig.17):

- a) for the lower amplitude of the disturbance, strong “beats” were signaled especially for the column placed at the intersection of axes B and 3’ and for the slab panel placed between axes A – B and 1’ – 2’; practically no beats were observed in the slab panel placed between A – B and 2’ – 3’;

Fig. 16 . Office building. Normal operation of 5 (a) and 17 (b) rapier type weaving looms. Signal filtered in the interval 14...14.9 Hz. Displacements [μm].

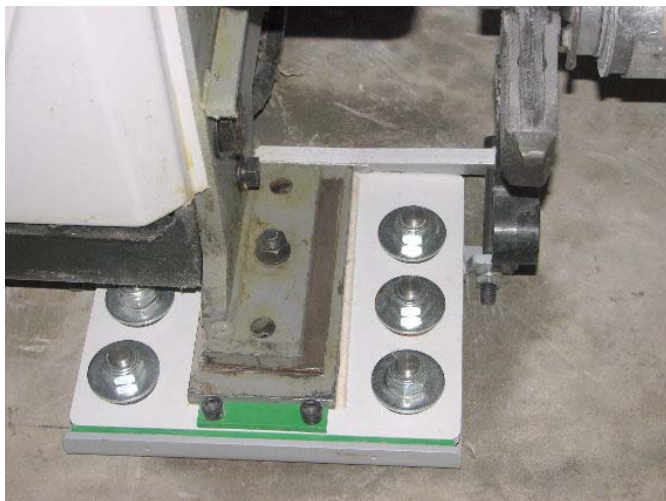
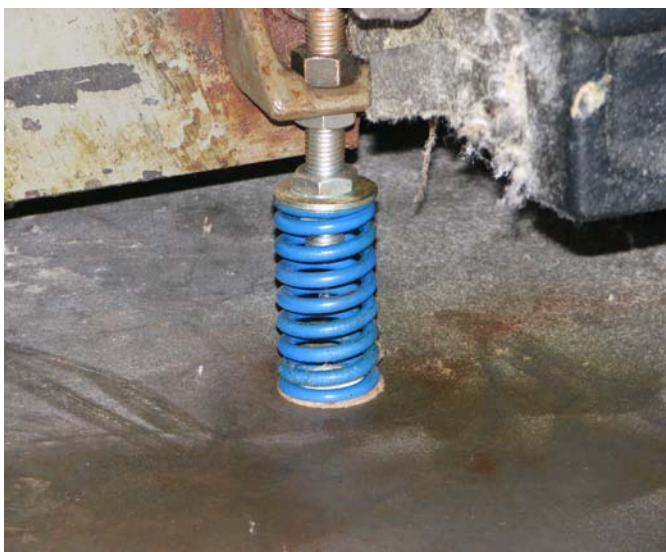
Fig. 18. The new system of isolation for the raper type weaving looms.

- f) The associated phenomena to this intervention being extremely complex imposed the initiation of a costly research program, entirely sustained by the owner of the weaving looms, both in Romania and in Italy. Based on the first stage instrumental investigation results, the Italian manufacturer asked a specialized company from Italy to carry out a “*system of isolation*”, capable to avoid the excessive vertical vibrations perceived both in the weaving shed and in the office building. Two systems of isolations were tested. The first type was set at two weaving looms and the second one was set at two other weaving machines. The results obtained by instrumental investigations were that the level of vibrations in the weaving shed was reduced, but the annoying effects at the fifth floor in the office building still persisted. In this situation, the two systems of isolation were tested in the laboratory of R.N.C.E.E.V. The obtained results led to the necessity of performing new instrumental investigations in the office building. This was the story of the second stage of instrumental investigations when three sensors were mounted directly on three columns and other three on three panels of the general slab of the fifth floor of the office building. The conclusions that have resulted were presented in paragraph 4.2. As it was established that the two systems of isolation could offer neither the warranty of reducing the level of vibrations and, more than that, nor the annoying permanent noise at the last floor of the office building, the decision to design a new system of isolation was taken. An engineer of a specialized company in weaving looms vibrations isolation, together with the owner of the equipment arrived in Romania to evaluate *in situ* the actual situation. Based on the second stage results of the instrumental investigations, a new type of “isolators” was created by the Italian company “ST – Soluzioni Tecniche” (Fig. 18). The system of isolation reduced the vibrations on

both horizontal and especially in the vertical direction. After setting up these isolators the level of vibrations in the two buildings was substantially reduced. The permanent noise, but in principal the exceedance of “*thresholds of high intensity*”, extremely annoying, which have produced the phenomenon of “*acoustical fatigue*” have also disappeared.
