The Stability and Deformation Limit State Corresponding to the High Road Embankments Close to a Bridge

THE STABILITY AND DEFORMATION LIMIT STATE CORRESPONDING TO THE HIGH ROAD EMBANKMENTS CLOSE TO A BRIDGE

The paper presents the analysis of a road embankment with variable height (between 4-10m) placed at Iassy, Romania, in the first year of service. It's about access ledge at a bridge with total length of about 300m. At this time the embankment presents longitudinal cracks parallel with road axle, lateral knobs corresponding to each compacted layer, infiltrations through the backfill from the top (faulty pluvial system) and from the bottom (flooded foundation soil without drainage system).

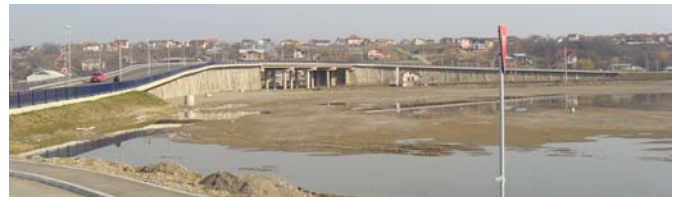
Fig. 1. General view of the embankment

The object of this paper is to present the analysis of a road embankment with variable height (between 4-10m) placed at Iassy, Romania. This embankment presents from the first year of service longitudinal cracks parallel with road axle, lateral knobs corresponding to each compacted layer, infiltrations through the backfill from the top and from the bottom. The owner employed an investigation team to identify, analyse and propose consolidation work for this embankment.

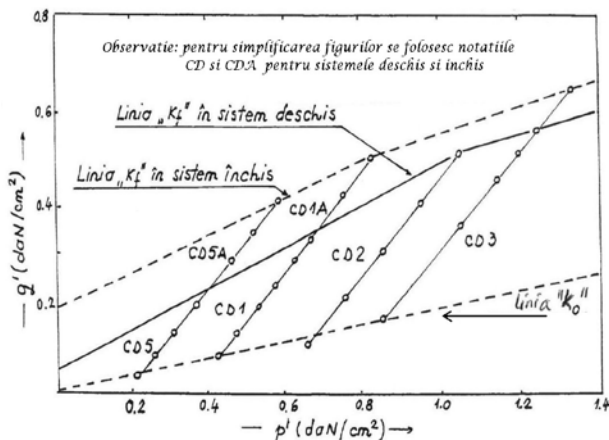
Fig. 7. $\epsilon_{ax} \div p$ ($\epsilon_1 \div q$) relations.

The following picture presents stress paths for all specimens and also the results obtained, for parameters of shearing resistance for both loading systems.

We can see that on both loading systems, in the zone of normal stresses $\sigma' < 0,8 \text{ daN/cm}^2$ intrinsic curve has big values for angle of internal friction and low values for cohesion and in the zone of normal stresses $\sigma' > 0,8 \text{ daN/cm}^2$ situation is reversed. Also it can be seen that for closed system of testing intrinsic curve near the origin of axis Bahlui clay has values 4 times bigger for apparent cohesion c' , and in the zone of normal stresses $\sigma' > 0,8 \text{ daN/cm}^2$ presents values a little bigger for apparent angle of internal friction ϕ' .

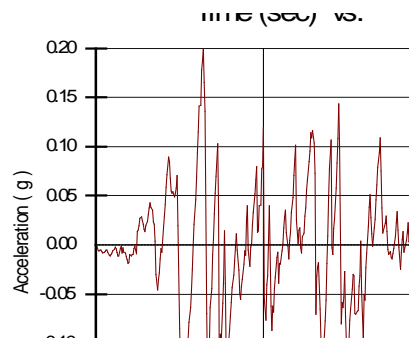
Fig. 22. Acceleration - input.

For this model GEOSLOPE is used for analysis. Here a dynamic analysis is performed according to the Romanian seismic code P100-2006. A scaled accelerogram was used with peak ground acceleration of 0,2g and 15s. Time increment was 0,02s and results were saved at every 10 steps.
