Attenuation of Peak Ground Acceleration with Distance of the June 15, 1999, Tehuacán, México, Earthquake

ATTENUATION OF PEAK GROUND ACCELERATION WITH DISTANCE OF THE JUNE 15, 1999, TEHUACÁN, MÉXICO, EARTHQUAKE

ABSTRACT

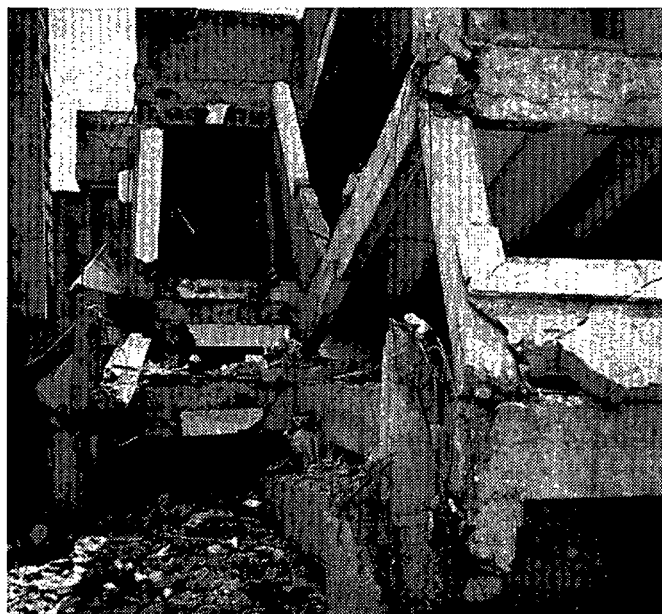
Fig. 2: Collapse of a four story structure in downtown Puebla in the zone of predicted maximum amplification

Puebla City, located approximately 125 km from the location of the June 15 epicenter, has a population of about 5 million and is home to more than 2,000 churches and temples. More than 100 of these structures were damaged by the two seismic events. A typical example of the effect of local site conditions was observed in downtown Puebla. In this case, 2 out of 4 (apparently) similar four story buildings completely collapsed or were severely damaged in an area underlying by alluvial soil deposits. Figure 2 shows one of the buildings which collapsed in the area. A second building with a street level garage also collapsed likely due to column shear (or buckling) since no punching, settlement or foundation failure was apparent. Local soil conditions at this site had led to the prediction of significant amplification in earlier microzonation studies performed by Chávez-García et al., 1995. Another example of "local site effects" is the damage to the church in the town of Cholula, approximately 10 km west of Puebla city (Pestana et al., 1999). The church was built on top of an ancient stone pyramid. The severe damage observed may be attributed, in part, to topographic amplification of ground motions due to the pyramid.

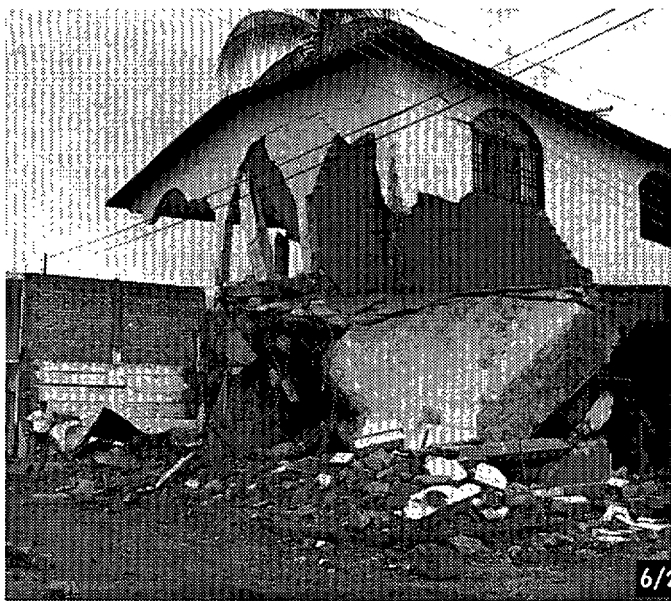
Fig. 3: Damaged modern reinforced concrete structure in Acatlán de Osorio.

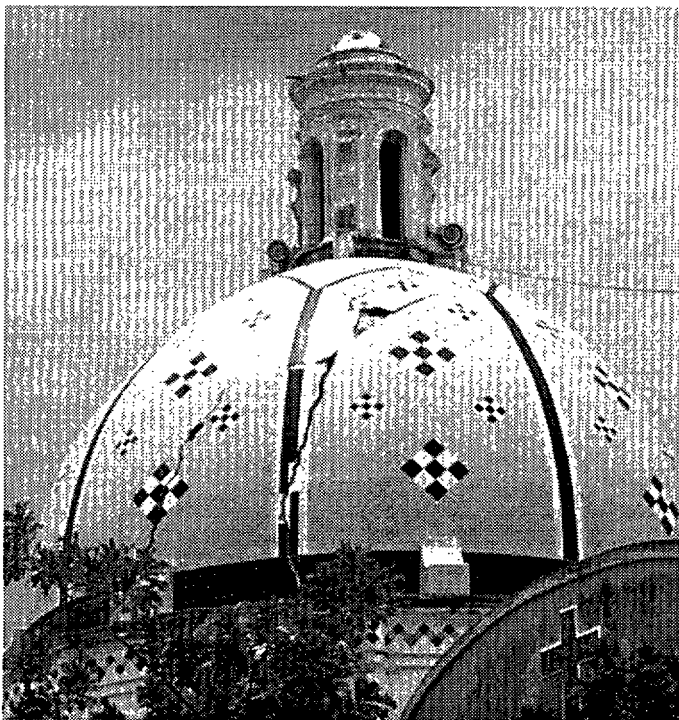
Fig. 4 : Cracked church dome in Acatlán de Osorio, typical of observed damage in the churches in the State of Puebla.

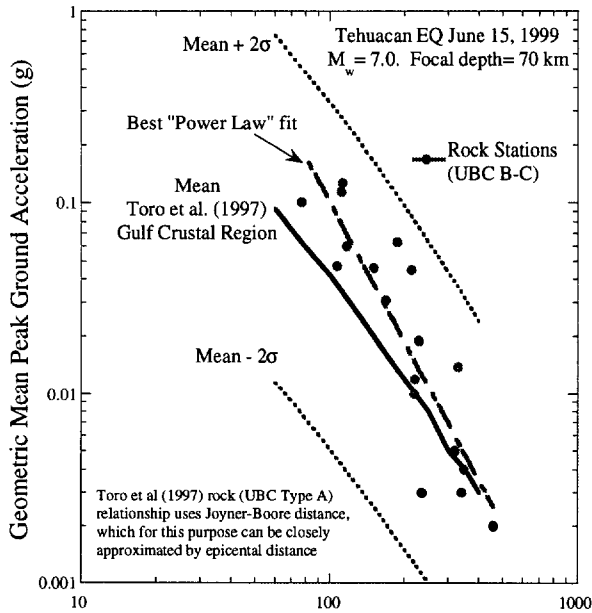
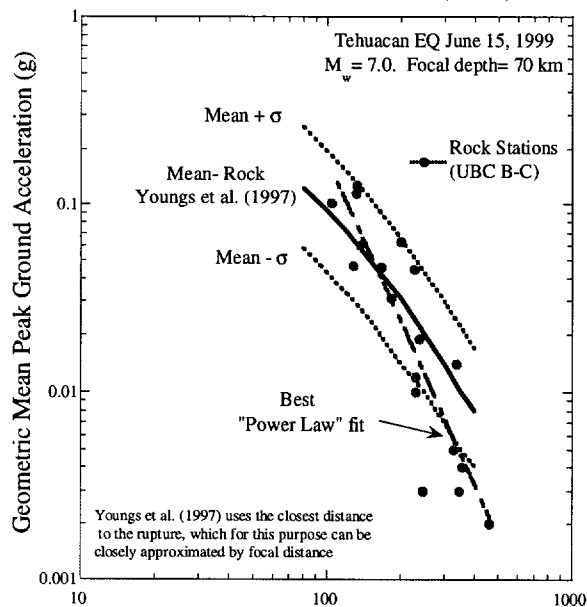
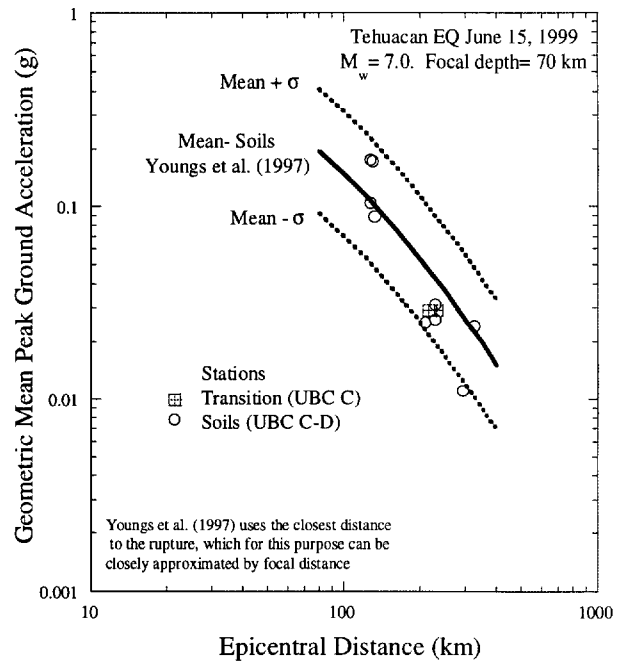
A series of North American attenuation relationships were analyzed with the collected ground motion data (Pestana et al., 1999). The Toro et al. (1997) Central and Eastern North America "Gulf" hard rock attenuation relationship appeared to represent the trends of the recorded data well, although the

PGA values were slightly underestimated by this hard rock relationship as seen in figure 7a. This is attributed, in part, to the fact the rock stations correspond to sites with soft rocks characteristics. Figure 7b and 7c shows the Youngs et al. (1997) intraslab attenuation relationship for rock (UBC, Type B) and soil (UBC, Types C and D) sites respectively, which is consistent with the conditions encountered at the ground motion stations. This attenuation relationship was developed for intraslab earthquakes associated with subduction zones using data that included, among many others, the August 28 1973, $M_w=7.0$ Mexican event as well as other Central Mexico earthquake events. The distance parameter used by this attenuation relationship is the closest distance to the rupture. In this work hypocentral distance was used in lieu of the distance to the rupture. This substitution is consistent with Youngs et al. (1997) when the fault plane geometry is not available, and is not considered to introduce a significant error due to the great source-to-site distance of the recordings.

a) Rock Conditions – Toro et al (1997)

b) Rock conditions- Youngs et al (1997)

c) Soil conditions- Youngs et al (1997)

Fig. 7: Attenuation Relationships for the Mean Peak Ground Acceleration (PGA) vs. distance

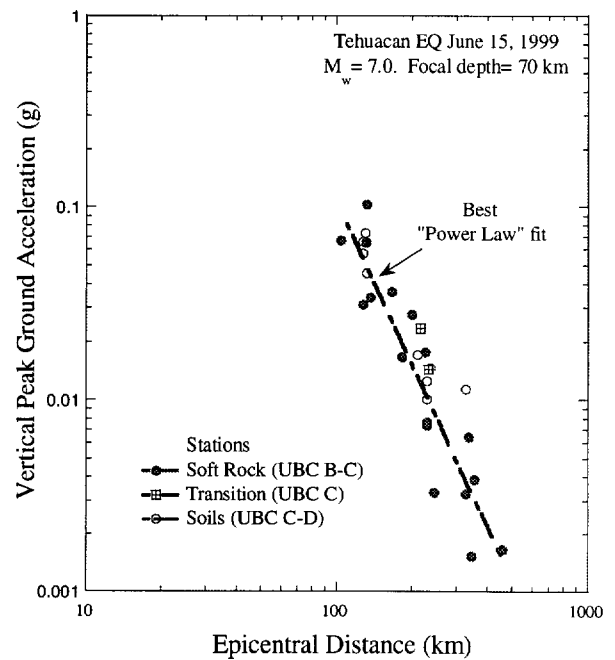
Figure 8 shows the vertical peak ground acceleration as a function of distance for the June 15 event. It can be observed that the attenuation relationship for the vertical peak acceleration is nearly the same regardless of soil conditions as opposed to the peak horizontal ground acceleration. For these deep seismic events, the ratio of peak vertical to horizontal ground motion is relatively large when compared with those measured due to shallow earthquakes resulting from subduction mechanisms near the Pacific coast.

Fig. 8: Vertical Peak Ground Acceleration as a function of distance for the Tehuacán Earthquake of June 15, 1999

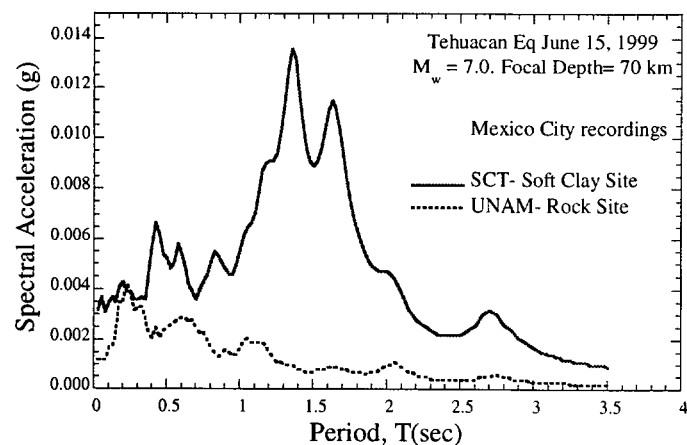
Fig. 10: Measured Soft Site Amplification in Mexico City (distance ~ 300 km)
