## **Experimental Evaluation of the Strength and Behaviour of 16- and 18-Gauge Cold Formed Steel Top Track Systems**

**RESEARCH REPORT RP05-4**

**EXPERIMENTAL EVALUATION OF THE STRENGTH AND  
BEHAVIOUR OF 16- AND 18-GAUGE COLD FORMED STEEL  
TOP TRACK SYSTEMS - 92 MM AND 152 MM, 16''- and 24''-  
SPANS (W & W/O 2X4 AND 2X6 WOOD TOP PLATES)**

**A Study Conducted at the University of New Brunswick Structural Engineering  
Laboratory under the Supervision of J. L. Dawe, PhD, P.Eng.**

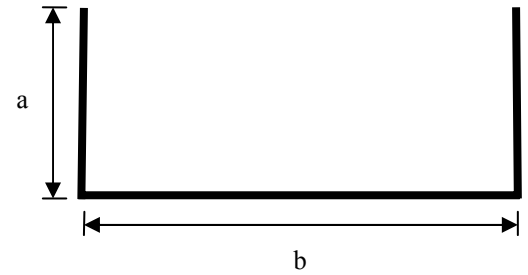
**Table 3.2 – Track Dimensions**

Designation	a(mm)	b(mm)
3 5/8"	29.97	92.58
6"	29.97	152.91
DL	50.80	92.58

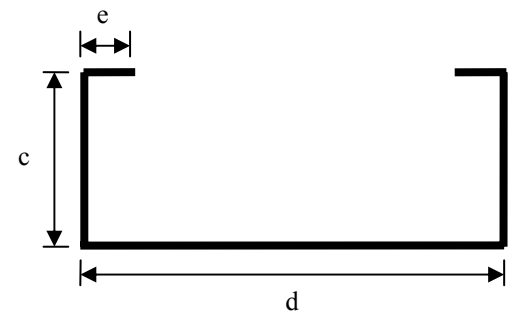
**Table 3.3 – Stud Dimensions**

Designation	c(mm)	d(mm)	e(mm)
3 5/8"	41.28	92.08	12.7
6"	41.28	152.40	12.7

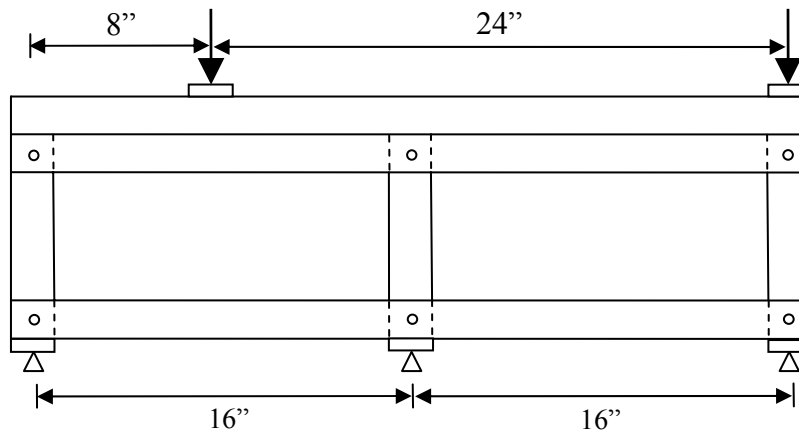
**Figure 3.1 – Typical Test Setup of 16 Inch Specimen**

Typical test set-ups are illustrated in Figures 3.1 and 3.2 which show the locations of the point-applied loads for the 16 inch and 24 inch stud spacing configurations. Figure 3.3 is a photograph of a typical set-up in the Baldwin UTM.

A distribution beam was used to transfer equal loads from the load head to the points of load application of each specimen. Reaction plates measuring approximately 18x50x250 mm were placed between each point of load application of the distribution beam and the test specimen. A W200x36 steel section was utilized as a support reaction beam for the majority of specimens. Due to various laboratory demands, it was necessary to replace this beam with a C230x30 steel section for all specimens under Objective C with the exception of specimen 1C16-16.

Each specimen was constructed as a frame consisting of three 8-inch long studs spaced at 16 or 24 inches and supporting a top track as described in objective A, B, C, D, or E. The assembly was completed by attaching a bottom track of the same specified size as the top track. Studs and track were connected with #8 hexagonal self-drilling screws. Standard 2x4 pieces of lumber were attached as required to top tracks using 3-inch long galvanized common nails. Stud spacing was either 610 mm (24") or 406 mm (16"). Typical specimens are diagrammatically illustrated in Figures 3.1 and 3.2.

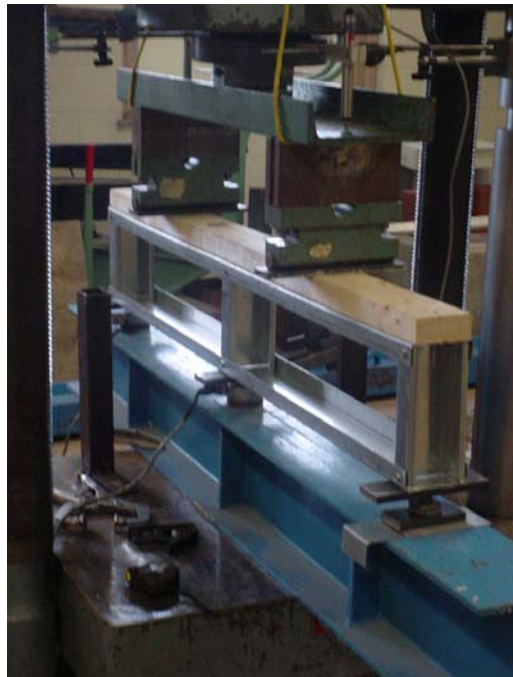
**Figure 3.3 – Typical Test Setup Showing Placement of LSCs and Load Cells**

As shown in Figure 3.3, load cells were placed between two of the specimen supports and the platen of the UTM while a ball and socket joint was used to support the specimen at the third support point. Linear strain converters (LSCs) were used to measure deflections. Two LSCs were placed so as to measure downward movement of the distribution beam and another was positioned on the platen to track its progress upward. Steel restraints were placed at either end of the specimen to prevent in-plane and lateral movement.

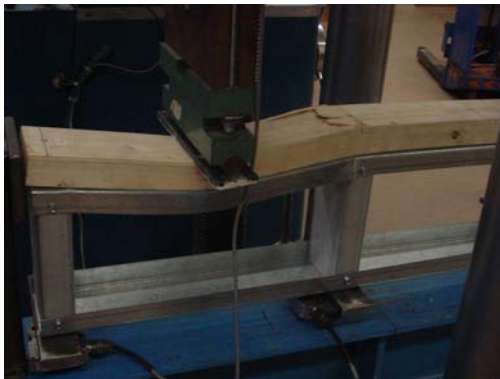
**Figure 4.1 – Failed specimen, Group A16-16**

Specimen 1A16-16 developed a slight bowing of the top track leg over its length and subsequently failed at ultimate due to tensile fracturing of the wood at mid-span. The specimen continued to deform without taking additional load as local buckling of the track legs developed at the central support in the compression zone followed by failure of the wood in the tension zone at this negative moment location. The ultimate failure of specimen 2A16-16 and 3A16-16 also occurred as a result of tension failure of the wood at mid-span followed by tensile fracturing of the wood and leg local buckling at the central support as the deformation increased and the load dropped off. The photograph in Figure 4.1, taken after failure, illustrates a typical failure mode for this specimen group.

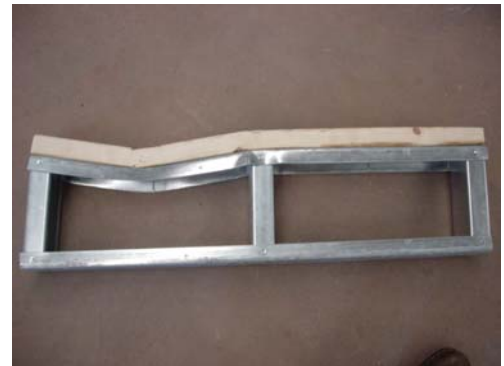
**Figure 4.2 – Flexural failure of Specimen 1A16-18**

At approximately 60% of the ultimate load, the legs of Specimen 1A16-18 began to buckle locally in the negative moment region of the central support. At ultimate, the wood failed in tensile flexure above the centre stud as shown in Figure 4.2. As deformation continued, cracking of the wood and bearing failure of the steel track occurred directly beneath the mid-span point load. Specimen 3A16-18 and 4A16-18 failed in a similar manner.

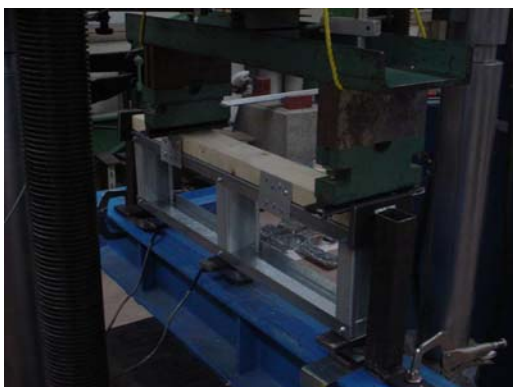
**Figure 4.3 – Specimen 2A16-18 with shear plates**

The shear connection between the wood and top track for specimen 2A16-18 was varied and consisted of steel plates fastened to the wood and steel track as shown in Figure 4.3. This specimen failed almost identically to specimen 1A16-18, although the shear connection was less efficient, and there was separation of the wood from the steel as indicated in Figure 4.4. For graphing purposes, specimen 2A16-18 was excluded as the shear connection was fundamentally different from that of the other specimens in this group.

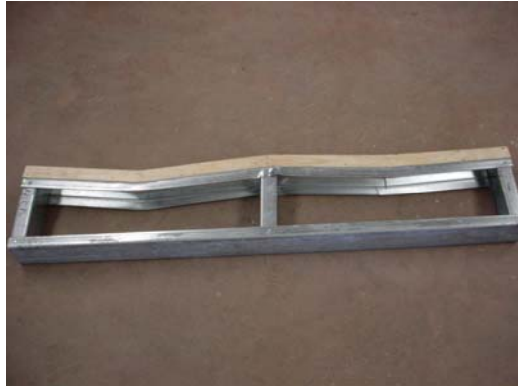
**Figure 4.5 – Failed Specimen, 1A24-16**

Specimens 1A24-16, 2A24-16, and 3A24-16 reached ultimate load and failed by tension fracturing of the wood top plate in the flexural tension zone of a preferential span along with leg buckling of the top track near the middle support. Visible local buckling at the center support

was not as pronounced as that of the 16 inch specimens in this group. A typical specimen failure is shown in Figure 4.5.

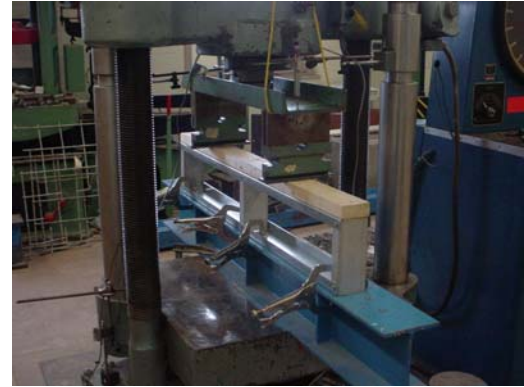
**Figure 4.6 – Clamped Specimen, 3A24-18**

In this group, the usual specimen installation was used for specimen 1A24-18 and 2A24-18 while specimen 3A24-18 was tested with the bottom track clamped directly to the reaction beam as shown in Figure 4.6. This procedure was used to evaluate any effect that may have resulted from using three individual supports as opposed to supporting the specimen along the full length of the bottom track. It was determined that this resulted in no significant difference in specimen behaviour or strength

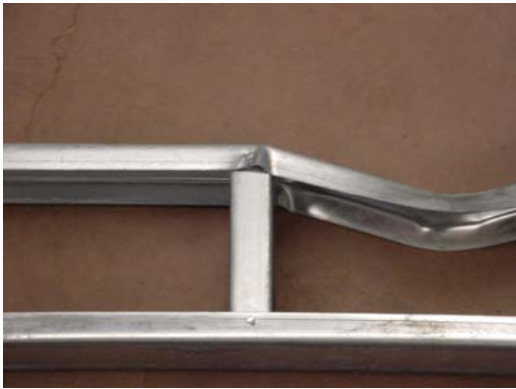
**Figure 4.7 – Specimen 2B16-16**

At approximately 90% of the ultimate load, the specimens began to buckle at mid-span under the point load followed by top track buckling near the central support. Figure 4.7 shows specimen 2B16-16 after failure. Both this deformation and the midspan deflection were more pronounced than those of Group A16-16, which was composed of similar specimens but with the addition of a wood top plate. The wood, when attached to the steel, prevented such excessive deflections.

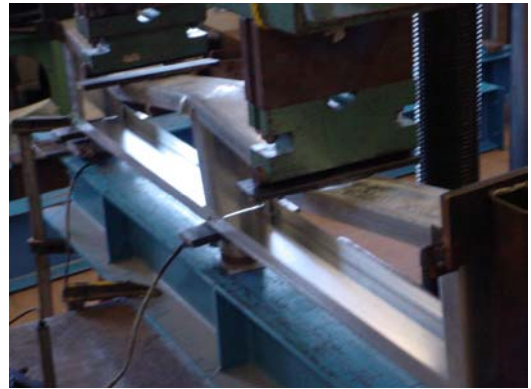
**Figure 4.8 – Failure of Specimen 2B24-16**

As with other groups under Objective B, specimens in this group failed primarily by buckling of the middle support accompanied by significant deformation at midspan load point. Buckling became noticeable at around 95% of the ultimate load, with permanent deflection of

the centre spans occurring shortly thereafter. Figure 4.8 shows specimen 2B24-16 after reaching ultimate as it is still deflecting with significant deformation evident at the centres of both spans.

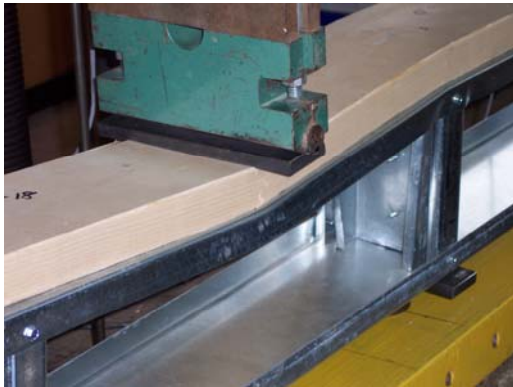
**Figure 4.9 – Deformation of Specimen 2C16-16**

Specimens in this group reacted similarly to those tested previously in Specimen Group C16-16. At approximately 80% of the maximum load specimens began to show noticeable signs of buckling near the middle support. As this buckling became more distinct, a tension crack

began to form in the wood at midspan and above the middle support as ultimate was approached. Figure 4.9 shows specimen 2C16-16 near the end of testing.

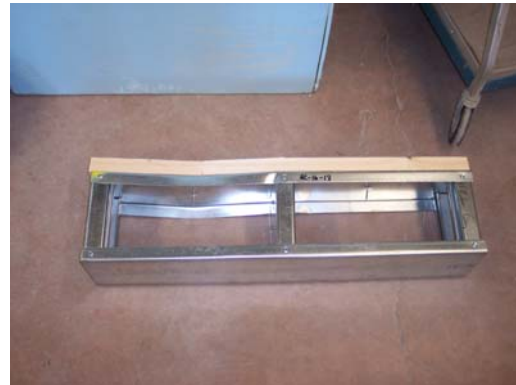
**Figure 4.10 – Preferential Span Deflection, Specimen 2C24-18**

Specimens in this group, which consisted of lighter gauge steel, began buckling at the middle support at around 50% of the ultimate load. Ultimate capacity was determined by cracking of the wood shortly after the legs of the steel top track began to buckle. The wood fractured in the flexural tension zones at the middle support and at each point load. As is often the case for symmetrical test specimens, as ultimate load is approached, accentuated preferential deformation occurs under one of the two symmetrical loads. This is evident in Figure 4-10 for example. As can be understood, this is not indicative of unequal loads being applied throughout the test, but rather that near ultimate, the randomly weaker of the two spans shows significantly more deformation.

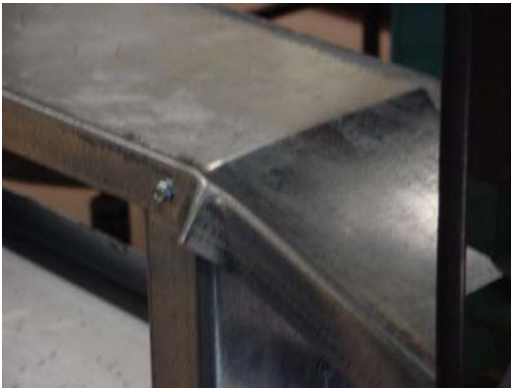
Figure 4.11-Buckling at Central Support

The track legs of the specimens in this group began to buckle at the middle support before any significant deformation was noted at the midspan. As the support buckling progressed, deflections at midspan became more pronounced and ultimate capacity became imminent. Severe deformation occurred at the middle support as shown in Figure 4.11.

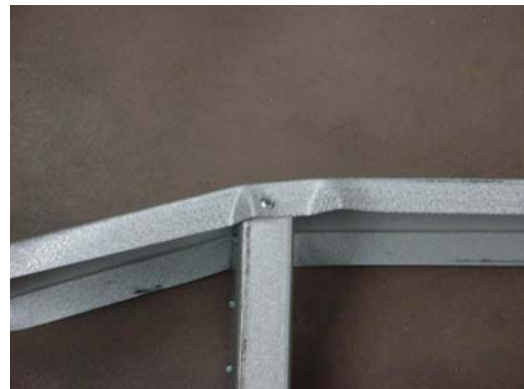
Figure 4.12-Failure of 18-ga. track

The specimens in this group acted in a manner very similar to those of Group D16-16. Buckling was noted at the middle support followed by deformation at midspan as load increased. Near ultimate, severe deformations of the top track developed at the central support as can be seen in Figure 4.12.

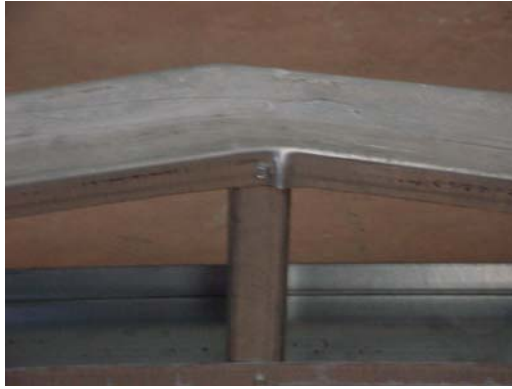
**Figure 4.13 – Failure of Specimen 3D24-16**

Failure of specimens in this group was initiated by buckling of the top track at the middle support, followed by bending at mid-span below each load point. The midspan deflection was noticeable in both spans, although one was usually more prominent than the other.

At approximately 95% of the ultimate load, the specimens yielded after which followed by ductile behaviour and a slight load increase as deformations became significantly noticeable. An example of a failed specimen, 3D24-16, is shown in Figure 4.13. Buckling of the top track legs was especially noticeable in this specimen.

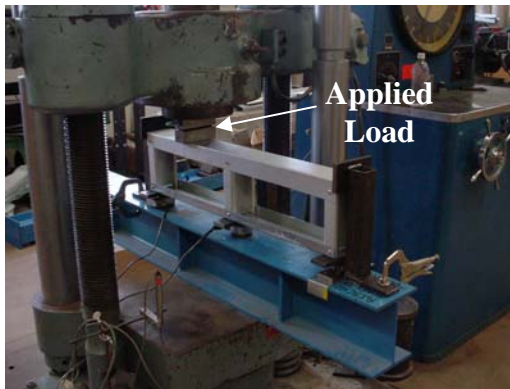
**Figure 4.14: Failed Specimen 1E16-18**

The setup for specimen 1E16-18 and 2E16-18 is shown in Figure 4.14. A bearing failure initiated under the point load at approximately 50% of the ultimate load. Near ultimate load, the

far stud started to lift off of the support and local buckles formed on the legs of the bottom track near the centre stud. A failed specimen for this configuration is shown in Figure 4.14.

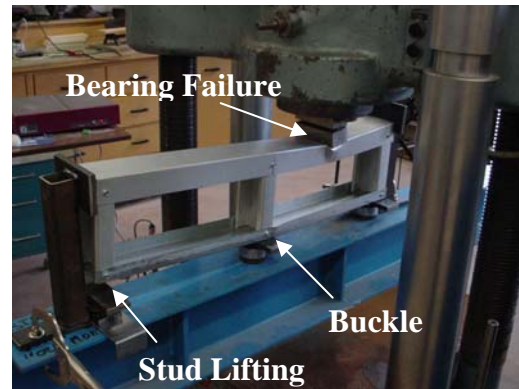
**Figure 4.15 – Failed Specimen 4E16-18**

Specimens 3E16-18 to 5E16-18 were tested using the two load point configuration, as used for all other tests. The initiation of bearing failure was first noticed at approximately 50% of the ultimate load at the location of the mid-span load point. This was followed by the start of local buckling in the legs of the top track near the centre stud. Each leg of the top track had two buckles start to form symmetrically around the centre stud. A failed specimen is shown in Figure 4.15.

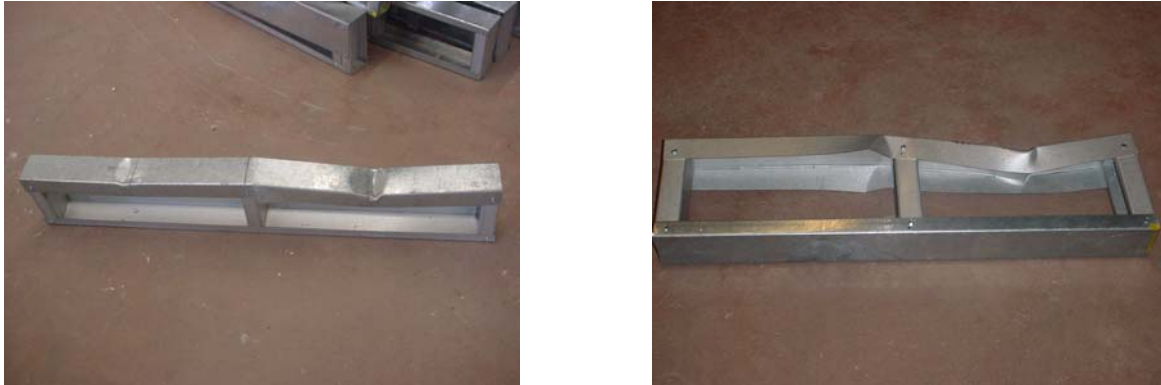
**Figure 4.16 – Bearing Failures, Specimen Group E24-18**

The legs of the top track began to buckle at the centre support at roughly 65% of the maximum load. As the load on the specimens was increased, this buckling became more evident. In fact, large buckles were present in the top track before any deformation was

noticeable at midspan. As Figure 4.16 shows, specimens in this group deformed locally predominantly under the point loads. Typically the span would bend at the support, and bending would be evident throughout the span. In this case, and to a larger extent most specimens in Objective E, the majority of each span deflected only slightly, with the majority of deformation occurring immediately below the loading points.
