(2010) - 20th International Specialty Conference on Cold-Formed Steel Structures

## Angle Cleat Base Connections

M. Dundu<sup>1</sup> and S. Maphosa<sup>2</sup>

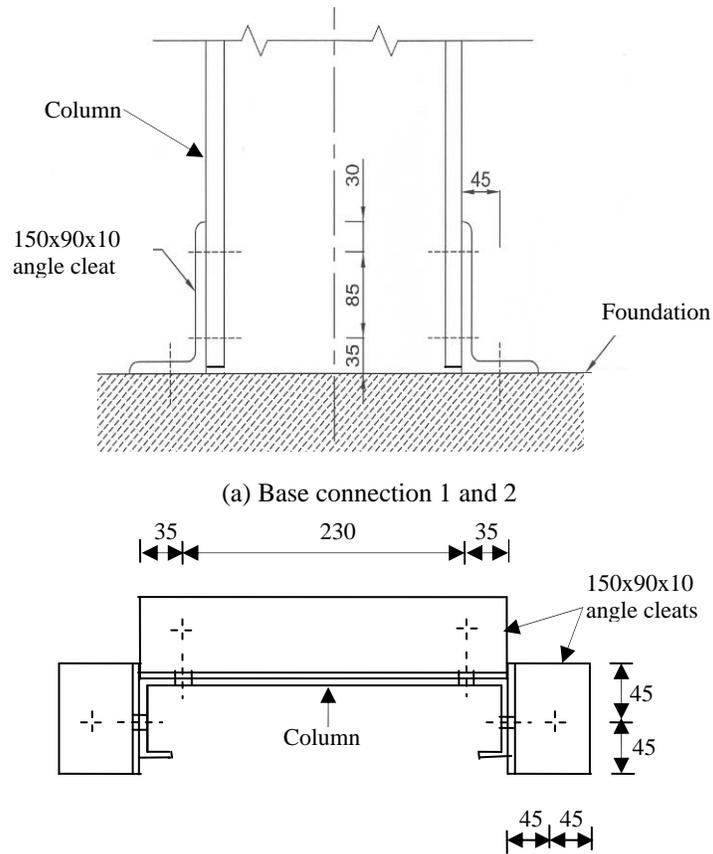
Figure 1 Base connections

In previous work, portal frames were developed from cold-formed lipped channels, connected back-to-back at the eaves and apex connections (Dundu and Kemp 2006). Current investigations are focused on the base connections of these frames. Three base connections are investigated in these tests; 1) Base connections with cold-formed angle cleats, connected to the flanges only, 2) Base connections with hot-rolled angle cleats, connected to the flange only and 3) Base connections with hot-rolled angle cleats connected on both the flanges and web. In base connections 1 and 2, angle cleats are connected to the flanges by two bolts and a single bolt secures them to the foundation as shown in Figure 1(a). Since the connection configuration in this figure is such that loads are transferred from the entire column section through the flanges only to the angle cleats, in order to increase the capacity of the connection it was decided to incorporate another angle cleat in the web to form base connection 3. The plan of this

connection is shown in Figure 1(b). In both base connections the angle cleats are of the same size and the column is short in order to prevent premature failure caused by overall flexural buckling. The angle cleats are connected to the column such that no end bearing at the bottom of the column takes place; instead the load is fully transferred to the foundation through angle cleats. As shown in the figure, the longer leg of the cleats is connected to the flange of the column. The angle cleats were chosen so that they can accommodate two bolts.

Figure (b) Plan of base connection 3

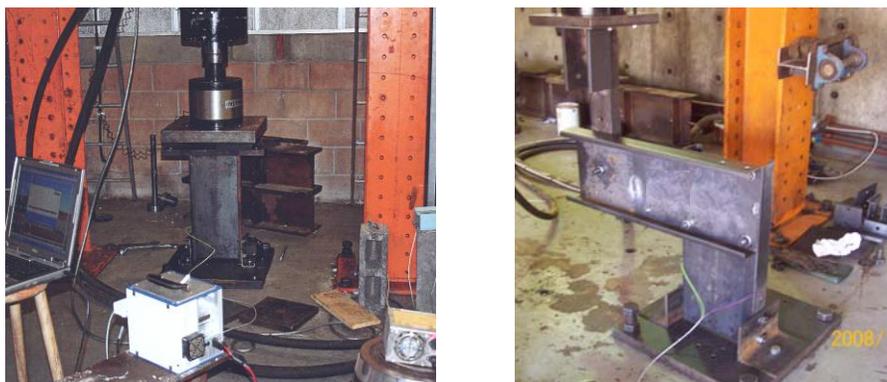
Figure 2 Base connections with angle cleats connected to the flange only

The bases were loaded using a 500kN Instron Testing Machine. A total of 24 column bases were tested. For each base connection, two tests were performed with the load applied at centroid of the column section (Load case 1) as shown in Figure 2(a), one third of the depth of the section (Load case 2), edge of the column section (Load case 3) and through a beam (Load case 4) as shown in Figure 2(b). A beam was introduced in Load case 4 in order to generate a large moment into the connection. Variables in the tests include the size of the column sections, number and type of angle cleats, material properties, and location of loading. A list of these variables and the corresponding bases are given in Table 1. High strength structural bolts, size M20, of Grade 8.8 steel are used for the base connections.

(a) Load cases 1-3

(b) Load case 4

All tests are arranged in such a way that the column does not bear on its bottom face, but is suspended entirely by M20 bolts. Since these tests were performed in

the laboratory the angle cleats were bolted to a plate instead of the concrete foundation. A compressive loading was applied along the minor axis of the channel sections through specially designed plates with circular grooves at the centre to accommodate a steel ball. The steel ball ensured that the applied load is a point load and the bottom plate prevented the top of the stub column from localized damage. The applied load and shortening were recorded at pre-determined intervals using an automatic data acquisition system as the experiments were carried out. The load was applied at a gradual rate of 2mm/min to allow the structure to deform in a ductile manner. In Load Case 4, the load was applied at the shear centre of the column section to prevent it from twisting.

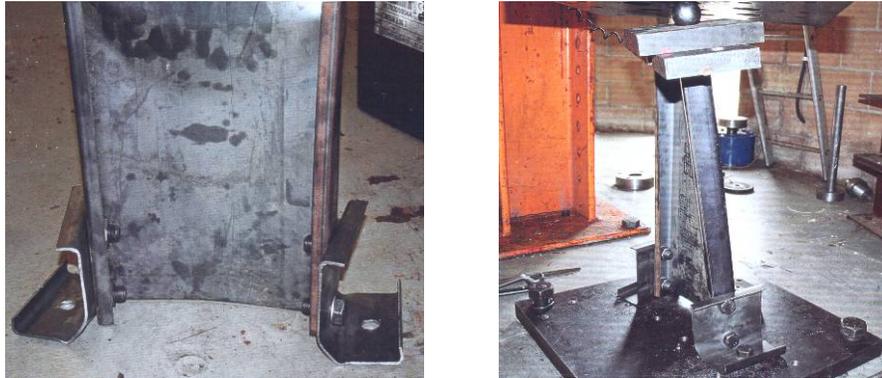
Figure 3 Failure of cold-formed angle cleats connected to the flange only

In all tests where cold-formed angle cleats were used the base connection failed prematurely by the deformation of the angle cleats. When the load was gradually applied at the centroid of the column section, the first sign of deformation was observed at the bottom of the web as it curved into a parabolic shape (Figure 3(a)). This was followed by the deformation of the angle cleats. The deformation of the angle cleats became excessive as the load was increased, consequently causing the set-up to fail. Significant cross bending occurred in the channel (Figure 3(b)) when the load was applied at the edge of the column section (Load case 3). This was immediately followed by the deformation of the angle cleat, directly below the load. The set-up ultimately failed due to excessive deformation of this angle cleat. No deformation was experienced in the other angle cleat, implying that little or no load was carried by this angle cleat. In the case where the load was applied through a beam the moment uplifted one angle cleat and a compressed the other. The base connection failed by the opening up of the angle cleat on the tension side and the closing of the angle cleat on the compression side. No bearing distortions were experienced in the bolt holes of all tests in this group.

(a) Deformation of web and angle cleats

(b) Cross-bending of channels

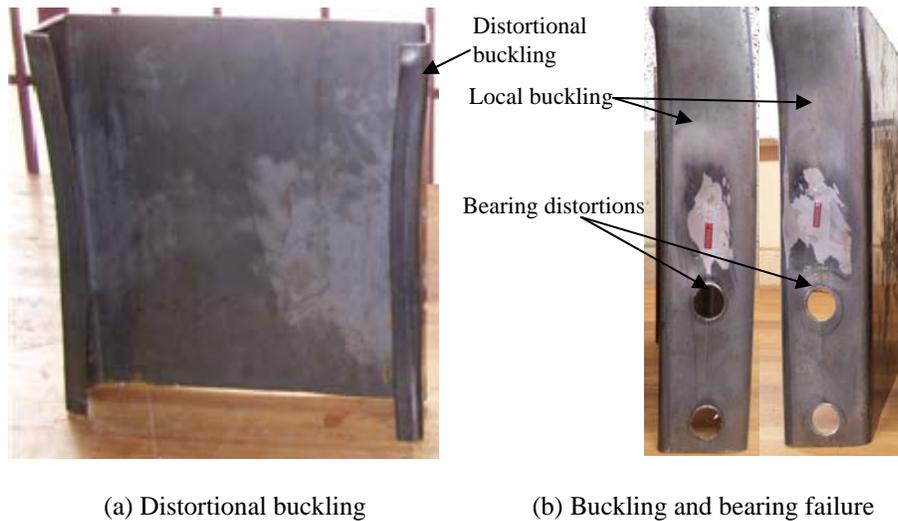
Figure 4 Failure of hot-rolled angle cleats connected to the flange only

Distortional buckling of the stub column was experienced in all the tests conducted. In Load Case 1, where the compressive load was applied at the centre, distortional buckling resulted in equal outward movement of the column flanges as shown in Figure 4 (a). Large deformations occurred in both flanges of the column just above the angle cleat. In the other two cases distortional buckling was more pronounced in the flange subjected to a larger force. The final mode of failure in all tests where rigid cleats were used was local buckling in the flange (see Figure 4(b)). Local buckling occurred after considerable rotation of the flange above the angle cleat. After local buckling, the applied load dropped slowly.

After testing, it was observed that both channels experienced significant bolt-bearing deformations around the bolt-holes. These bearing deformations or distortions were found to be of equal magnitude in the first series of tests, where the compressive load was applied at the centre. In the other two cases, where the load was applied eccentrically from the centre, no bearing deformation was observed in the lightly loaded flange. Bearing distortions were more pronounced in the flange that transferred more load to the angle cleat (Figure 4(b)). Bearing distortion of steel around bolt-holes is a ductile mode of failure and provides the ductility required for moment redistribution.

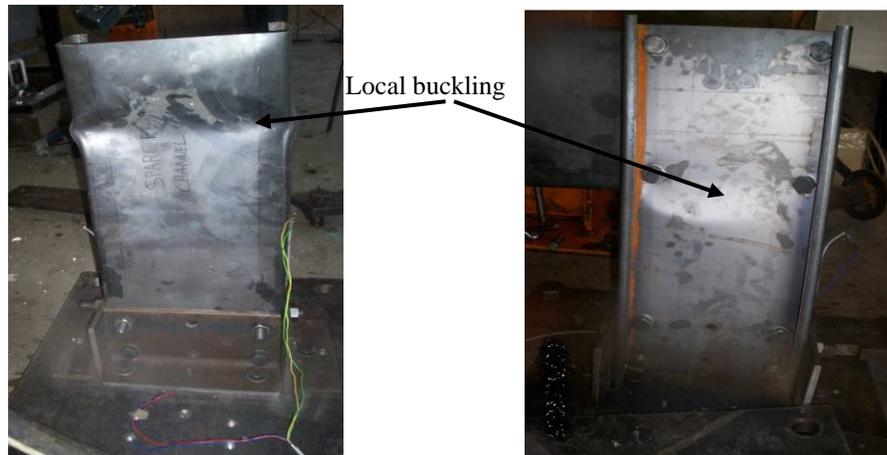
Figure 5 Failure of hot-rolled angle cleats connected to the flange and web

As in hot-rolled angle cleats connected to the flange only, three modes of failure were identified in these base connections, that is, distortional buckling, local buckling of the channel section and bearing failure around the bolt-holes. Distortional buckling was observed in load cases 1-3. Local buckling of the channel section was the final mode of failure in all load cases. Deformation began in the flange as a result of distortional buckling and progressed into the web. Unlike base connections of hot-rolled angle cleats connected in the flange only, where local buckling occurred just above the cleats, in this case local buckling was experienced at the beam-column connection. This mode of failure did not

occur close to angle cleats because the base was significantly stiffened. Bearing distortion was more visible in specimens where the load was applied away from the column centre (load case 2, 3 and 4).

(a) Local buckling due to Load case 1      (b) Local buckling due to Load Case 4

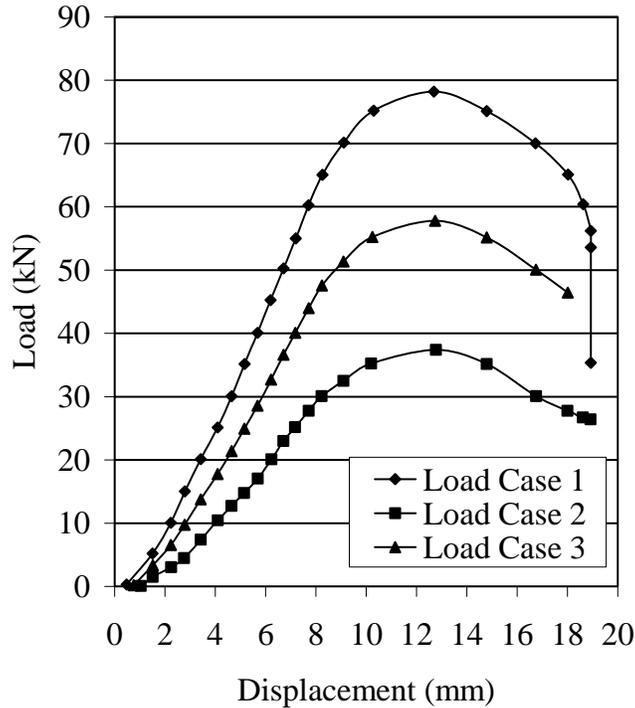
Figure 6 Cold-formed angle cleats, connected to the flanges

The behaviour of the three base connections are shown by load-deformation curves in Figures 6, 7 and 8. These load-displacement curves represent the average curve for the tests in each load case. The load-deflection curves for Load Case 4 are deliberately excluded from these graphs because the base connections

experienced relatively large deflections and low loads in comparison with other load cases. The load-deflection curves show the initial stages to be linear followed by a non-linear range. The non-linear response and decreasing connection stiffness exhibited late in the loading sequence is attributed, primarily, to local buckling in the flange. The non-linear response exhibited by the structures occurs at approximately 85% of the ultimate load. After this point large deformations take place and result in the collapse of the base. Both graphs show decrease in load carrying capacity of the base connections as the eccentricity of the applied load was increased.
