Safe Control of Manufacturing Vehicles Research Towards Standard Test Methods

SAFE CONTROL OF MANUFACTURING VEHICLES RESEARCH TOWARDS STANDARD TEST METHODS

Abstract

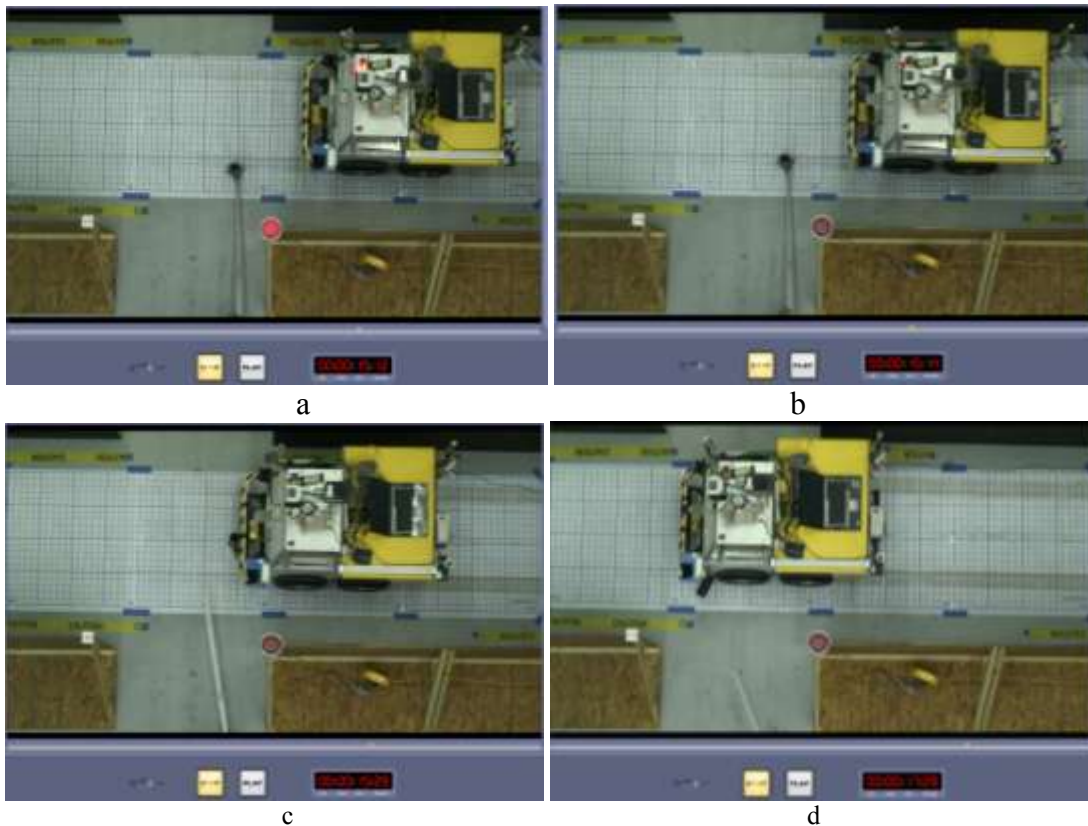
In Figure 5 d, the test piece is shown beneath the vehicle and in front of the wheel. The test piece was never run over by the AGV. A front shroud could be added to the AGV so that the test piece always stays in front of it.

Figure 5 – Snapshots from the overhead video showing when: (a) the test piece crosses the photo-sensor, (b) the test piece is detected by the AGV safety sensor, (c) the AGV hits the test piece (or when the test piece stops in the AGV path), (d) the AGV stops.

Using Figure 5, Test 18, as an example, the video shows that: at time 15:12, the test piece crossed the Photosensor 1 line; at time 15:14, the test piece was detected by the

AGV safety sensor; at time 15:28, the test piece was hit by the AGV and therefore the test piece stopped moving across the AGV path; and at 17:28, the AGV stopped.

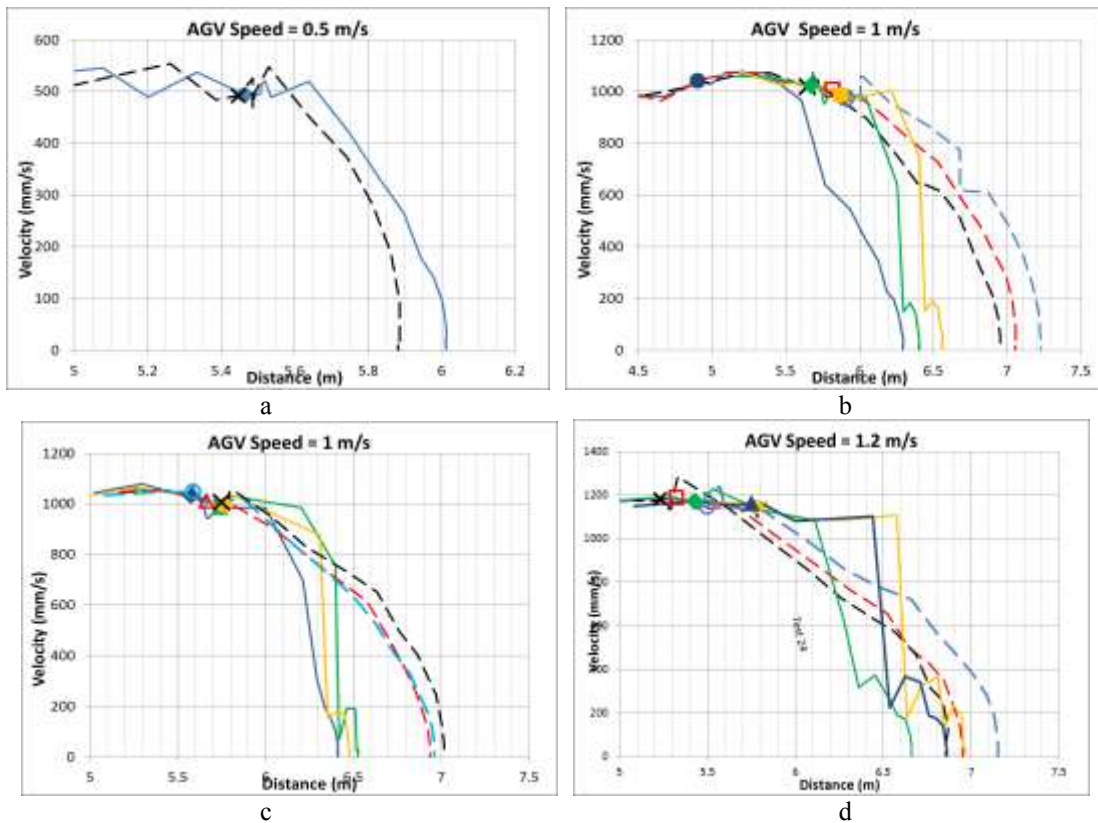
Figure 7 (a) shows comparison of the two braking methods at 0.5 m/s velocity for Tests 6 and 7. In this case, the braking distance is longer for the controlled braking

because the vehicle actually needed less than 2 m distance to stop and therefore decelerated at a rate that was appropriate for the vehicle speed. Figure 7 (b and c) shows results of Tests 9 to 19 for 1 m/s AGV velocity. Results clearly showed a difference in low-level stop and controlled braking with shorter stopping distance for controlled braking and which equates to a faster reduction in AGV kinetic energy.

Figure 7 (d) shows results of the tests with the AGV moving at 1.2 m/s. These test results show that the velocity stays at about 1.2 m/s for some time before there is a sudden drop in velocity, i.e., there was a delay in reaction. In these tests, results showed that controlled braking may have slightly higher reduction in energy, although the data plots are not very conclusive to determine the best braking method.

Figure 7 – Grid test results showing plots of AGV velocity versus distance for AGV velocities of: (a) 0.5 m/s, (b and c) 1 m/s, (d) 1.2 m/s. In these plots, solid lines show controlled braking and dashed lines show low-level stop. The various markers indicate when the test pieces entered the AGV path.

Two pieces of information were captured from the tests: 1) comparison of braking distances for the two methods and 2) the energy reduced for the two different braking methods. Velocity versus distance travelled was plotted for all tests. Figure 7 shows plots from tests using the three AGV speeds, including: (a) 0.5 m/s, (b and c) 1 m/s, and (c) 1.2 m/s. Figure 7 (b and c) were separated

Potential sources of the delay in reaction may be due to:

- mechanical issues (e.g., time lag) from when the safety sensors detects the test piece to when the brakes are applied,

- software issues where the AGV controller computes a deceleration such that there appears to be enough time to stop and therefore does not apply the brakes until later
- or a combination of these two potential sources of error.

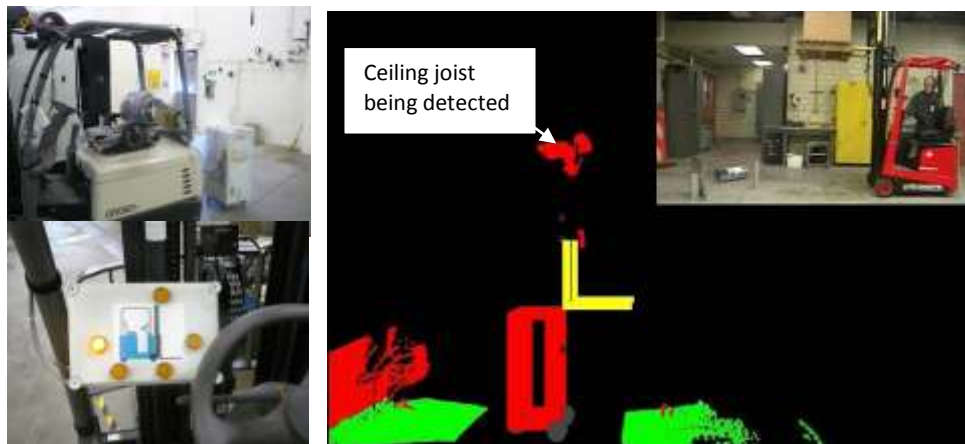
using 3D sensors mounted on a forklift to provide the operator with alerts. Figure 16 (top-left) shows a forklift backing up and nearing a piece of equipment and (bottom-left) shows the operator alert light turned on to indicate the region from which the alert originated. For these tests, a rear, downward-looking sensor and a rear-facing 3D sensor were used to obtain the data and an algorithm was developed to issue an alert.

An onboard computer computed in real time that an obstacle was in the vehicle's path and provided an output to an operator alert light. Figure 16 (right) shows the results of using a sensor mounted on the forklift tine frame to detect high or elevated objects. The 3D image (Figure 16 lower right) shows data when the sensor detected ceiling joists. It also shows green floor regions where there are no obstacles in vehicle path.

Figure 16 – (top-left) 3D LIDAR sensors mounted on a forklift and integrated with simple operator alerts. The obstacle is behind the forklift and (bottom-left) the alert indicates the location of the obstacle relative to the forklift, (right) high-lift obstacle detect sensor mounted on the forklift frame and raised (upper right inset photo is shown reversed from the data) to capture data of the ceiling joists.

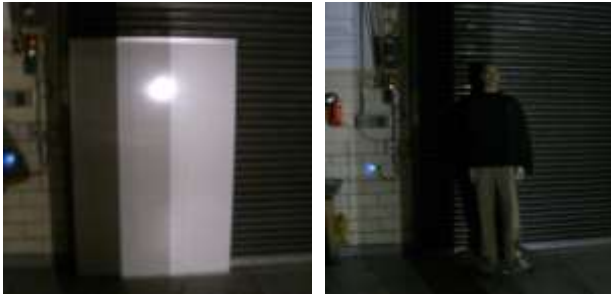
a b

The current ANSI/ITSDF B56.11.6 standard, soon to be called B56.11.6.1, includes a test method that uses a row of lights positioned where a forklift operator's head would be and shadows cast by the lights on a test board marked with a grid pattern. The shadows are

Figure 17- Shadows: (a) on a test board as specified in the standard, (b) using a mannequin instead of the test board.

equivalent to occluded regions and are quantified by counting the grid blocks. Figure 17 (a) shows a standard test using a forklift and (b) a mannequin placed in the same shadowed region. The current method shows that there are occluded regions but does not specify their exact locations. Occlusion is caused by vehicle obstructions. Advanced imagers could be mounted to detect obstacles/pedestrians in these occluded regions. The current light method provides only the direction having occluded regions and not the

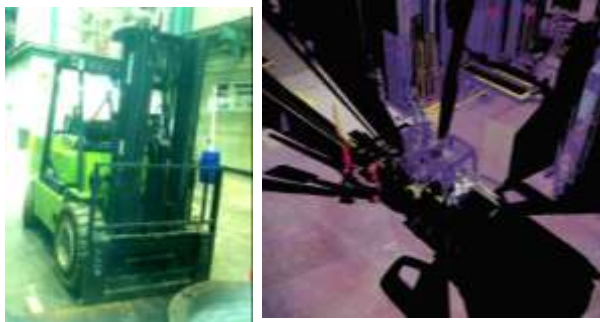
Figure 18 – (left) forklift with scanner located at the operator's head location and (right) data plot from the scanner showing (black) occluded regions.

occluded regions in a forklift, such a system was located at the approximate position of an operator's head according to visibility standard test methods inside a forklift. A 360° (H) by about 320° (V) scan was performed. The set-up time was about 15 minutes and the scan time was about 5 minutes. The 3D point cloud is shown in Figure 18. The black regions are shadows cast by obstacles (e.g., cab frame) where the operator would not be able to see. In this demonstration, the forklift was unloaded. Further tests will be
