Coated Steel Rebar for Enhanced Concrete-Steel Bond Strength and Corrosion Resistance

Organizational Results Research Report

September 2010
OR11.004

Final Report

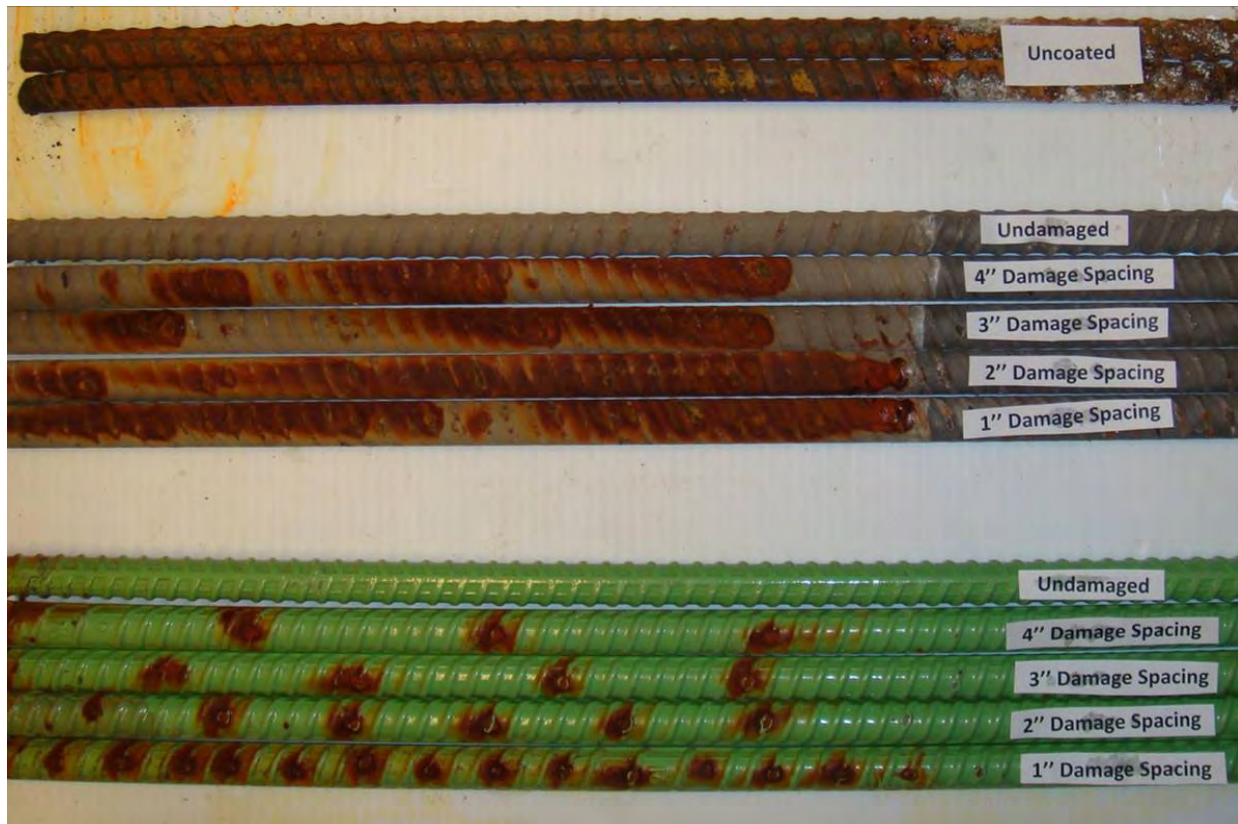
Figure 6.31 Surface conditions of all tested rebar after testing

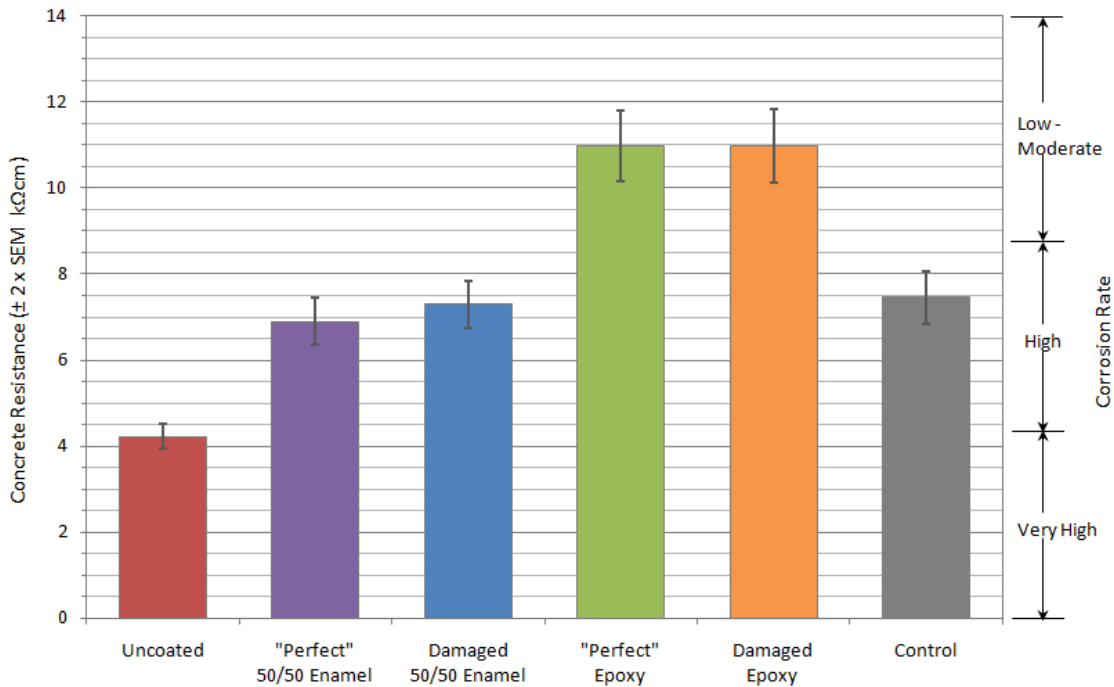
Figure 6.40 Average resistance of each specimen type.

As shown in Figure 6.39, the resistivity for each group of specimens remained relatively constant during the testing period. Both the "perfect" and damaged 50/50 enamel specimens have approximately the same resistance throughout the 54 weeks of testing. Similarly, both the "perfect" and damaged epoxy groups have the overall resistance values of 11.0 kΩcm. A specimen group's overall resistance was calculated by averaging the group's ten data points shown within Figure 6.39. The overall resistance for each of the six groups of specimens, along with the 95% confidence interval corresponding to each value, is shown in Figure 6.40.

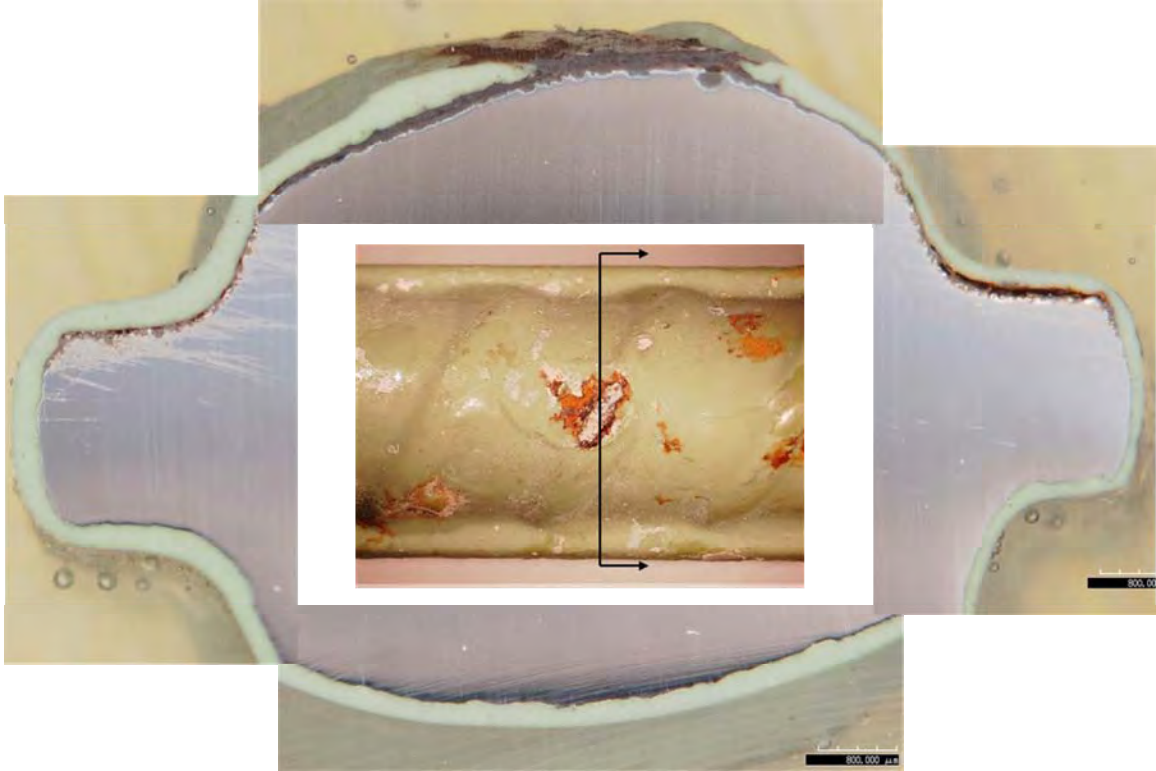
Figure C - 37: A cross-section through an intentionally damaged area along bar-3 of specimen EP-D-2.
