## Coaxial Cable Sensors and Sensing Instrument for Crack Detection in Bridge Structures -- Phase I: Field Qualification/ Validation Planning

**COAXIAL CABLE SENSORS AND SENSING INSTRUMENT FOR  
CRACK DETECTION IN BRIDGE STRUCTURES –  
PHASE I: FIELD QUALIFICATION/VALIDATION PLANNING**

**Final Report**

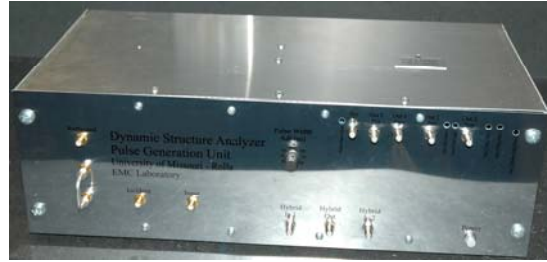
Fig. 2 Distributed Cable Sensor and Sensing System

The proposed sensor and instrument are basically a communication coaxial cable and a fast ETDR system as illustrated in Figs. 2(a, b). A communication coaxial cable consists of a solid inner conductor, a cylindrical outer conductor, and a cylindrical dielectric layer in between the conductors. The outer conductor of a coaxial cable sensor for distributed crack detection is spirally wrapped around the dielectric layer so that the finished outer conductor is mechanically in spiral shape but electrically cylindrical. To ensure the continuity between spirals at zero strain, outside the outer conductor is a thin layer of plasma sprayed coating (Brower et al. 2006). When a crack sensor is embedded into a RC member, a crack intercepting the sensor creates a local separation between two spirals, generating a reflected electromagnetic wave when traveling through the coaxial cable, an electromagnetic wave guide.

(a) Prototype coaxial cable sensor

(b) Fast ETDR instrument

The fast ETDR system, Fig. 2(b), mainly consists of a fast pulse generator, a directional coupler, a combiner, a compensation circuit, and a TDS7404 oscilloscope. It allows for a sequence of crack distribution profiles placed one after another into memory without saving them until completion of the measurements. As such, retriggering delays of microseconds can be achieved. To improve the dynamic range and precision of measurements, unlike any commercial EDTR system, a directional coupler was designed to separate the reflected wave from the incident wave, both traveling through a coaxial cable sensor. Furthermore, a compensation circuit was introduced to cancel out part of the reflected wave that is independent of the crack-induced signal along the cable sensor, representing the effect of mismatched characteristic impedances between the cable sensor and the extension cable.

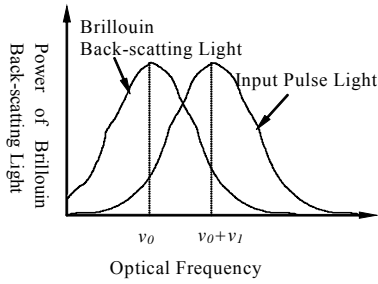
Fig. 4 Frequency Shift of Brillouin Back-Scattering

In a BOTDR system, the Rayleigh backscatter mechanism is replaced by Brillouin backscattering. The Brillouin scattered light occurs by an interaction between a high-coherence incident light and an acoustic wave generated by the incident light in an optical fiber. The scattered Brillouin light frequency is shifted from incident light frequency due to the velocity of the acoustic wave. The Brillouin frequency shift is given by the following equation.

where  $v_B(\varepsilon)$  is the Brillouin frequency shift with a strain  $\varepsilon$ ,  $v_B(0)$  is the Brillouin frequency shift without a strain,  $C$  is the strain coefficient and  $\varepsilon$  is the strain applied on the fiber.

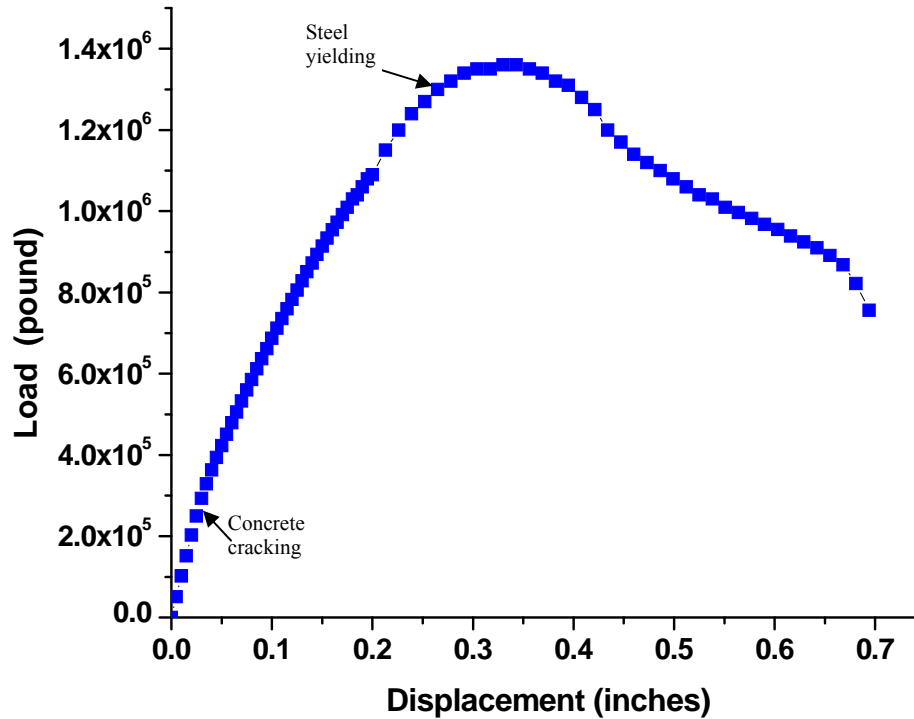
Fig. 10 Load-Displacement Curve of the Column at Pier 6

For each analysis, a total of 79 loading steps was applied to Pier 6 in displacement control. The load-displacement curve is presented in Fig. 10. It consists of an initial concrete crack, elastic steel deformation, steel yielding, and collapse. The maximum load that can result in the column collapse is 1360 kips at a displacement of approximately 0.33 inches. Note that steel yielding corresponds to a mid-height column displacement of approximately 0.26 inches.

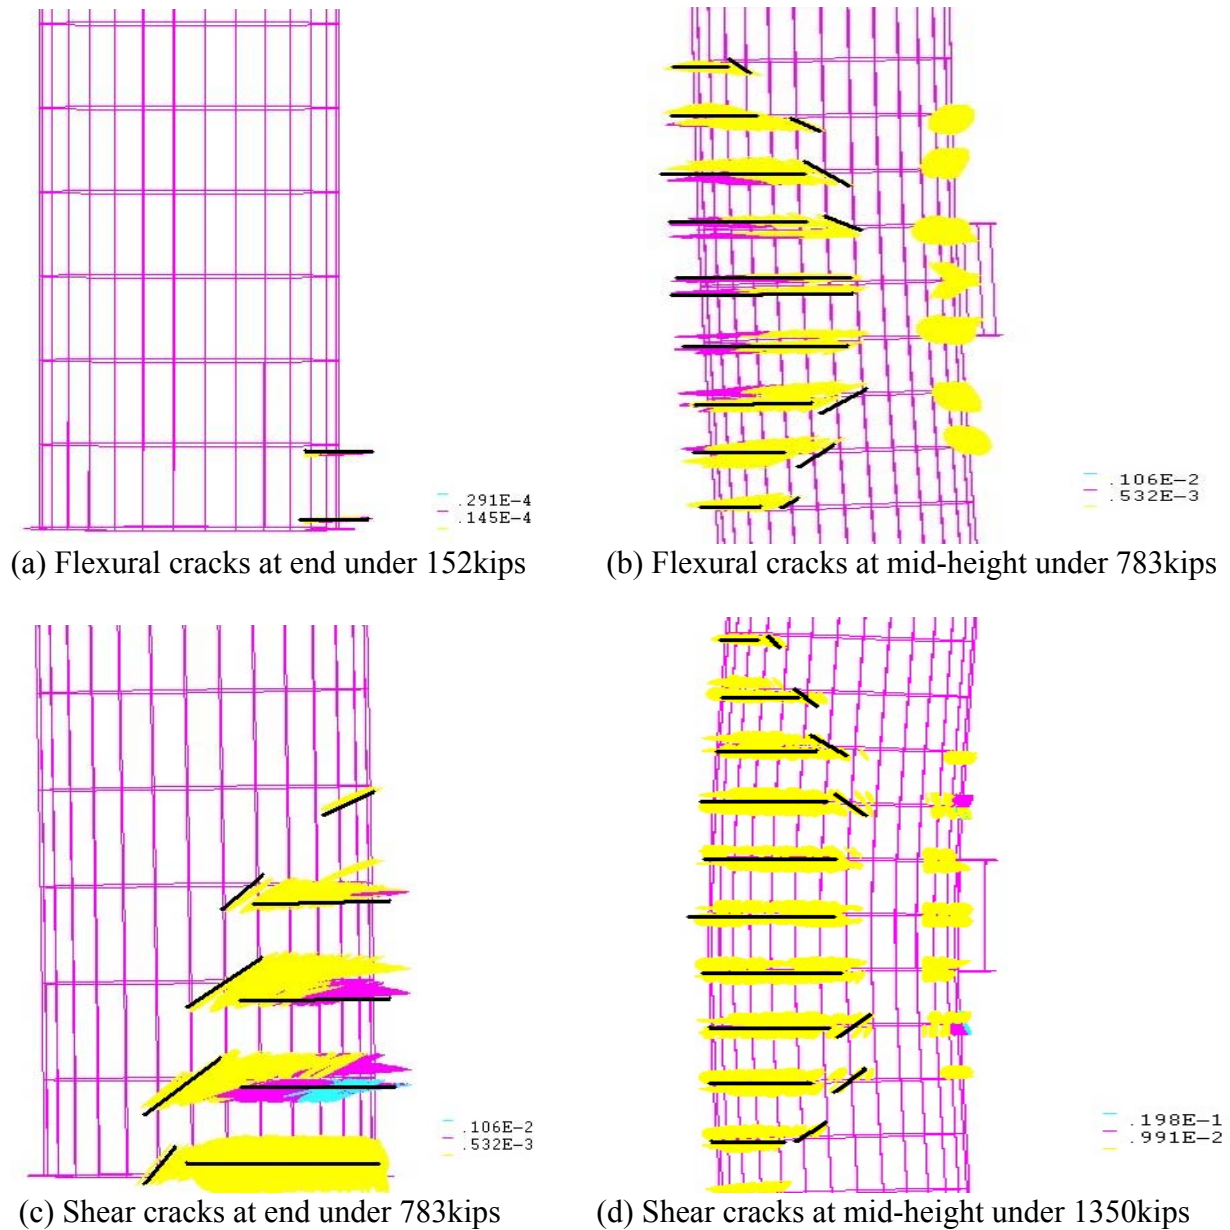
Fig. 12 Onset of Flexural and Shear Cracks on the RC Column under Various Loads

To understand the onset of flexure and shear cracks, the detailed crack distributions at two ends and mid-height of the column were investigated. As presented in Fig. 12, the first flexural crack

appears at both ends of the column under a load of 152 kips (shown by straight lines perpendicular to the column axis in Fig. 12). Both shear cracks and flexural cracks develop with the increase the load (shown by horizontal and inclined lines in Fig. 12, respectively). At the ultimate load of 1360 kips, the flexural and shear cracks are shown in Fig. 13. Both the ends and mid-height are close to experience fully penetrated cracks.

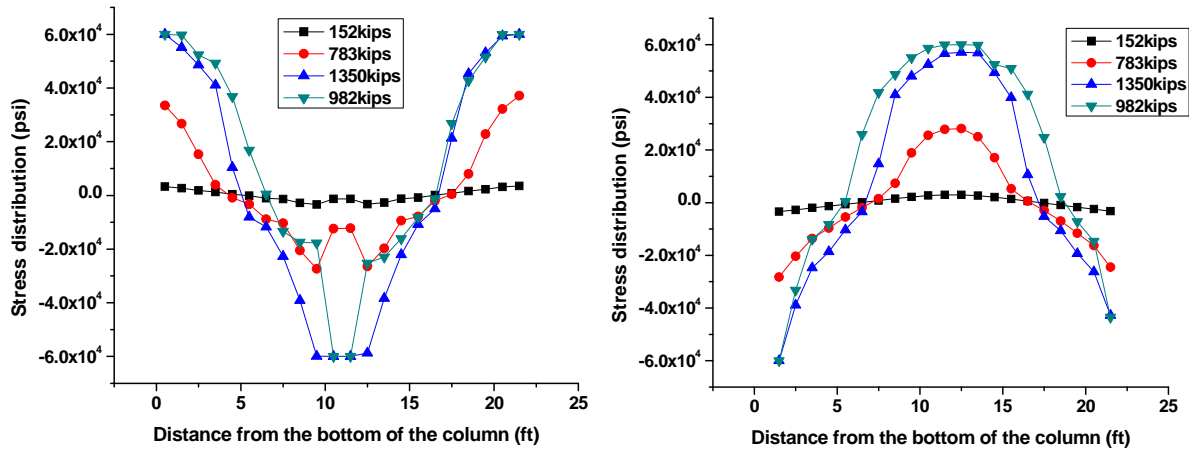
The stress distribution along the steel reinforcement near and far sides of the loading point is presented in Fig. 14. On the near side, the main reinforcement is subjected to compression at mid-height of the column and tension at both ends of the column. It can be clearly observed from Fig. 14 that at 1350 kips, all steel reinforcing bars on the loading side yield at both ends and the mid-height of the column. On the far side, the mid-span tensile bars appear to experience more yielding.

(a) Near side of the loading region

(b) Far side of the loading region

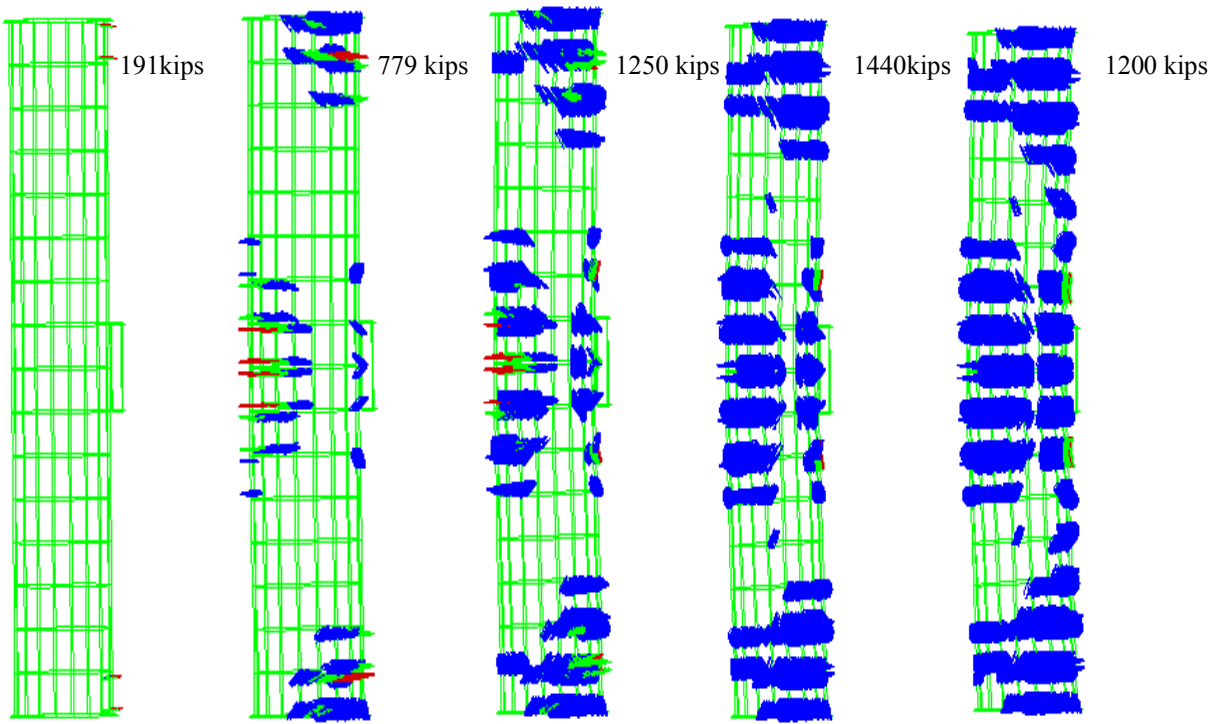
Fig. 17 Stress and Crack Distributions under Various Loads

The stress and crack distributions under various loads are presented in Fig. 17. It can be clearly seen from Fig. 17(a) that the stress was concentrated at the two ends and the mid-height of the column. As a result, cracks develop at these locations as illustrated in Fig. 17(b).

As the crack at both ends of the column penetrates the cross section, two plastic hinges forms under a load of approximately 1250kips. When the crack in the mid-height of the column fully penetrates its cross section, the column reaches its ultimate load 1440kips. The column fails due to steel yielding at both ends and the mid-height.

(a) Stress distribution under various loads

(b) Crack distribution

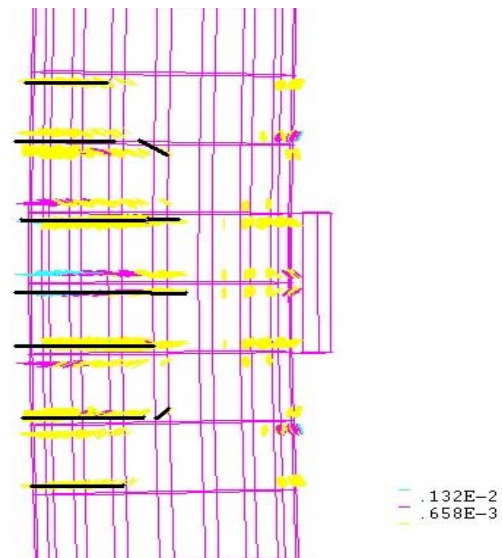
Fig. 18 Onset of Flexural and Shear Cracks on the RC Column under Various Loads

To understand the onset of flexure and shear cracks, the detailed crack distributions at two ends and mid-height of the column were investigated. As presented in Fig. 18, the first flexural crack

appears at its ends under a load of 191 kips (shown by straight lines perpendicular to the column axis in Fig. 18). Both shear cracks and flexural cracks develop with the increase of load (shown by inclined lines and straight lines to the column axis in Fig. 18). At the ultimate load of 1440 kips, the flexural and shear cracks are shown in Fig. 19. Both the ends and the mid-height are close to experience fully penetrated cracks.

(a) Flexural cracks at end under 191kips

(b) Flexural cracks at mid-height under 779kips

(c) Shear cracks at end under 779kips

(d) Shear cracks at mid-height under 1250kips

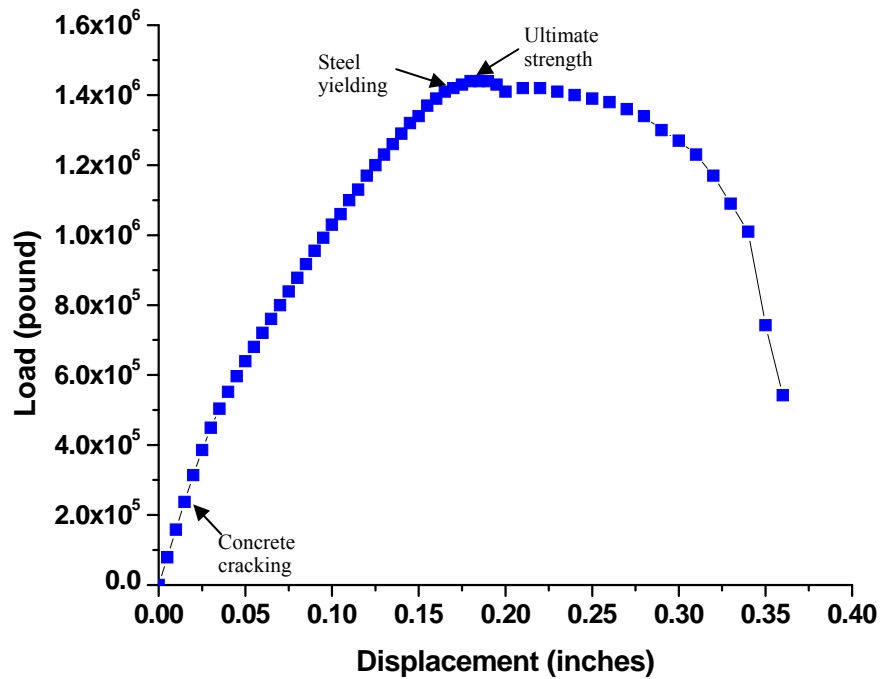
Fig. 22 Load-Displacement Curve of the Column at Pier 8

A FEM similar to Fig. 8 was established in DIANA software for a column in Pier 8. The same material and material models were considered in numerical analysis. The load-displacement curve is presented in Fig. 22. It consists of an initial concrete crack, elastic steel deformation,

steel yielding and collapse. The maximum load that can result in the column collapse is 1440 kips at a displacement of approximately 0.18 inches.

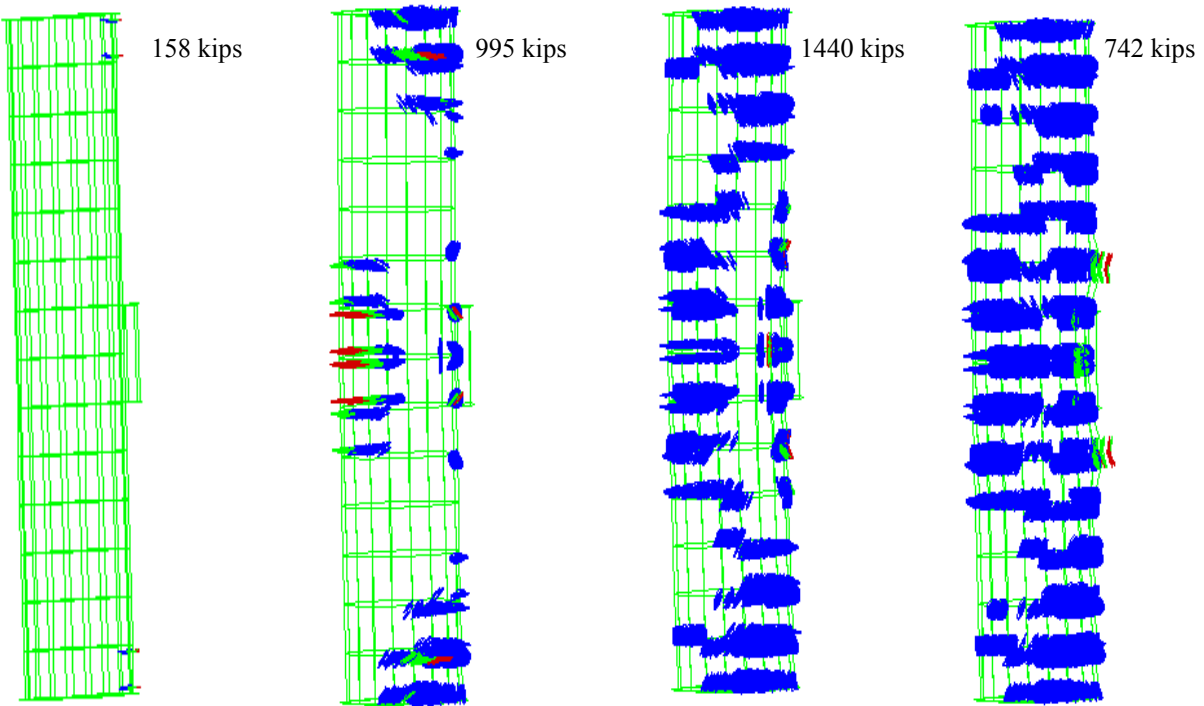
Fig. 23 Stress and Crack Distributions under Various Loads

The stress and crack distributions under various loads are presented in Fig. 23. It can be clearly seen from Fig. 23(a) that the stress was concentrated at the two ends and the mid-height of the column. As a result, cracks develop at these locations as illustrated in Fig. 23(b).

In the beginning of loading, the flexural cracks develop at both ends and the mid-height of the column. With the increase of load, the shear crack develops as shown by inclined lines in Figure 23 (b). When the load reaches 1440 kips, the shear cracks intersect with flexural cracks at both ends, the cracks penetrates the cross section of the column.

(a) Stress distribution under various loads

(b) Crack distribution

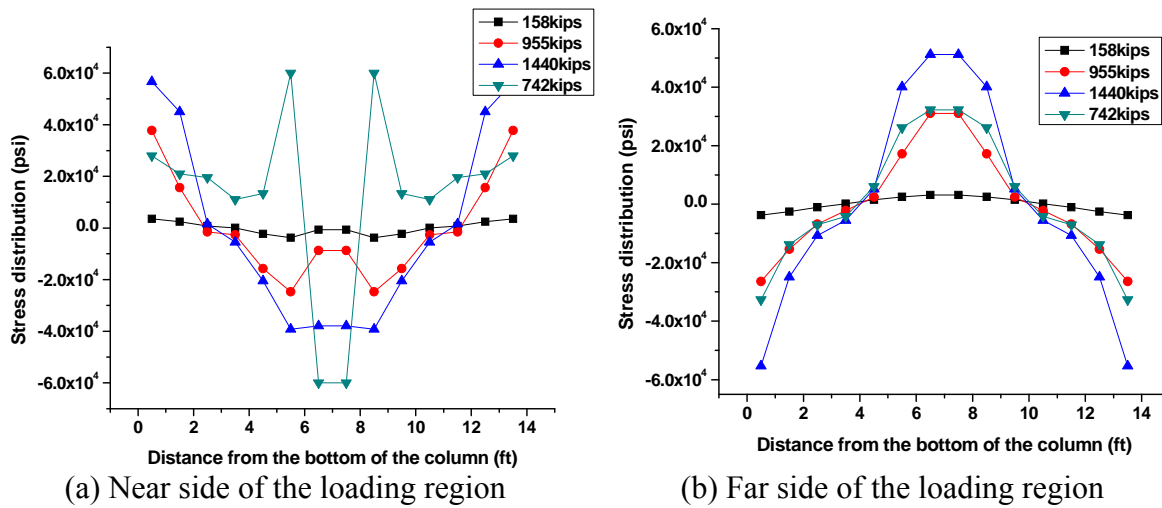
The stress distribution along the steel reinforcement near and far sides of the loading point is presented in Fig. 26. The main reinforcing bars on both sides are subjected to a similar magnitude of compressive and tensile stresses at the mid-height and both ends of the column. It can be clearly observed from Fig. 26 that only at both ends of the column, the steel reinforcing bars yield when the load reaches ultimate load 1440kips.

(a) Near side of the loading region
