Design, Construction and Load Testing of the Pat Daly Road Bridge in Washington County, MO, with Internal Glass Fiber Reinforced Polymers Reinforcement

**CENTER FOR TRANSPORTATION
INFRASTRUCTURE AND SAFETY**

**NUTC
R275**

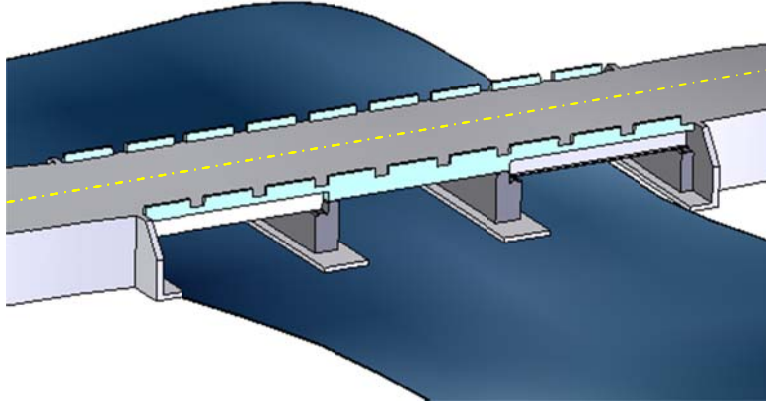
(a) Isometric view

Commission decided to replace the culvert with a rapidly-constructed, corrosion-free, elevated bridge as schematically shown in Figure 1.2.

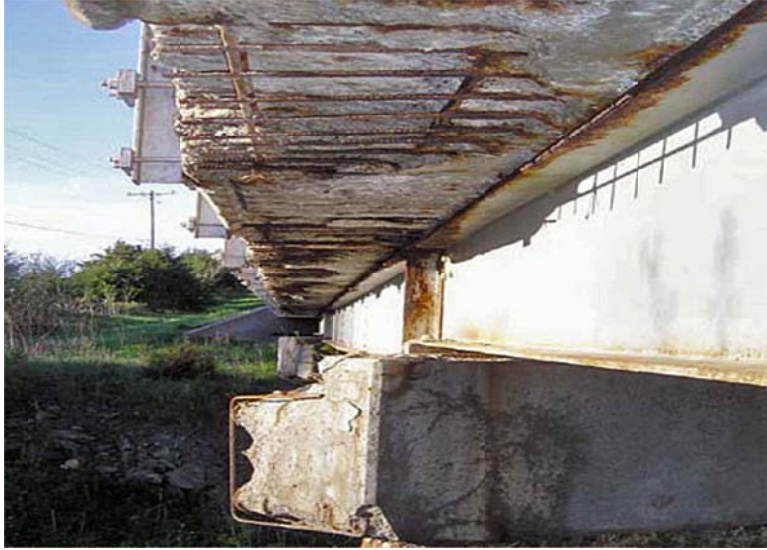
Figure 2.1: Missouri deteriorated bridge deck (from the Missouri Department of Transportation in http://minnesota.publicradio.org/display/web/2008/02/11/missouri_bridges/)

deicing salts; and chloride penetration and the resulting corrosion of steel reinforcements, as typically shown in Figure 2.1. Thus, concrete bridge decks need multiple repairs and even replacements during the design lifespan of bridges (Cady and Weyers, 1984; Elzafraney and Soroushian, 2005). Daily truck traffic might cause fatigue-related damage to bridge decks (Oh, 1999; Laman and Ashbaugh, 2000; Boothby and Laman, 1999; Lin et al., 2012). Laboratory studies (Aldea et al., 1999 and Lin et al., 2012) have indicated the possibility of damaging bridge decks and other elements due to chloride ions ingress. Thus, corrosion of reinforcement (Bertolini et al., 2004) in bridge systems plays an essential role in the durability and service life of bridges (ACI Committee 201 and CEB, 1999).

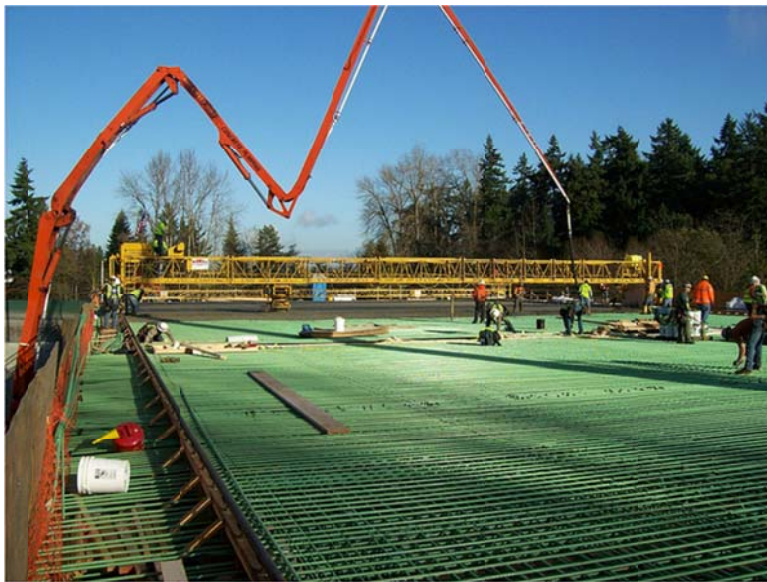
Figure 2.2: Epoxy coated steel reinforcement used in bridge deck (http://minnesota.publicradio.org/display/web/2008/02/11/missouri_bridges/)

Among various corrosion control methods (Mehta and Gerwick, 1982; Sarja and Vesikari, 1996), epoxy coating has been widely accepted for reinforcing steel bars in reinforced concrete structures as shown in Figure 2.2. Significant research has demonstrated that epoxy coated bars can decelerate the corrosion process of steel if it remains intact. However, epoxy coating is often subjected to local damage during shipping and handling as well as at construction sites. As illustrated in Figure 2.3, a pinhole defect or a breach that occurs during handling or placement at a construction site will cause an epoxy coated bar to degrade rapidly. In addition, both laboratory tests and field inspections indicate that epoxy-coated bars in a marine environment are susceptible to corrosion. Therefore, it is imperative to find alternative methods or materials with enhanced corrosion resistance or corrosion-free performance. For example, fiber reinforced polymer (FRP) products as exemplified in Figure 2.4 have received significant attentions in construction industries due to their corrosion-free, magnetics-immune, and high strength-to-weight ratio features.

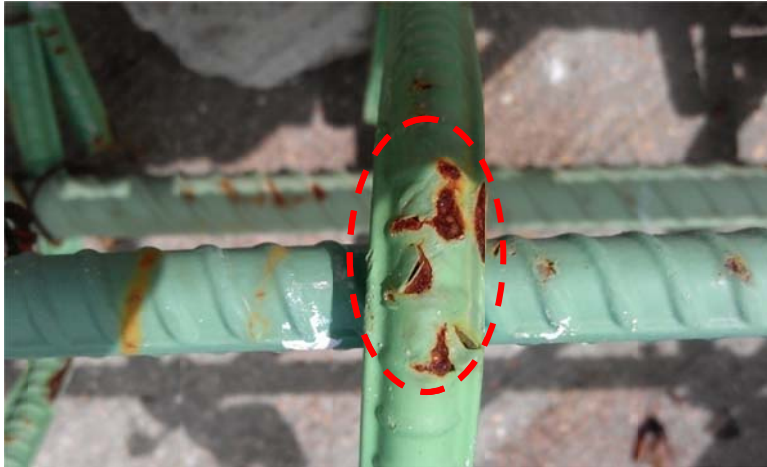
Figure 2.3: Damaged epoxy coating and rebar corrosion

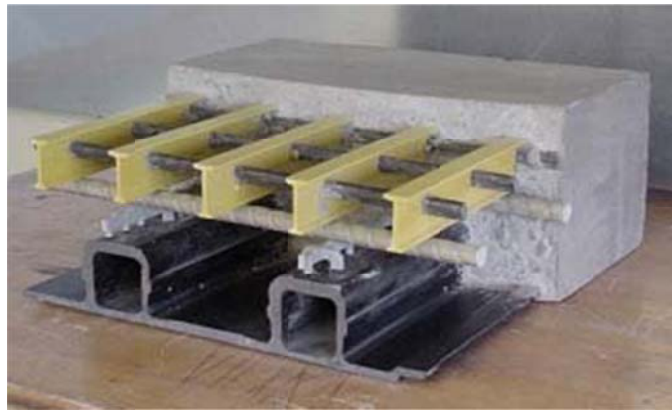
Figure 2.4: FRP reinforcement in concrete deck (<http://www.engr.wisc.edu/centers/wsmtl/WSMTL-WEB-pg02R-NEWS-IBRC-I.htm>)

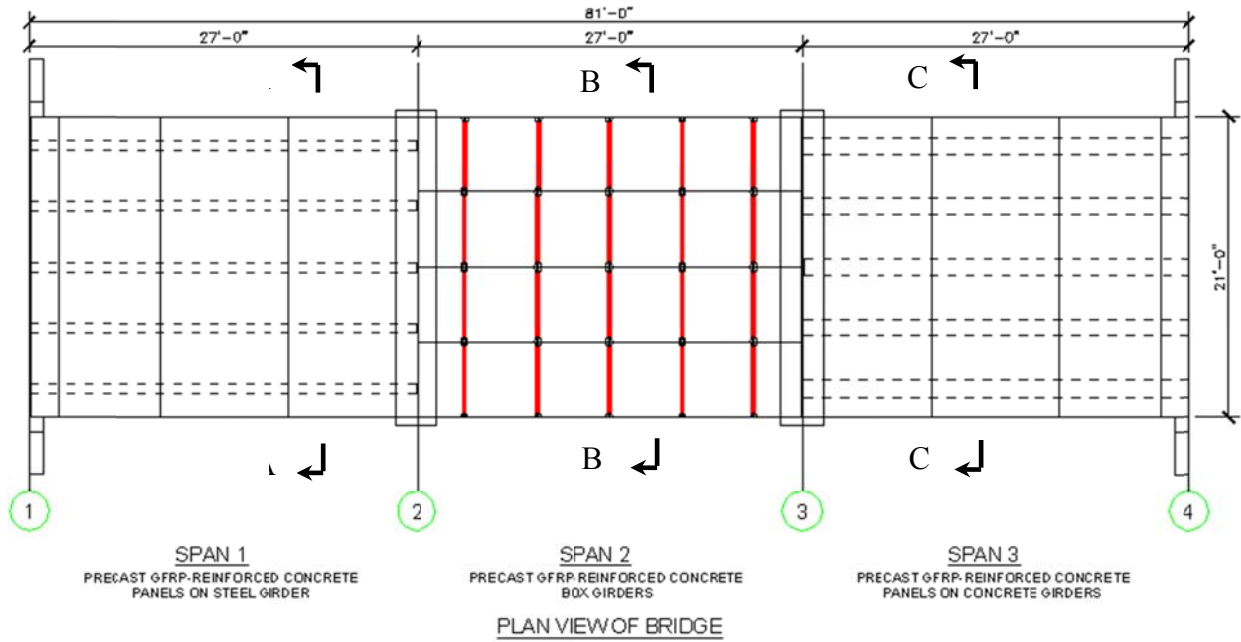
(a) Plan view

(d) Concrete deck slab over concrete girders (section C-C)
 Figure 3.1: Layout of the new three-span bridge

The design approaches and calculations of the Pat Daly Road Bridge were summarized in Yan et al. (2010). Figures 3.1a through 3.1d present the overview and reinforcement detail of the bridge. To ensure that the validated technologies in this study are applicable to both new construction and the deck replacement of existing bridges, one conventional steel-girder span, one conventional concrete-girder span, and one innovative concrete box-girder span were considered for the bridge superstructure. The conventional steel- and concrete-girder structures served as good benchmarks for the box-girder structure. Their performance will be compared over time in an identical operating environment. Each span of the bridge was 21 ft (6.40 m) wide and 27 ft (8.23 m) long, totaling 81 ft (24.69 m) in length of the entire bridge. Specifically, the innovative strategies for bridge design and accelerated construction are introduced below.

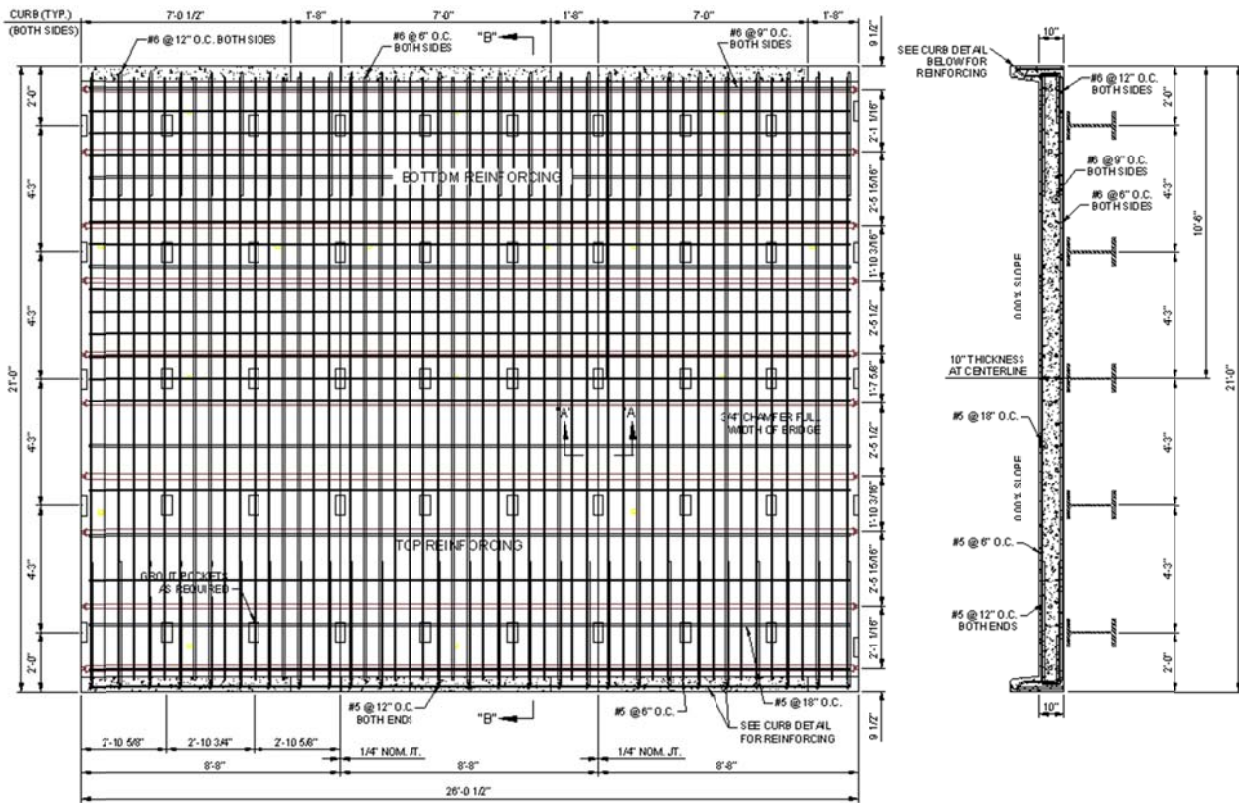
Figure 3.2: GFRP bar reinforcement layout for steel-girder supported deck slabs

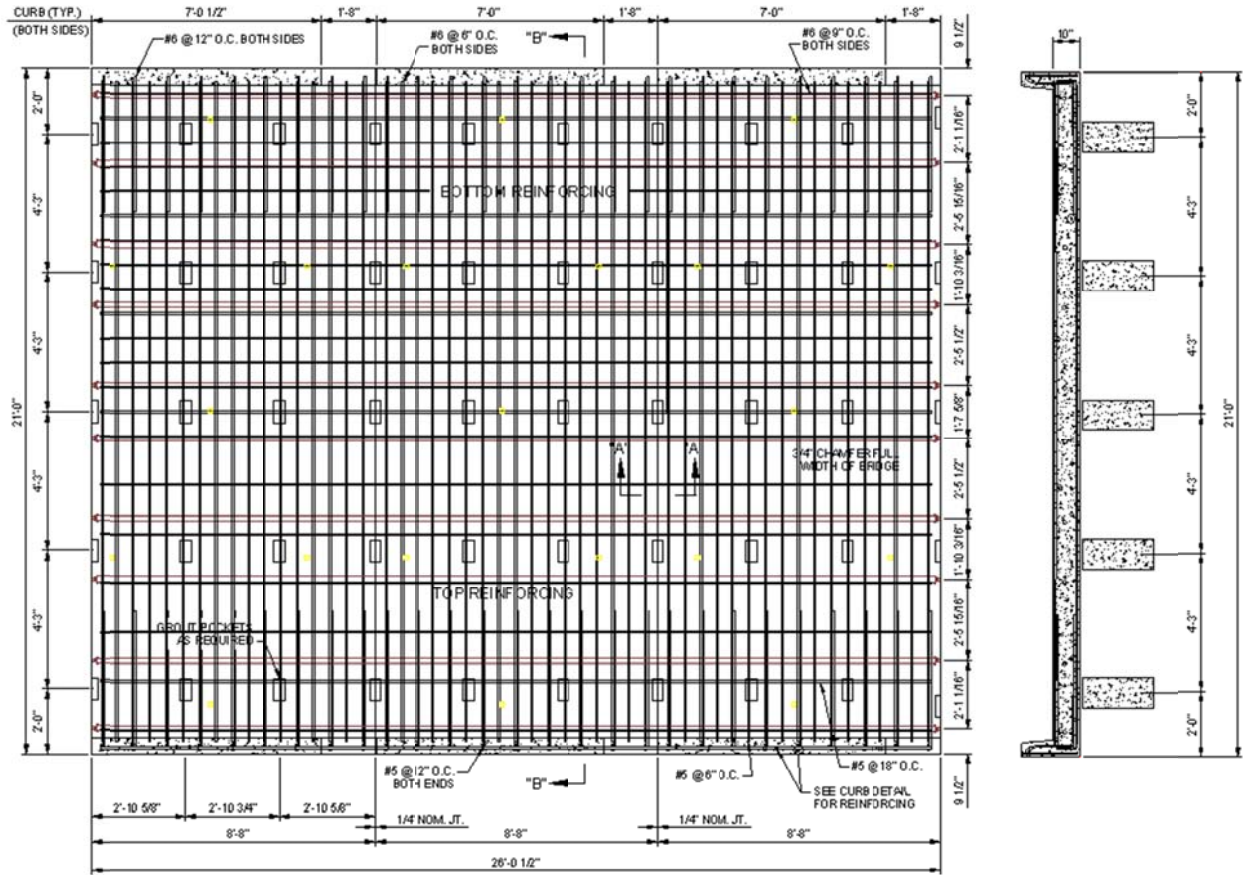
Figure 3.3: GFRP bar reinforcement layout for concrete-girder supported deck slabs

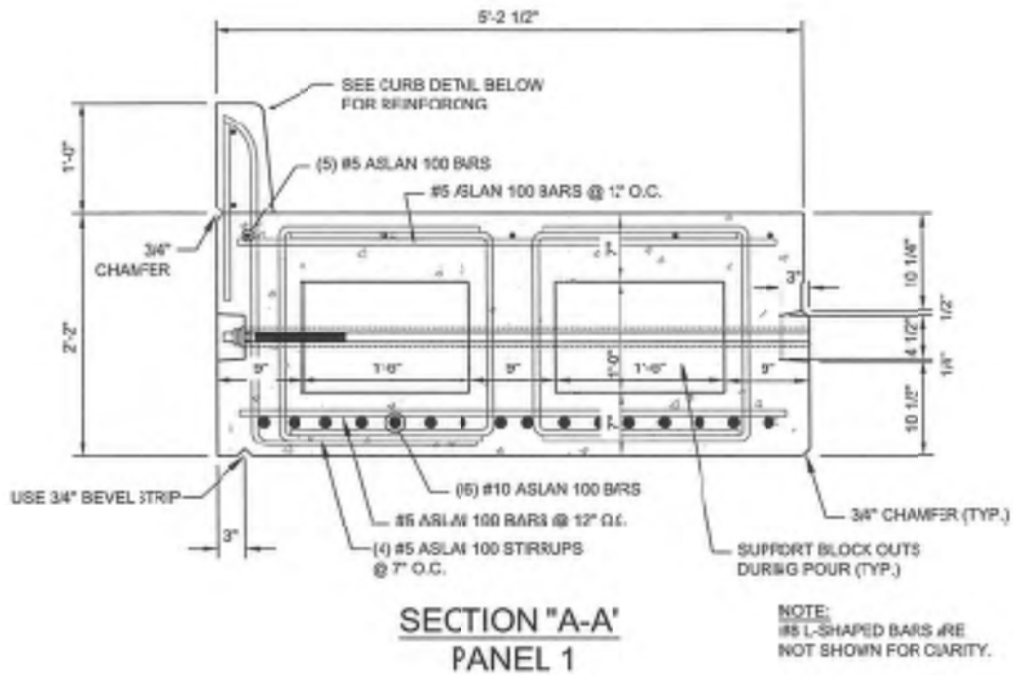
Figure 3.5: Detailed GFRP bar reinforcement layout for concrete box girder

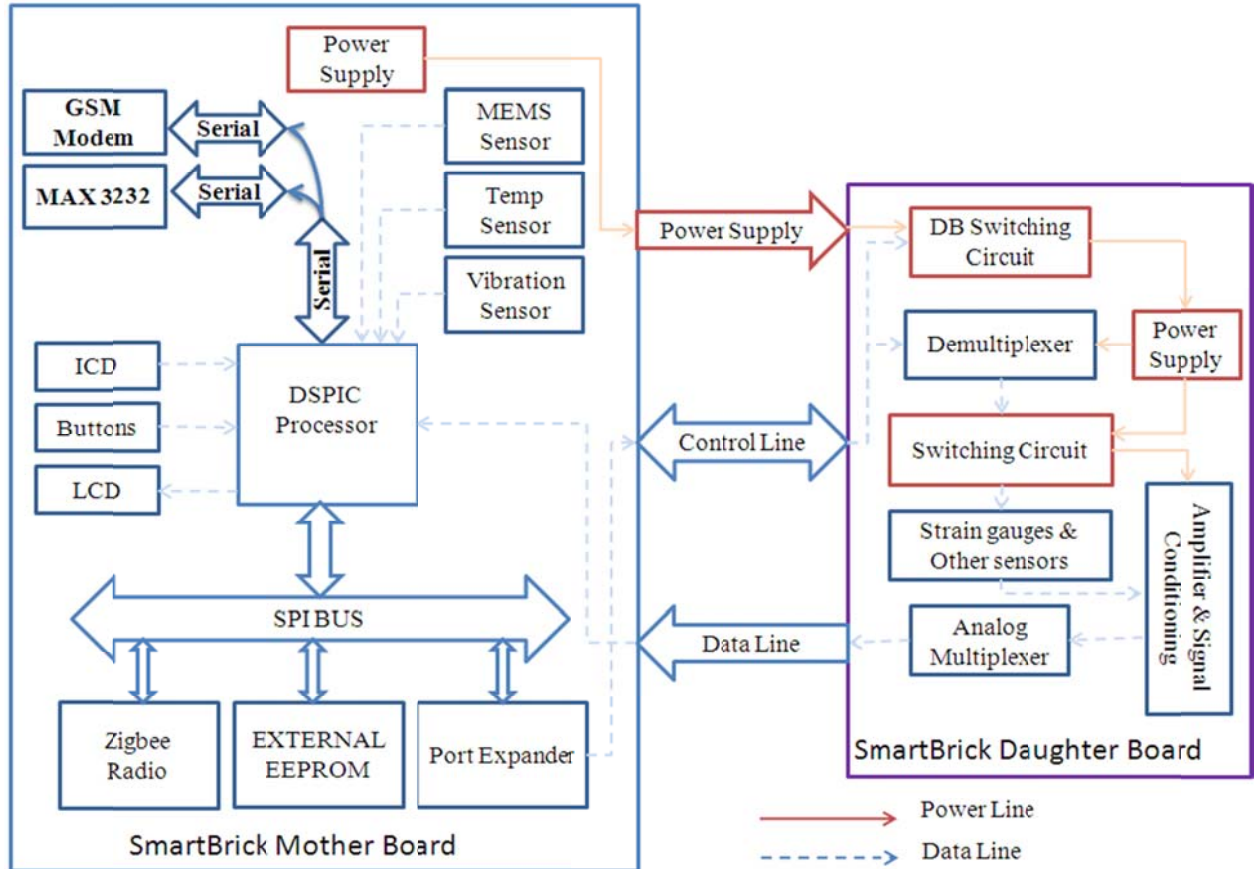
Figure 4.1: Architectures of SmartBrick motherboard (left) and daughterboard (right)

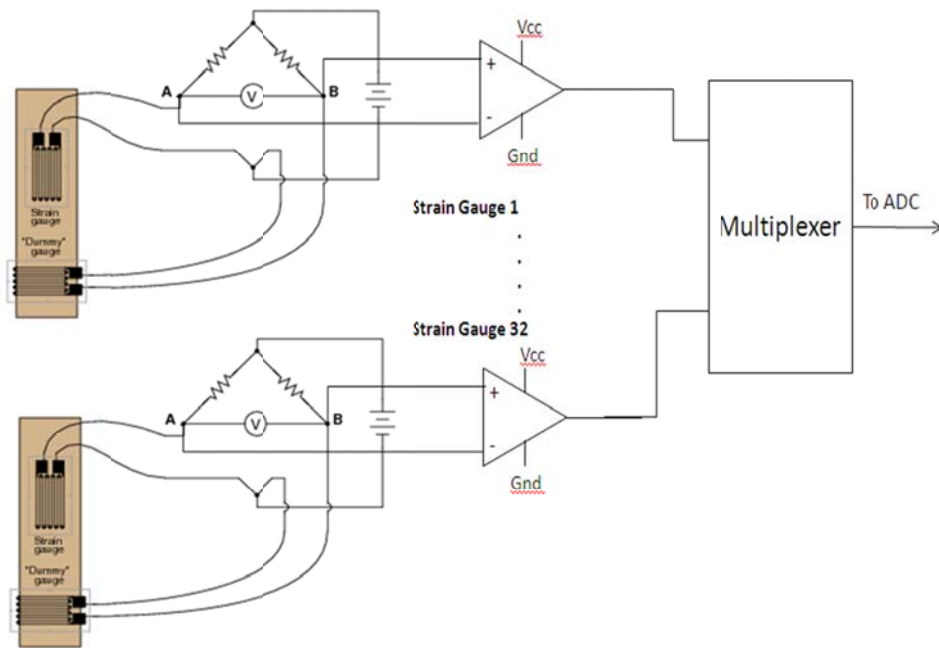
Figure 4.2: Half-bridge configuration and multiplexer in SmartBrick Daughterboard

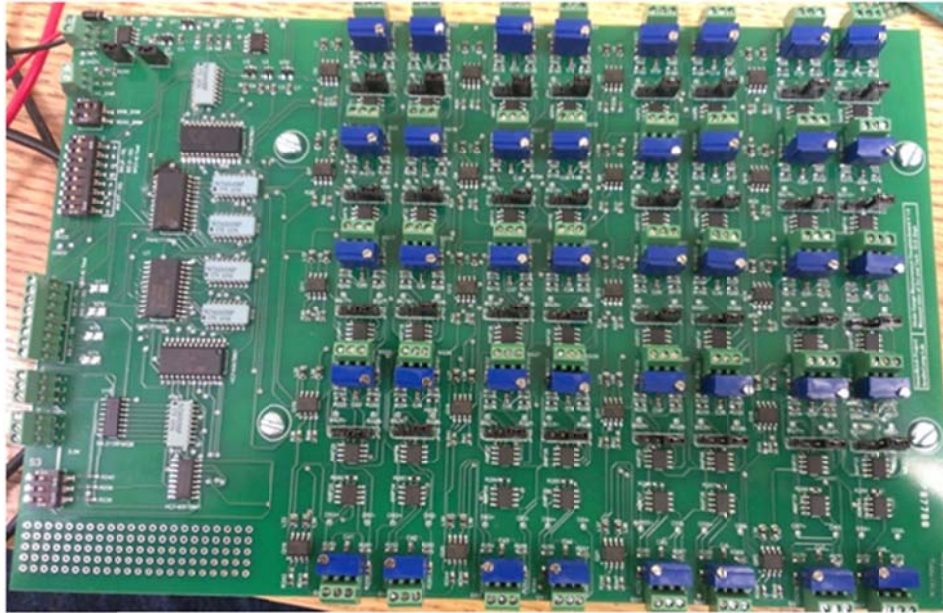
Figure 4.3: Prototype daughterboard in SmartBrick for strain gauge measurement

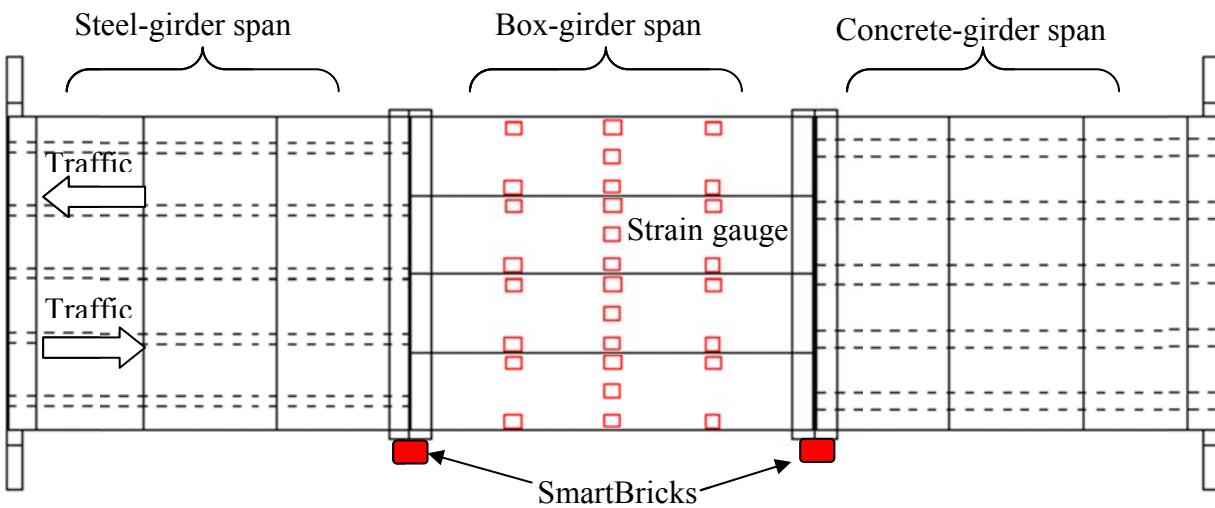
Figure 4.4: Instrumentation layout in GFRP reinforced box-girder span of the Washington County Bridge

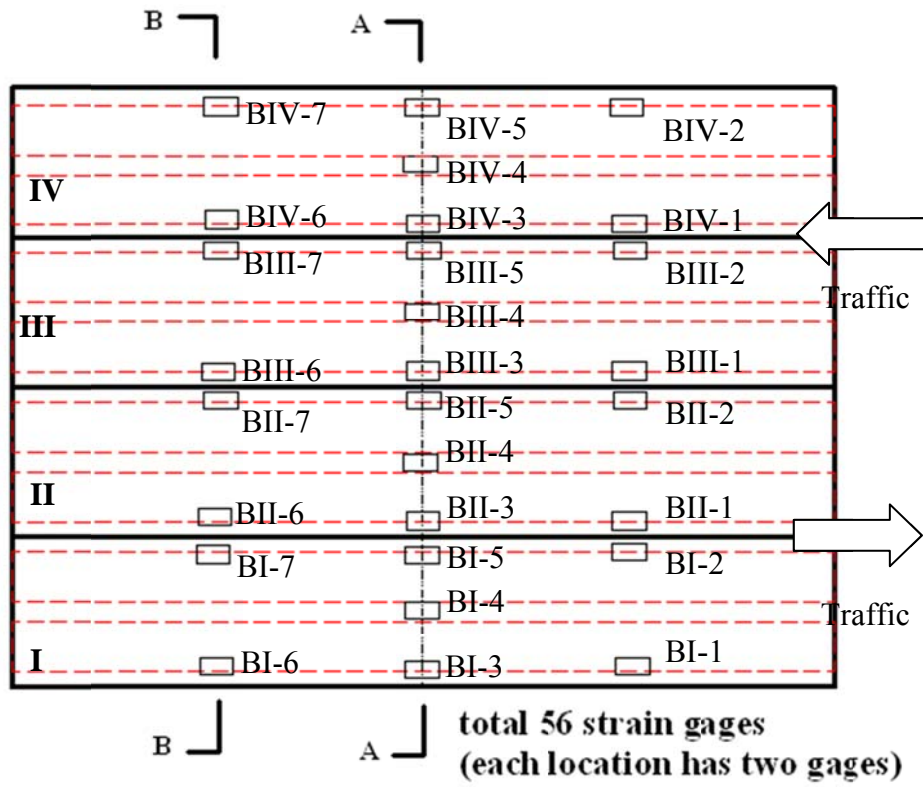
(a) Plan view (56 strain gauges total)

Figure 4.5: Longitudinal strain gauges layout in the GFRP reinforced box-girder span

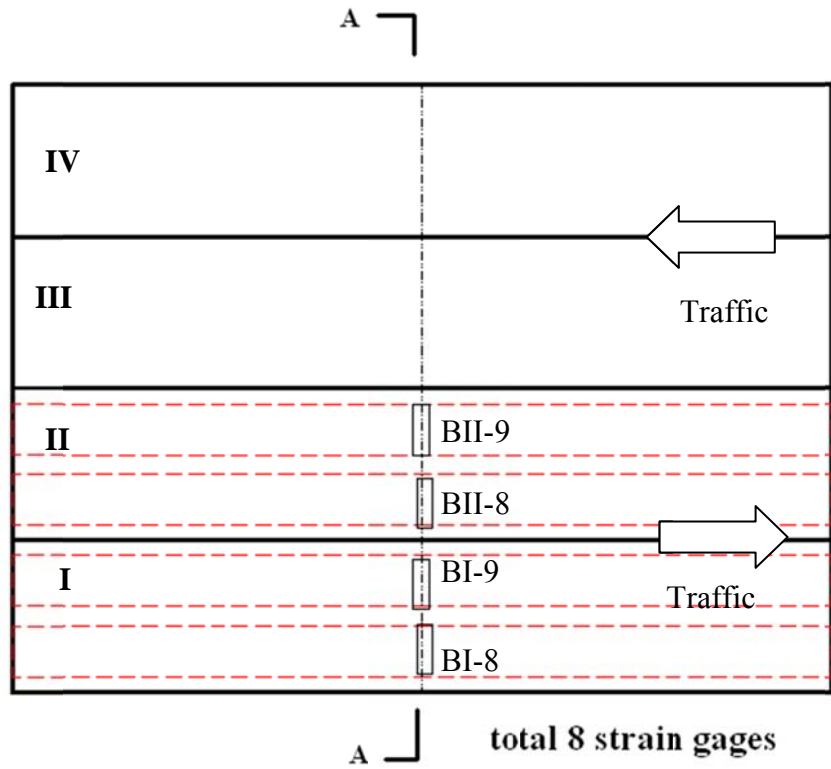
(a) Plan view (8 strain gauges total)

(b) Section A-A

Figure 4.6: Transverse strain gauges layout in the GFRP reinforced box-girder span

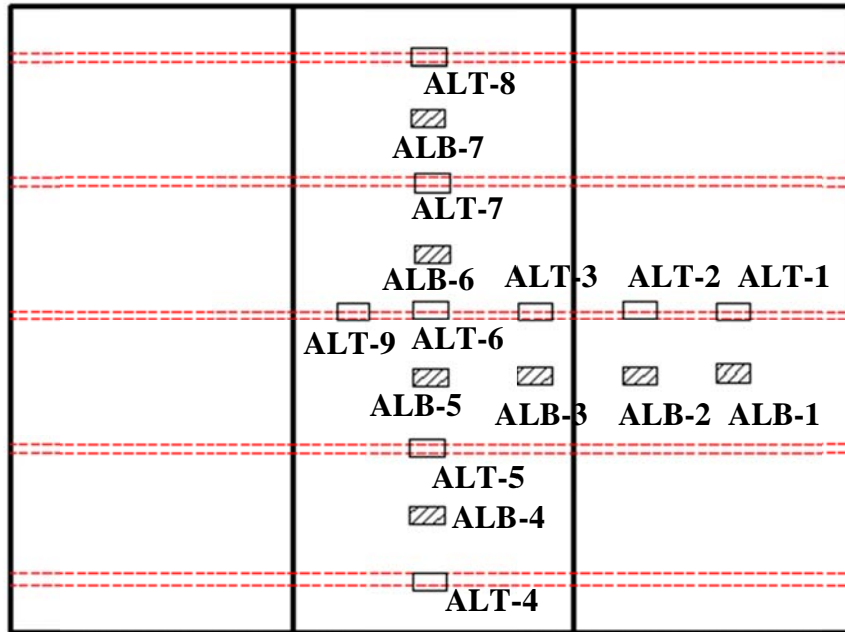
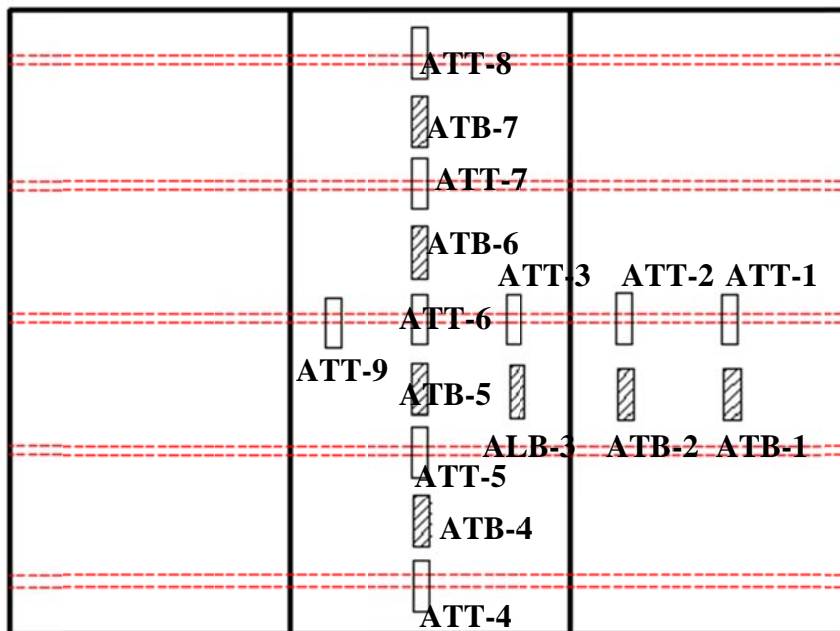
(a) Longitudinal strain gauges in deck slabs (32 total)

(b) Transverse strain gauges in deck slabs (32 total)

Figure 4.7: Strain gauges layout in the GFRP reinforced concrete deck of the concrete- or steel-girder span

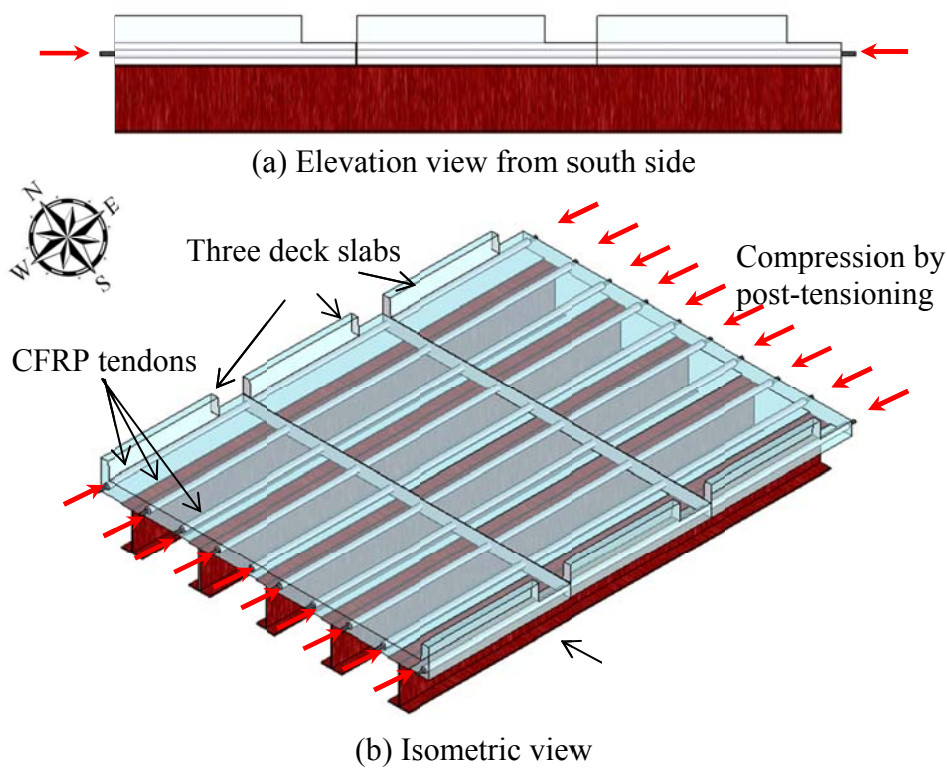
Figure 5.18: Schematics of a post-tensioned, steel-girder deck (3 slabs) with ten CFRP tendons

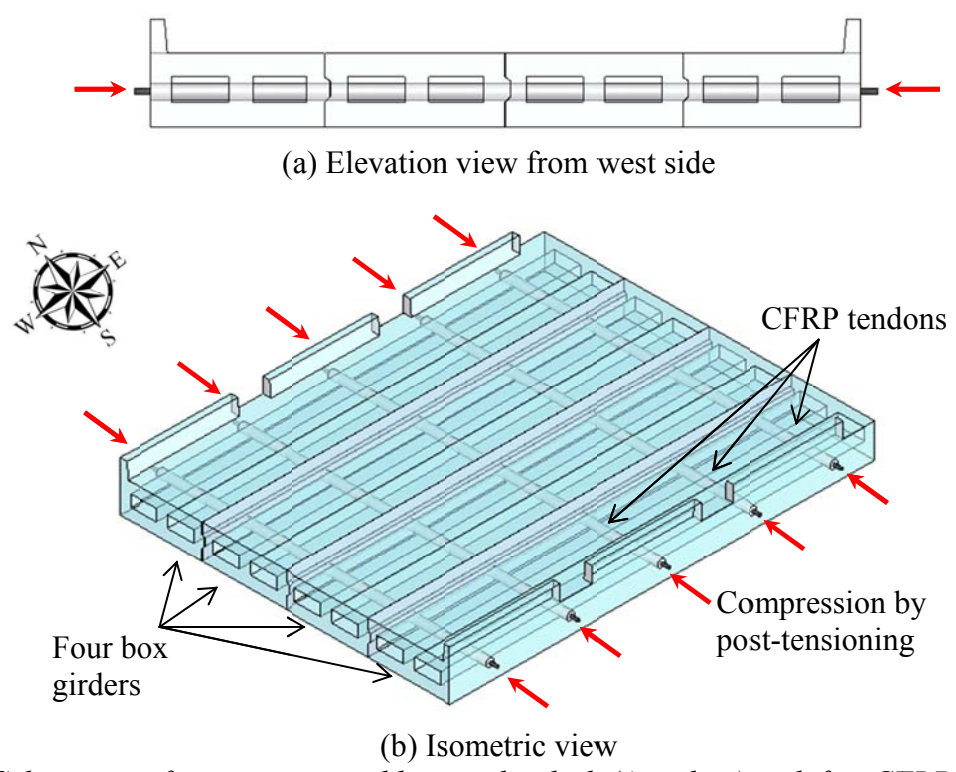
Figure 5.19: Schematics of a post-tensioned box-girder deck (4 girders) with five CFRP tendons (3 fractured during installation)

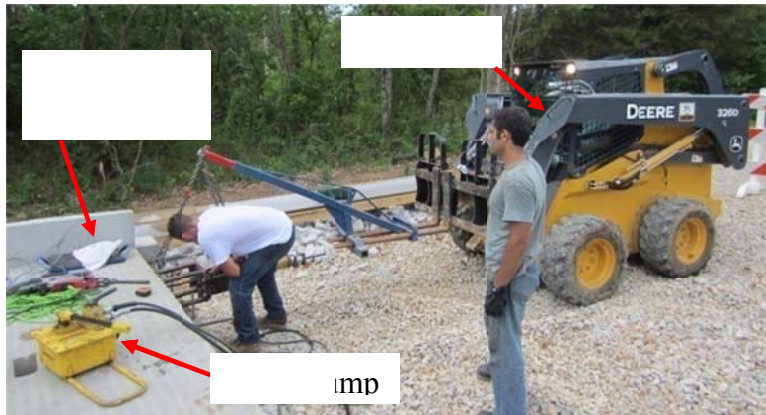
(a) Preparation for on-site post-tensioning

Figure 5.20: Post-tensioning of one CFRP tendon

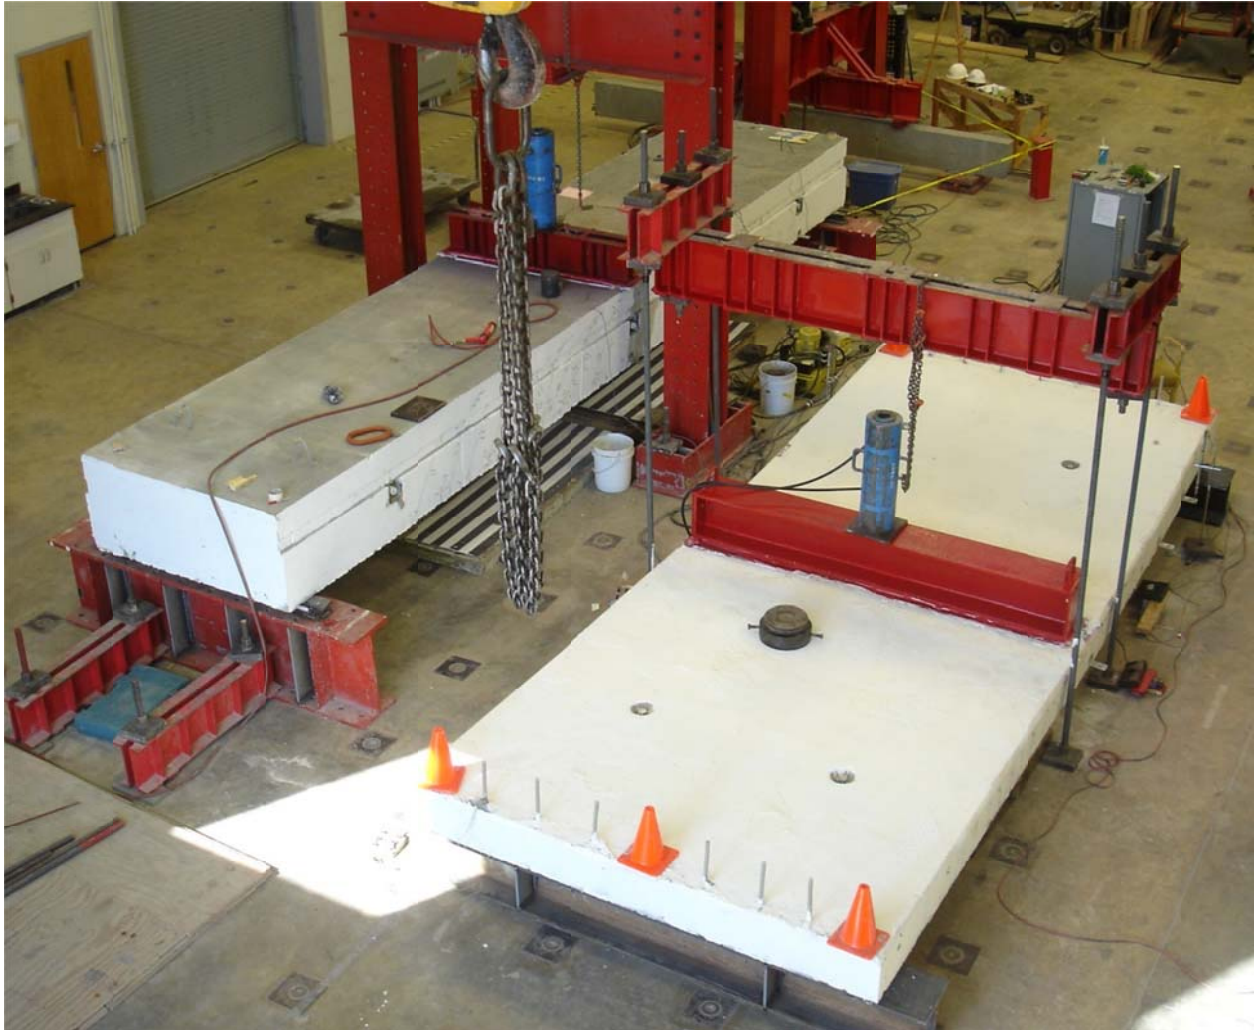
Figure 6.1: Overview of laboratory test setups for full-scale precast bridge elements

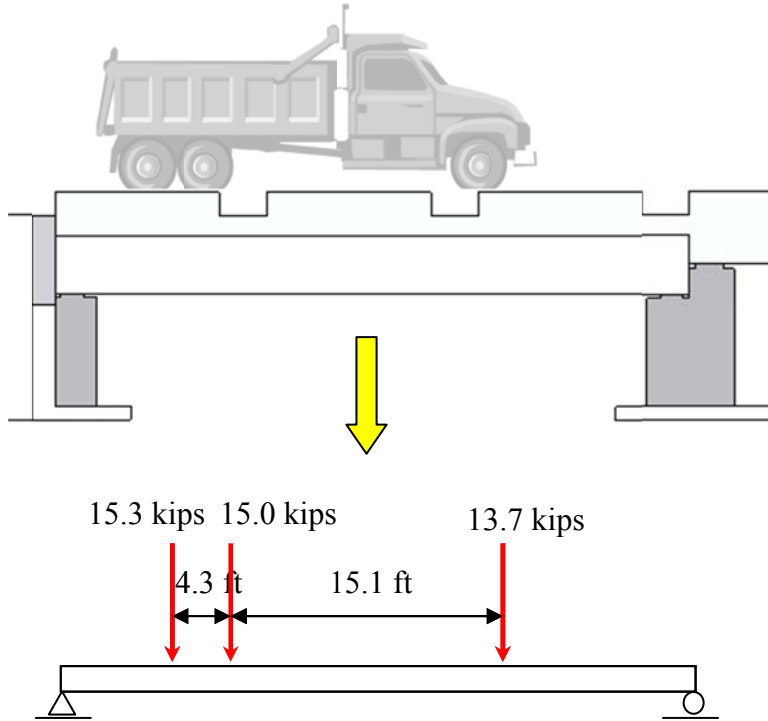
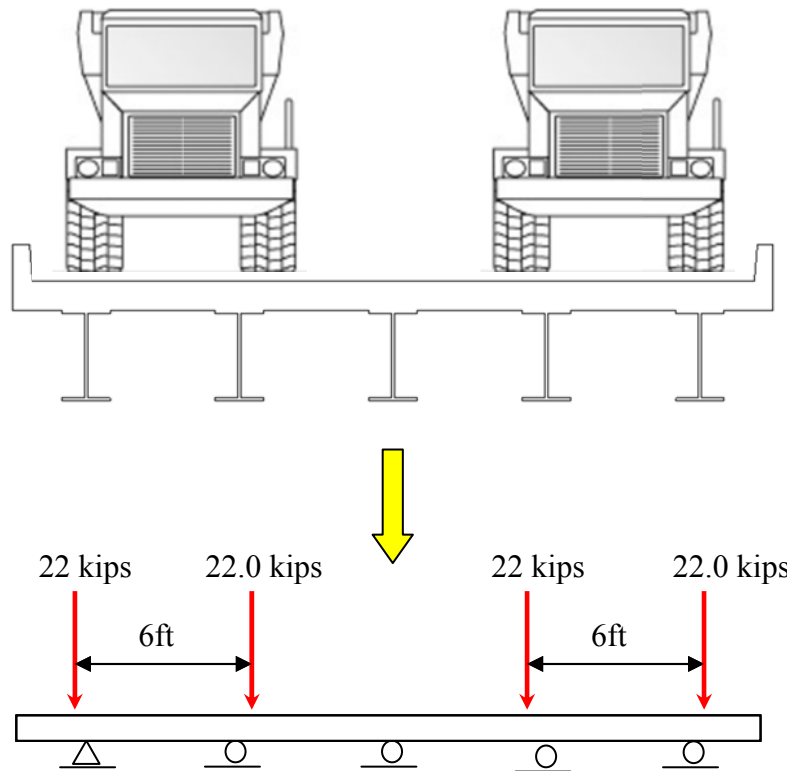
(a) Idealized simply-supported beam along longitudinal direction (traffic flow)

(b) Idealized continuous beam along transverse direction (river flow)

Figure 6.3: Preliminary design of load protocol for field tests

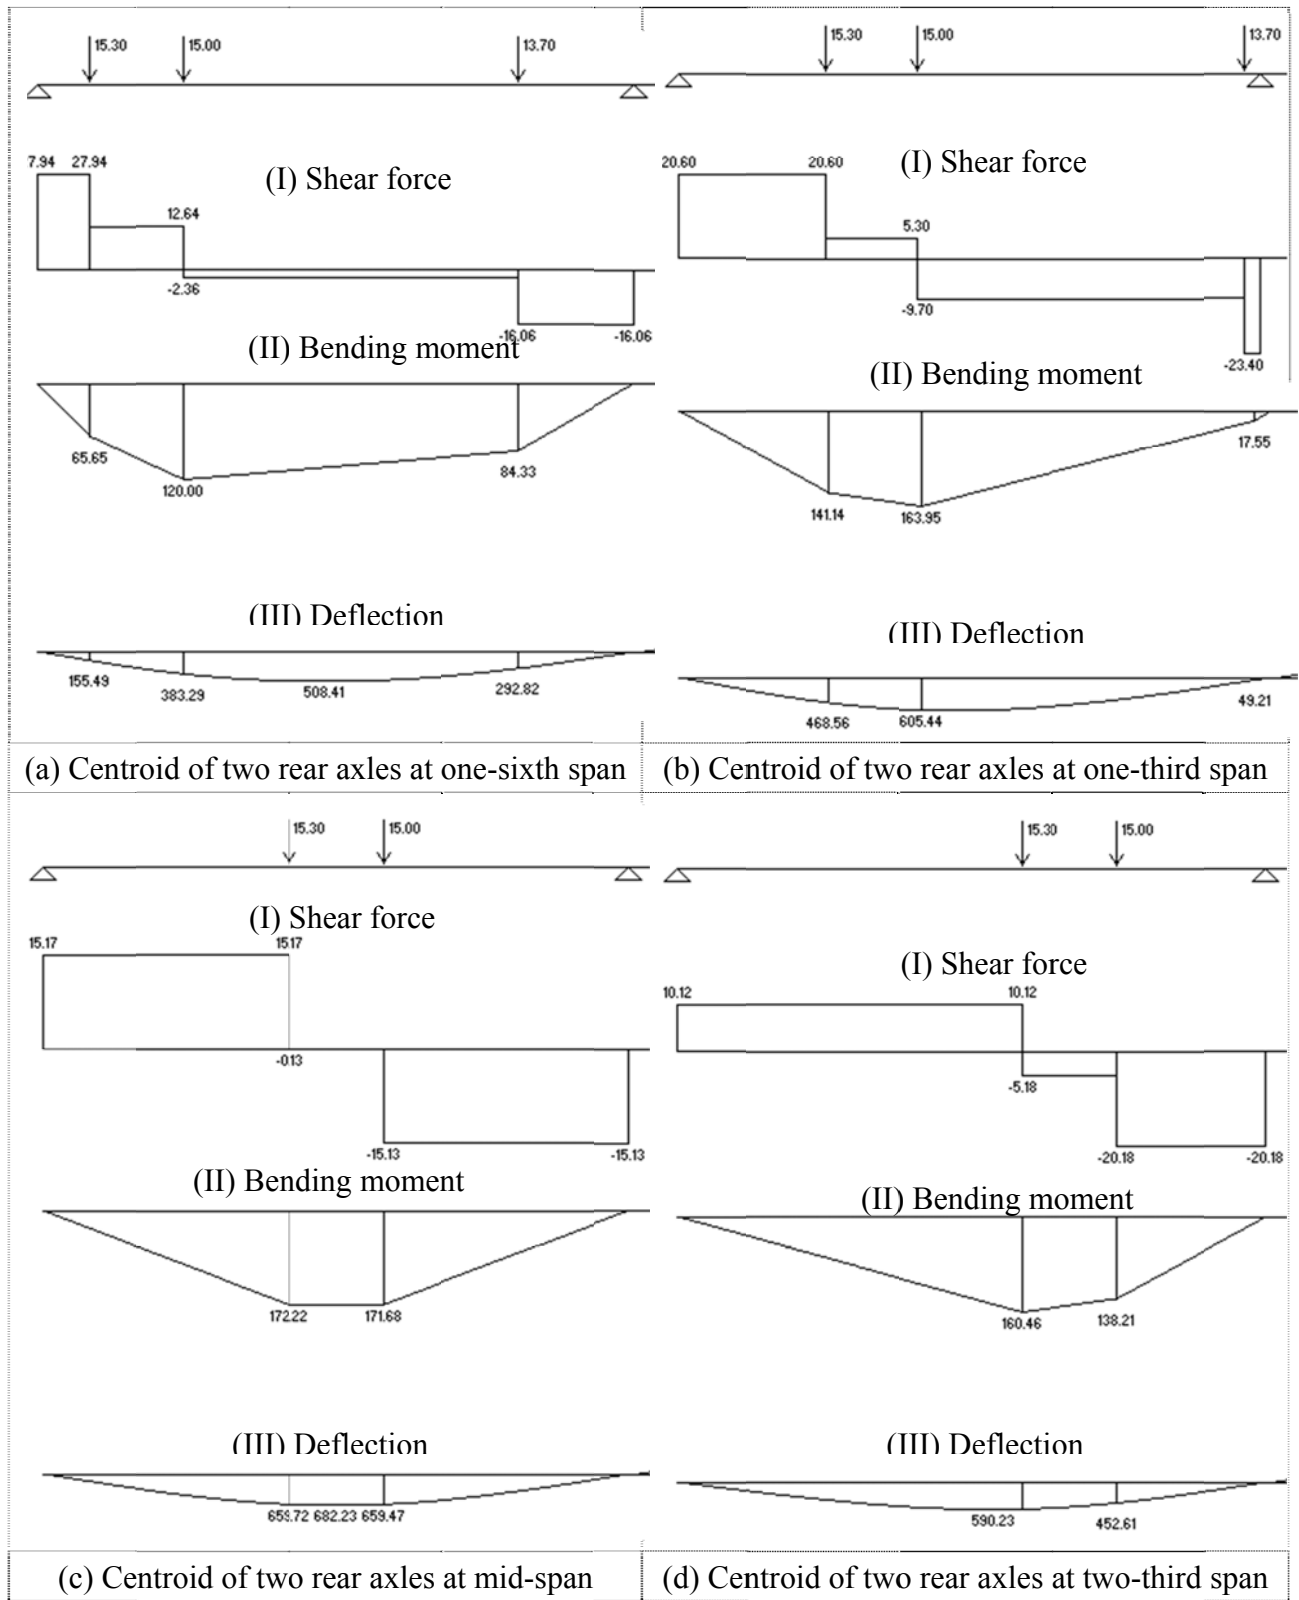
Figure 6.4: Determination of truck location in longitudinal direction for field tests

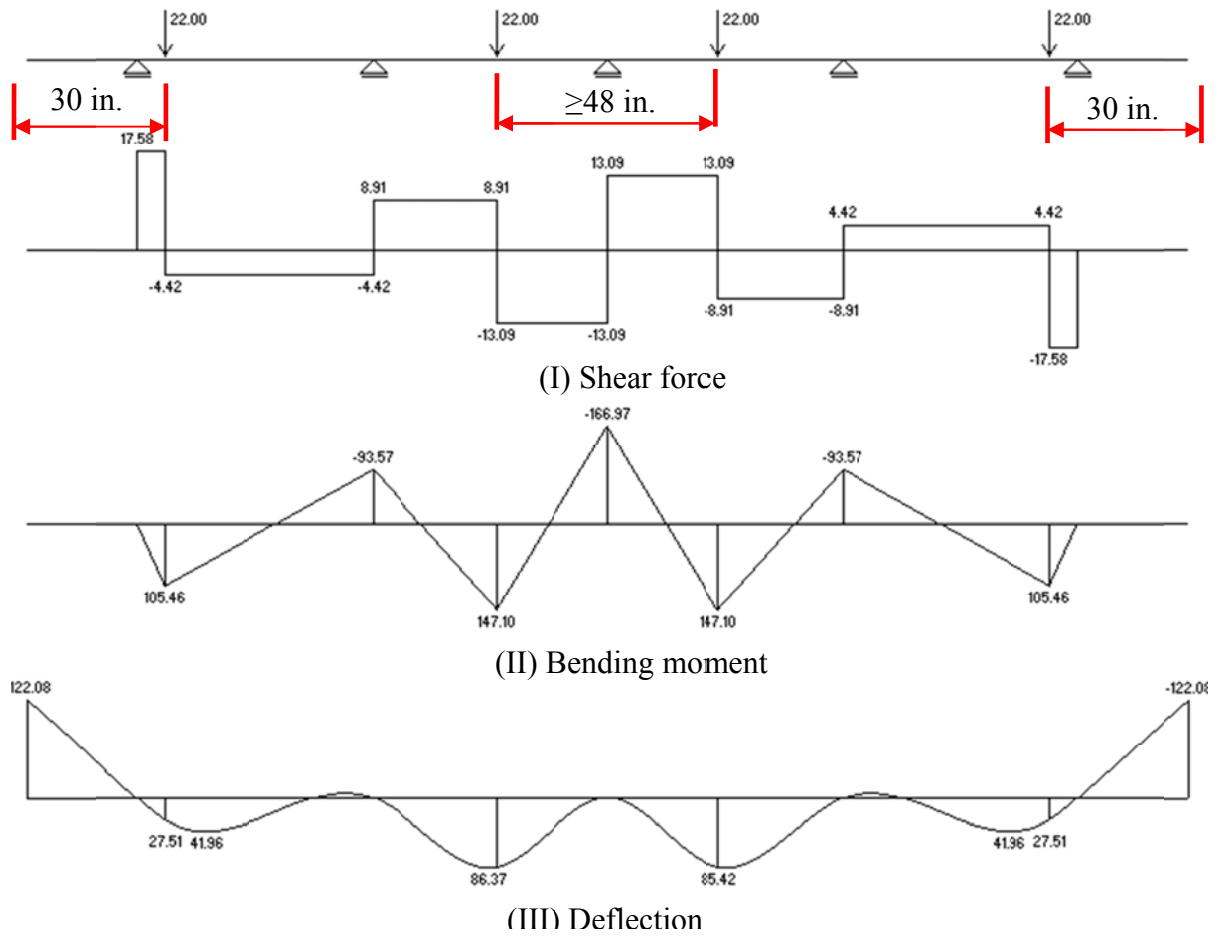
(d) Load case 4 with two trucks

(e) Load case 5 with two trucks

Figure 6.5: Determination of truck location (pass) in transverse direction for field tests

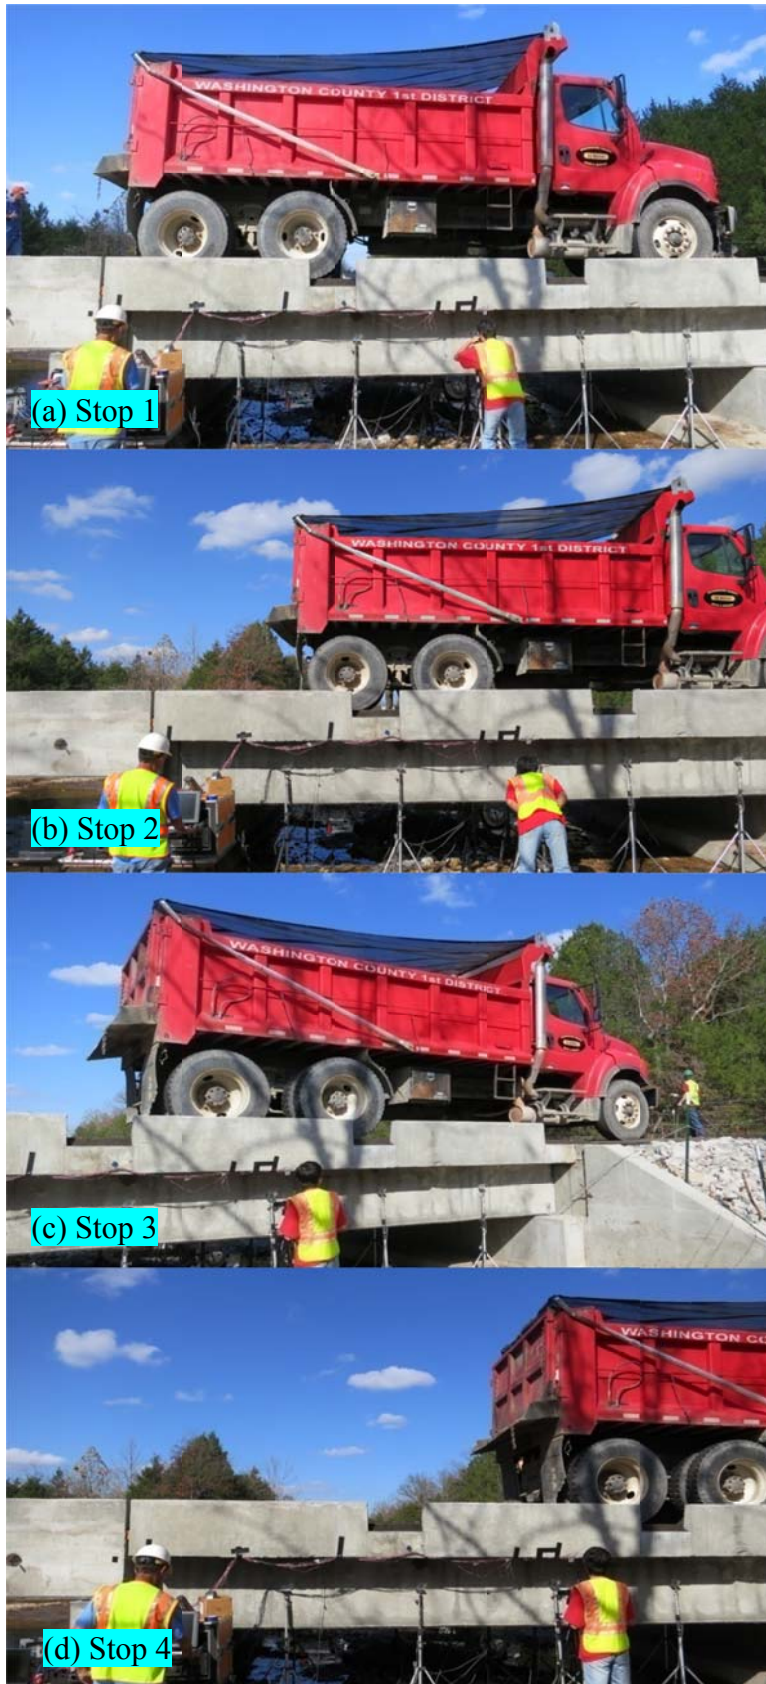
Figure 6.7: Illustrated four steps of one truck over each span

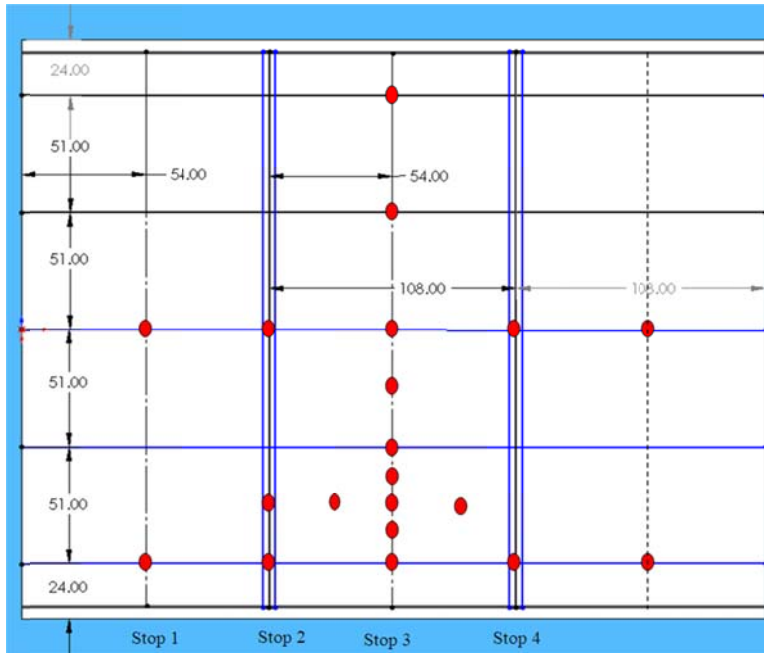
(a) Concrete/steel girder supported deck slabs in the first and third spans

Figure 6.15: DC-LVDT transducers layout (red dots)

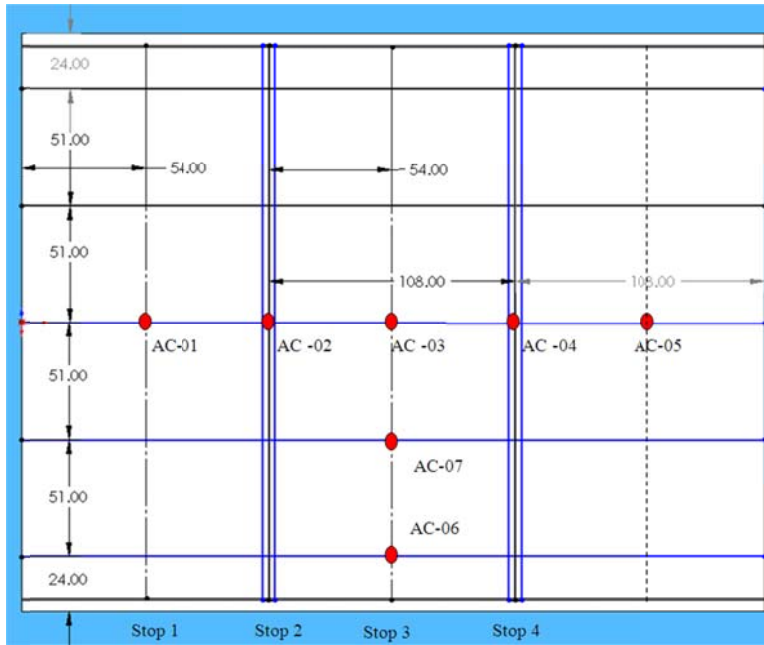
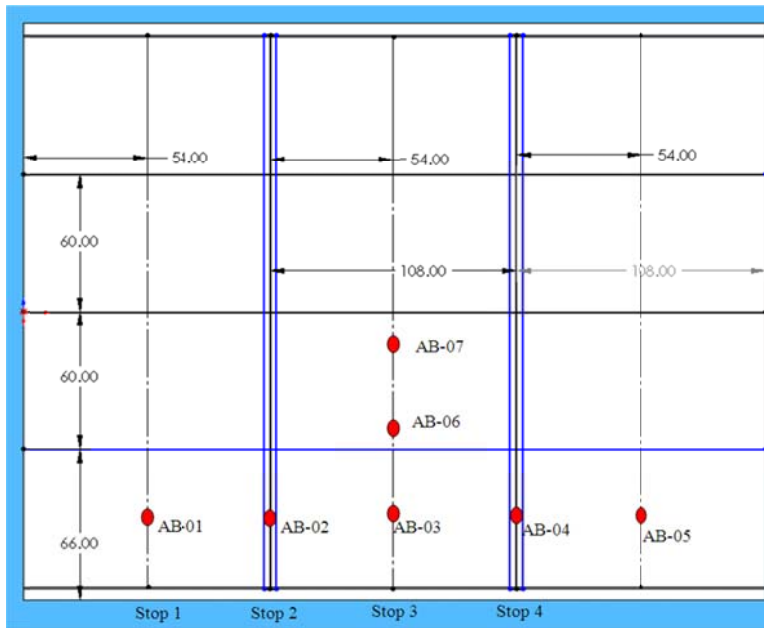
(a) Concrete/steel girder supported deck slabs in the first and third spans

(b) Concrete box girders in the middle span

Figure 6.16: Accelerometer layout (red dots)
