Design, Construction and Load Testing of the Pat Daly Road Bridge in Washington County, MO, with Internal Glass Fiber Reinforced Polymers Reinforcement

**CENTER FOR TRANSPORTATION
INFRASTRUCTURE AND SAFETY**

**NUTC
R275**

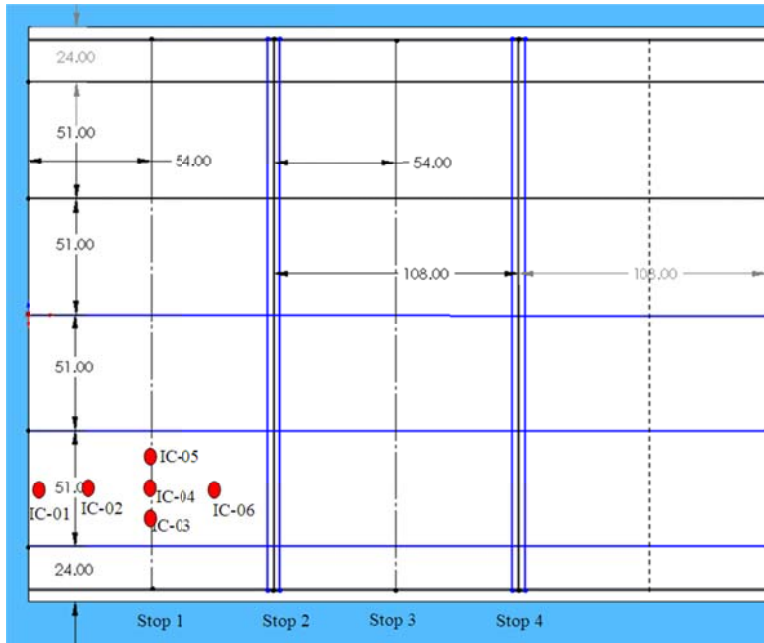
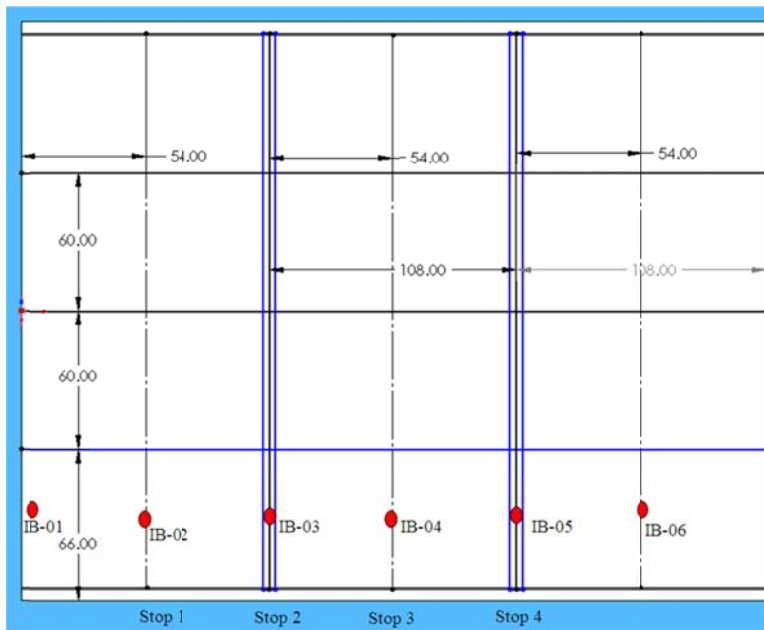
(a) Concrete/steel girder supported deck slabs in the first and third spans

(b) Concrete girders in the middle span

Figure 6.17: Inclinometer layout (red dots)

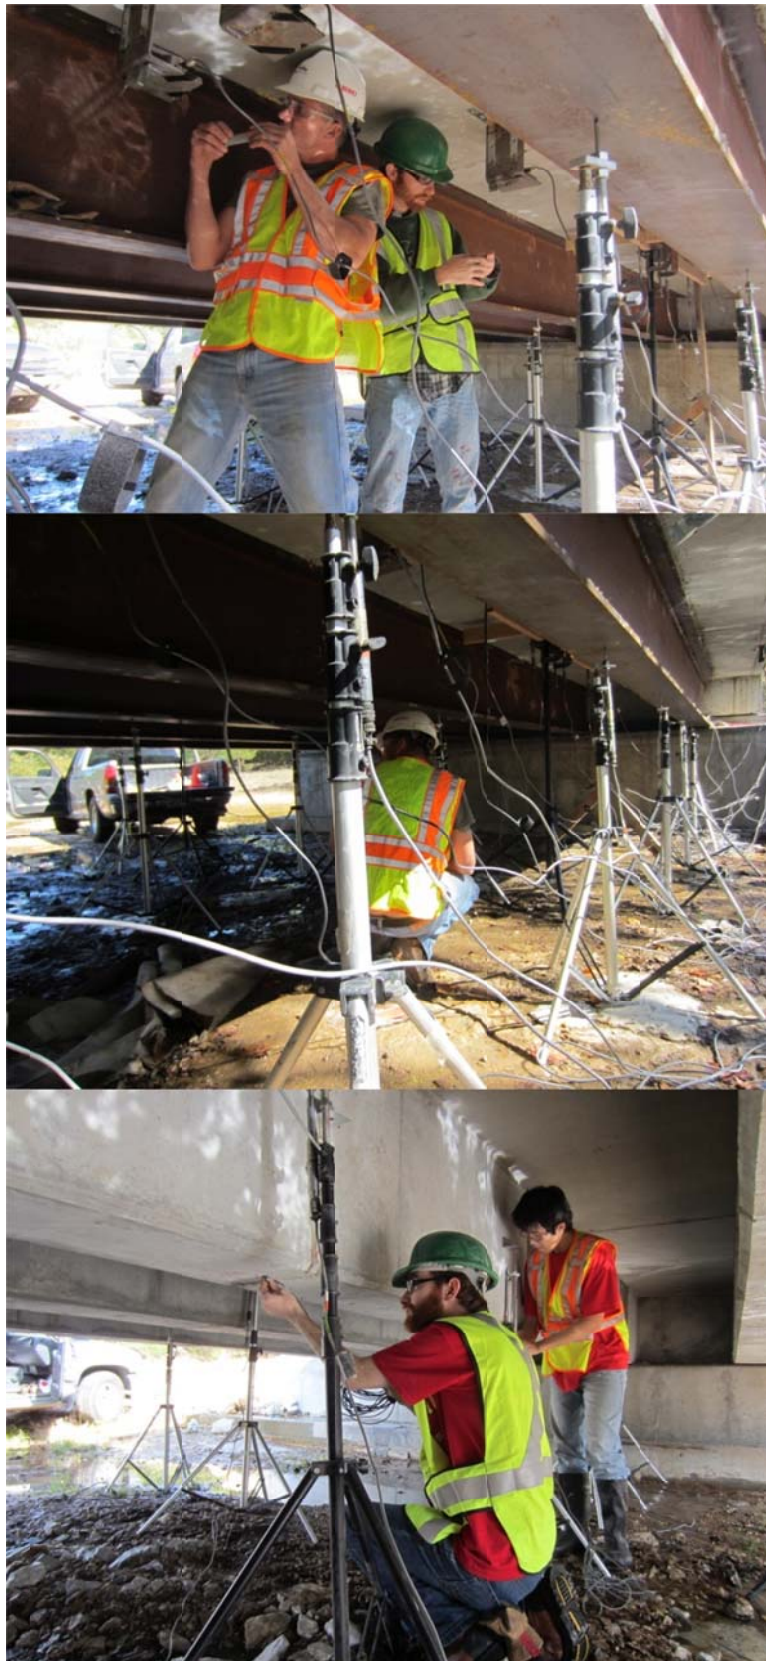
Figure 6.18: Installation process of representative sensors

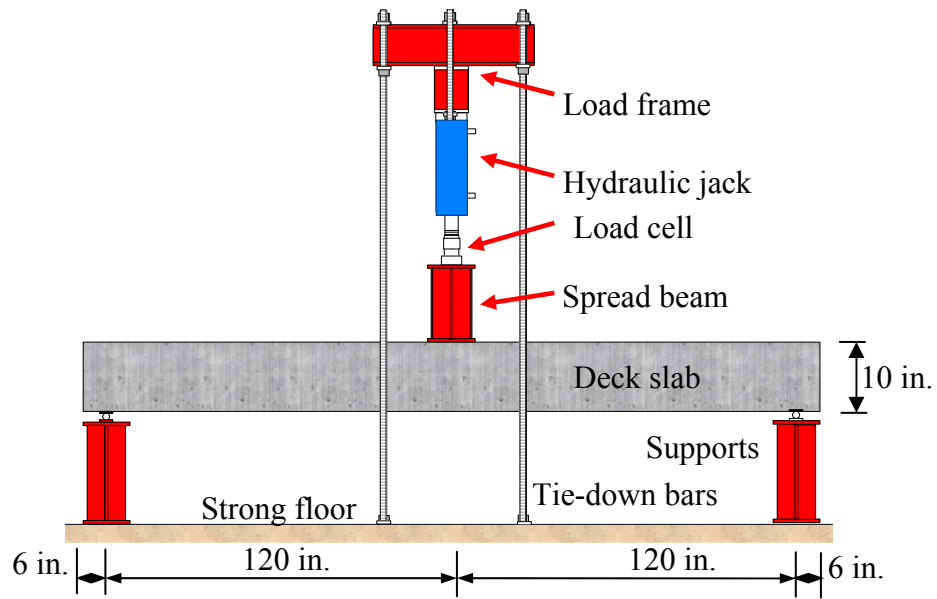
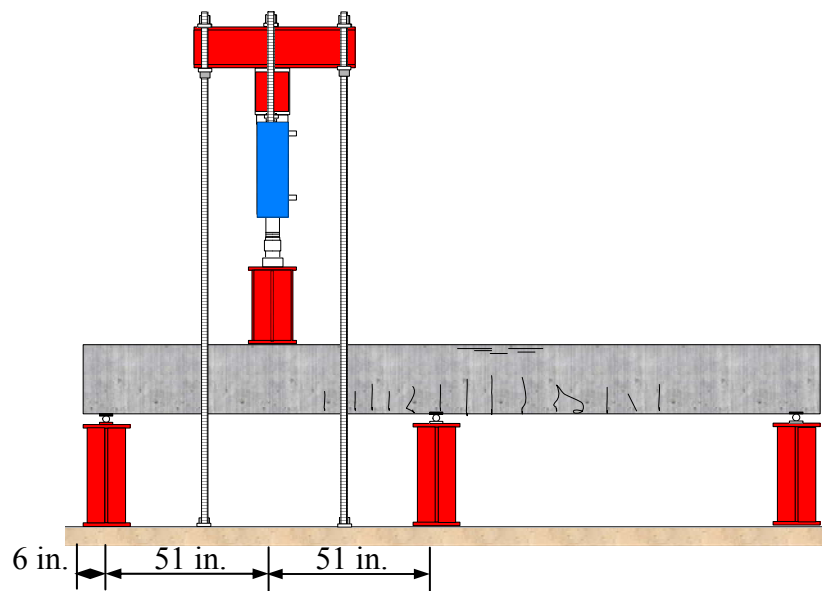
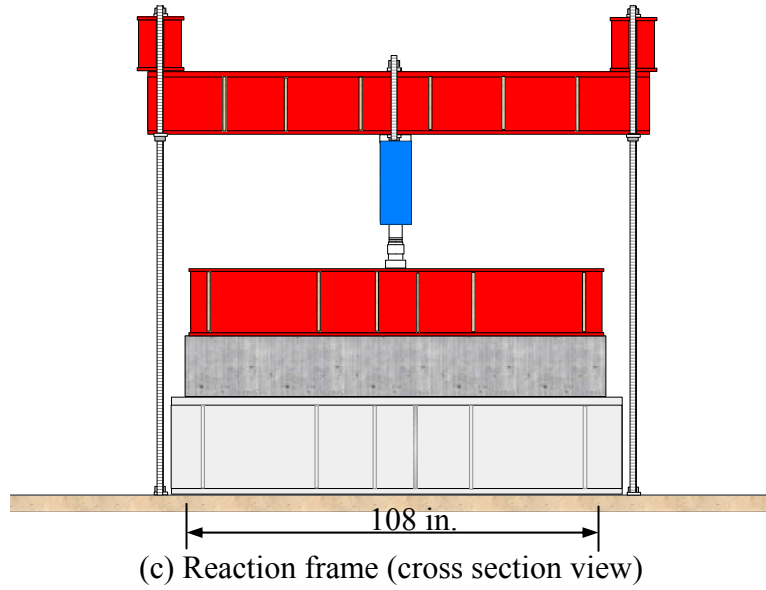
(a) Schematic test setup for Load Case 1 with a predicted flexural failure (elevation view)

(b) Schematic test setup for Load Case 2 with a predicted shear failure (elevation view)

Figure 7.1: Laboratory test schemes for a full-size concrete slab

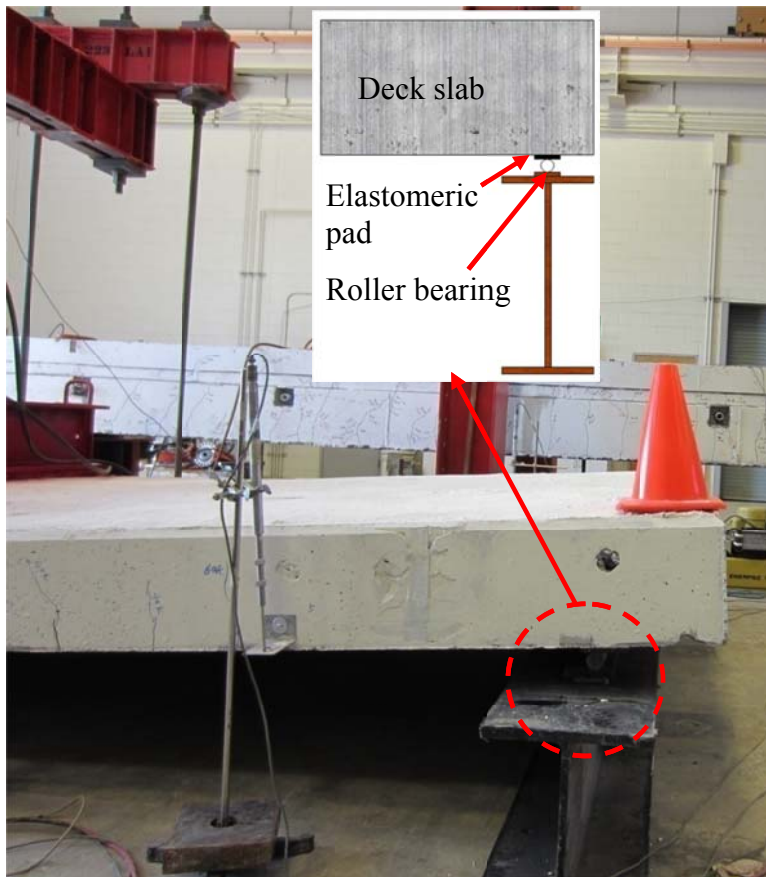
(b) End support of the concrete slab

Figure 7.3: Details of slab test setup

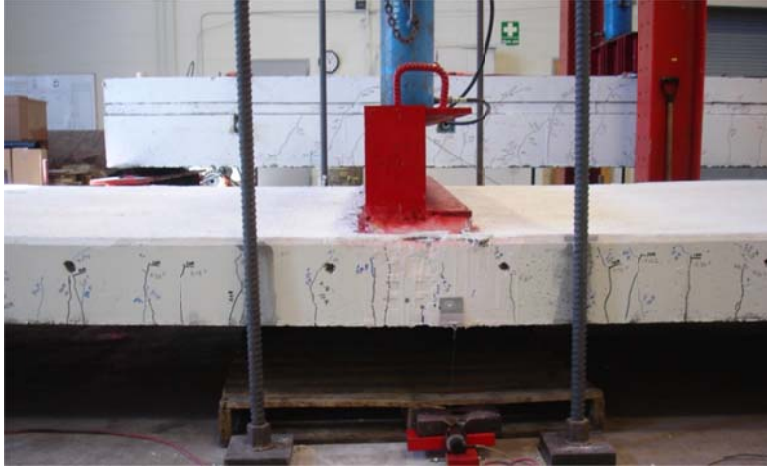
Figure 7.10: Crack pattern during the slab test with initial cracks observed at 10 kips

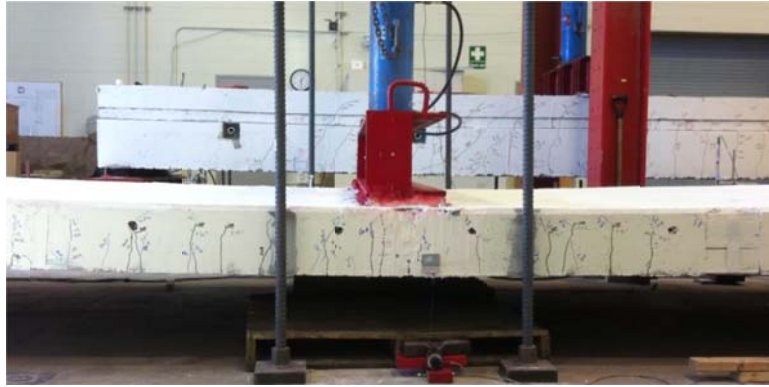
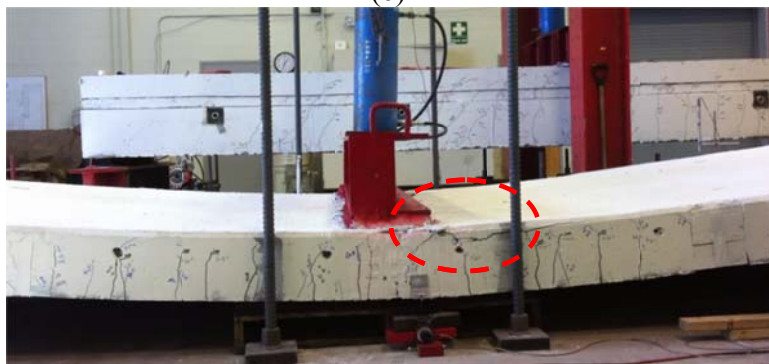
Figure 7.11: Flexural failure process

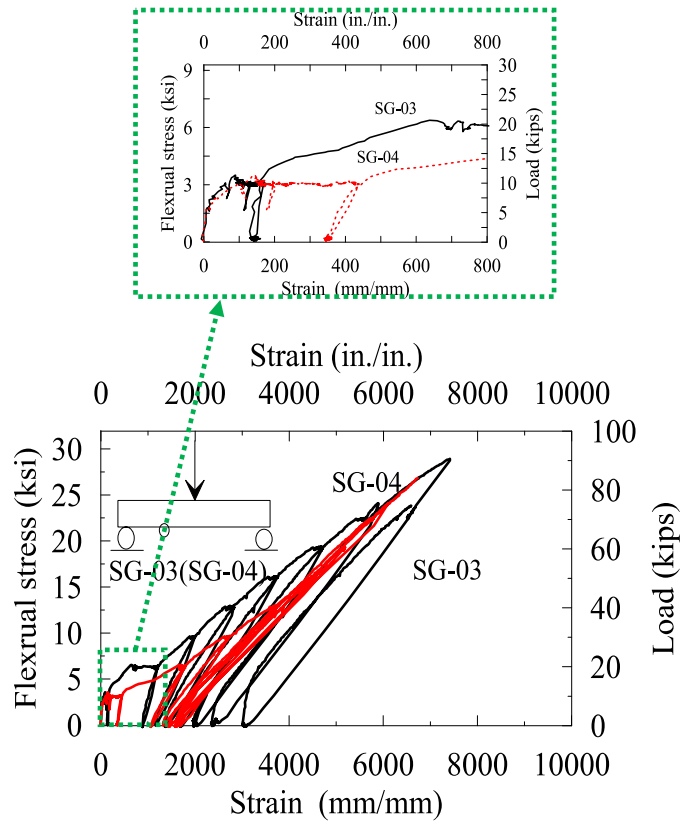
Figure 7.16: Stress-strain curves for quarter span bottom GFRP bar (Load Case 1)

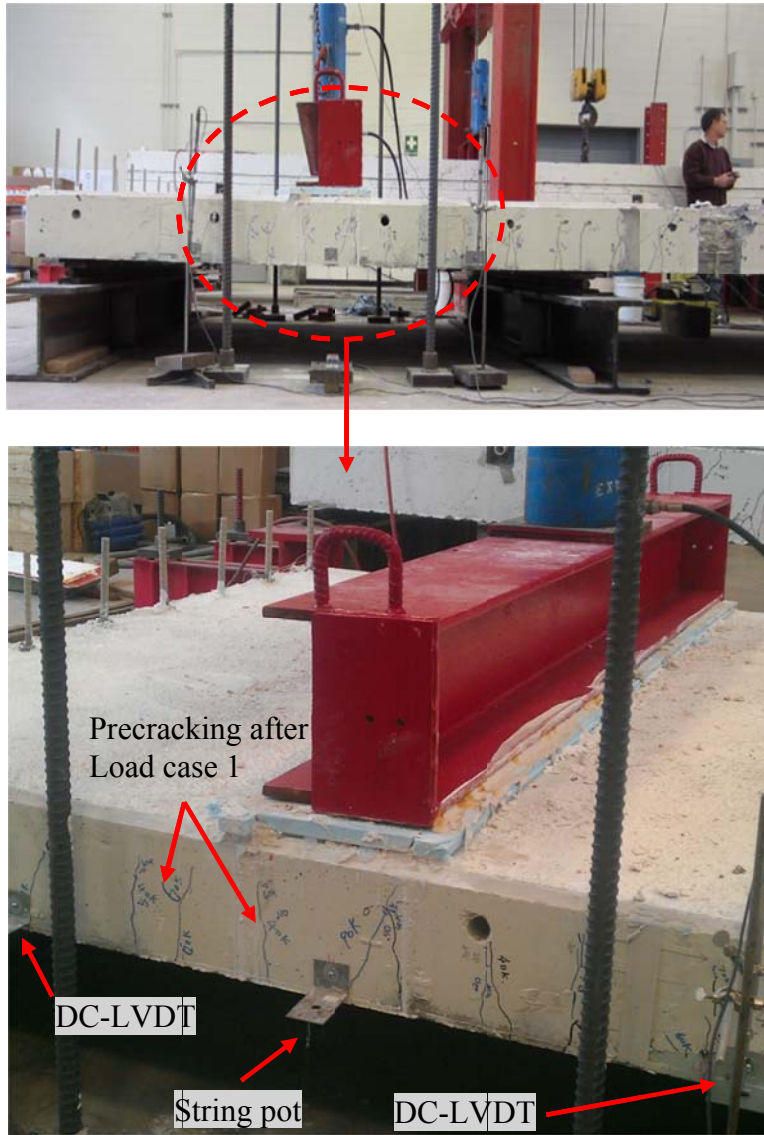
Figure 7.17: Setup for shear test in Load Case 2

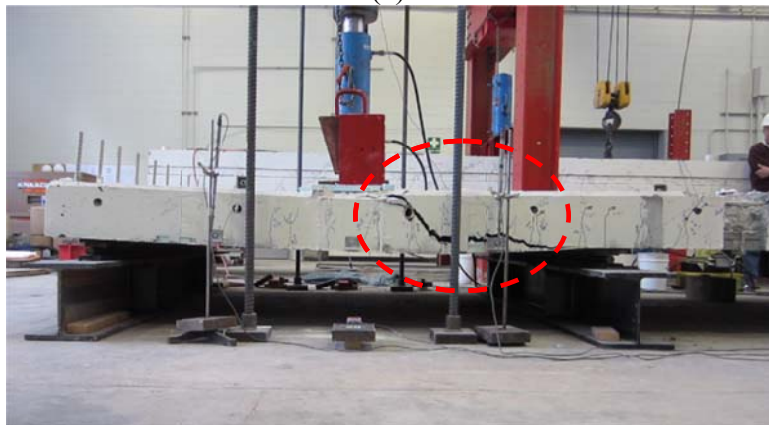
Figure 7.18: Shear failure process and cracking propagation

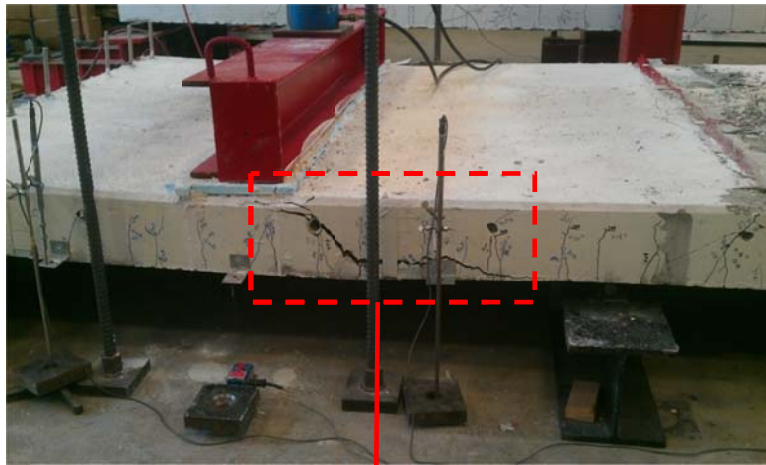
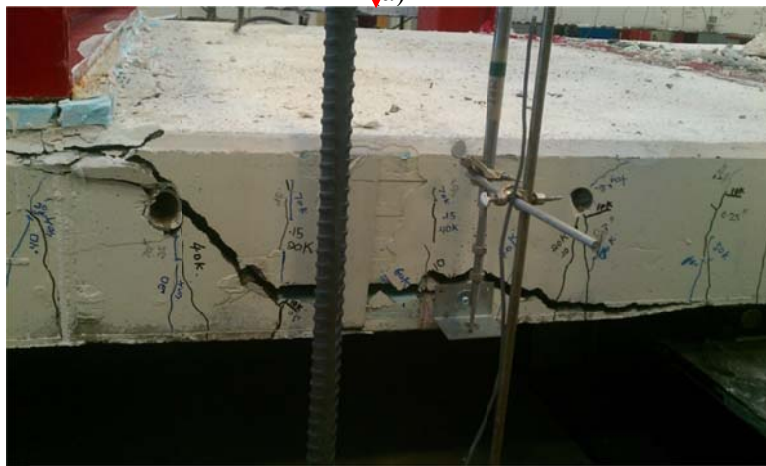
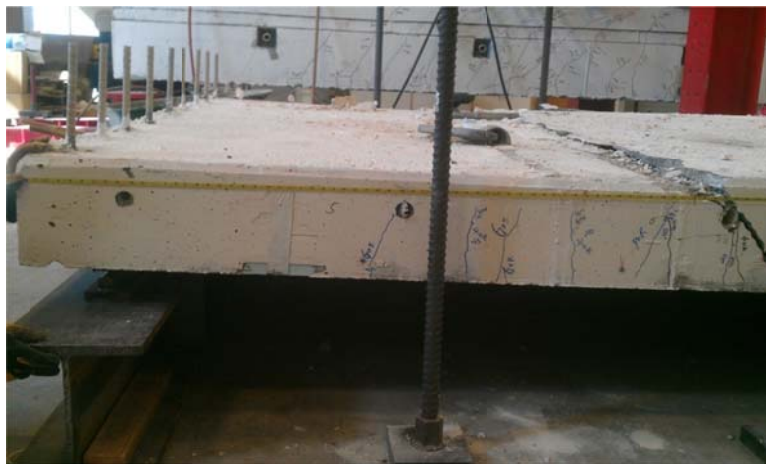
Figure 7.19: Slab failure by shear

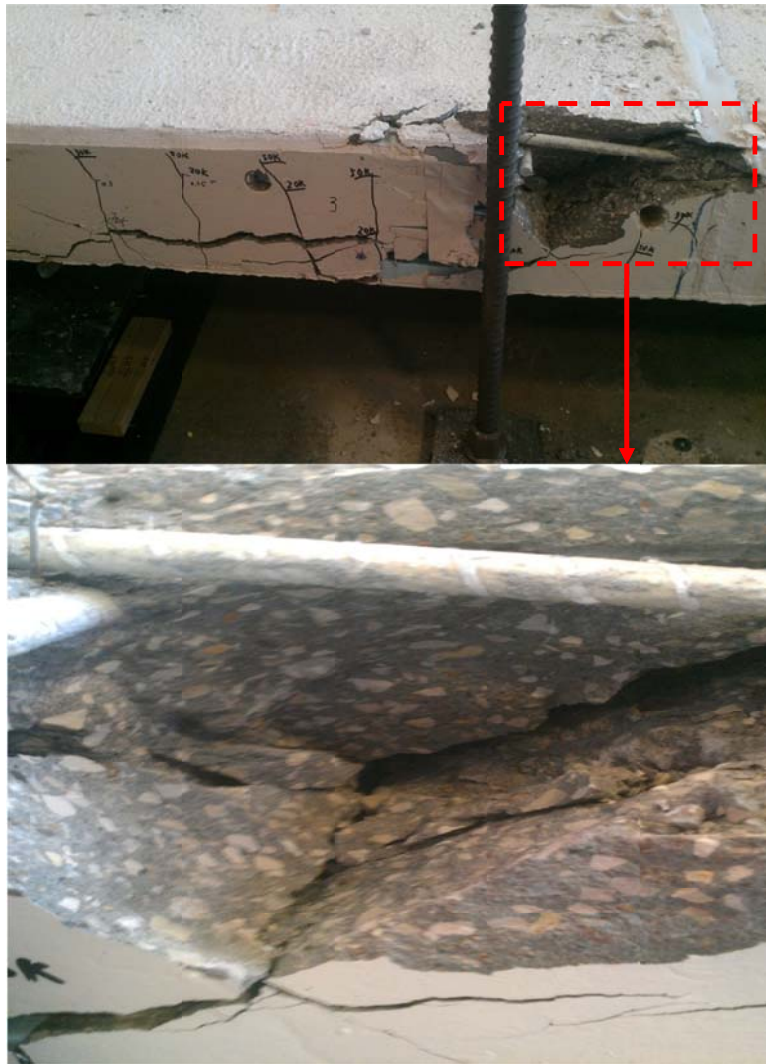
Figure 7.20: GFRP bar condition at shear failure

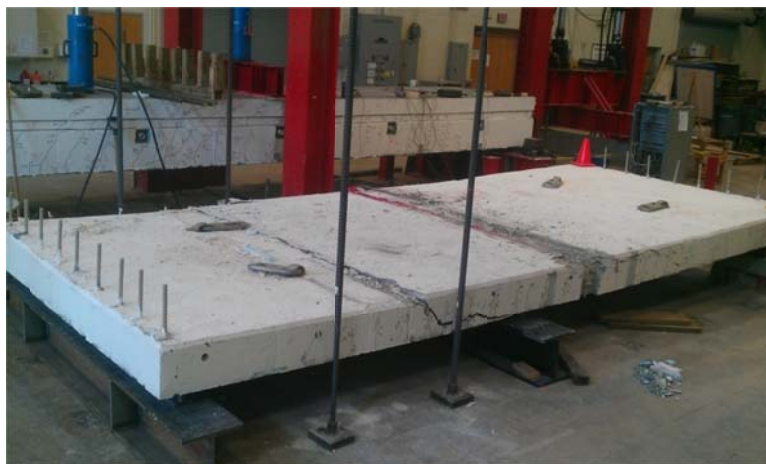
Figure 7.21: Overview of the collapsed slab after two load cases

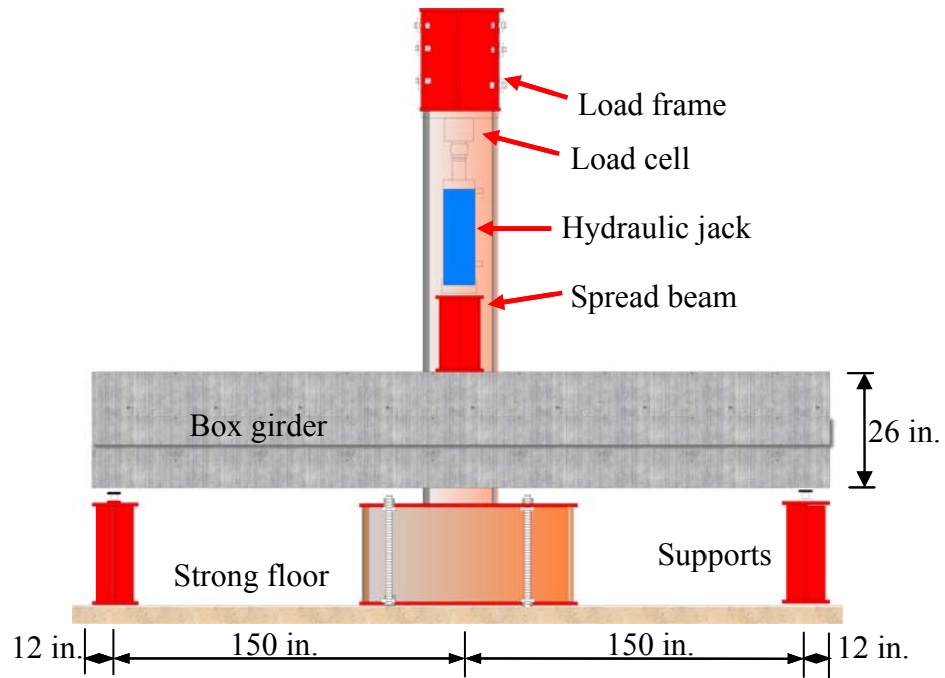
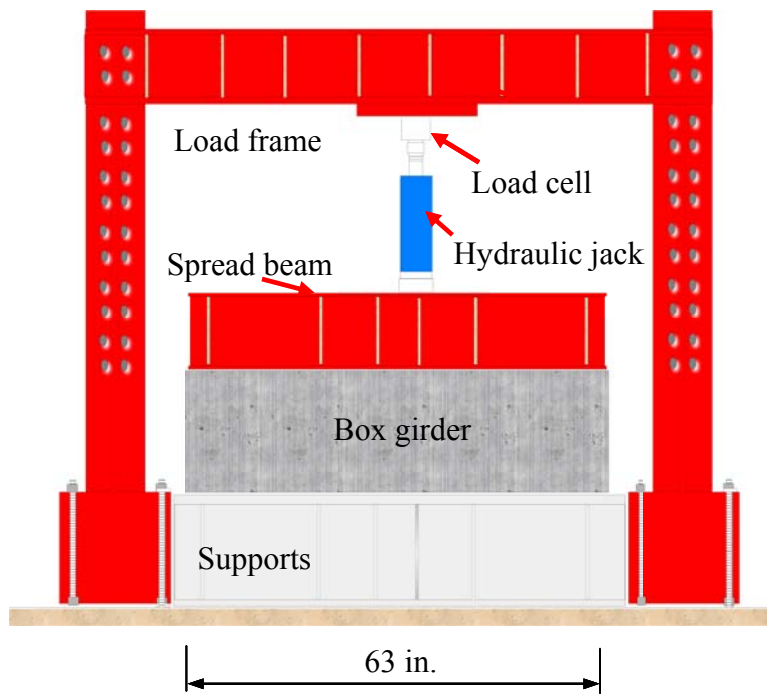
(a) Elevation view with a point load at mid-span

(b) End view

Figure 8.1: Schematic of laboratory test setup for concrete box girder

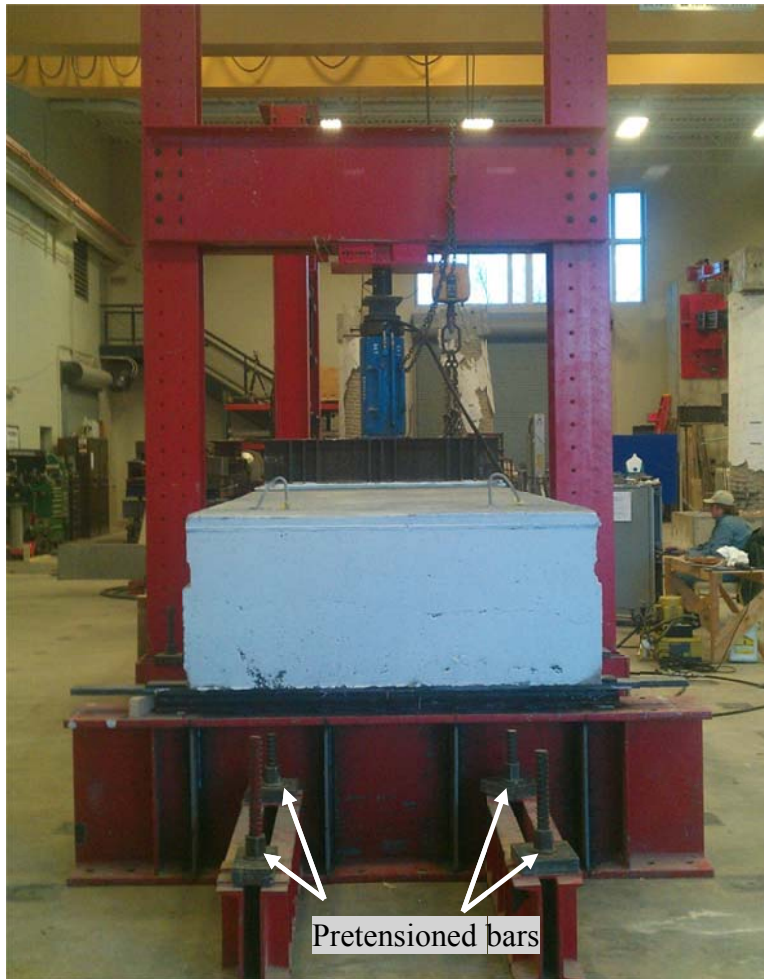
(a) Load frame

(b) Overview of test setup

Figure 8.2: Photos of laboratory test setup for concrete box girder

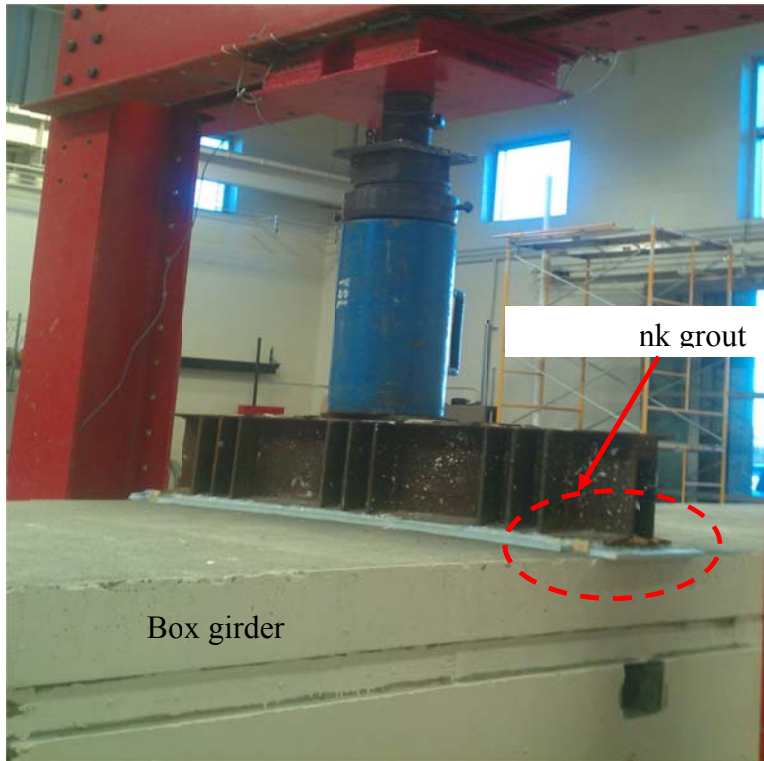
(a) Spread beam attachment on top surface of the box girder

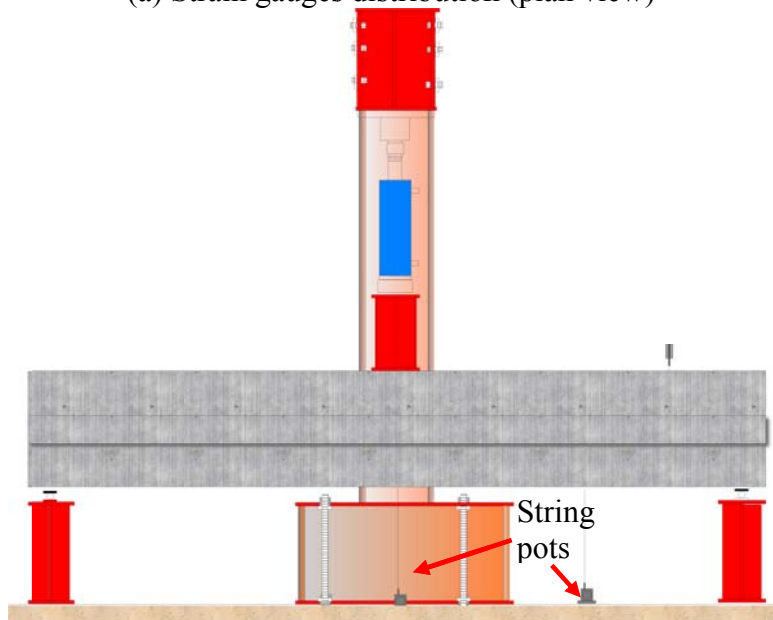
(b) Schematics of DCVTs and string pots layout (symmetrically distribution at both sides)

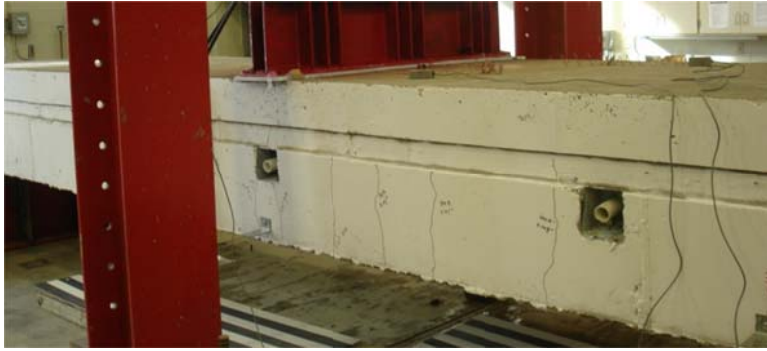
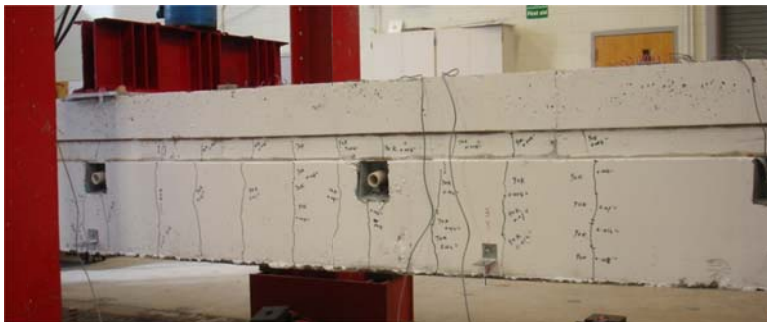
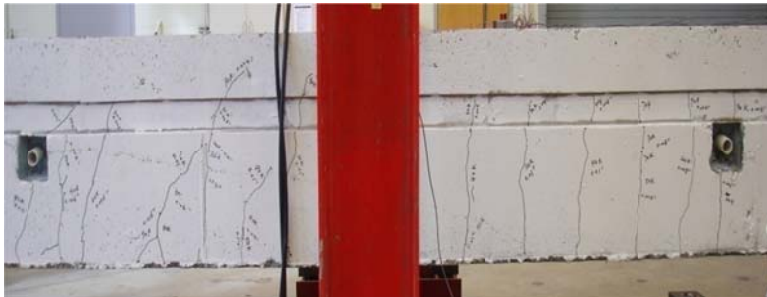
(a) Initial flexural cracks

(b) Further cracks developed over the span

(c) Diagonal cracks developed away from the mid-span
Figure 8.6: Crack development and propagation

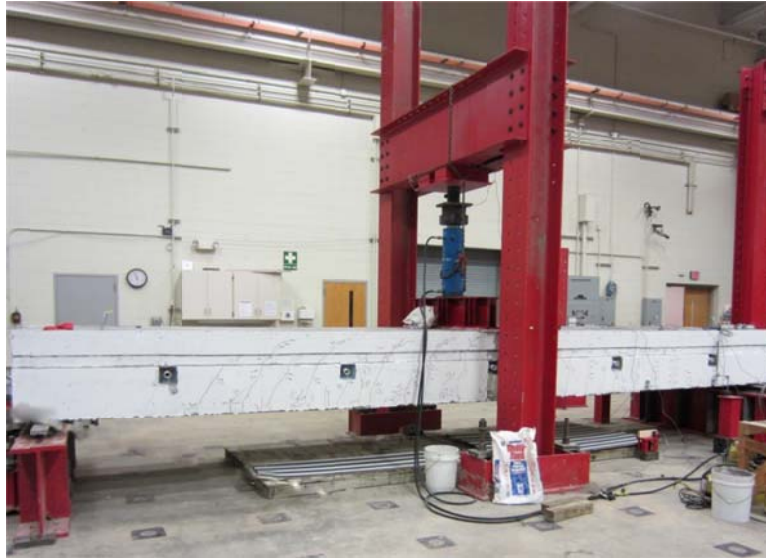
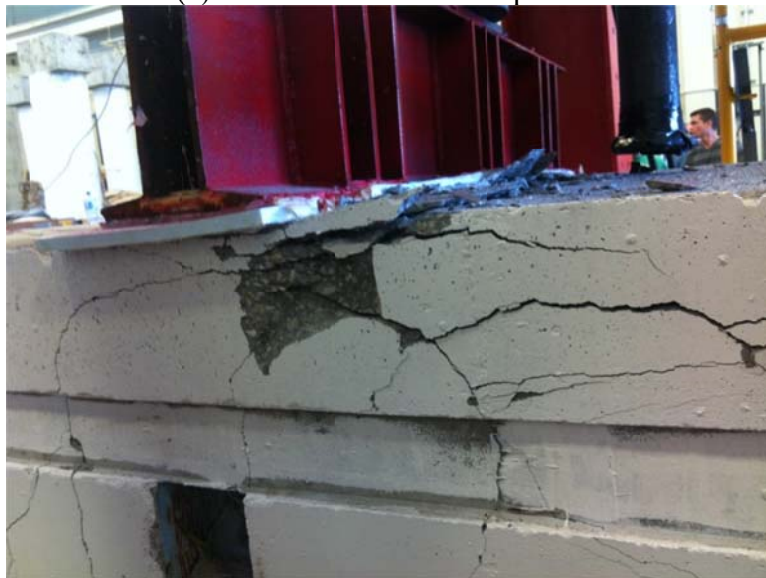
(a) Overview of the crack pattern

(b) Concrete crushing and horizontal splitting cracks

Figure 8.7: Box girder failure by concrete crushing in compression zone

Corresponding to concrete crushing of the tested box girder, the mid-span strain of GFRP reinforcing bars was approximately 42 % of the ultimate strain specified by the GFRP manufacturer. The stress level proportional to the maximum strain was approximately 29.6 ksi (204 MPa), which is comparable with 25 ksi (172 MPa) predicted by ACI 440.1R-06 Guidelines. Since only 42 % of the specified ultimate tensile strength of GFRP bars was used when the GFRP reinforced box girder failed in concrete crushing, the girder design provided sufficient reserved capacity to prevent GFRP bars from rupture in unexpected circumstances. In addition, the maximum load that the box girder can take prior to concrete crushing as designed was approximately 270 kips (1200 kN). This level of load capacity (concentrated at mid-span) is substantially larger than the maximum load effect that two fully-loaded HS20 trucks in application can possibly induce on a simply-supported bridge with a clear span of 25-ft (7.62 m). For example, the total load of two rear axles of two HS20 trucks is only 128 kips (570 kN).

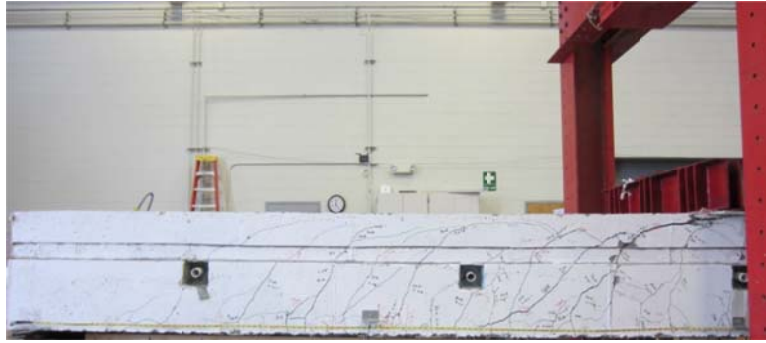
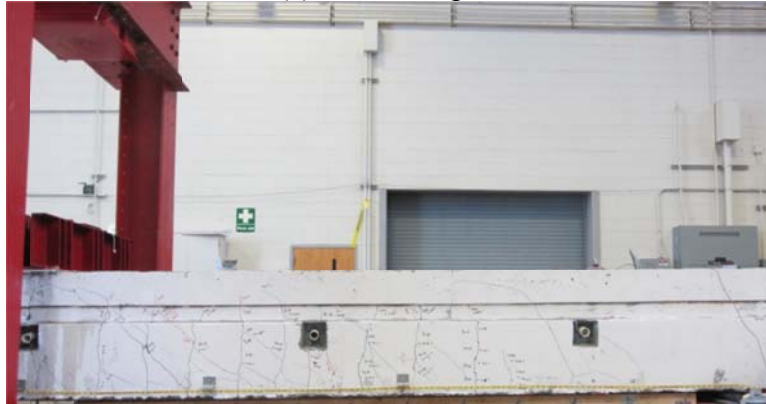
(a) Left half span

(b) Right half span

Figure 8.8: Crack pattern across the span

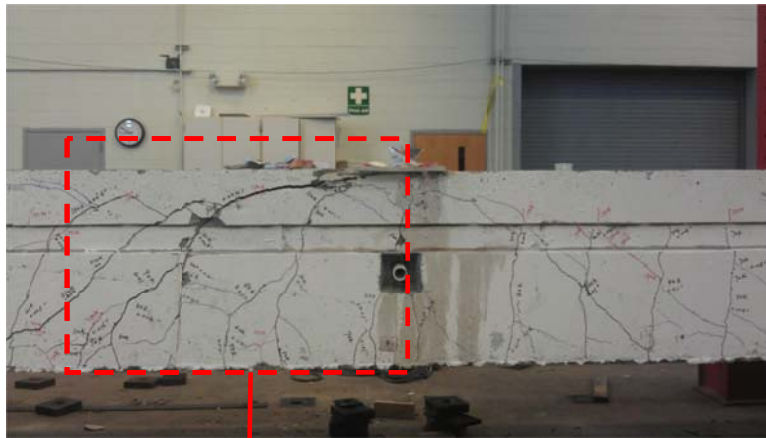
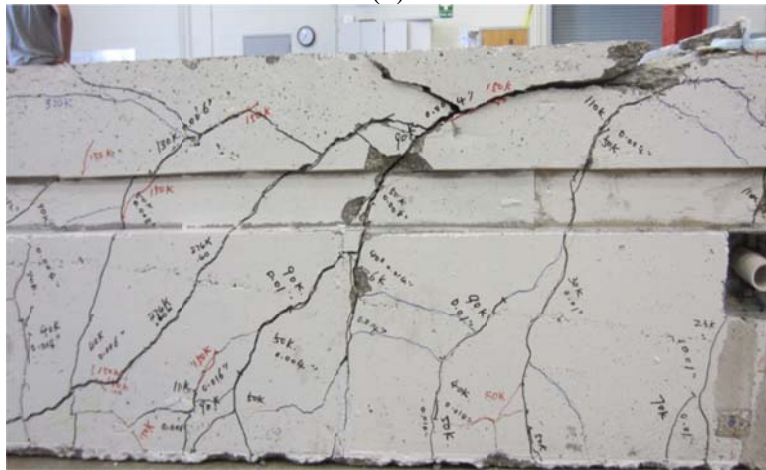
Figure 8.9: Shear failure details

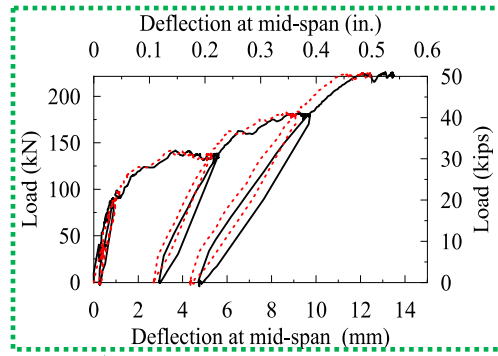
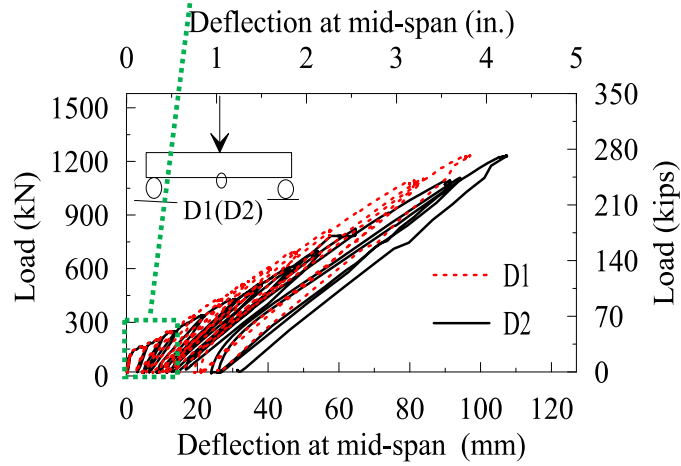
(a) Mid-span

Figure 8.10: Load-displacement curves at various locations
