Failure Investigation of the Steel Strut of Paseo Suspension Bridge

RDT 05-008

June, 2005

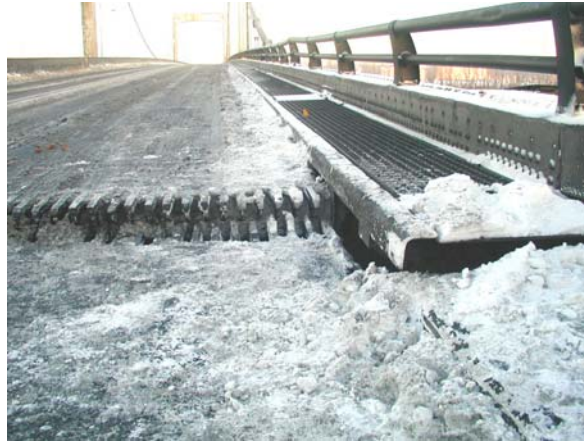
Figure 1.3 Rise in Southern Span

The construction of the bridge began in 1952. Currently the bridge supports Interstates I-29 and I-35, and US Highway 71, and as of 2003 data carries an average of 89,000 vehicles daily. On January 22, 2003, the Paseo Bridge was hurriedly closed to traffic during the Wednesday afternoon rush hours when a pronounced gap between sections of the bridge's deck sparked fears about the span's safety. At the time, temperatures were reported to hit a record low of 9°F below zero and wind chills approached 25°F below zero. As shown in Figure 1.3, the bridge deck of the southern side span rose approximately 8 inches above the approach deck. The following day, it was found that the strut (web) in the southeastern link anchorage assembly was fractured, see Figure 1.4. Close-up views are presented in Figures 1.5 and 1.6. During fracture, several rivets were sheared off as seen from Figure 1.7. Also seen in Figure 1.7 as well as Figure 1.8 is a view of the fractured surface, indicating a brittle failure.

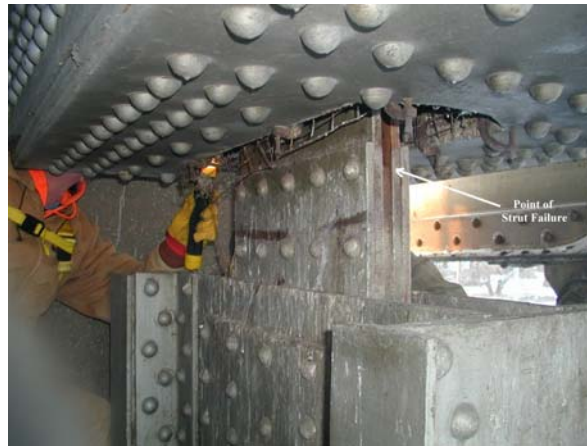
Figure 1.4 Point of Strut Failure

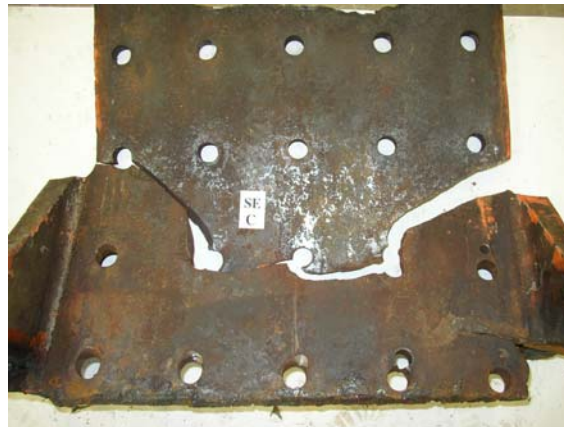
Figure 1.8 Fracture Pattern of SE Strut Web

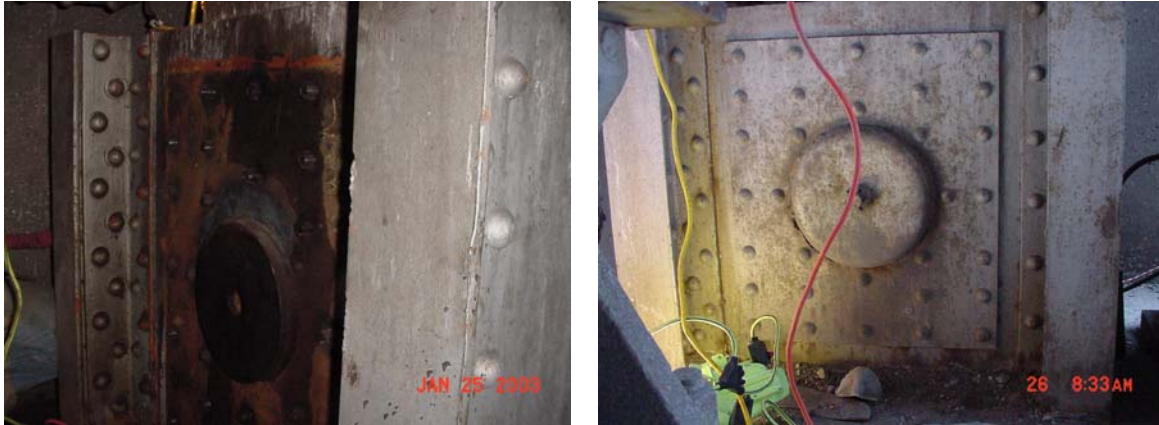
Based on the reports from field inspectors, the lower pin in the southeastern hanger was frozen and did not allow for free rotation of the superstructure. The surface condition of the pin on the Southeastern side was severely corroded. This can be seen from the comparison between two pins (Southeastern (a) vs. Southwestern (b) sides) in Figure 1.9.

(a) Southeastern Pin

(b) Southwestern Pin

Figure 1.9 Comparison of Pin Conditions

2. Partial sealing the lower housings to prevent salt and sand accumulation near the pins or providing traps under the finger expansion joints to stop salt and sand debris from dropping to the lower link housing. These corrosive materials damage and/or clog free rotation.

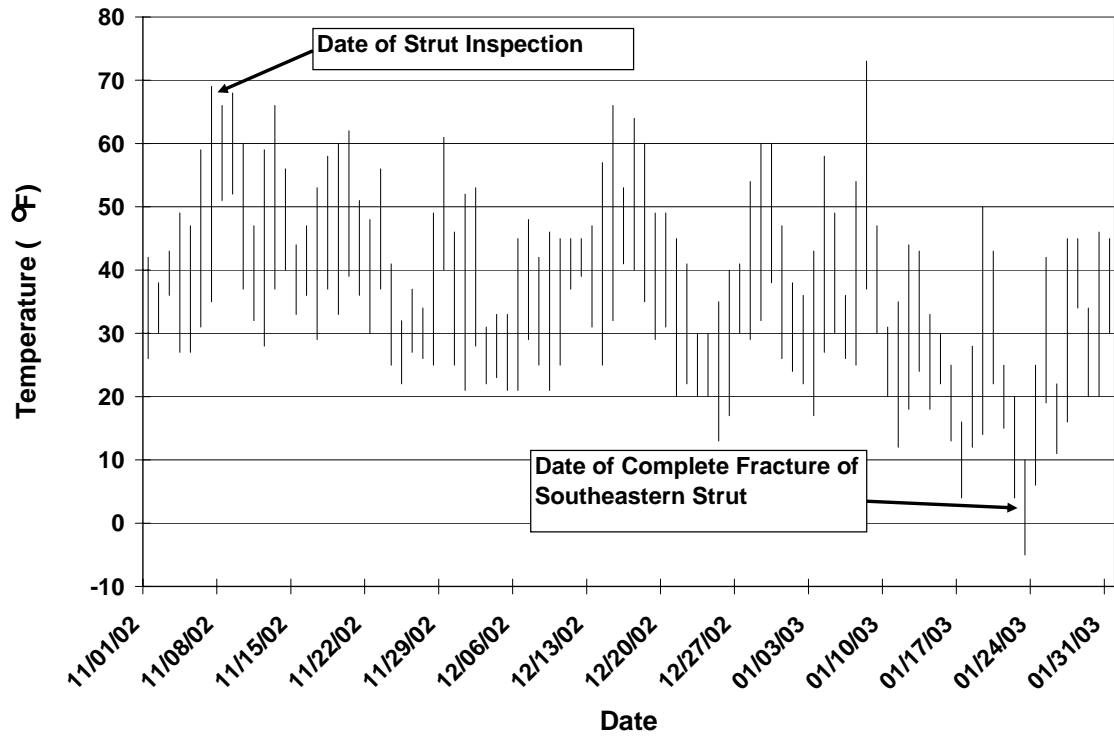
The temperature at the time fracture occurred on the Southeastern vertical strut was reported to be approximately 9°F below zero. Daily temperature data, reported for the downtown airport in Kansas City, MO, was obtained to analyze what temperatures the bridge was exposed to during the period following the Parson's inspection. The day fracture occurred was the coldest day since the Parson's report that longitudinal motion was observed for the links. Figure 2.2 shows the temperature history giving the daily high and low for the months of November, 2002 until January, 2003.

Figure 2.2 Temperature History for Downtown Kansas City Airport

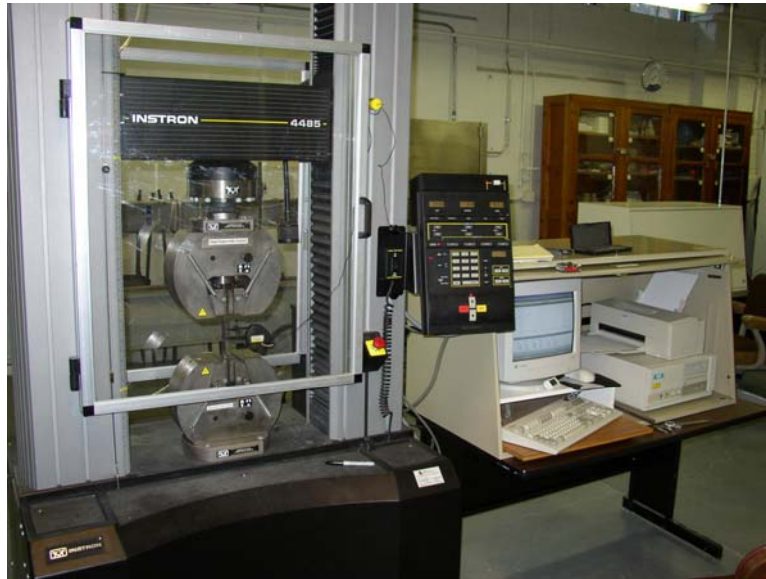
Figure 3.1 Instron 4485 and Data Acquisition System

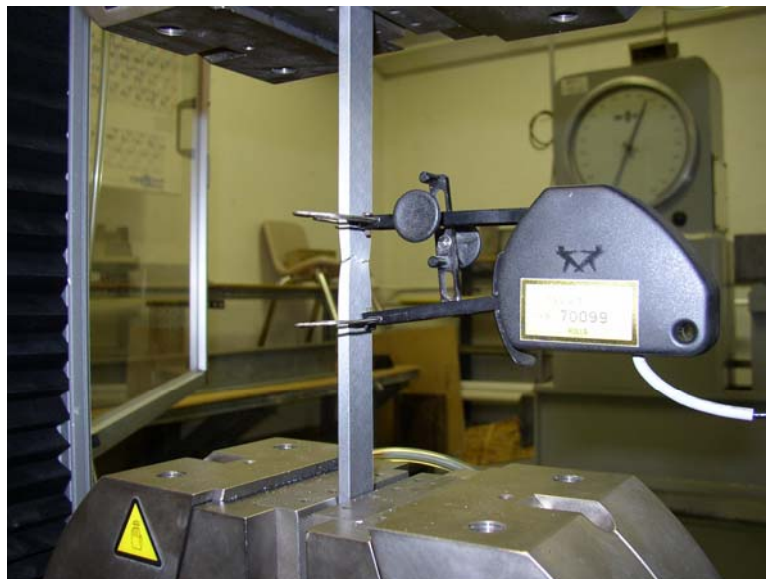
Figure 3.2 Calibrated Extensometer

A total of six specimens were tested in the Materials Testing Lab of the Basic Engineering Department at the University of Missouri-Rolla. An Instron 4485 displacement controlled testing machine, Figure 3.1, was used in combination with automated data retrieval software. Following ASTM E 8, the testing was displacement controlled at a rate of 0.2 inches per minute. Specimen dimensions were input into the software. As seen in Figure 3.2, a

calibrated one inch extensometer was attached to each specimen to measure longitudinal strain. After failure, measurements were taken on each specimen to ensure fracture occurred at a minimum of two widths away from the grips, Figure 3.3. The third specimen was determined as an invalid test due to this criterion.

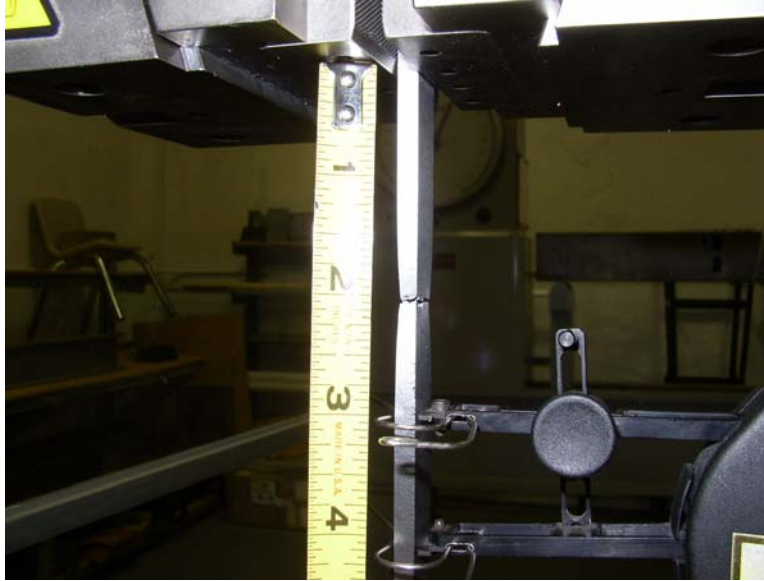
Figure 3.3 Verification of Test Validity

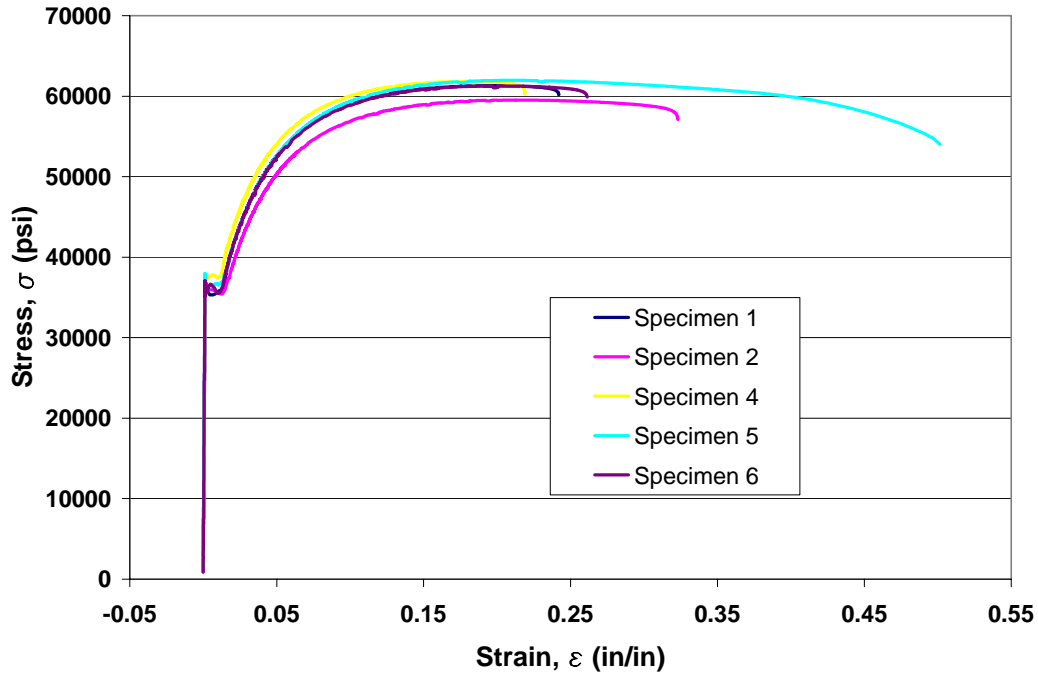
Upon completion of five valid tests at room temperature, material constants were determined by the automated data retrieval software. The constants were then verified from the raw data. These material constants included yield stress, σ_y , ultimate stress, σ_u , and Young's Modulus, E . Yield stress was determined by 0.2% offset method, whereby stress deviation from the linear portion of the stress-strain curve by more than 0.2% resulted in the return of a value for σ_y . Ultimate stress was found using the peak value on the engineering stress-strain curve. Young's Modulus was calculated as the slope of the linear portion of the stress-strain curve prior to yield stress. Measurements were taken using precision calipers on the cross section of the fractured area. These measurements were used to calculate fracture stress, σ_f , and percent reduction in area, %RA. Figure 3.4, shows the engineering stress-strain curves obtained from valid tests for this material. Individual specimen stress-strain curves as well as additional data generated by the data acquisition system are available in Appendix A. Table 3.2, lists the aforementioned constants found from testing. Averages from the five valid tests were determined and used as the accepted constants. These values compare well to Frank's findings of tensile properties from bridge components (Frank, 1974) of the same decade mentioned in the Literature Review section of this report.

Figure 3.4 Engineering Stress-Strain Curves

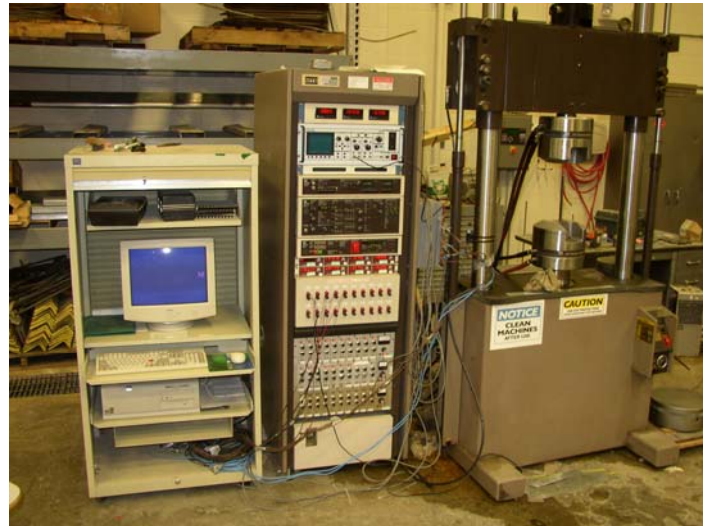
Figure 4.2 MTS 880 and Data Acquisition System

Testing was done in the High Bay Structural Lab of the Civil Engineering Department at the University of Missouri-Rolla on an MTS 880 equipped with digital data acquisition interfaced with LabView. Figure 4.2, shows the MTS 880 and data acquisition system. Longitudinal strain was measured two ways in the specimen, using a calibrated two inch extensometer and 0.5 in. strain gages. Since the available extensometer gage length was longer than the specimen gage length, strain data collected from it was always lower than that collected from the strain gages, thus extensometer measurements were used only to verify strain gage values. Figure 4.3 shows the test set-up with the strain devices attached.

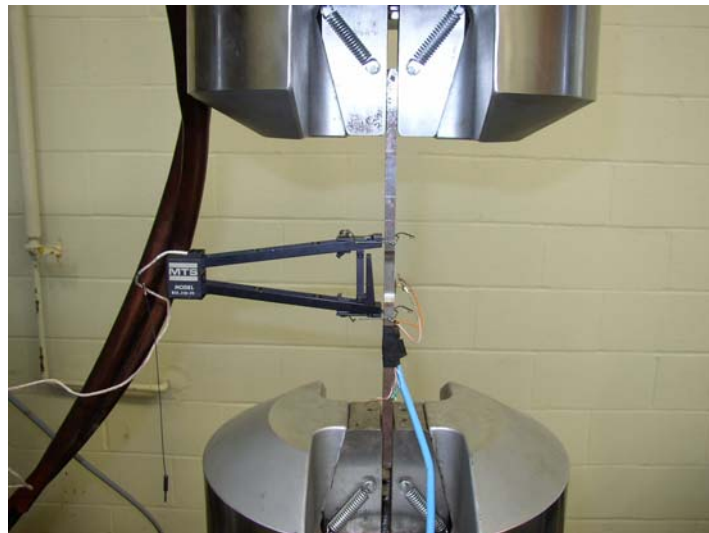
Figure 4.3 Longitudinal Strain Measurement Devices

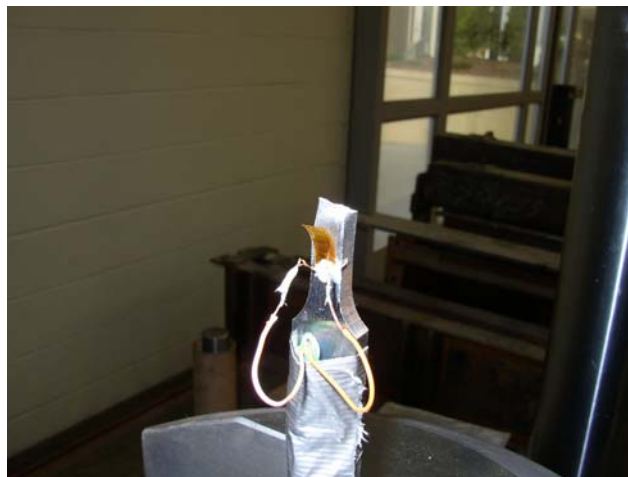
Figure 4.4 Failure of Fatigue Specimen

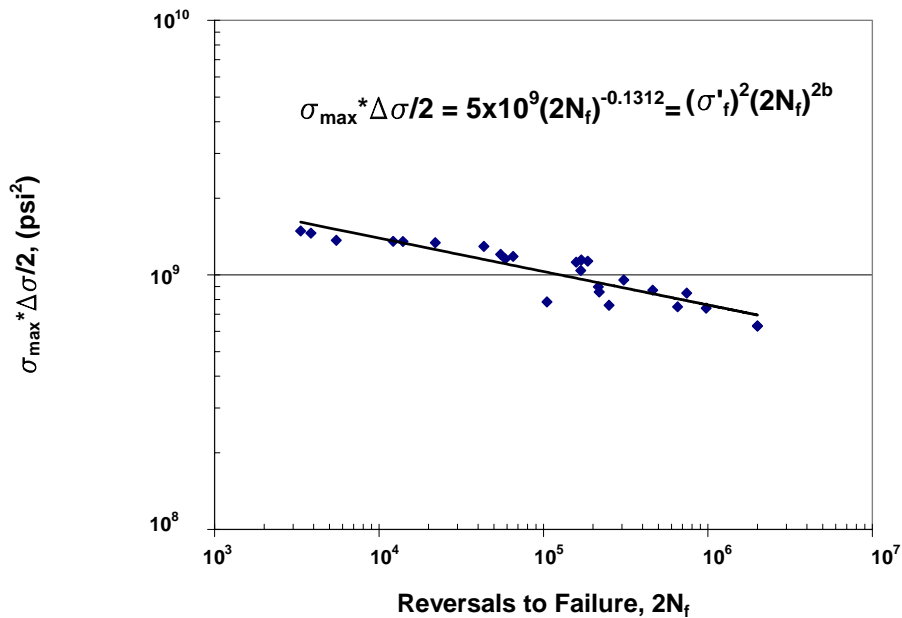
The empirical material constants, as defined in the Smith, Watson, Topper equation, were determined from fitting power law relationships to the plots of stress amplitude versus reversals to failure and plastic strain amplitudes versus reversals respectively on log-log scales. Figures 4.6 and 4.7 show these plots and the corresponding power law curve fit produced in Excel. Table 4.2 lists the empirical constants found from the curve fits. The empirical constants are needed to predict the crack initiation life.

Figure 4.6 Power Law Curve Fit for Stress Amplitude vs. Reversals to Failure

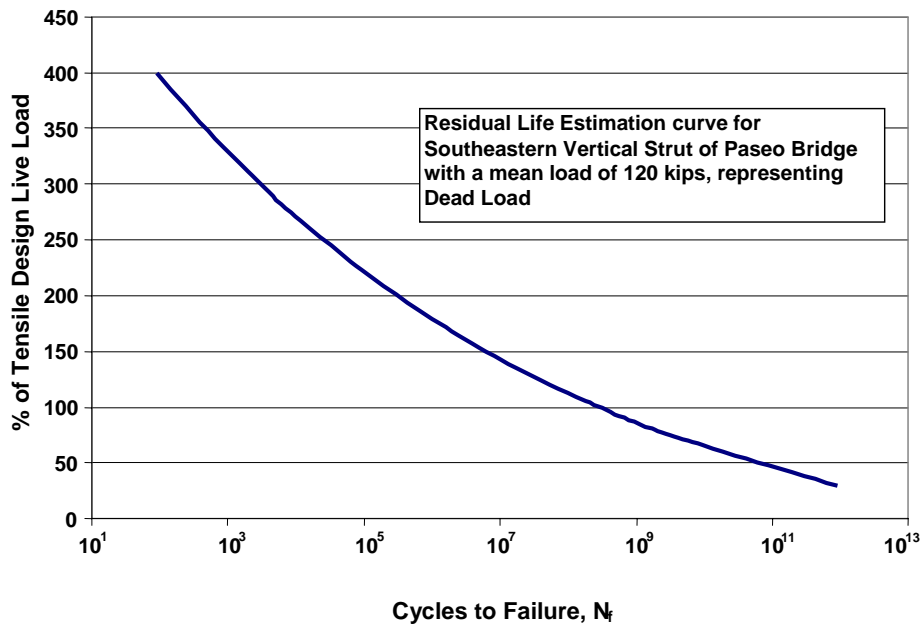
Using the residual life curve in Figure 4.10, the predicted residual life of the vertical struts, assuming the pin was not mechanically frozen, is found to be practically infinite. This is calculated by taking the number of cycles for 100% live load, 10^8 , and dividing by the daily number of cycles, 230, found in Section 7.5 of this report. The resulting value is nearly 1200 years. It should be noted, that this value is for fully reversed loading at 100% of the design live load and a constant dead load value of 120 kips.

Figure 4.10 Residual Life Estimation Curve for Paseo Bridge Struts

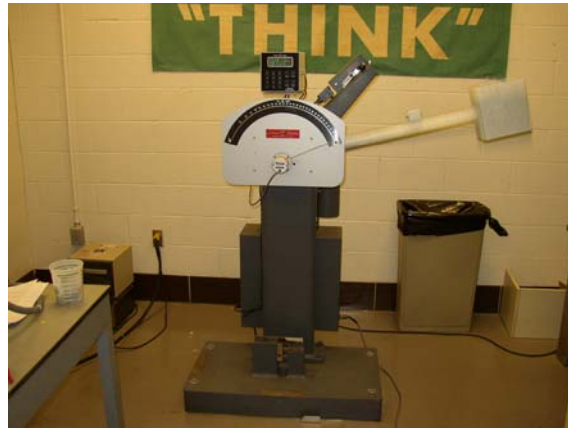
Charpy V-notch impact testing was done in a metallurgical lab at the University of Missouri-Rolla. Tests were performed using a calibrated Tinius Olsen Model 84 Universal Impact Tester, Figure 5.2. The tester has an anvil where specimens are placed and a swinging pendulum which rotates down to fracture the specimen. Data in the form of breaking energy is displayed and is calculated from the change of kinetic energy of the swinging pendulum after impact.

Figure 5.2 Tinius Olsen Model 84 Universal Impact Tester

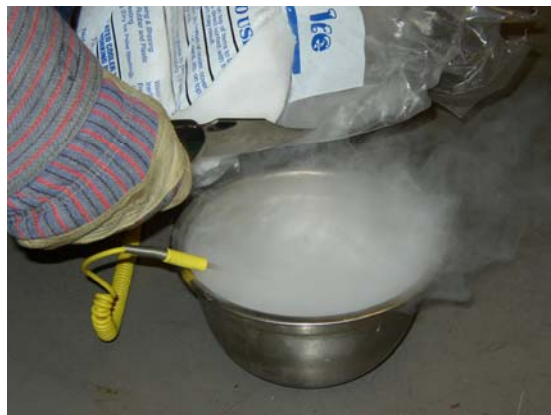
Figure 5.3 Dry-Ice and Alcohol Bath

The temperature range chosen, -10°F to 140°F , represents the temperature range the material was likely exposed to during service. Temperatures below room temperature were obtained using an alcohol bath and dry ice, see Figure 5.3. The specimens were submerged in the alcohol in an insulated container and the temperature monitored using a submersible probe as flakes of dry ice were put in the bath. Figure 5.4 shows the temperature being measured at the lower end of the scale -10°F . Temperatures were monitored in the bath and kept relatively constant for 20 minutes prior to impact to minimize temperature gradients within the specimen material. Temperatures above room temperature were obtained using a laboratory oven and again sufficient time given for stabilization of internal temperatures.

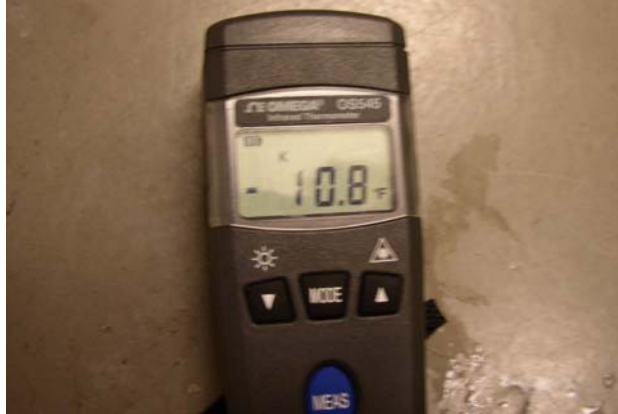
Figure 5.4 Temperature as Measured from Alcohol Bath

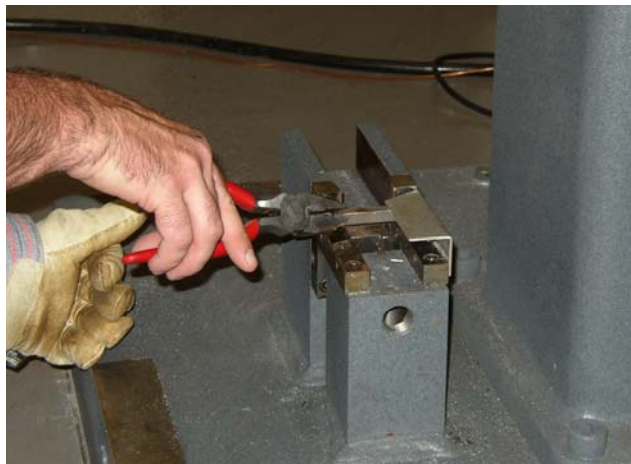
Upon reaching equilibrium of the desired temperature, specimens were quickly removed from the bath or oven and placed in the anvils of the impact tester, Figure 5.5. The pendulum was released from its starting position and allowed to swing through and strike the specimen causing fracture. The breaking energy, C_v , was recorded and the test repeated until five valid tests had been performed at each temperature. Test validity, given in ASTM E 23, was determined as complete fracture of the specimen.

Figure 5.5 Placing Charpy V-Notch Specimen in Anvil

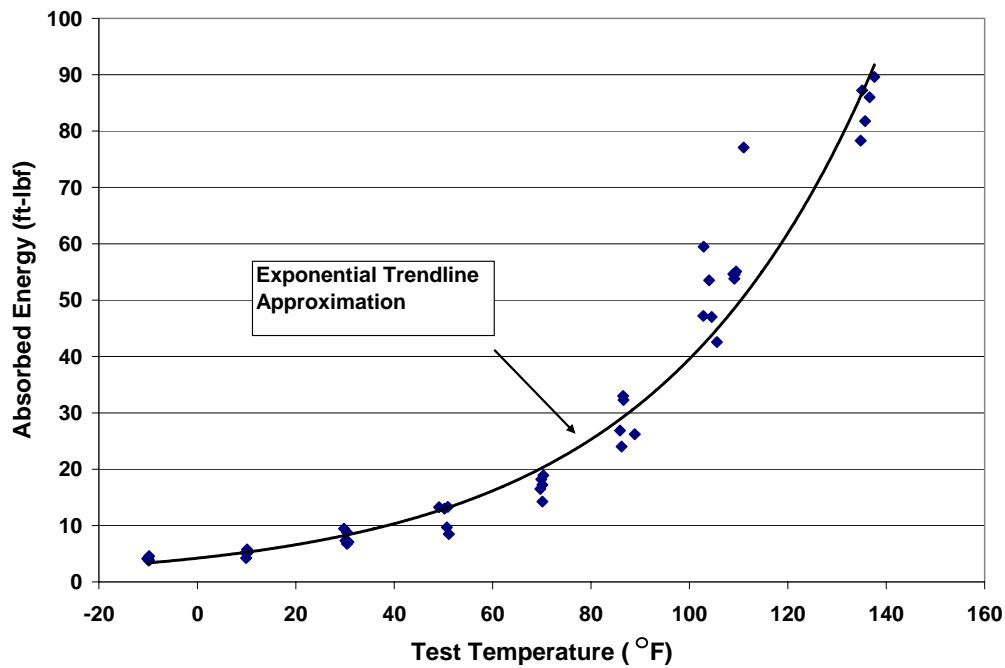
Since this is an empirically derived equation, Equation 5.1 is valid using the units of psi and inch for Young's Modulus, E, and fracture toughness, K_{IC} . Units of Charpy breaking energy, Cv, must be ft-lb. Barsom used this relationship in developing the AASHTO fracture toughness requirements for bridge steels (Phaal et al., 1997). Table 5.1 shows the fracture toughness, K_{IC} , calculated using Equation 5.1 and the average breaking energy of the five specimens at each temperature level tested.

Figure 5.6 Absorbed Energy at Temperatures Tested

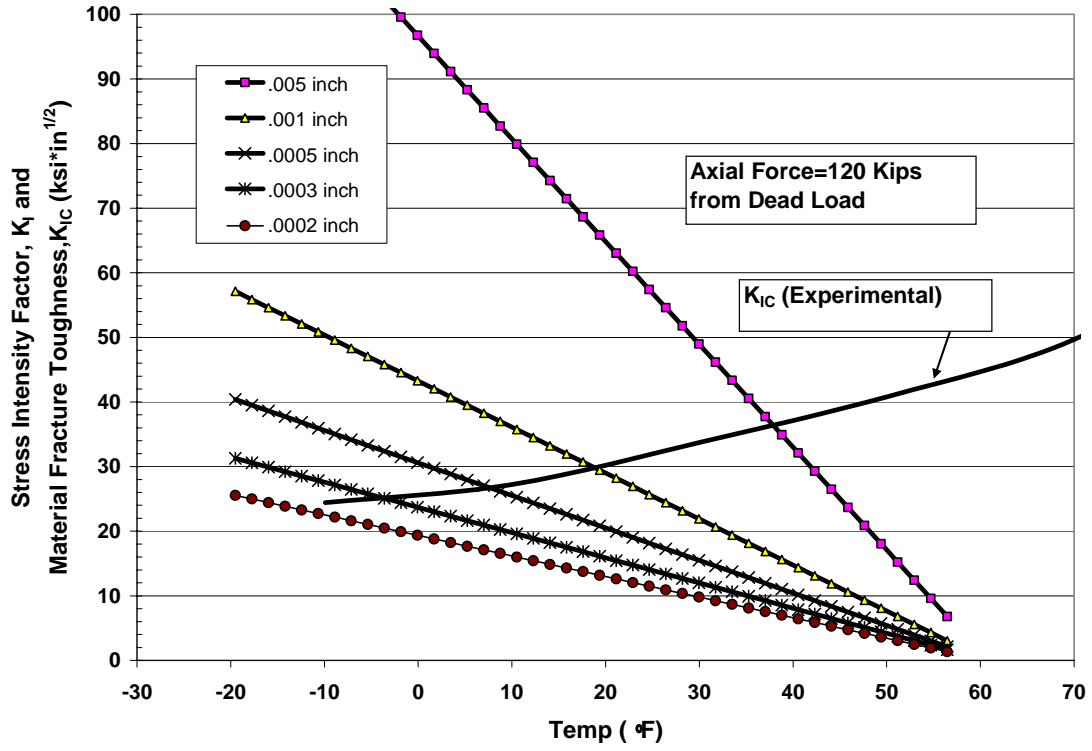
The applied axial force was from dead load alone. The moments applied were a function of temperature, caused by thermal contraction of the bridge deck, assuming the lower pin was mechanically frozen such that the strut was in a completely vertical position. These moments were obtained from a SAP 2000 model of the bridge discussed in Section 7 of this report. A zero moment condition exists at 60°F, the temperature at which structural dimensions were given. Figure 5.7 shows the relation between stress intensity factor and temperature, as well as the fracture toughness obtained from the Charpy impact tests. This figure can be considered as a supply-demand diagram. The “supply” curve or the K_{IC} is the positively sloped curve in Figure 5.7. The “demand” curves are the negatively sloped lines, each representing the stress intensity factor, K_I , at the given temperature. Where the “demand” curves cross and lie above the “supply” curve sudden fracture occurs. For example, with an initial crack length of 0.001 inch, sudden fracture of the Southeastern strut would occur at 20°F with no live load present. It should be reminded that this is for the strut being mechanically frozen in the vertical position. Moments generated from the thermal contraction of the bridge are much lower as the frozen position of the strut is at an increasing angle toward the deck. This would shift the “demand” curves to the left in Figure 5.7, as would a less conservative estimate of the stress intensity factor.

Figure 5.7 Prediction of Fracture of Southeastern Strut

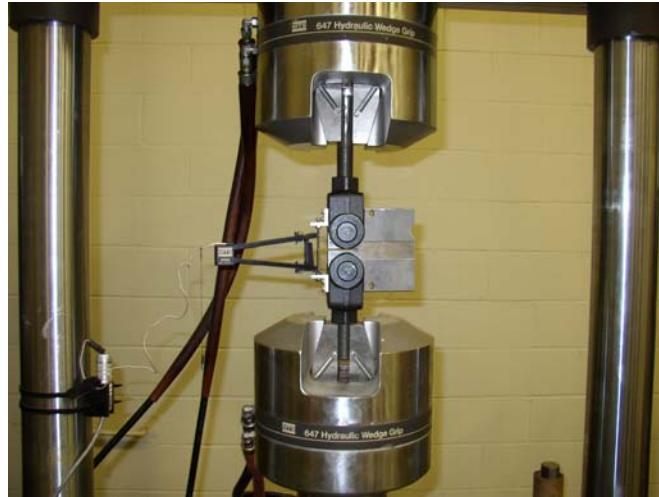
Specimens were tested in the Structural High-Bay Lab at the University of Missouri-Rolla using the same MTS 880 and data acquisition system as the fatigue specimens. Specimens were attached to the MTS grips using a clevis and pin assembly as outlined in ASTM E 647. Specimens were tested under cyclic loading fluctuations in the form of a sine wave at 5 Hz. The loading sine wave had a maximum value of 11,000 lbs. and a minimum value of 400 lbs. Again, due to errors generated in the data retrieval system, zero load was approached but avoided. An extensometer, as shown in Figure 6.4 can be used to check crack length by the compliance method (ASTM E 647). Figure 6.4, shows the test set up prior to testing. After measurable crack growth was noticed in the specimens, measurements were taken on both the front and rear faces using precision calibrated calipers. Measurements of crack length, a , were taken every 3000 cycles, see Figure 6.5, and repeated until the specimen failed. Data for the five valid tests is supplied in Appendix D.

Figure 6.4 Crack Growth Test Set-up

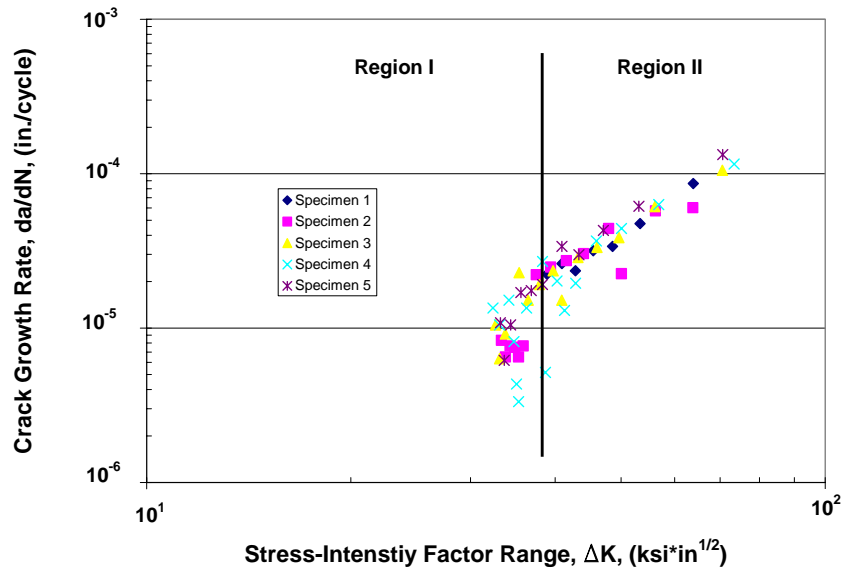
The variable B is specimen width, plate thickness in this case, and W is dimension from load line to back face, see Figure 6.3. Stress-intensity factors were calculated for each crack length measured. The change in crack length per cycle, da/dN , was calculated by dividing the crack length measurements by the number of cycles elapsed between measurements. The stress-intensity factor ranges were then plotted versus the change in crack length per cycle calculations on a log-log scale and are given in Figure 6.6.

Figure 6.6 Plot Showing Regions I and II

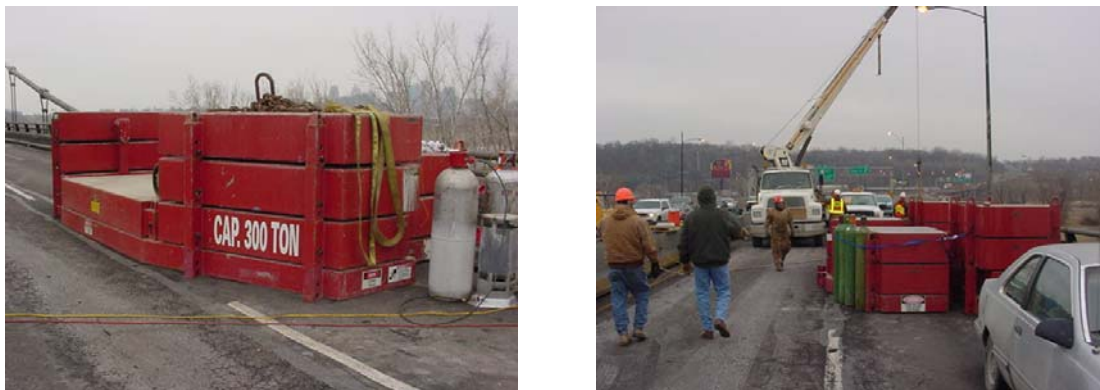
Dead load on the strut was calculated from ballast payload that was placed on the bridge during replacement of the strut assemblies. Approximately 240 kips was placed on the end of the bridge during repositioning of the deck, see Figures 7.1. From this payload, and assuming equal load distribution between the two struts at each end of the bridge, the dead load on the failed strut equaled to 120 kips, the same as calculated during retrofit design.

Figure 7.1 Dead Load Ballast Used During Deck Repositioning

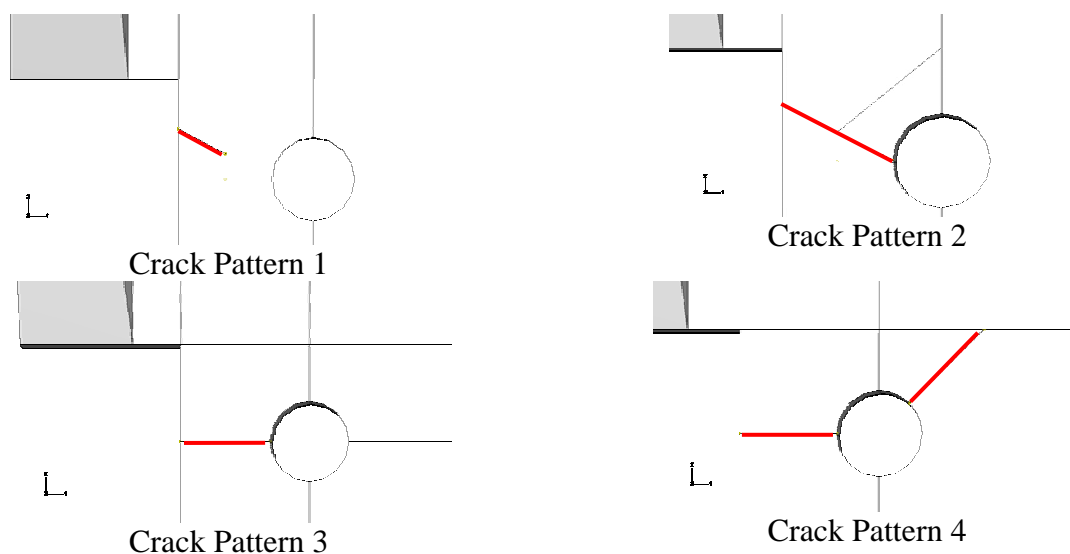
Figure 8.10 Crack Patterns

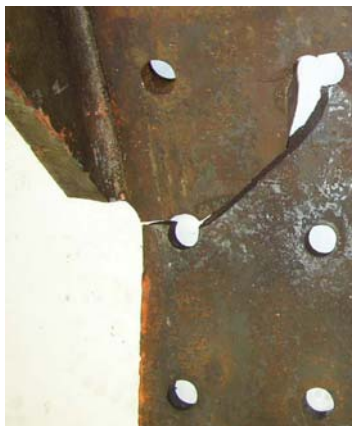
Figure 8.12 Actual Crack Propagation Pattern
