## Signal Mast Arm Fatigue Failure Investigation

**RDT 03-010**

# Signal Mast Arm Failure Investigation

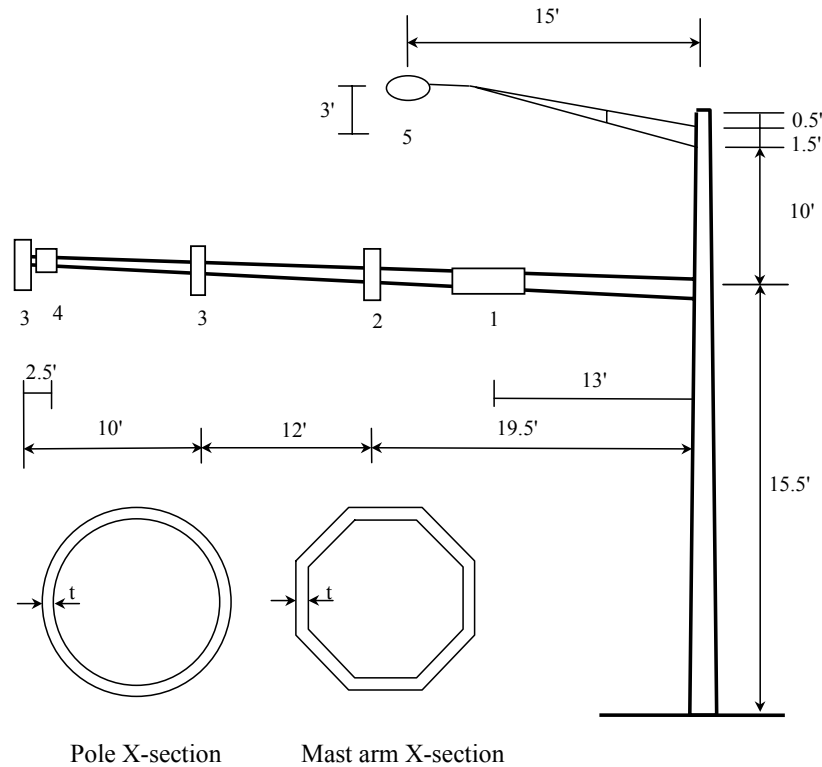
The other structure is located at Providence (Rt. 163) & Green Meadows Rd, which was manufactured by JEM Engineering. Its elevation is shown in Figure 5.2. The mast arm is octagonal and the post is circular. They are respectively 10.5"×3.5"×42'×7GA(0.1793") and 14.25"×11.5"×27.5'×0.2188". The luminaire arm was built with a 2" schedule 40 pipe. The geometry and weight of the supporting structure is given in Table 4.2.

Figure 4.2 Traffic signal support structure at Providence & Green Meadows

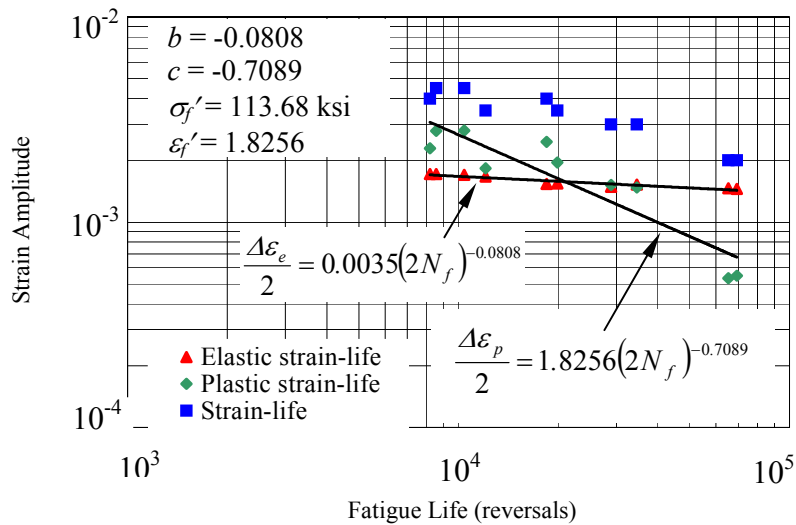
Figure 5.5 Parameters in the crack initiation prediction model

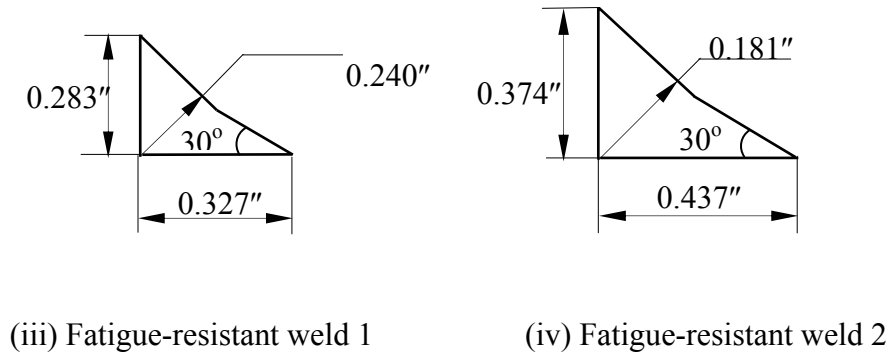
The Missouri Department of Transportation has recently introduced a so-called fatigue resistant weld profile with varying slopes. For this weld profile, the weld length on the mast arm is 1.83T, and that on the base plate is 1.57T, where T is the weld throat, i.e. the shortest distance between the root of the joint and the face of the weld. The maximum slope of the fatigue resistant weld is 30 degree. To understand the effects of weld profile on the stress concentration, four profiles for the octagonal mast arm are selected as shown in Figure 5.6(a). Profile (i) is the typical weld used in the current structure. Profile (ii) is a comparative weld, which possesses the same area as that of (i), but its slope on the mast arm is 45 degree. Profile (iii) is a fatigue-resistant weld with the weld throat equal to the thickness of the mast arm tube (0.1793 in). Profile (iv) is another fatigue-resistant weld. Its length on the mast arm is equal to that of Profile (i). Their effects on the stress concentration are presented in Figure 5.6(b). It can be observed that the actual weld yields the smallest concentration of stress with a factor of 2.88 at the weld toe even though its weld leg on the base plate is the shortest. This is mainly because the actual weld has the longest weld leg and the smallest slope on the mast arm wall. The stress concentration factor for the 45-degree weld is 3.01, although it has the same weld area as (i). The fatigue-resistant weld 1 has the largest stress concentration factor of 3.09, because its length on the mast arm is the shortest. Increasing the length of the fatigue-resistant weld to that of the actual weld, the stress concentration factor will be decreased to 2.96. Therefore, it is concluded that the stress concentration not only depends upon the slope of a weld profile but also depends on the weld length along the mast arm wall. The fatigue-resistant design could lessen the stress concentration if used to lengthen the weld leg on the arm wall.

Figure 5.6 Stress concentration factors for various weld profiles

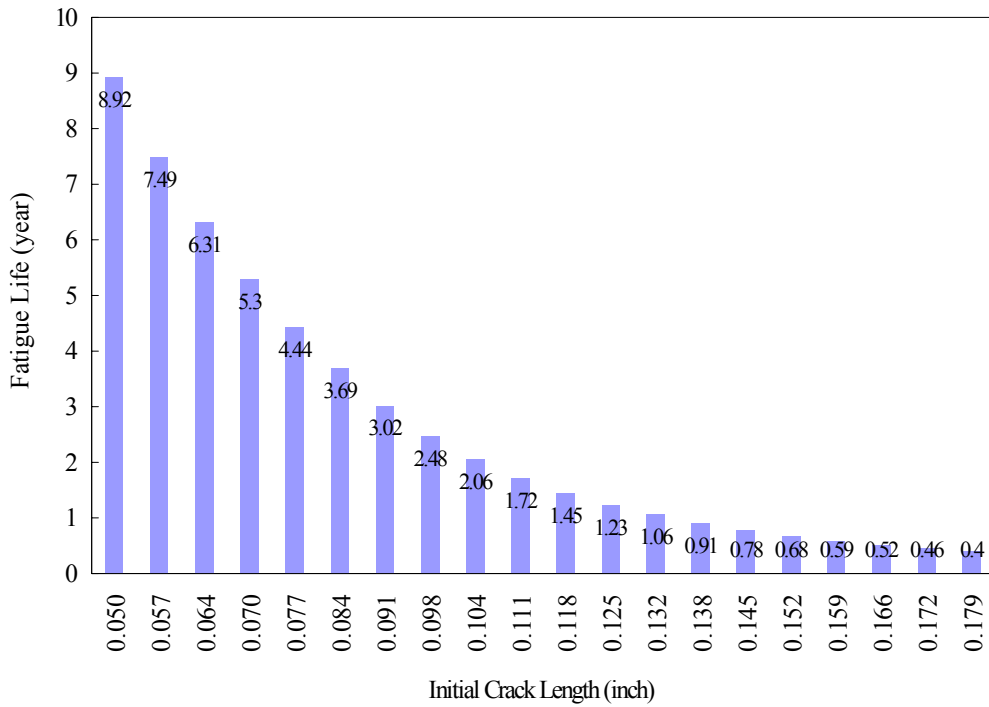
Figure 5.14 Remaining fatigue life for the mast arm at Stadium & Forum (correlated with 0.4 million cycles fatigue life for the lab test)
