Unbonded Portland Cement Concrete Overlay/Pavement Monitoring with Integrated Grating and Scattering Optical Fiber Sensors

Unbonded Portland Cement Concrete Overlay/ Pavement Monitoring with Integrated Grating and Scattering Optical Fiber Sensors

**NUTC
R330**

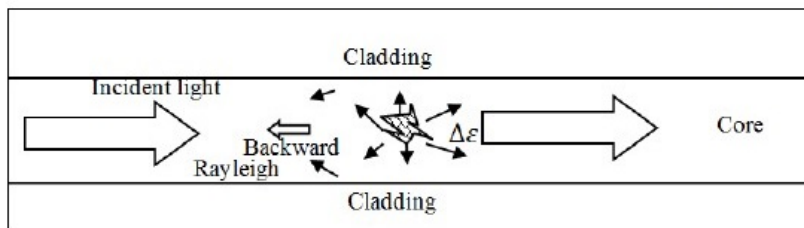
Fig. 1.2. Schematic diagram for the spontaneous Rayleigh scattering process.

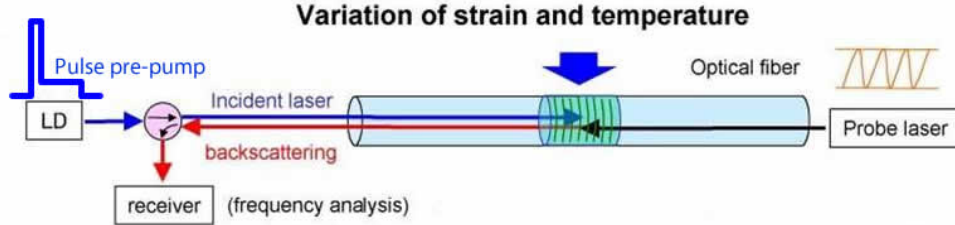
To achieve high spatial resolution, PPP-BOTDA was developed by stimulating the phonons in an optical fiber with a pre-pump pulse before a narrow bandwidth pulse arrives [18]. In this way, the pump pulse length can be chosen to remain significantly shorter than the relaxation time of phonons, thus improving spatial resolution in distributed measurement, while the BGS becomes narrow due to stimulation of the pre-pump pulse and can be evaluated at high SNR. The combined effect of the pump and pre-pump pulses results in an immediate time response and a narrow BGS at the same time. In commercialized applications (Neubrescope) with a pulse of 0.2 ns width, 2 cm spatial resolution was achieved over 0.5 km measurement distance with 15 $\mu\epsilon$ / 0.75°C measurement accuracy for strain and temperature, respectively [19]. Compared with BOTDA in Fig. 1.3, PPP-BOTDA as schematically illustrated in Fig. 1.6 differs only in the shape of the pump pulse. The sensing principle of the PPP-BOTDA is the same as that of BOTDA as shown in Fig. 1.4. The probe light is CW.

Fig. 1.6. A representative PPP-BOTDA system.

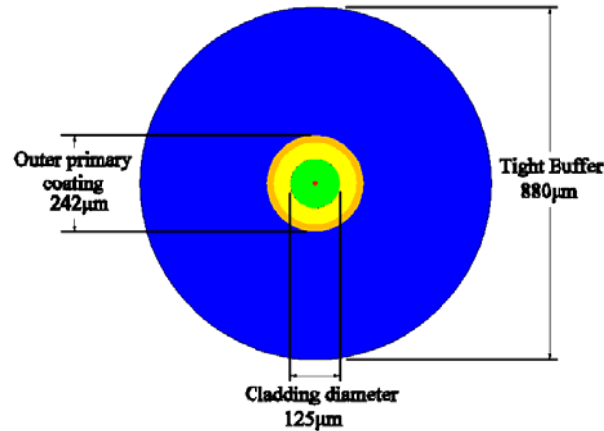
Due to the fragility of bare SMF-28e⁺ fibers, the SMF-28e⁺ fiber with tight buffer, as shown in Fig. 2.5, were invented by uniformly and tightly coating a layer of polyethylene on the bare SMF-28e⁺ fiber. Due to its elasticity, the polyethylene buffer can uniquely transfer strain from the surface of the buffer to the fiber and thus doesn't compromise the sensing ability of the fiber. In addition, the buffer can significantly enhance the tensile strength and shear strength of the coated fiber, and thus reduce the risk of sensor damage during handling, transportation, and installation.

Fig. 2.5. The cross section of a TB.

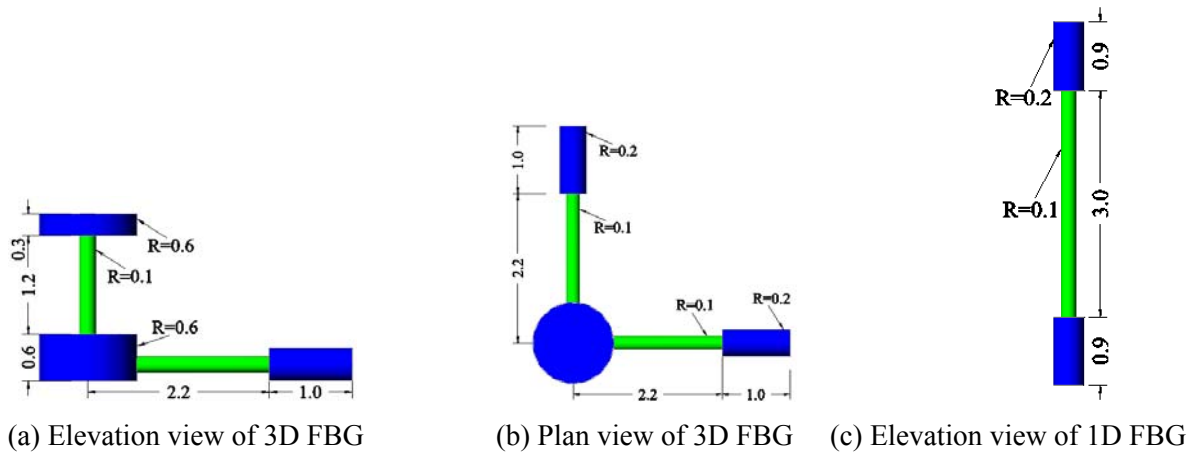
When used as strain sensors, FBG sensors measure the strain change within their gauge length and thus provide their average values over the gauge length. Since the gauge length is usually short as indicated in Fig. 2.8, the FBG sensors can provide reasonable results for one location unless the strain suddenly changes in a short distance, for example, around a crack. As such, these sensors are referred to as point sensors at the location of their installation. The strain transfer mechanisms for embedded point sensors and surface attached sensors have been studied [61].

Fig. 2.8 Configuration and geometry of FBG sensors (in inch = 2.5 cm).

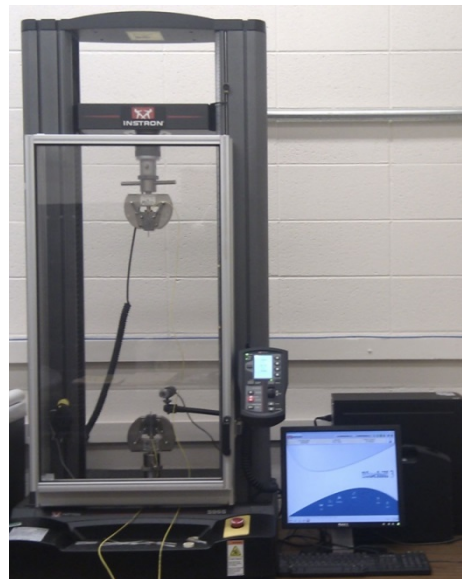
Two tests were run for each type of optical fibers: mechanical test and optical-mechanical test. For mechanical tests, each fiber was loaded in tension to failure in displacement-controlled mode. The loading rate was 2 mm/min. The load-extension relation was obtained directly and transferred to the load-strain relation when the initial length of each fiber was measured. Therefore, the tensile strength and the elastic limit of strain ϵ_e can be determined. Once ϵ_e was known from the mechanical test, a small portion of it was applied during the optical-mechanical test at strain increment $\Delta\epsilon$. In this case, strains were simultaneously measured from the optical fiber with the Neubrescope and with load cell and extensometer of the Instron 5965. The measurements were conducted incrementally until enough data points were collected.

Fig. 3.1. Load frame (Instron 5965).

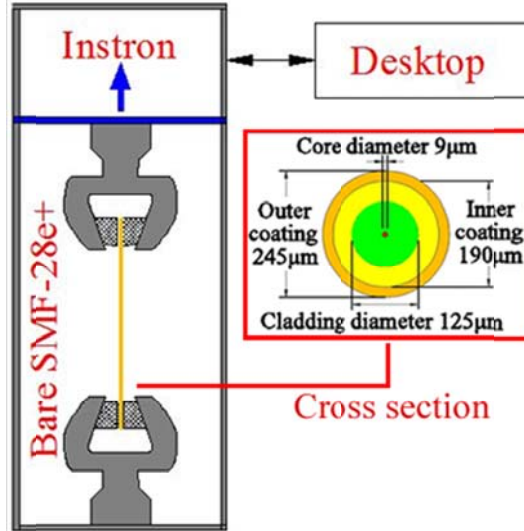
Mechanical properties of Corning BF were characterized at room temperature (21°C) with tensile tests in the laboratory. Fig. 3.2 shows the test setup and the cross section of the tested fiber. Each end of the fiber was spliced with a communication cable that was instrumented with a FC/APC connector. Considering the fragility of the BF, the portions of the fiber in direct contact with the Instron grips were protected with sleeves that can be directly gripped by the fixture of the load frame. The loading force and the extension were simultaneously recorded by the load transducer and the extensometer.

Fig. 3.2 Test setup and fiber cross section.

The mechanical properties of TB fibers were tested under tension as illustrated in Fig. 3.2. Ten fibers were tested to failure and the force-strain relations were obtained. A representative force-strain relation was presented in Fig. 3.11(a) from which it was observed that the tensile strength of the fiber was around 20 N and the corresponding strain was around 20,000 $\mu\epsilon$ (2%). The slope of the linear portion by regression was 9.76×10^{-4} N/ $\mu\epsilon$ as shown in Fig. 3.11(b). The force capacities and strains corresponding to the breakpoint of ten fibers are summarized in Fig. 3.12.

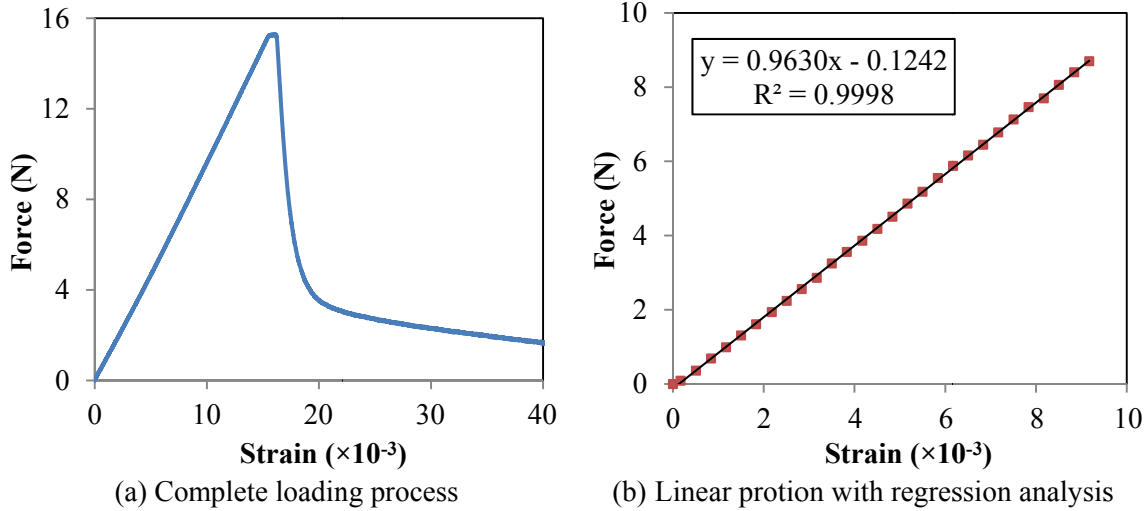
Ten fibers were tested to failure. Figs. 3.3(a, b) present the force-strain relation of a representative fiber and the linear regression for its linear portion, respectively. The optical fiber behaved linearly until ϵ_e and soon fractured with a suddenly reduced load that was resisted solely by the coating. The tensile strength of the fiber was approximately 15 N and the corresponding strain was $\epsilon_e = 16,000 \mu\epsilon$ (1.6%). An initial slope of $9.63 \times 10^{-4} \text{ N}/\mu\epsilon$ has been obtained from the force-strain curve by a linear regression technique as shown in Fig. 3.3(b). This value can be taken as the tensile stiffness of the optical fiber. The tensile strengths and their corresponding strains of the ten fibers are summarized in Figs. 3.3(a, b), respectively. The average tensile strength of the ten fibers is 12.68 N, and the average ϵ_e is $1.31 \times 10^4 \mu\epsilon$.

Fig. 3.3. Force-strain relation of a BF sensor.

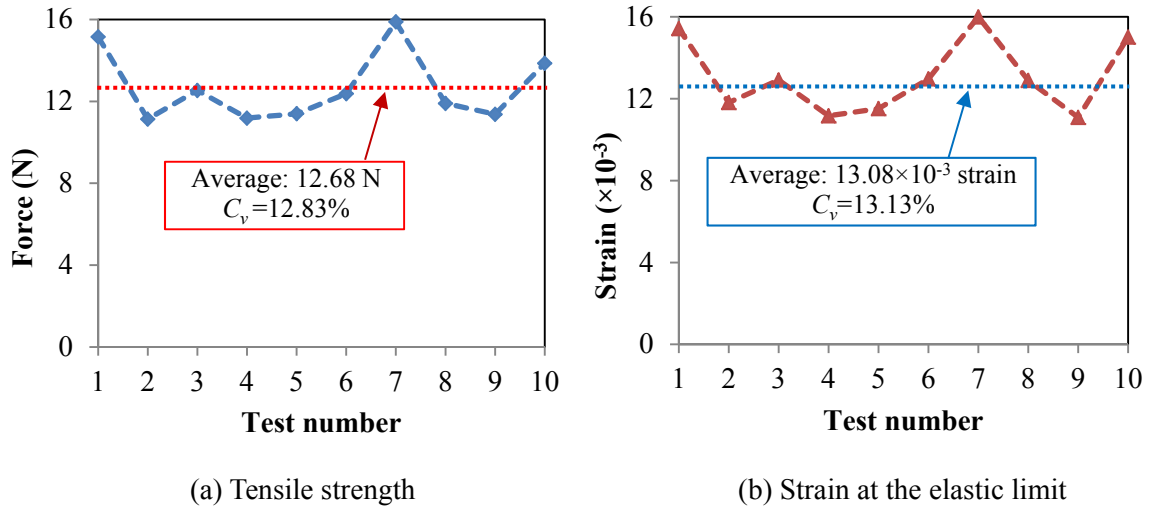
Fig. 3.4. Test results from ten fibers.

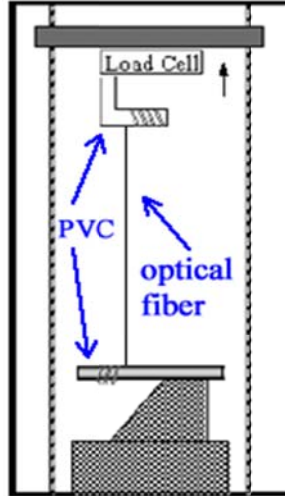
Fig. 3.6 shows the second test setup. In this case, the two ends of an optical fiber were wrapped on PVC pipes that were fixed by grips of the load frame. The force-strain relation of a representative BF is presented in Fig. 3.7(a). With this test setup, ten additional optical fibers were loaded to failure again. Local slippages were observed during the test and reflected on the force-strain relation as shown in Fig. 3.7(a). Because of slipping, the force-strain relation in Fig. 3.7(a) may not be as reliable as that in Fig. 3.3(a). Therefore, only the load capacity was used in analysis as summarized in Fig. 3.7(b) for ten tested optical fibers. It can be observed from Fig. 3.7(b) that a higher load capacity was obtained in comparison with that of the first test setup in Fig. 3.4(a). The actual load capacity is expected in between the two tests. For conservativeness, the results from the first test setup were considered in this study.

Fig. 3.6. Tensile test setup with a bare SMF-28e⁺ fiber wrapped on a circular pipe.

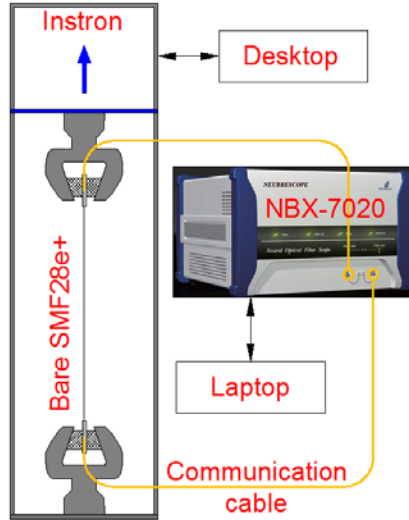
The elastic limit strain ϵ_e that was obtained from the mechanical tests was incrementally applied on optical fibers at constant increment so that enough data points can be collected before the optical fiber was broken. The fiber was loaded in tension with strain increment $\Delta\epsilon$ step by step. The test setup in this case is illustrated in Fig. 3.8. In each test, the strain in the optical fiber was simultaneously taken with the Neubrescope and the Instron. The Neubrescope measures the Brillouin frequency shift that can be modulated with the strain change when the ambient temperature is kept constant. The Instron measures the applied strain on the optical fiber. Together, the Neubrescope and the Instron can give a calibration strain-frequency sensitivity coefficient. Fig. 3.9 shows the Brillouin frequency shift as a function of the applied strain obtained from the Instron. The data used to generate Fig. 3.9 were taken at the mid-point of the tensioned portion of each fiber. The slope represents a strain-frequency sensitivity coefficient of 5.41×10^{-5} GHz/ $\mu\epsilon$ by linear regression.

Fig. 3.8. Calibration test setup.

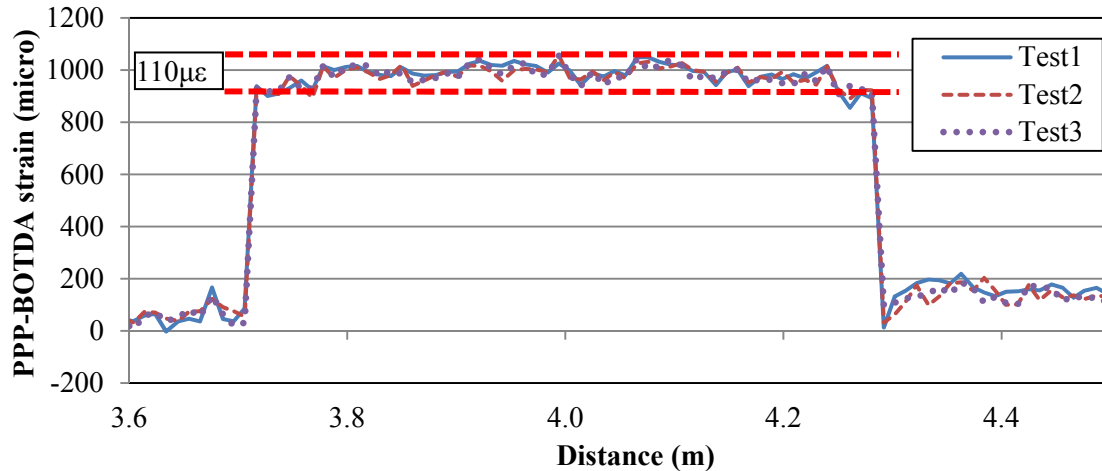
Fig. 3.10. Three measurements from the bare SMF-28e⁺ fiber.

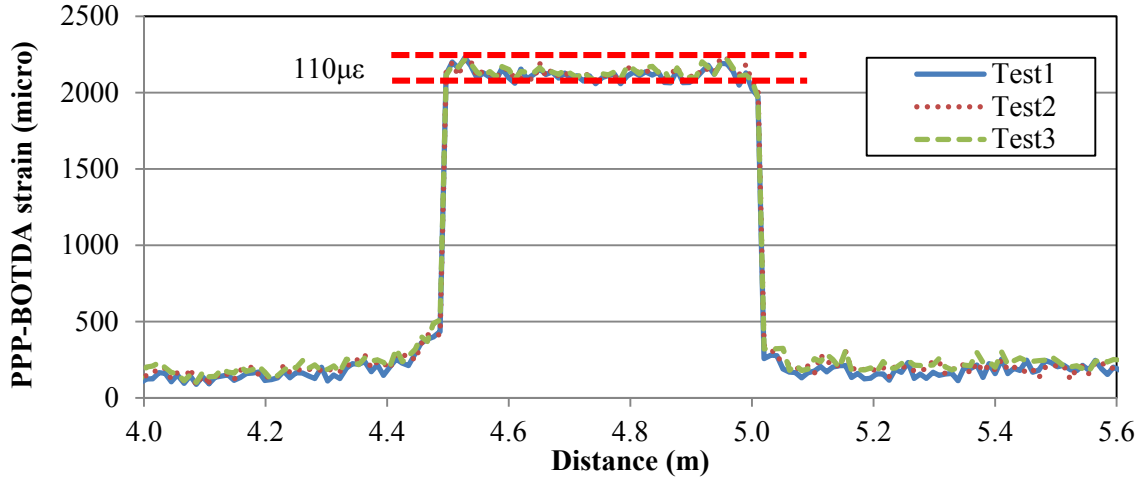
The repeatability of three strain measurements at one point was observed to be around 5-20 $\mu\epsilon$ as shown in Fig. 3.15. Although worse than 1-10 $\mu\epsilon$ in the datasheet of NBX-7020, this level of repeatability seems acceptable for most applications in civil engineering.

Fig. 3.15. Three measurements from the SMF-28e⁺ fiber with tight buffer.

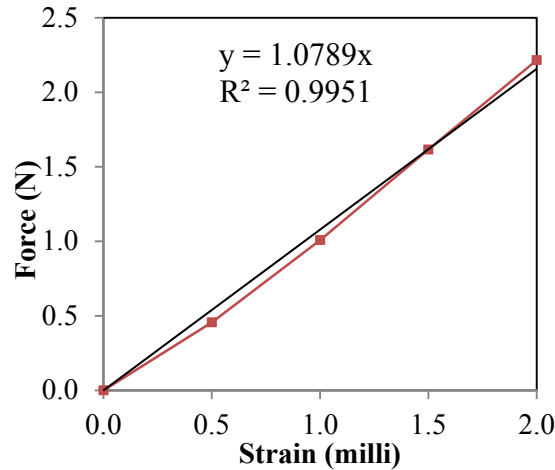
FN-SIL-1 concrete crack cable was tested in the similar way to other optical fibers. Each optical fiber was loaded in tension to failure. The force-strain relations were obtained as shown in Fig. 3.16. It can be observed from Fig. 3.16 that the tensile stiffness was about 1.08×10^{-3} N/μϵ. The FN-SIL-1 cable is slightly stiffer than the bare SMF-28e⁺ and the SMF-28e⁺ with tight buffer.

Fig. 3.16. Tensile test results of the FN-SIL-1 concrete crack cable.

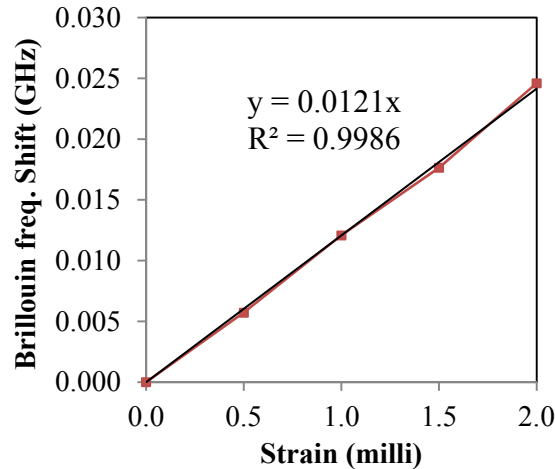
For each test, both the Brillouin frequency shift by PPP-BOTDA and the applied strain by the Instron were recorded simultaneously. They are plotted in Fig. 3.17 with high degree of linearity. The frequency-strain coefficient of the slope of the linear regression line is 1.21×10^{-5} GHz/ $\mu\epsilon$.

Fig. 3.17. Calibration of the FN-SIL-1 concrete crack cable with PPP-BOTDA.

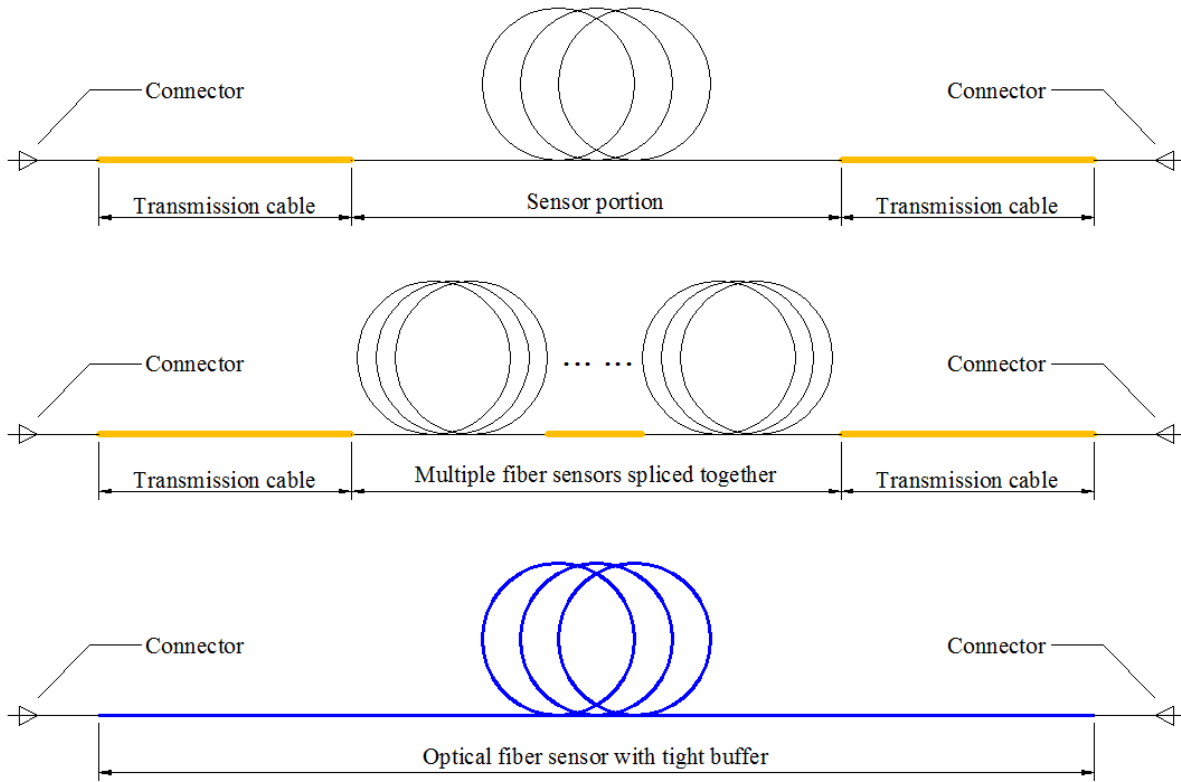
Each optical fiber sensor consists of at least five parts: two end connectors, one center sensor, and two transmission cables between the connectors and the sensor. In some cases, multiple fiber sensors are spliced together and then connected directly or connected by transmission cables. In other cases, the transmission cables can be eliminated when optical fibers are packaged with tight buffer and protected from damage. The three cases are illustrated in Fig. 4.2.

Fig. 4.2. Typical components of optical fiber sensors.

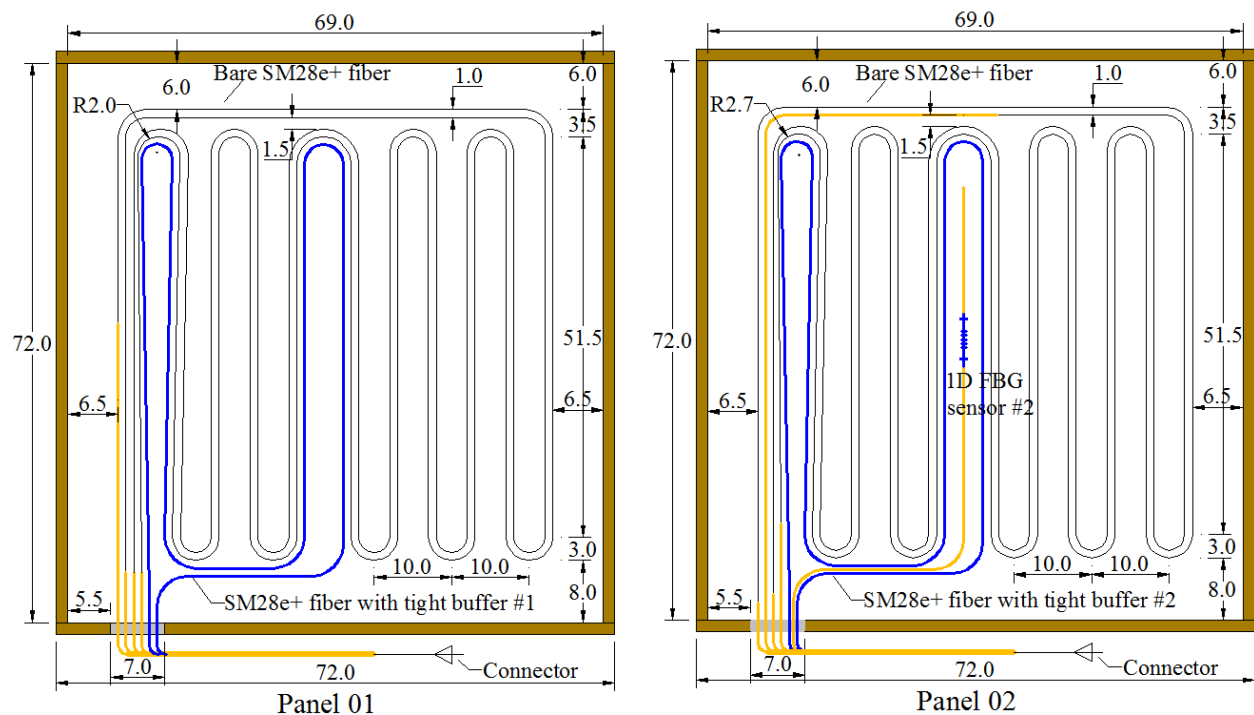
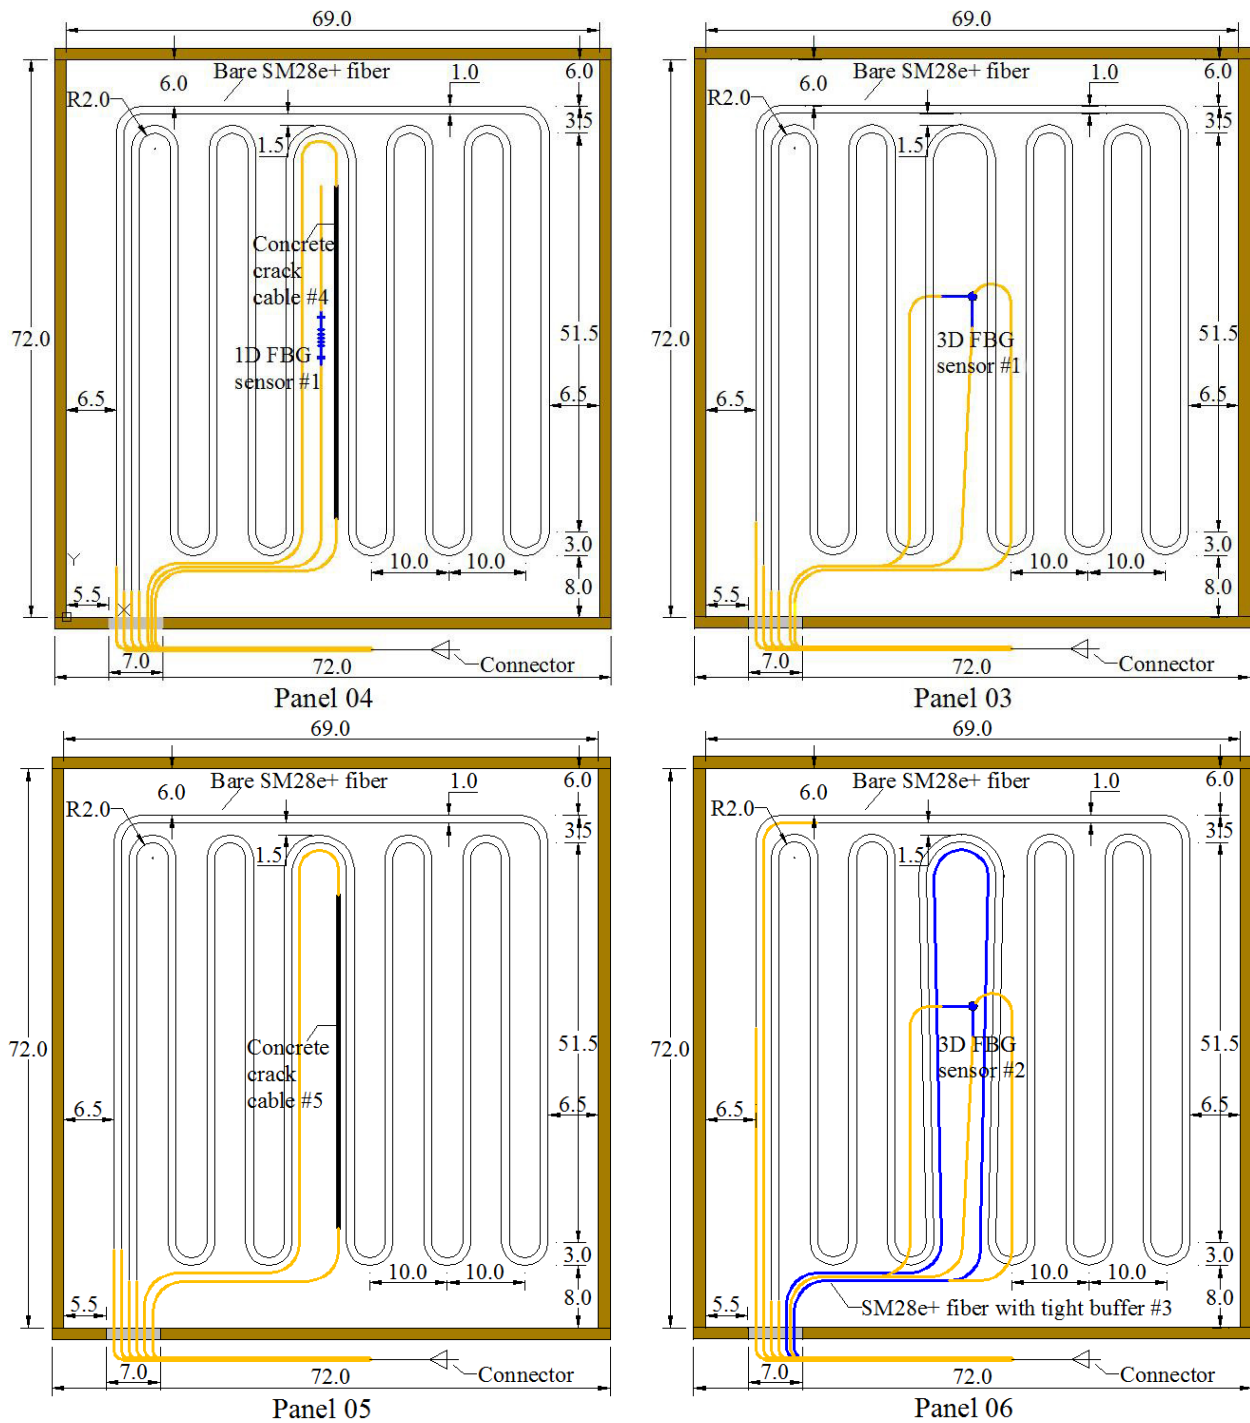
The distributed optical fiber sensors and FBG sensors were attached on top of the fabric sheet with adhesives as shown in Figs. 4.4 and 4.5. Two bare SMF-28e⁺ fibers (BF01 and BF13) and one SMF-28e⁺ fiber with a tight buffer (TB1) were installed in Panel 01 (P1). Two bare SMF-28e⁺ fibers (BF07 and BF08), one SMF-28e⁺ fiber with a tight buffer (TB1), and one 1D FBG sensor (1D-FBG-2) was installed in Panel 02 (P2). Two bare SMF-28e⁺ fibers (BF06 and BF09) and one 3D FBG sensor (3D-FBG-1) were in Panel 03 (P3). Two bare SMF-28e⁺ fibers (BF03 and BF15), one FN-SIL-1 concrete crack cable (CC4), and one 1D FBG sensor (1D-FBG-1) were in Panel 04 (P4). Two bare SMF-28e⁺ fibers (BF04 and BF16) and one FN-SIL-1 concrete crack cable (CC5) were in Panel 05 (P5). Two bare SMF-28e⁺ fibers (BF05 and BF18), one SMF-28e⁺ fiber with a tight buffer (TB3) and one 3D FBG sensor (3D-FBG-2) were in Panel 06 (P6).

Fig. 4.5. Layout of fiber sensors in six panels (in inch = 2.54 cm).

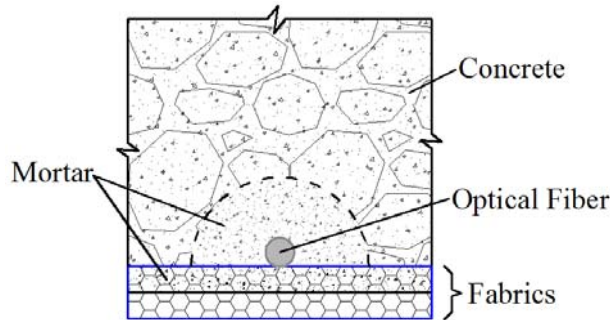
When concrete was poured on the fabric sheet to which the optical fibers are adhered, the fragile optical fibers were easy to damage. To prevent potential damage, the optical fibers were covered by a thin layer of mortar (5 - 10 mm thick) that was set for about 30 minutes before concrete was poured on top of the mortar. This installation method took advantage of the porous fabric for good sensor-concrete bonding because the mortar encapsulated the fragile optical fiber and flew between the fibers of the fabric, forming a strong bond as illustrated in Fig. 4.6. The SEM image in Fig. 4.7 verified the good sensor-concrete interface.

Fig. 4.6. Schematic diagram of an optical fiber covered with mortar and surrounded by mortar.

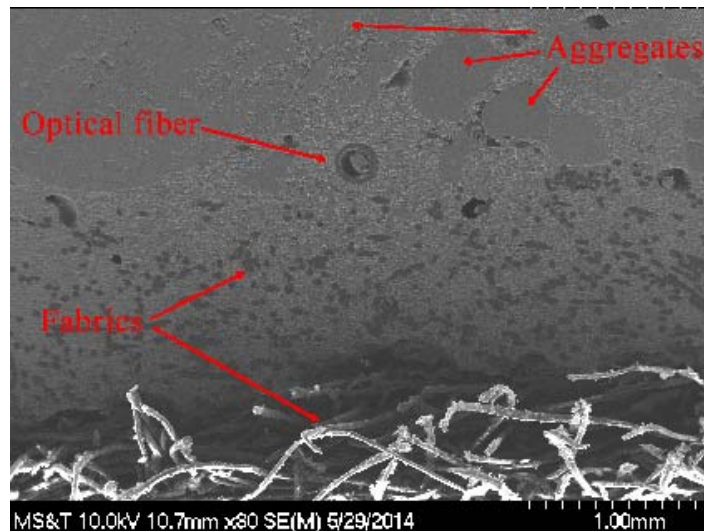
Fig. 4.7. SEM image of an optical fiber embedded in mortar.

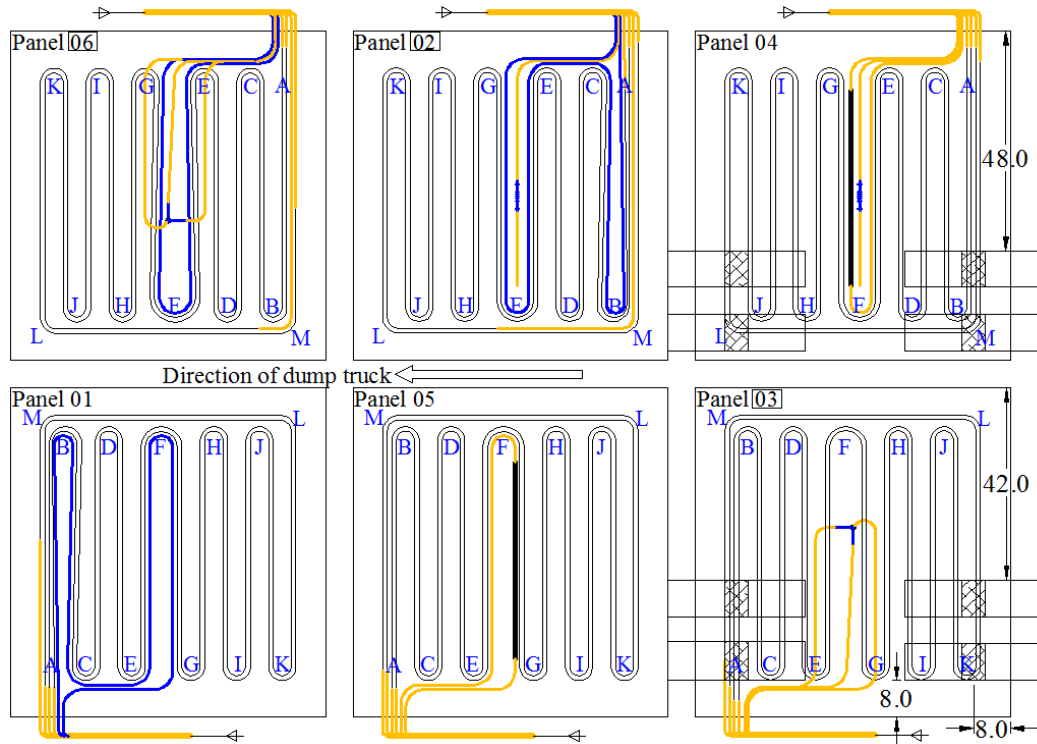
The first row of rear wheels were parked on P4 and P3 as shown in Fig. 5.3. Their positions were measured from edges of the wheels and the panels. Because of the uneven floor in the laboratory, some cracks appeared under the truck load.

Fig. 5.3. Location of the truck load P1S1 (in inch = 2.54 cm).

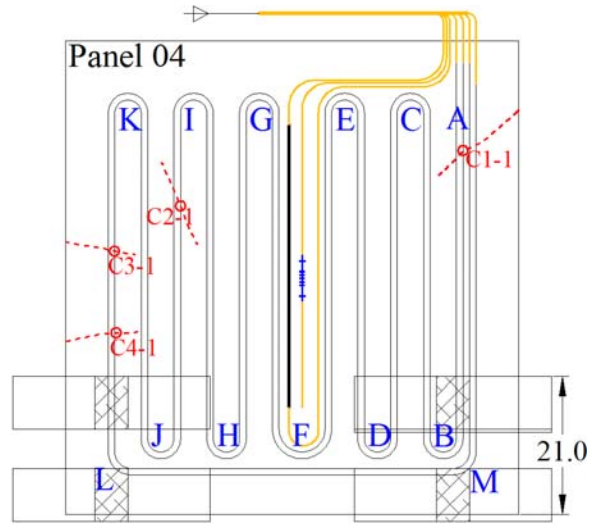
Panel P4 was instrumented with CC4W, CC4G, BF03, and BF13. However, BF13 was found malfunctioning at the time of the truck load test. As shown in Fig. 5.4, four hairline cracks that were difficult to see by naked eyes were successfully detected by the distributed optical fibers. As indicated in Fig. 5.5(a), three of them (C1-1, C2-1, and C4-1) were detected by BF03 under the empty truck load and the fourth crack (C3-1) was captured under the fully loaded truck load. Since no cracks crossed the concrete crack cable CC4W, no sharp peak can be seen in the strain distributions in Fig. 5.5(b). The strain distributions between points “F” and “G” were measured by both sensors and thus compared in Fig. 5.6. It can be observed from Fig. 5.6 that the measurement results from the two sensors match well with each other. Because the two fibers were separated in P4 with a short distance as shown in Fig. 5.4, the strains measured from the two fibers cannot be exactly the same. The cracks were located at the positions of peaks in strain distributions. Their widths can be estimated from the magnitude of the sharp peaks.

Fig. 5.4. Cracks in P4 under the truck load P1S1.

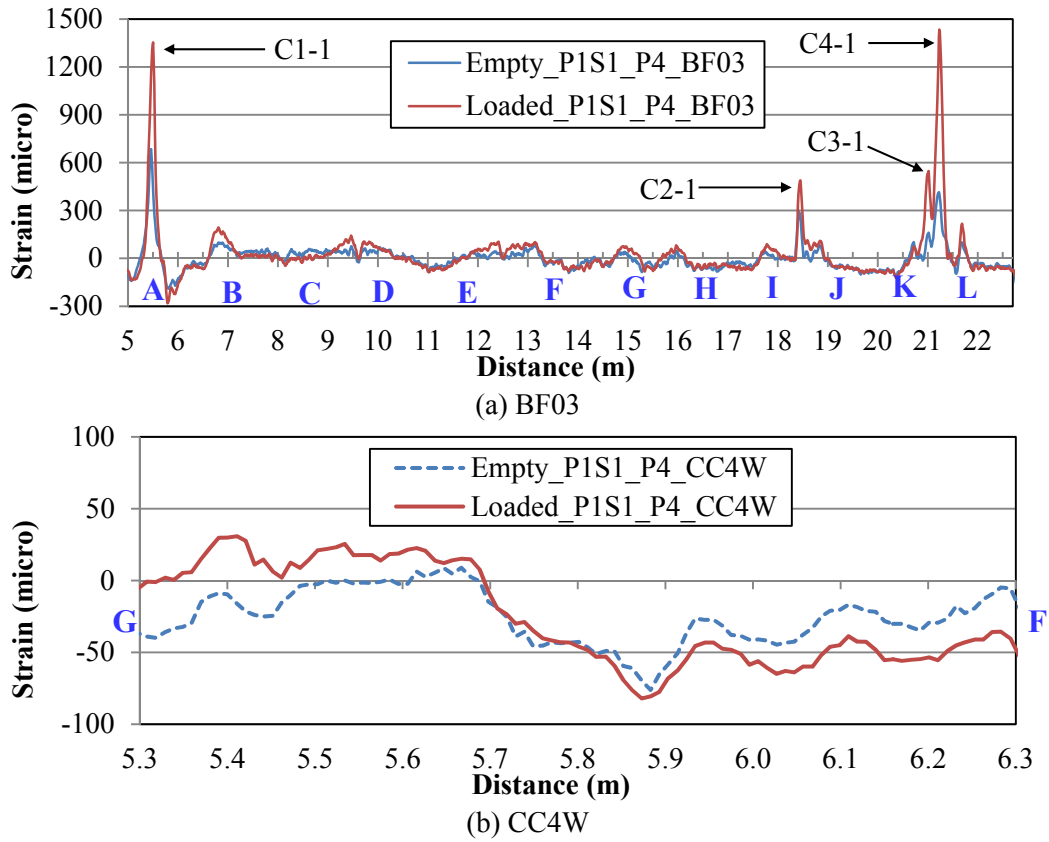
Fig. 5.5. Strain distributions in P4 under the truck load P1S1.

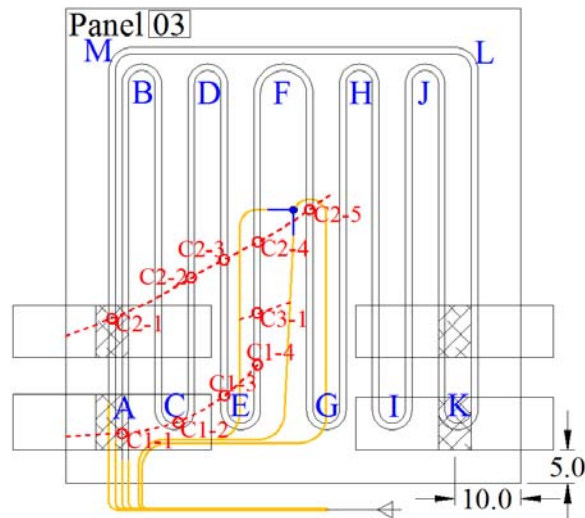
P03 were instrumented with BF06 and BF09 that were paralleled to each other and separated by 1 in. Both fiber sensors were functional during the truck load tests. Three hairline cracks were observed in P3 as shown in Fig. 5.7. They were located at the peaks in strain distributions. Their widths corresponded to the magnitude of the sharp peaks.

Fig. 5.7. Cracks in P3 in the truck load P1S1.

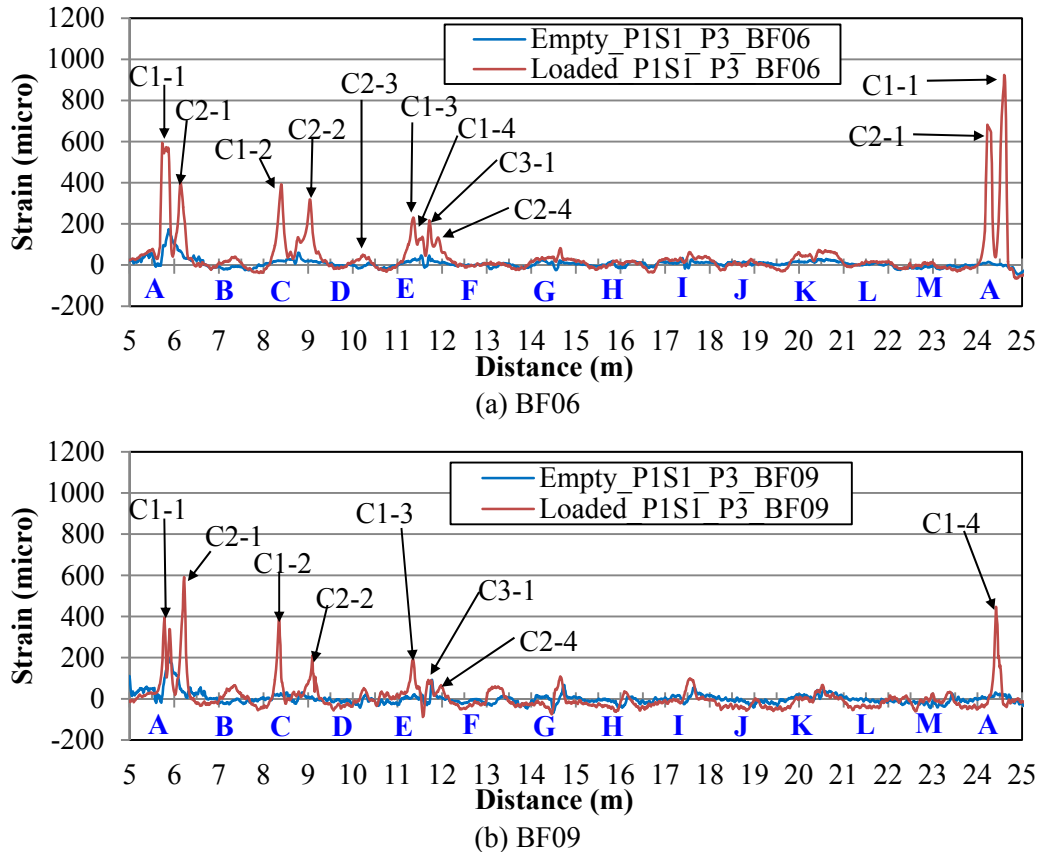
shown in Fig. 5.8. Since BF06 and BF09 were closed with 1 in separation, their measurement results were compared in Fig. 5.9. It can be observed from Fig. 5.9 that the strain distributions from the two fibers were close but not exactly the same, which reflected the variation of strain distributions in the lateral direction of the fiber. For instance, as shown in Fig. 5.9(b), two cracks were detected between point A and point B by either BF06 or BF09. However, the magnitude of the first peak detected by BF06 (about 600 $\mu\epsilon$) was 1.5 times that of the corresponding peak detected by BF09 (about 400 $\mu\epsilon$). This was because the crack width of each crack varied along the crack and the width of crack C1-1 at BF06 was larger than that at BF09.

Fig. 5.8. Strain distributions in P3 in the truck load P1S1.

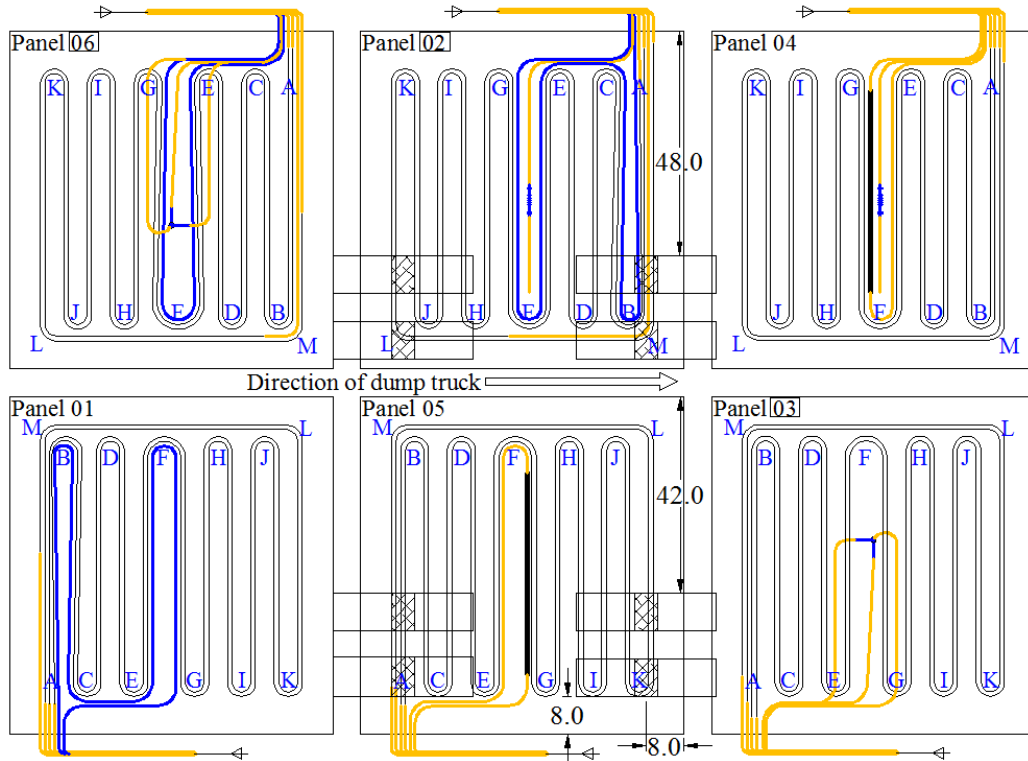
The first row of rear wheels were parked on P2 and P5 as shown in Fig. 5.10. P2 was instrumented with BF07, BF08 and TB2. All the three fibers worked. The optical fibers in P5 were damaged during concrete pouring. Strain distributions were collected from the optical fibers in P2 by the Neubrescope.

Fig. 5.10. Position of the truck load P1S2.

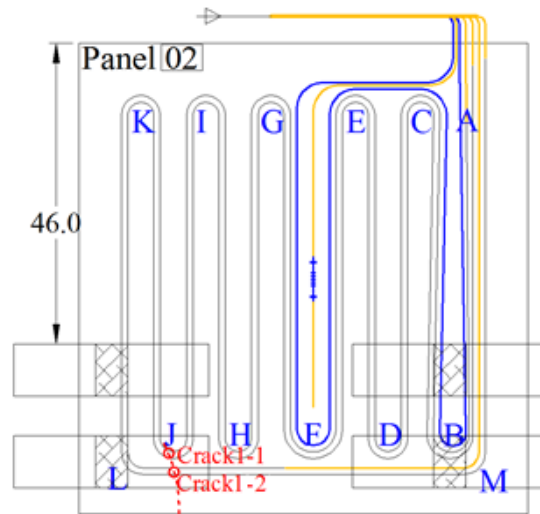
Due to the uneven support condition, P2 cracked as illustrated in Fig. 5.11. The cracks were detected and identified from the strain distributions. They were successfully localized.

Fig. 5.11. Crack in P2 in P1S2.

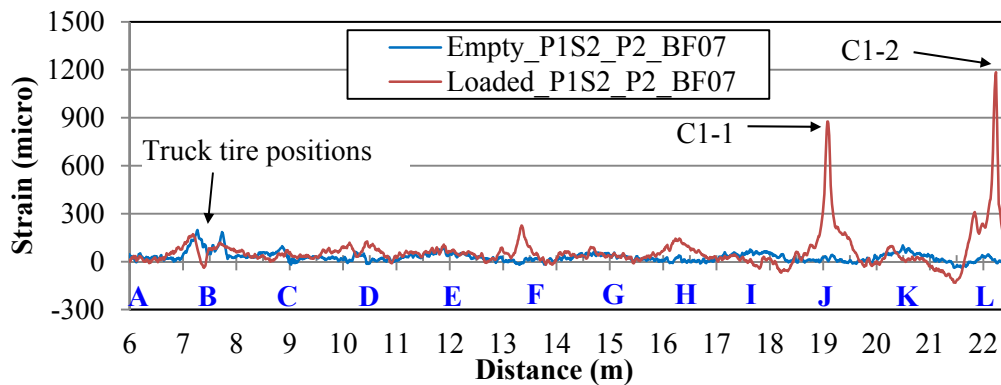
Fig. 5.12 shows the strain distributions in P2 from BF07 and BF08. Under the empty truck load, there was no crack. Under the loaded truck, C1 appeared and was detected by BF07 and BF08.

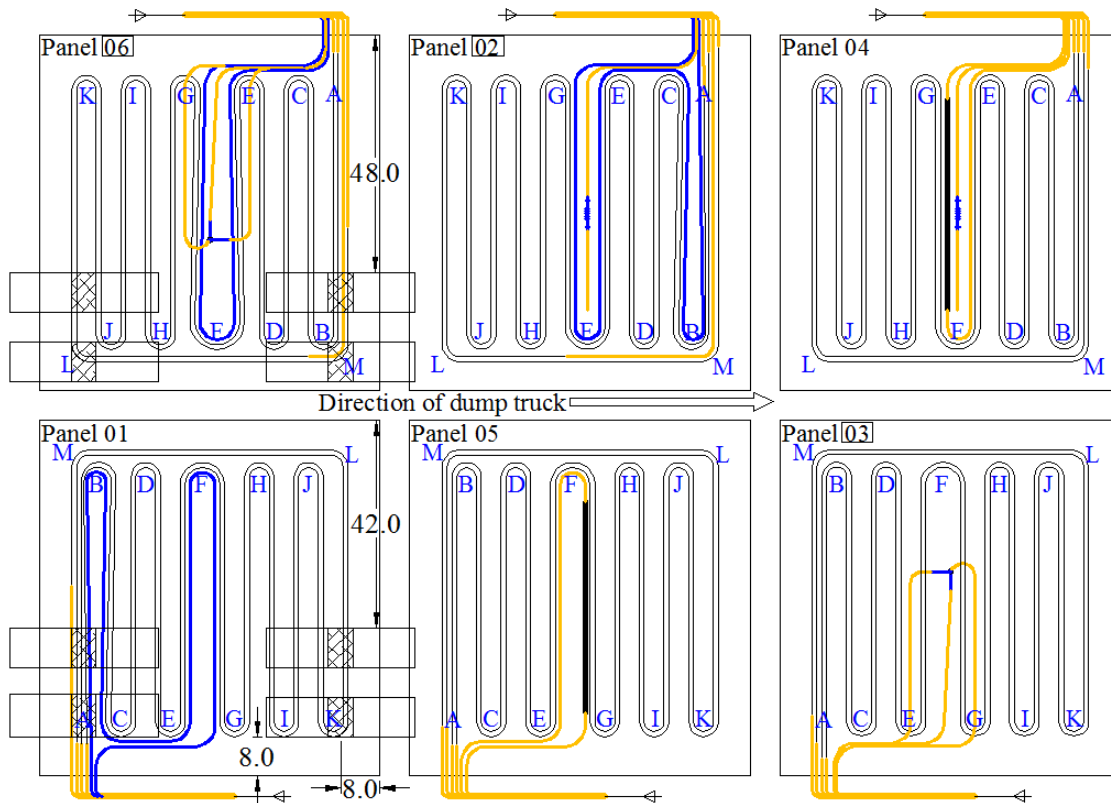
The first row of rear wheels were parked on P1 and P6 as shown in Fig. 5.14. P1 was instrumented with BF01, BF13 and TB1. But, BF01 and BF13 damaged during the specimen fabrication. P6 was instrumented with BF05, BF18 and TB3. All three fibers were functional. Strain distributions were collected from the optical fibers in P1 and P6 by the Neubrescope.

Fig. 5.14. Position of the truck load P1S3.

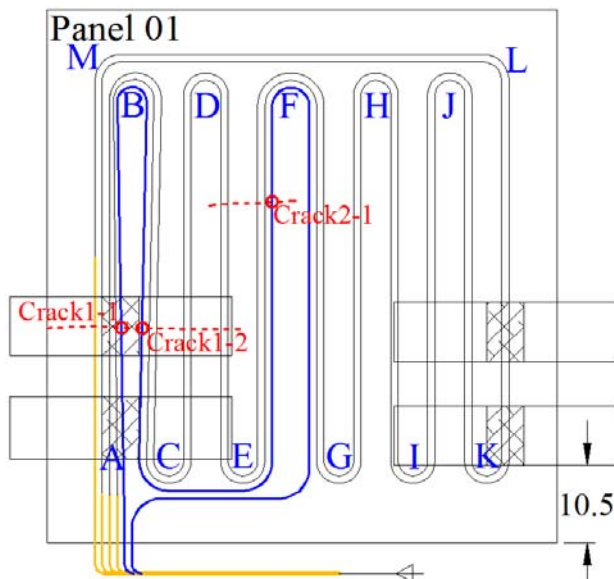
Fig. 5.15 shows the location of two cracks in P01. Fig. 5.16 shows the strain distributions in P1. No crack detected under the empty truck loading. Two cracks appeared and were detected by the fiber under the fully loaded truck. The cracks were located at the positions of peaks in strain distributions. In Fig. 5.16, the three peaks represented the three intersection points of the optical fiber TB1 and the cracks shown in Fig. 5.15.

Fig. 5.15. Cracks in P1 under the truck load P1S3.

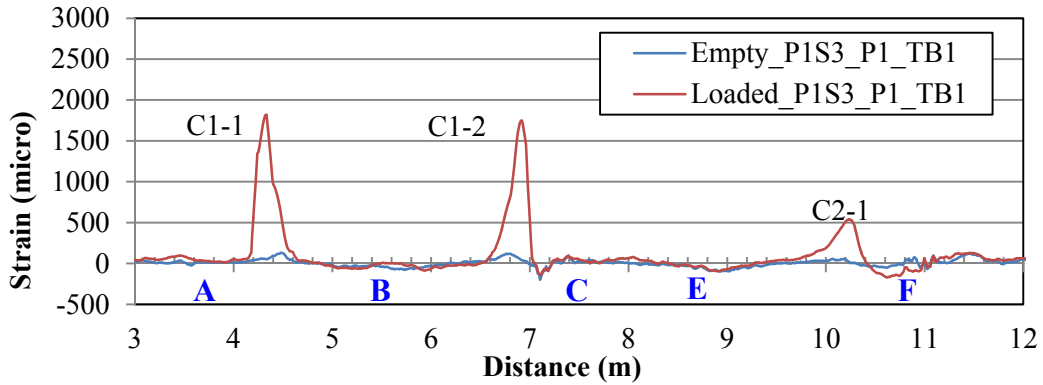
Fig. 5.16. Strain distributions in P1 under the truck load P1S3.

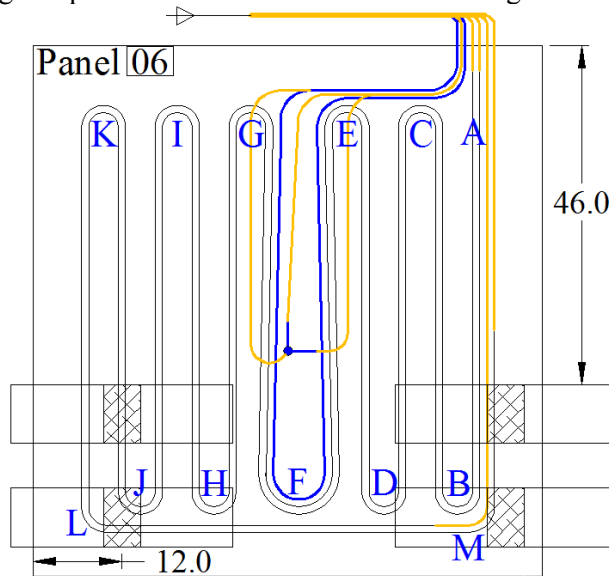
P6 was relatively evenly supported on the floor compared with other panels. No crack was observed in Fig. 5.17 under the same truck load as the other panels. As shown in Fig. 5.18, the peaks between point ‘J’ and ‘K’ well reflected the strain distributions due to the tire pressure while the ones between point ‘L’ and ‘M’ were not so corresponding due to the uneven floor. In addition, the measurement results from BF18 and TB3 were compared in Fig. 5.19. It can be observed from Fig. 5.19 that the bare fiber can provide strain distributions with higher spatial resolution than the fiber with tight buffer.

Fig. 5.17. Position in P6 of the truck load P1S3.

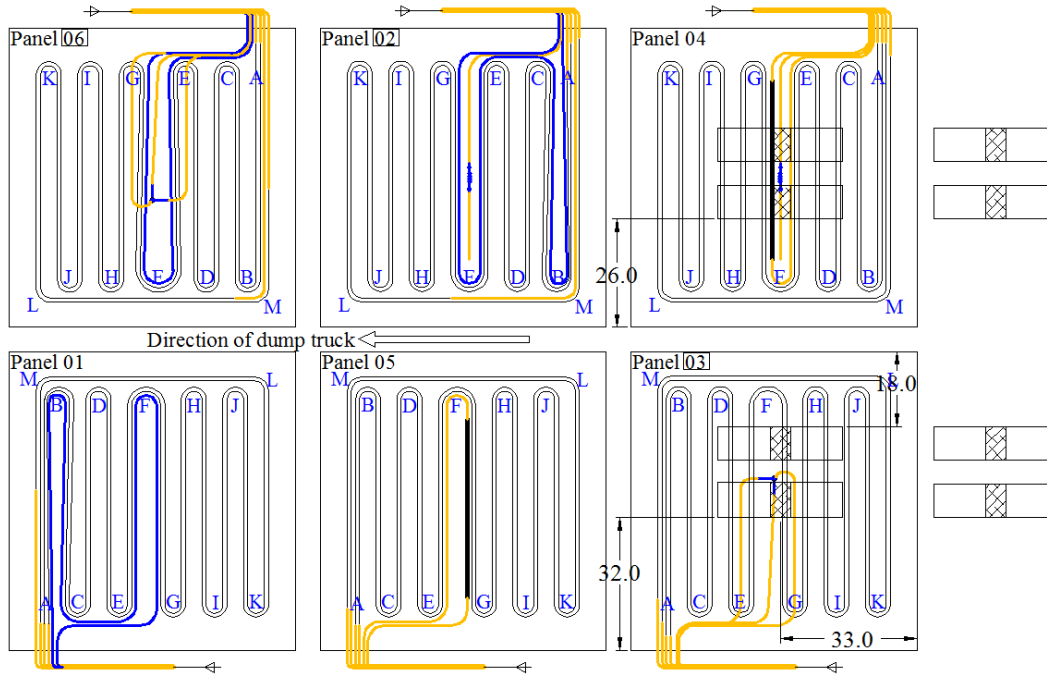
The first row of rear wheels were parked on P3 and P4 as shown in Fig. 5.21. P3 was instrumented with BF06 and BF09. Both fibers worked as expected. P4 was instrumented with CC4W, CC4G and BF03. All the fibers were functional as well. Strain distributions were collected from the optical fibers in P3 and P4 by the Neubrescope. Compared with the P1S1, more cracks appeared in this case.

Fig. 5.21. Position of the truck load P2S1.

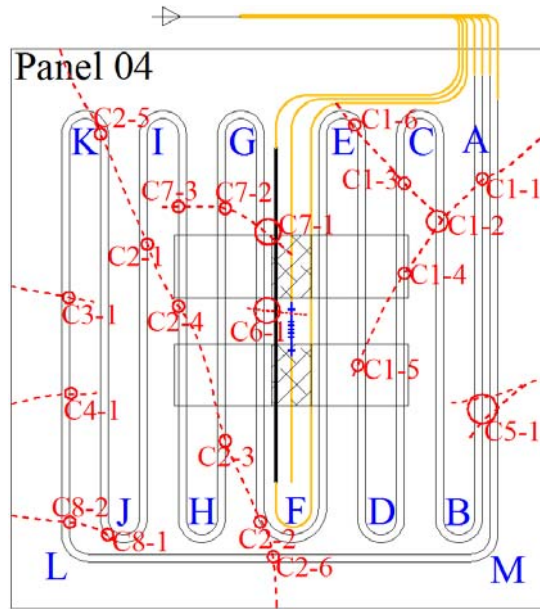
Due to the uneven support condition, P4 cracked under the loaded truck as illustrated in Fig. 5.22. The cracks were detected and identified from the strain distributions. They were successfully localized in Fig.5.23. Since BF03 and CC4W were close, their measurements were compared in Fig. 5.24. Overall, the measurements were in good agreement. But the spatial resolutions were not the same. The bare fiber provided much better spatial resolution than the packaged concrete crack cable.

Fig. 5.22. Cracks in P4 under the truck load P2S1.

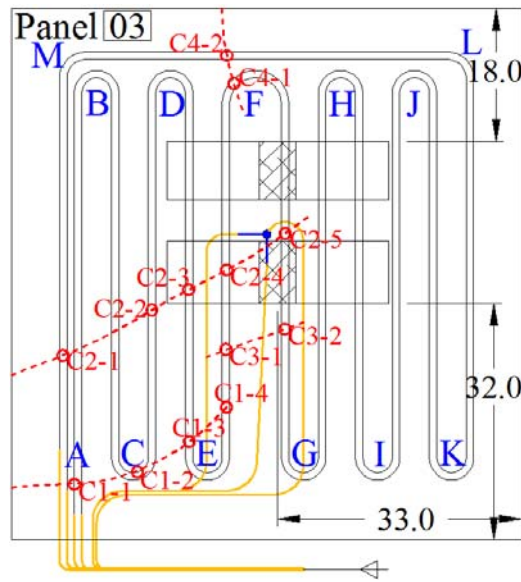
Fig. 5.25. Cracks in P3 under the truck load P2S1.

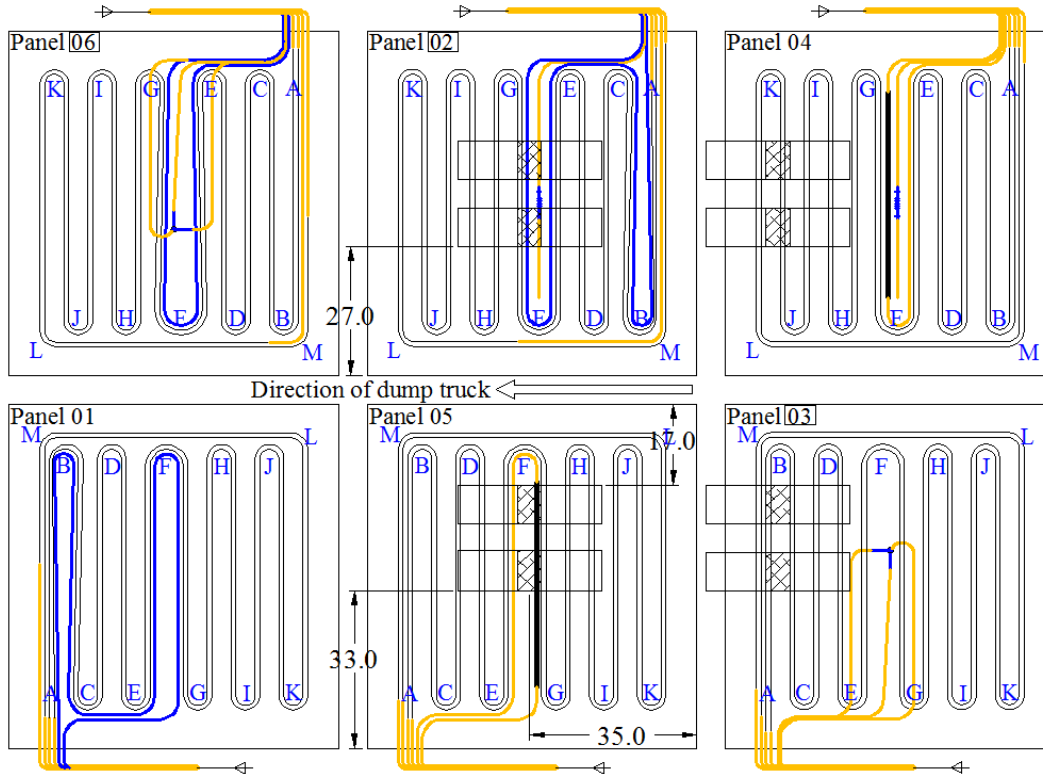
Fig. 5.27. Position of the truck load P2S2.
