Unbonded Portland Cement Concrete Overlay/Pavement Monitoring with Integrated Grating and Scattering Optical Fiber Sensors

Unbonded Portland Cement Concrete Overlay/ Pavement Monitoring with Integrated Grating and Scattering Optical Fiber Sensors

**NUTC
R330**

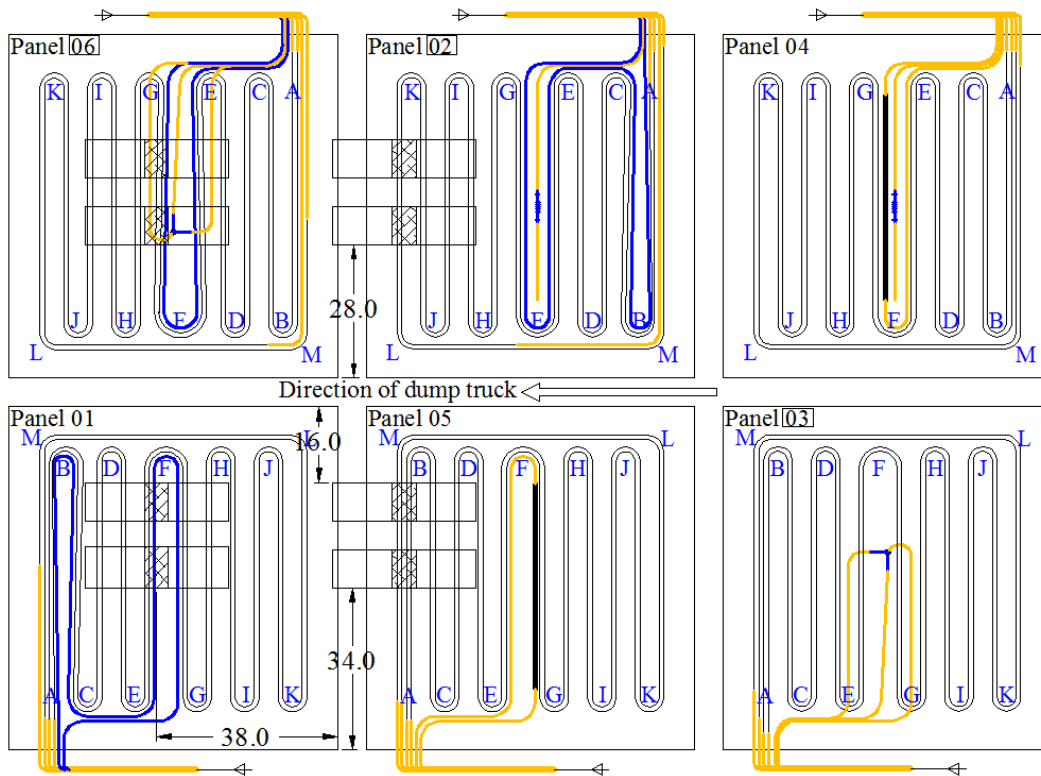
Fig. 5.31. Position of the truck load P2S3.

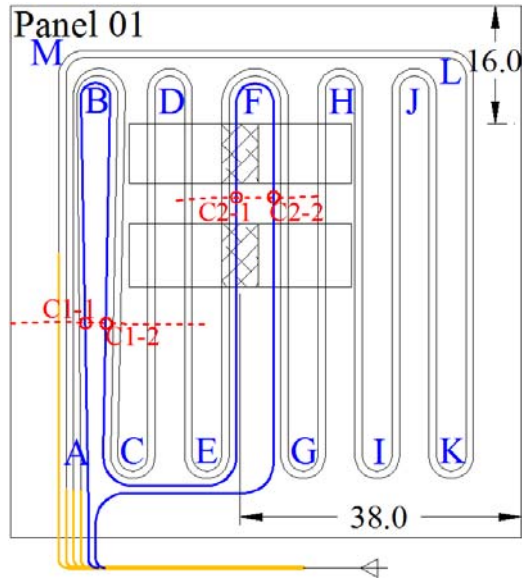
Fig. 5.32. Cracks in P1 under the truck load P2S3.

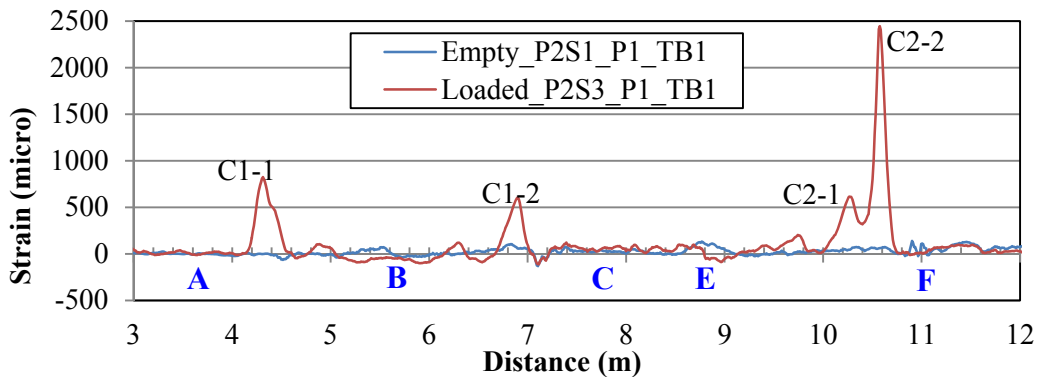
Fig. 5.33. Strain distribution in P1 under the truck load P2S3.

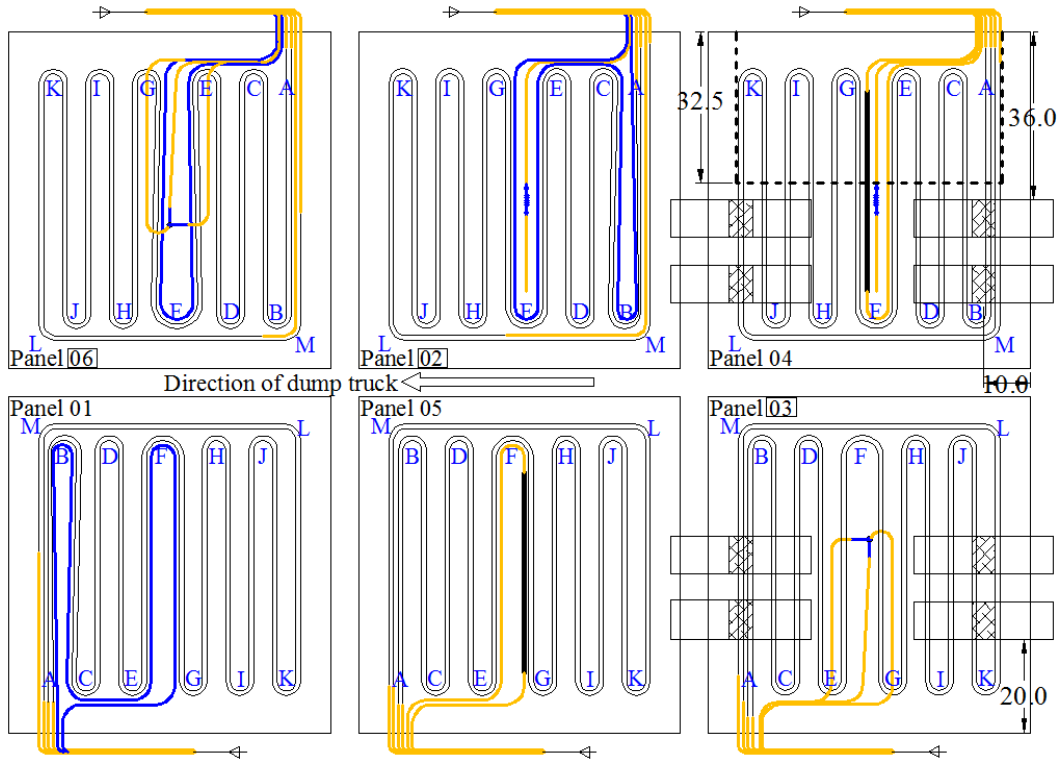
Fig. 5.34. Position of the plywood for substrate movement test.

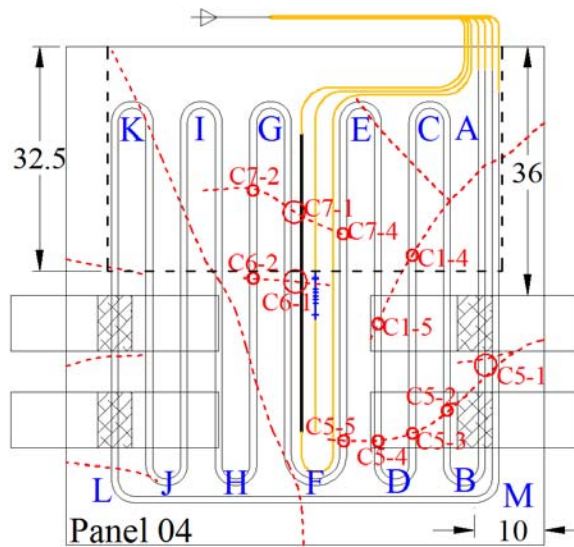
Fig. 5.35. Cracks in P4 under truck load with substrate movement.

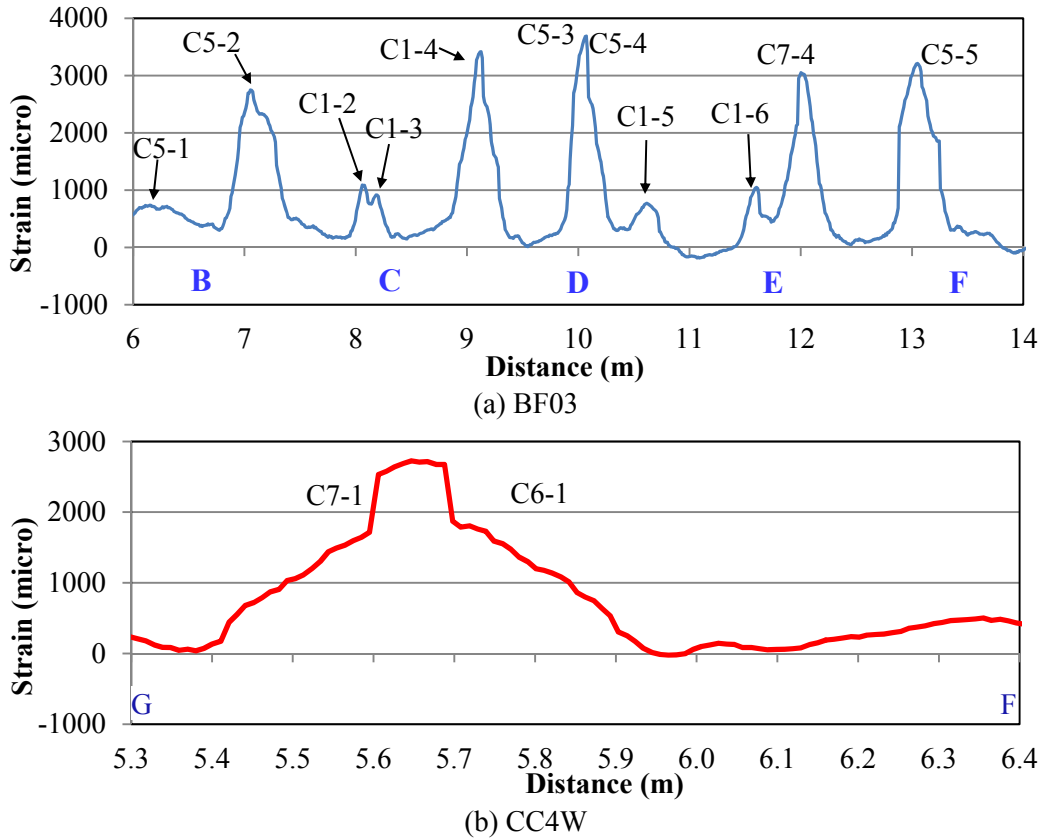
Fig. 5.36. Strain distributions in P4 under the truck load with substrate movement.

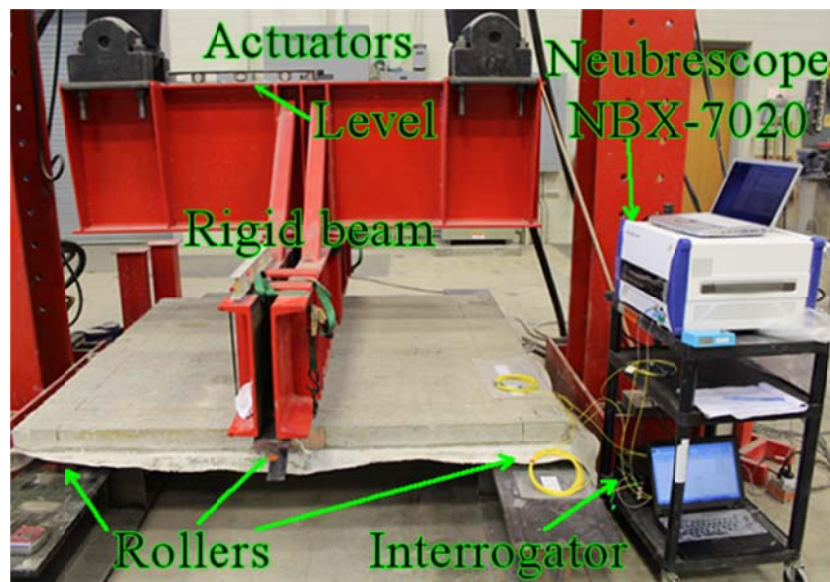
Fig. 6.1. Load frame test setup.

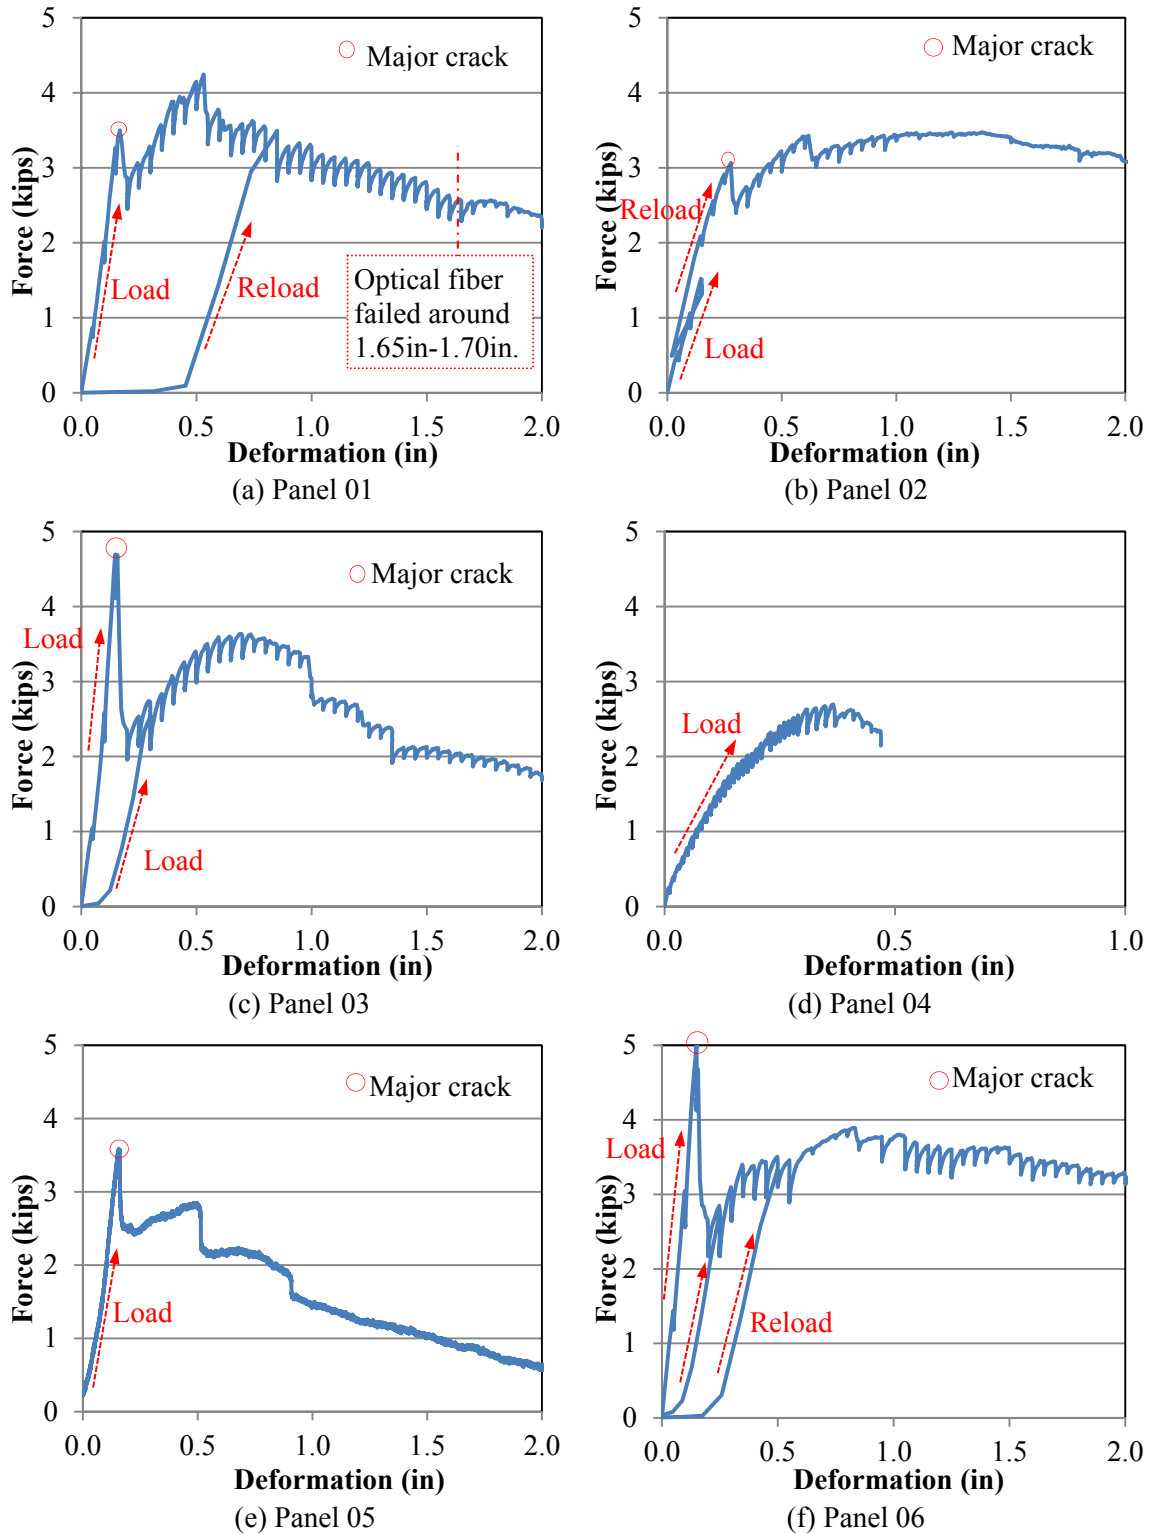
Fig. 6.2. Force-deflection relations of tested panels.

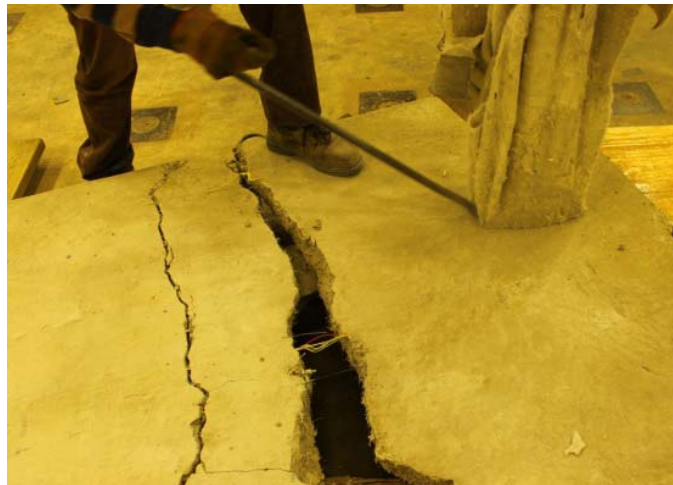
Fig. 6.3. Removal of the fabrics from concrete panel.

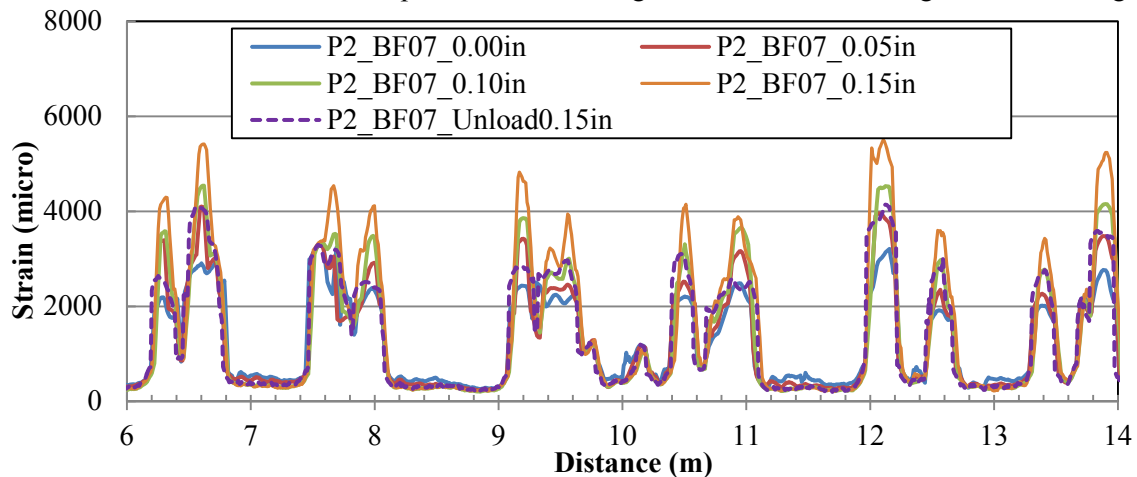
Fig. 6.6. Strain distributions in P2 by BF07.

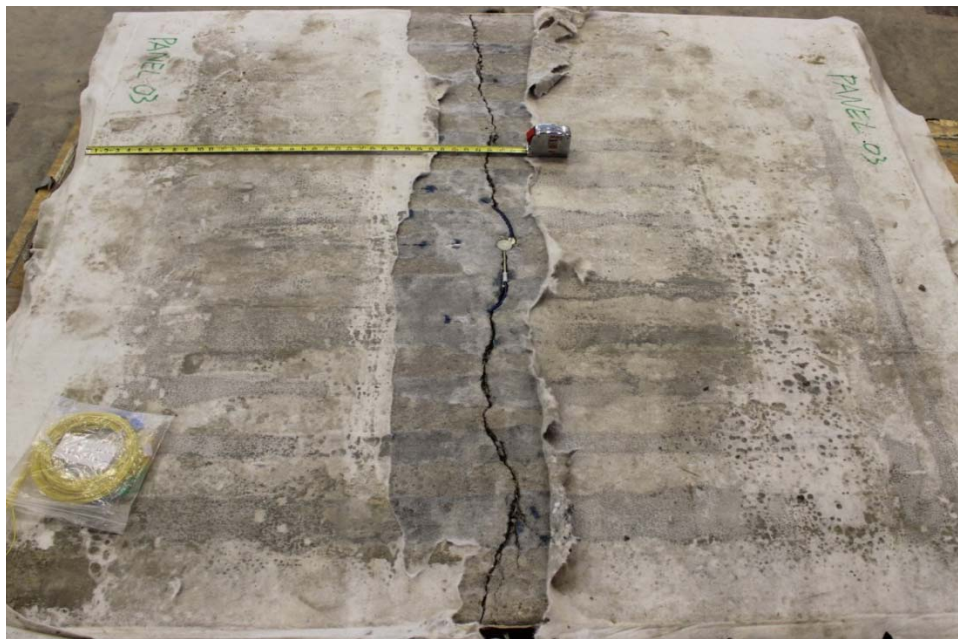
Fig. 6.8. Cracks in P3 after load frame test.

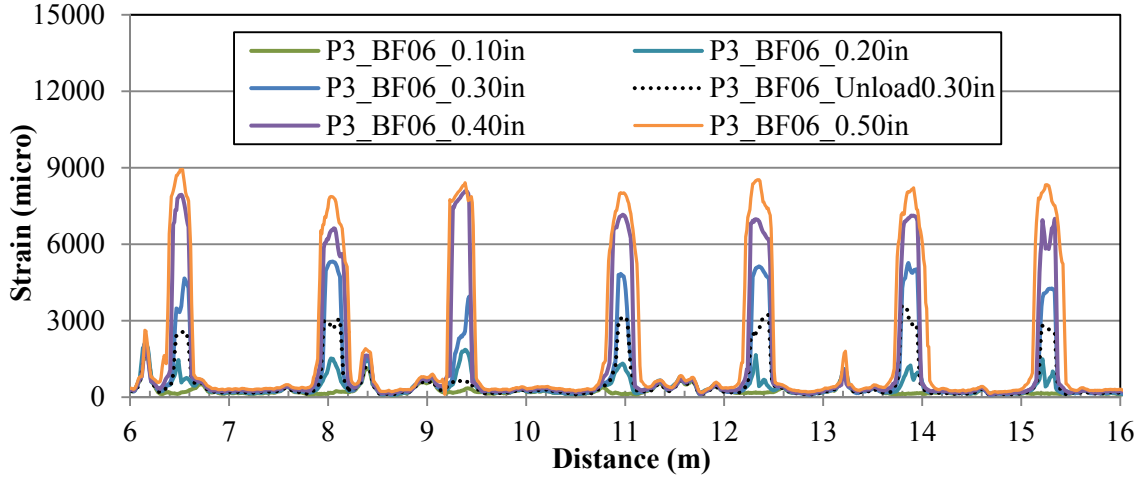
Fig. 6.9. Strain distributions in P3 by BF06.

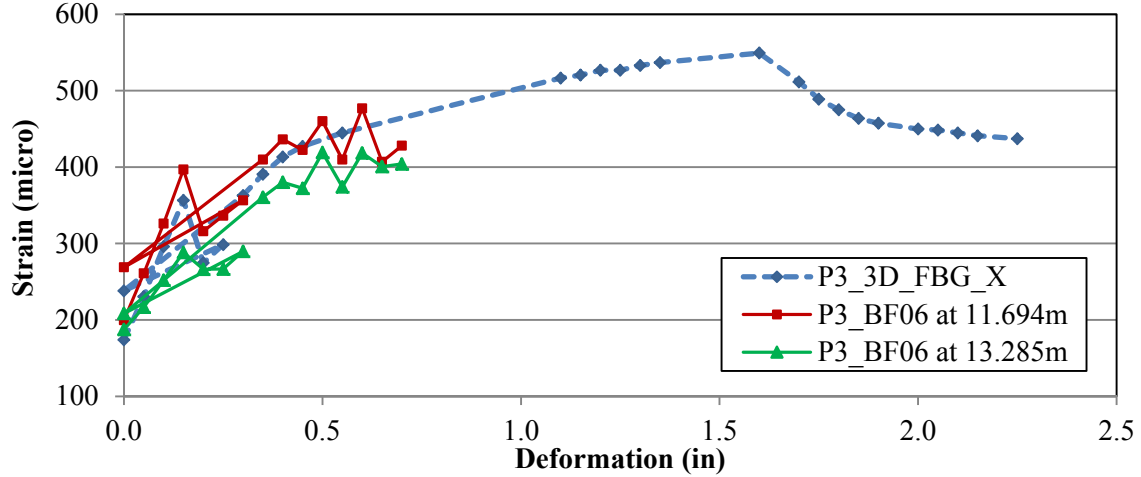
Fig. 6.11. Comparisons of strain measurements by BF06 and 3D-FBG-X.

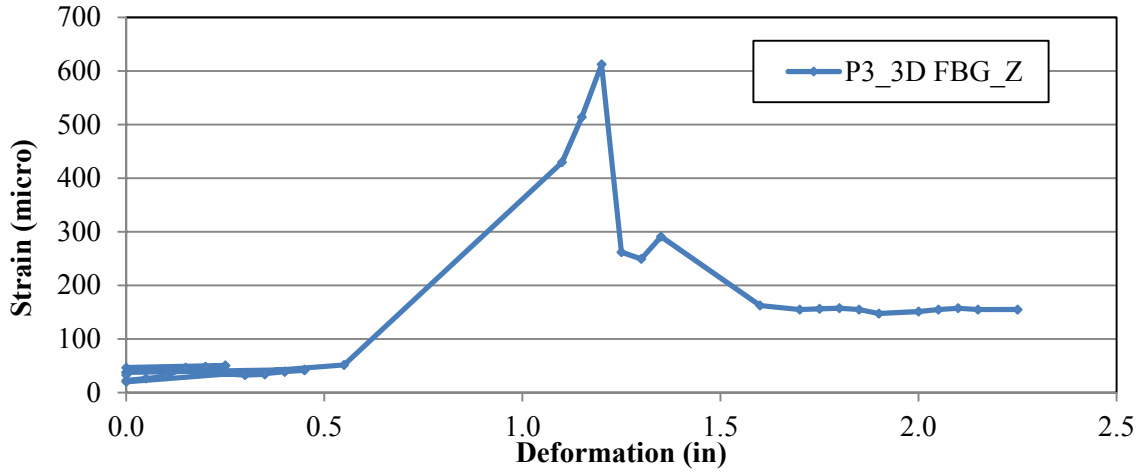
Fig. 6.12. Strain measurements by 3D-FBG-Z in Panel 03.

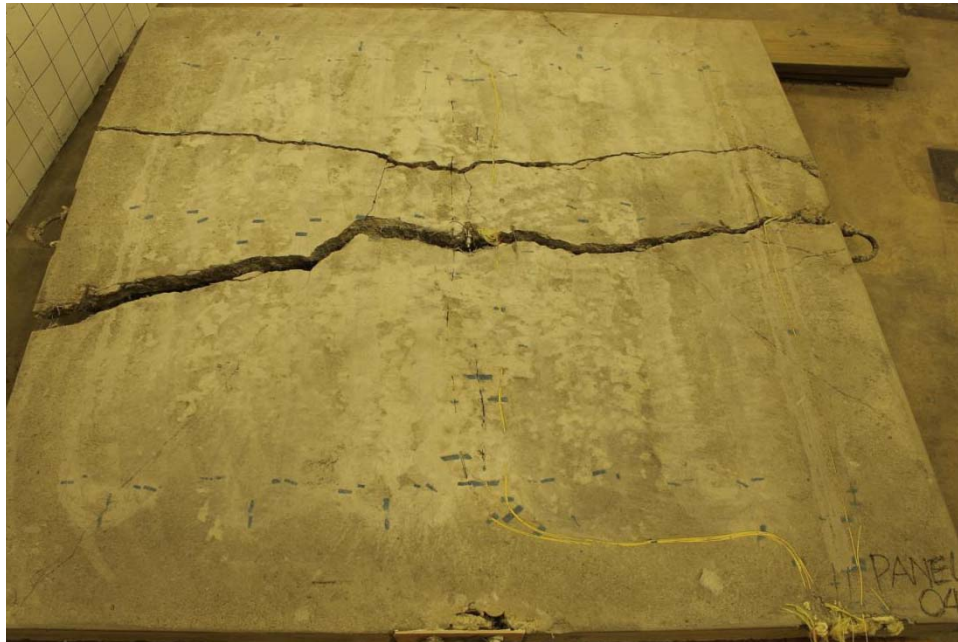
Fig. 6.13. Cracks in P4 after load frame test.

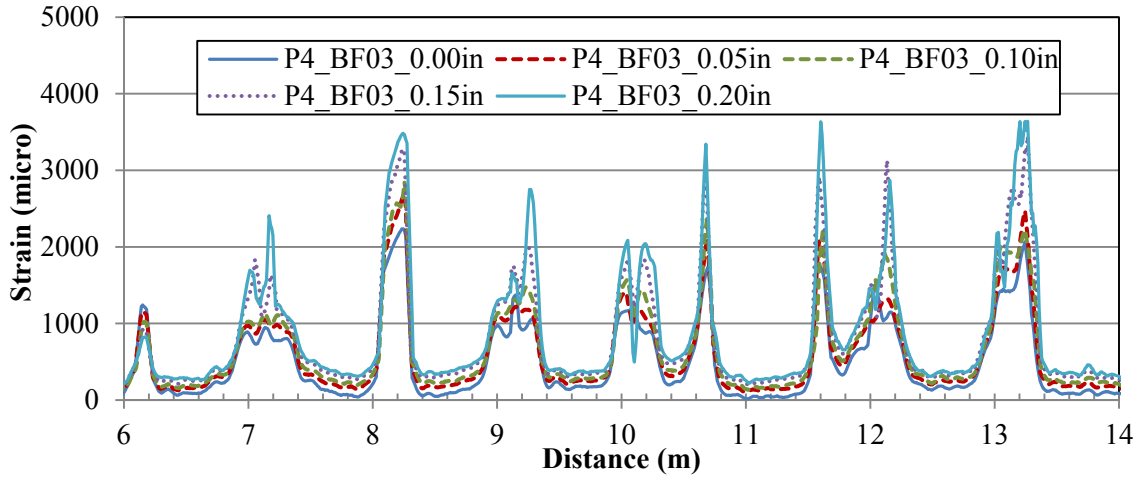
Fig. 6.14. Strain distributions in P4 by BF04.

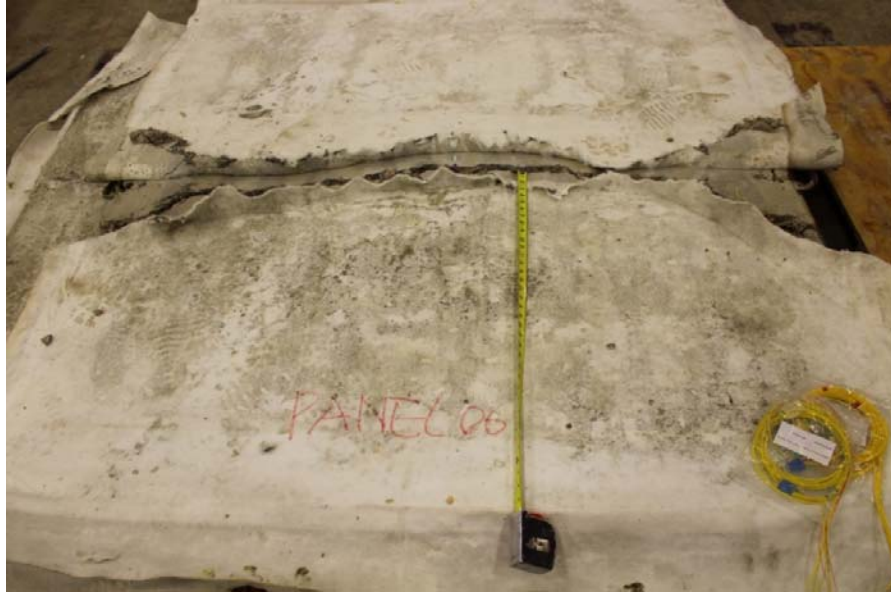
Fig. 6.16. Cracks in P6 after load frame test.

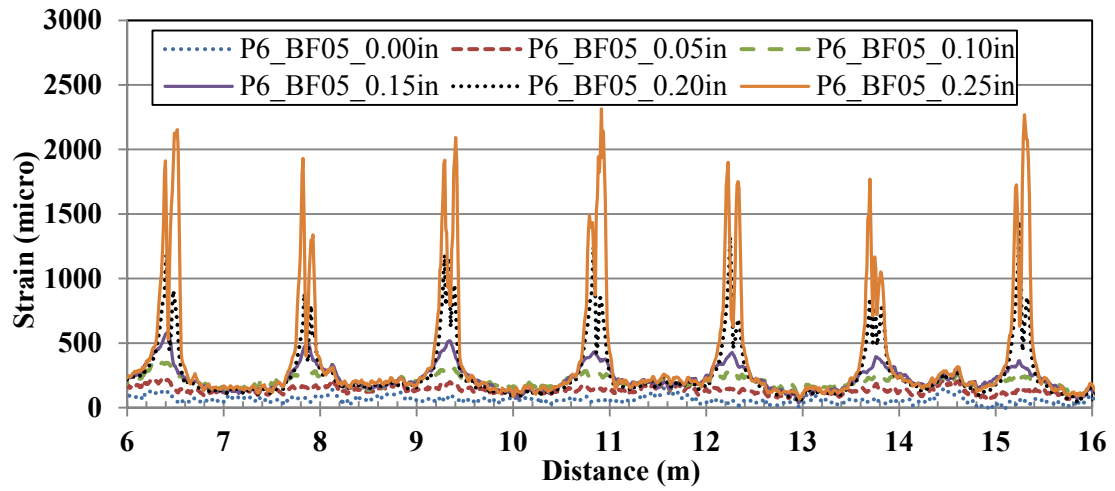
Fig. 6.17. Strain distributions in P6 by BF05.

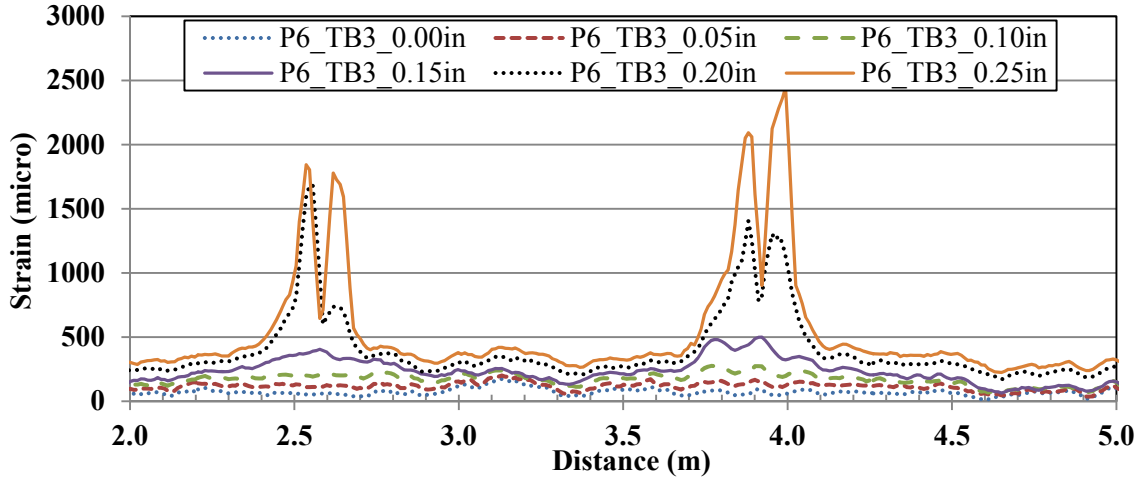
Fig. 6.19. Strain distributions in P6 by TB3.

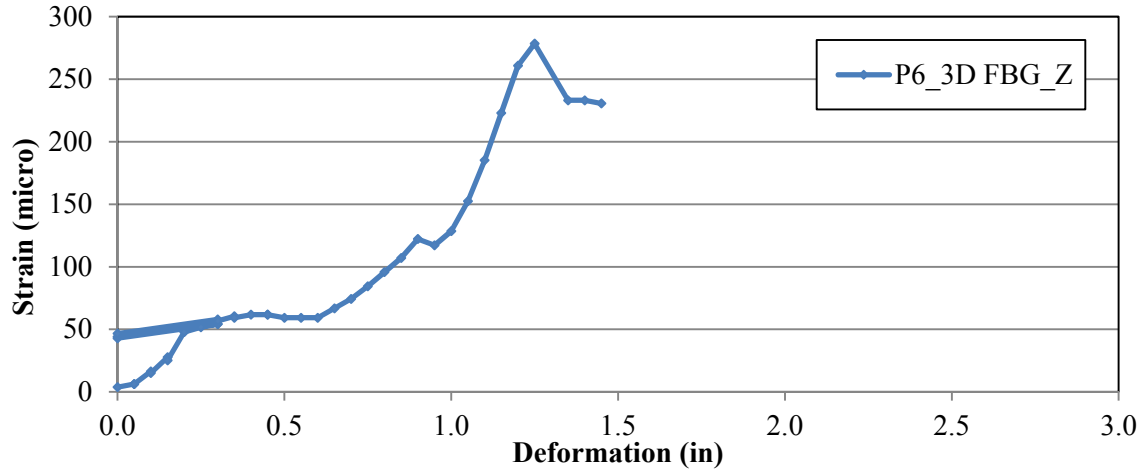
Fig. 6.21. Strain measurements by 3D-FBG-Z in Panel 6.

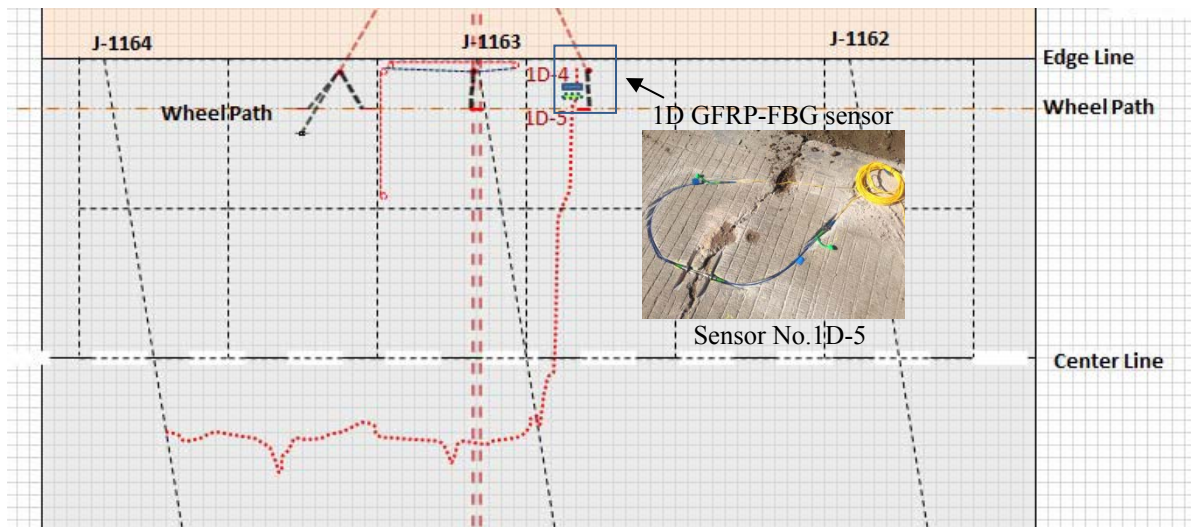
Fig. 7.1. Locations for the 1D-GFRP-FBG crack sensors.

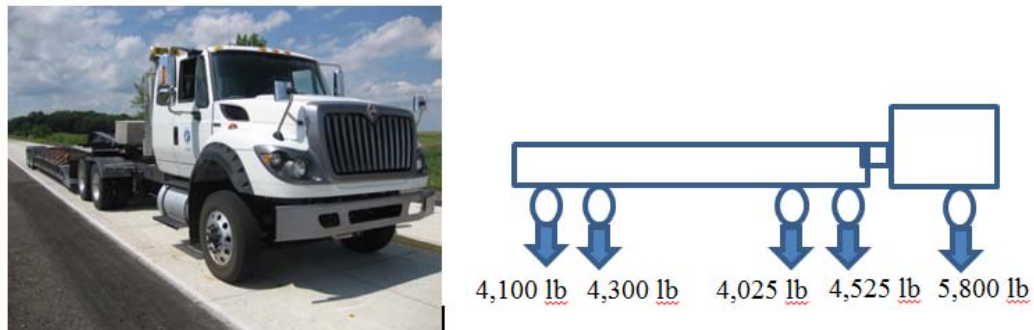
Fig. 7.4. Photos for overlay after paving, truck and truck dimensions.

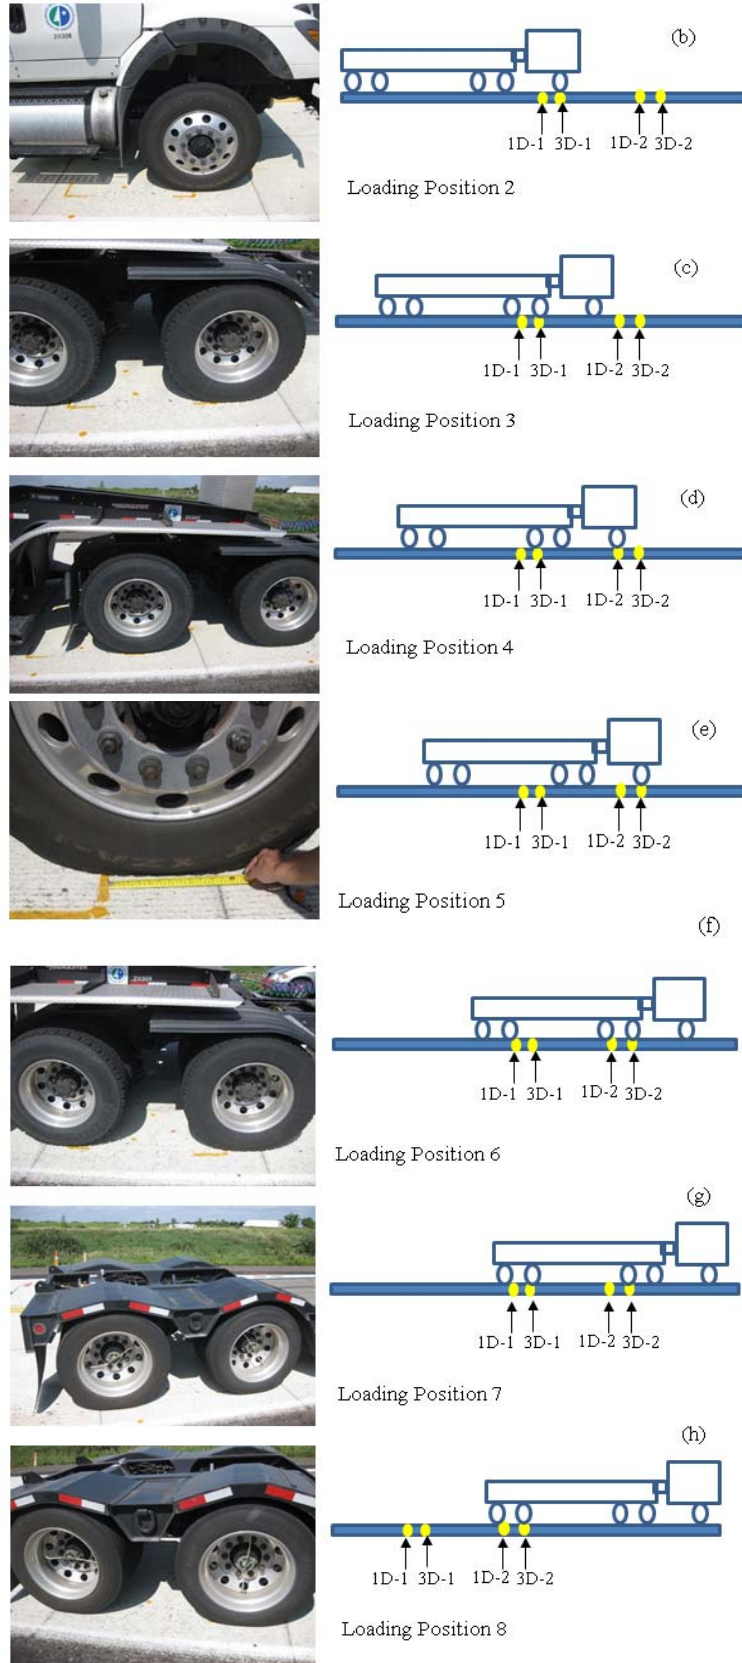
Fig. 7.5. Field static testing setup.

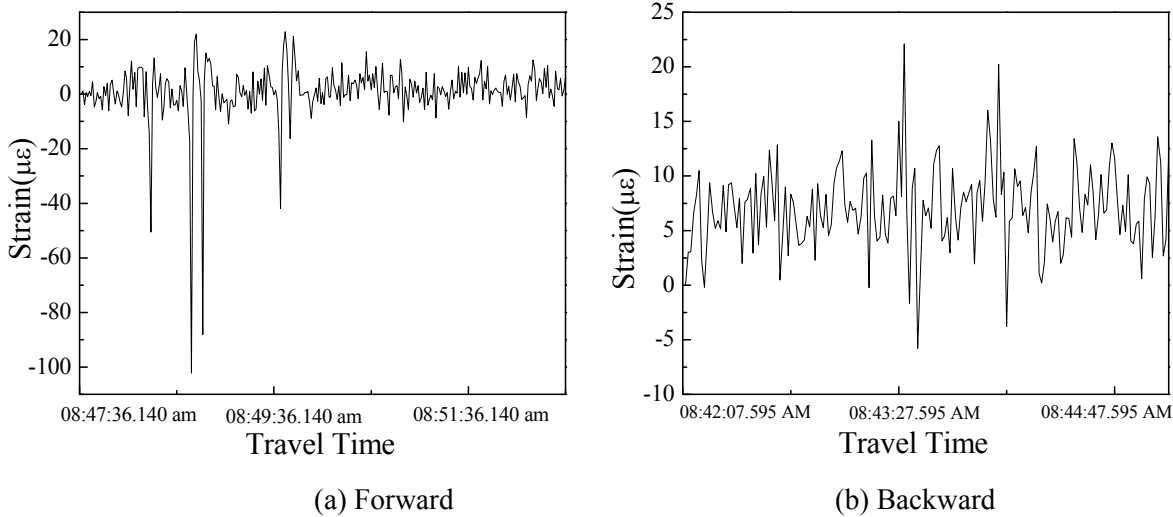
Fig. 7.7. Measured strains from vertical component of the 3D-GFRP-FBG sensor at 5mph.
