Nondestructive Evaluation of Mechanically Stabilized Earth Walls with Frequency-Modulated Continuous Wave (FM-CW) Radar

Report # MATC-MS&T: 196

Final Report
WBS:25-1121-0003-196

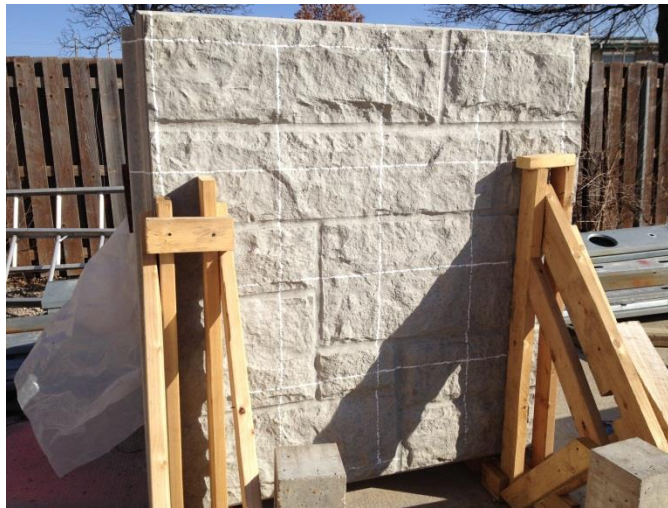
Figure 2.1 Erected MSE wall used in this investigation

As shown in figure 2.1, a 5ft × 5ft × 7in (full size) reinforced concrete MSE wall panel (TENSAR Int.) was used in this study. It was reinforced with #4 epoxy-coated steel bars that were 0.5 in. in minimum diameter and located approximately at its middle depth. The concrete used in the construction of panels was Class A-1, 4 ksi compressive strength, which contained both fine and coarse aggregates. The size of the coarse aggregates was up to 1 in. The wall panel had a 2 in. rugged decoration layer on the front side.

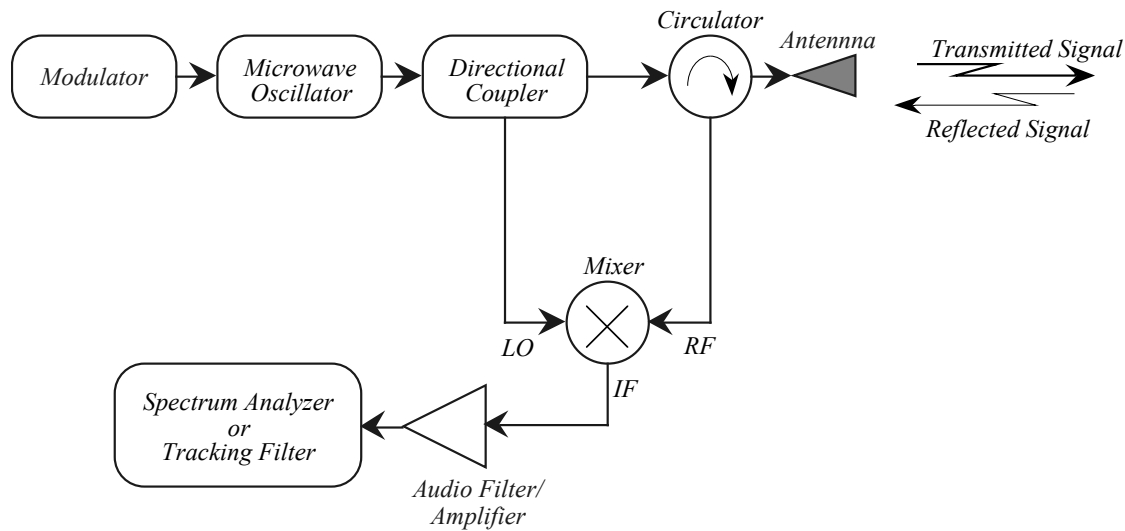
Figure 2.3 The general schematic of an FM-CW radar system

Figure 2.3 shows the general schematic of an FM-CW radar system. The modulator produces a triangular (or a linear ramp) waveform. A portion of the modulated signal is then sent to the local oscillator (LO) port of the mixer, using a directional coupler, while the remaining portion passes through a circulator and is then transmitted via the antenna. This signal travels through the wall and is partially reflected back from boundaries behind the wall, received by the antenna, sent through the circulator, and fed to the radio frequency (RF) port of the mixer. The reference signal at the LO port and this reflected signal at the RF port are then “mixed” to produce a low frequency signal at the intermediate frequency (IF) port of the mixer, which is proportional to the delay introduced in the reflected signal due to its two-way travel to the end of the wall and back (i.e., range or distance). Consequently, the frequency at which the signal appears at the IF port can be measured from a spectrum analyzer or a simple tracking filter and is *directly* related to the distance of the target.

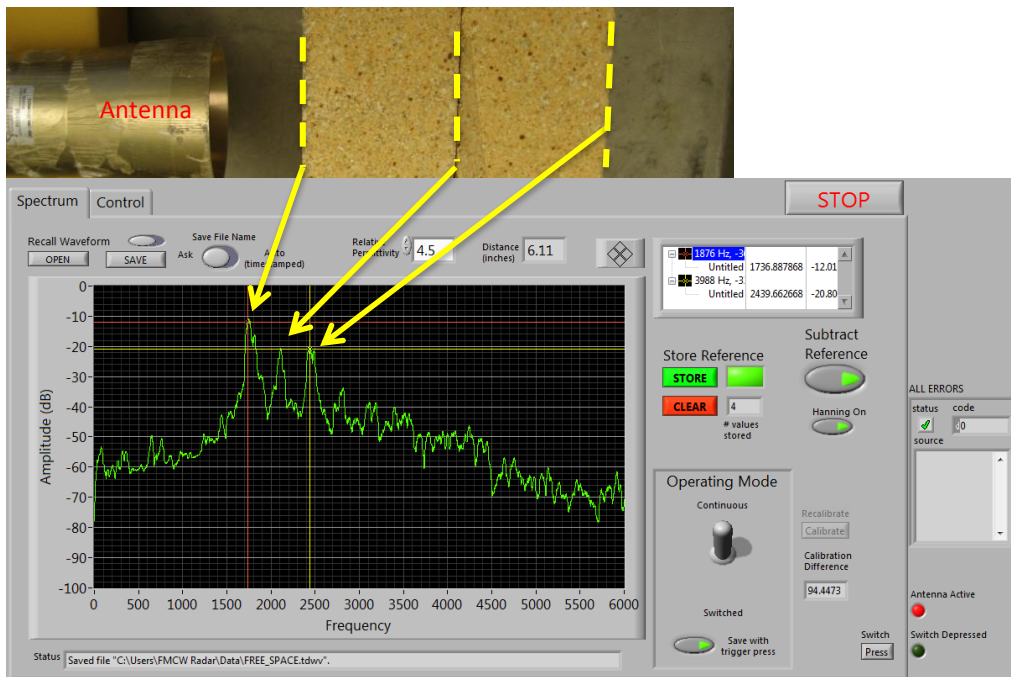
Figure 2.6 Using the FM-CW radar to find interfaces in-between refractory bricks; each peak represents a dielectric interface

application of the FM-CW radar for finding interfaces between refractory bricks. In the graph shown, each peak represents an interface. The reflection from the horn-air interface is removed by measuring this reflection when radiating into air and subsequently subtracting it from any consequent measurements.

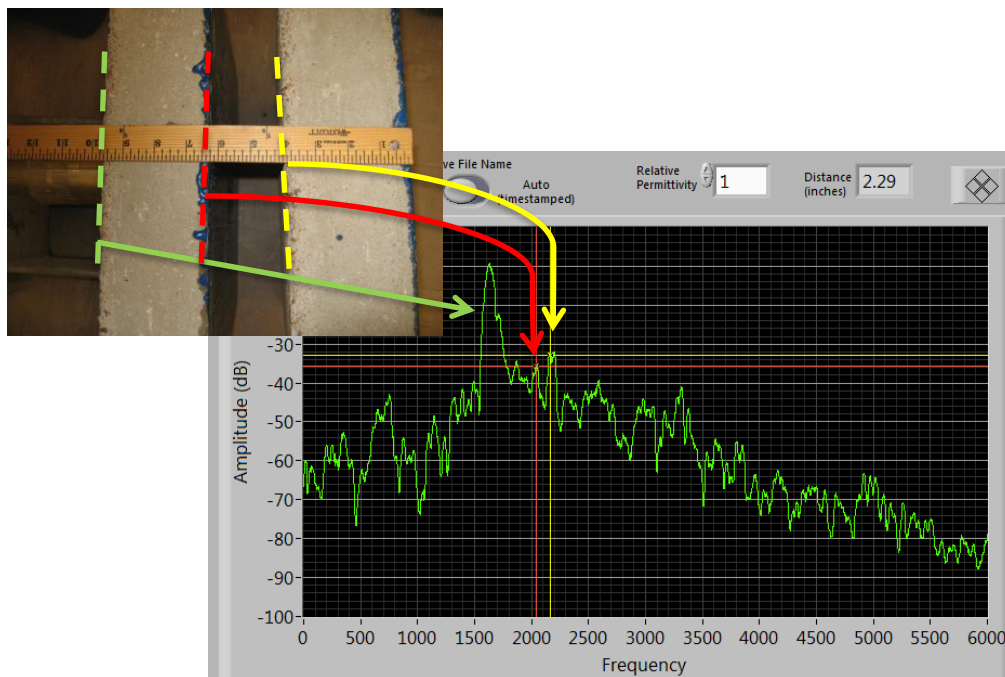
Figure 2.7 Testing the 8-18 GHz FM-CW radar on two concrete slabs in the laboratory

Figure 2.7 shows the results from a laboratory test performed using two 4”-thick concrete slabs with the FM-CW radar. In this test, the FM-CW radar shows the capability of detecting voids through a 4”-thick slab of concrete. However, the high signal loss associated with the concrete slab significantly attenuates the microwave signal to a great extent. Consequently, the

peaks representing the back wall and the far side of the void are quite faint when compared to the background clutter (other peaks). This experiment showed that because this particular FM-CW radar operates at relatively high frequencies (8-18 GHz), it may suffer from such signal attenuations when used on a thick MSE wall. To further assess the signal attenuation issue, a time-domain reflectometry experiment was performed using an Agilent 8753E vector network analyzer (VNA) and a wideband (1-4 GHz) horn antenna. This experiment is similar to the one using the FM-CW radar, however in this case, a lower frequency range was used. Signal attenuation through materials decreases as the operating frequency decreases. This setup was used to detect an air gap behind an 8"-thick concrete block, as shown in figure 2.8. As indicated by the various arrows pointing to the peaks in the graphs, this setup was capable of detecting a void behind the 8"-thick concrete block. Furthermore, due to the lower operating frequency range and the lower signal attenuation, the peaks resulting from the void are distinguishable from background clutter. The drawback of this setup is the smaller bandwidth of the system (3 GHz) that results in a lower than desirable range resolution. To obtain a higher range resolution, an antenna capable of operating in a wider frequency band may be used, such as a Vivaldi antenna. Figure 2.9 shows a 1-6 GHz Vivaldi antenna being used to detect a void behind a retaining wall section. The smaller concrete blocks behind the wall were used to create a 4"-thick gap. The test results are shown in figure 2.10. The Agilent 8753E VNA was also used to make these measurements. The results show that this system is capable of detecting the front and back interface of the wall. It is also capable of detecting a metallic plate (strong reflector) placed 4" behind the wall. However, when detecting the small concrete block from a 4" distance, the signal peak becomes weak and fades into the background clutter. It must be noted that this MSE wall section is an inhomogeneous medium with an uneven surface, a large aggregate, and a mesh

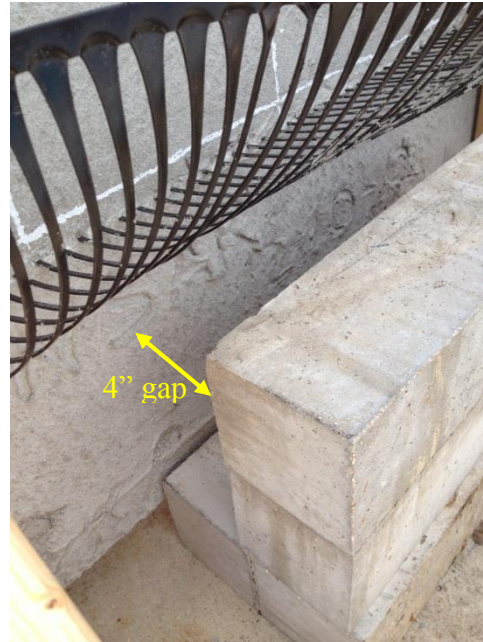
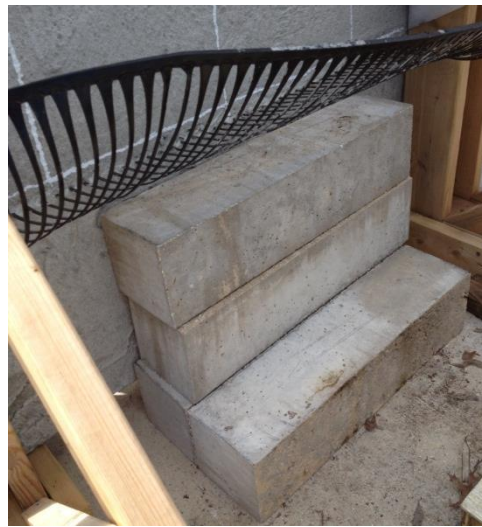
Figure 2.9 Using a wideband (1-6 GHz) Vivaldi antenna to perform time-domain reflectometry on an MSE wall section, which shows (a) the front of the wall with the Vivaldi antenna, (b) the back of the wall with concrete blocks creating a 4" gap, and (c) the back of the wall with concrete blocks firm against the wall (no gap)

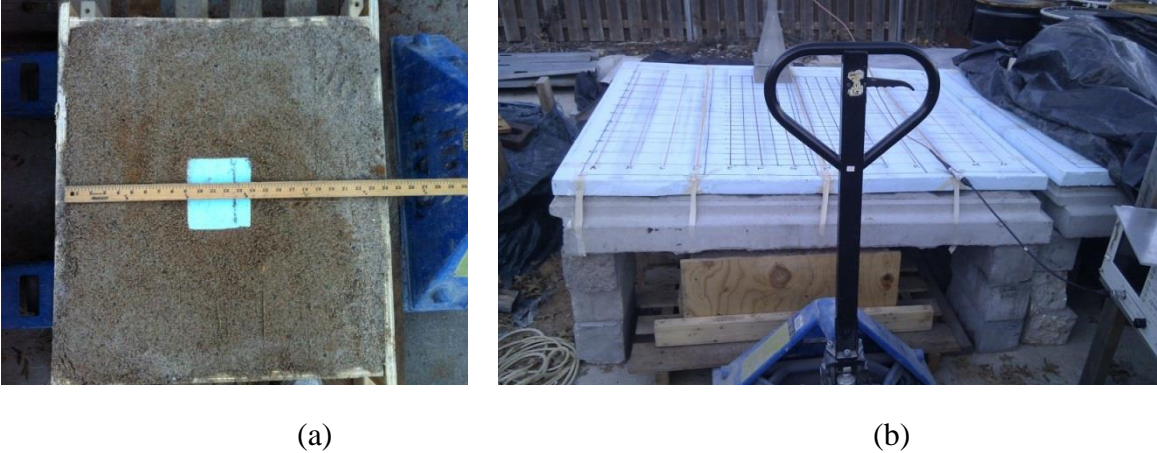
Figure 2.22 (a) Large sandbox and piece of construction foam to simulate void and (b) placed behind the MSE wall section using a pallet jack

So far, the inverse of the void (i.e., sandbox surrounded by air) was scanned to practically show the feasibility of void detection behind a concrete wall. In this section, the results of imaging actual voids are demonstrated. A large 24”x24”x12” wooden box was constructed on top of a pallet. This large box was filled with sand, and pieces of construction foam were used to simulate voids. Foam is electromagnetically similar to air. Figure 2.22 (a) shows a 5”x5”x2” piece of foam placed inside the sand box to simulate a small void. Figure 2.22 (b) shows the sandbox placed behind a wall section using a pallet jack to move and press the sandbox to the back surface of the MSW wall section. This setup was scanned, and SAR image slices were produced as before. Figures 2.23 (a-b) shows SAR image slices at the location of the sandbox (the back surface of the wall) for a small (5”x5”x2”) and a large (10”x10”x2”) void, respectively. These images indicate the capability of SAR imaging for detecting voids in sand (or backfill soil)
