INSPECTING AND PRESERVING  
INFRASTRUCTURE THROUGH  
ROBOTIC EXPLORATION

# Hyperspectral Image Analysis for Mechanical and Chemical Properties of Concrete and Steel Surfaces

Genda Chen\*, Ph.D., P.E., and Hongyan Ma, Ph.D.

August 14, 2018

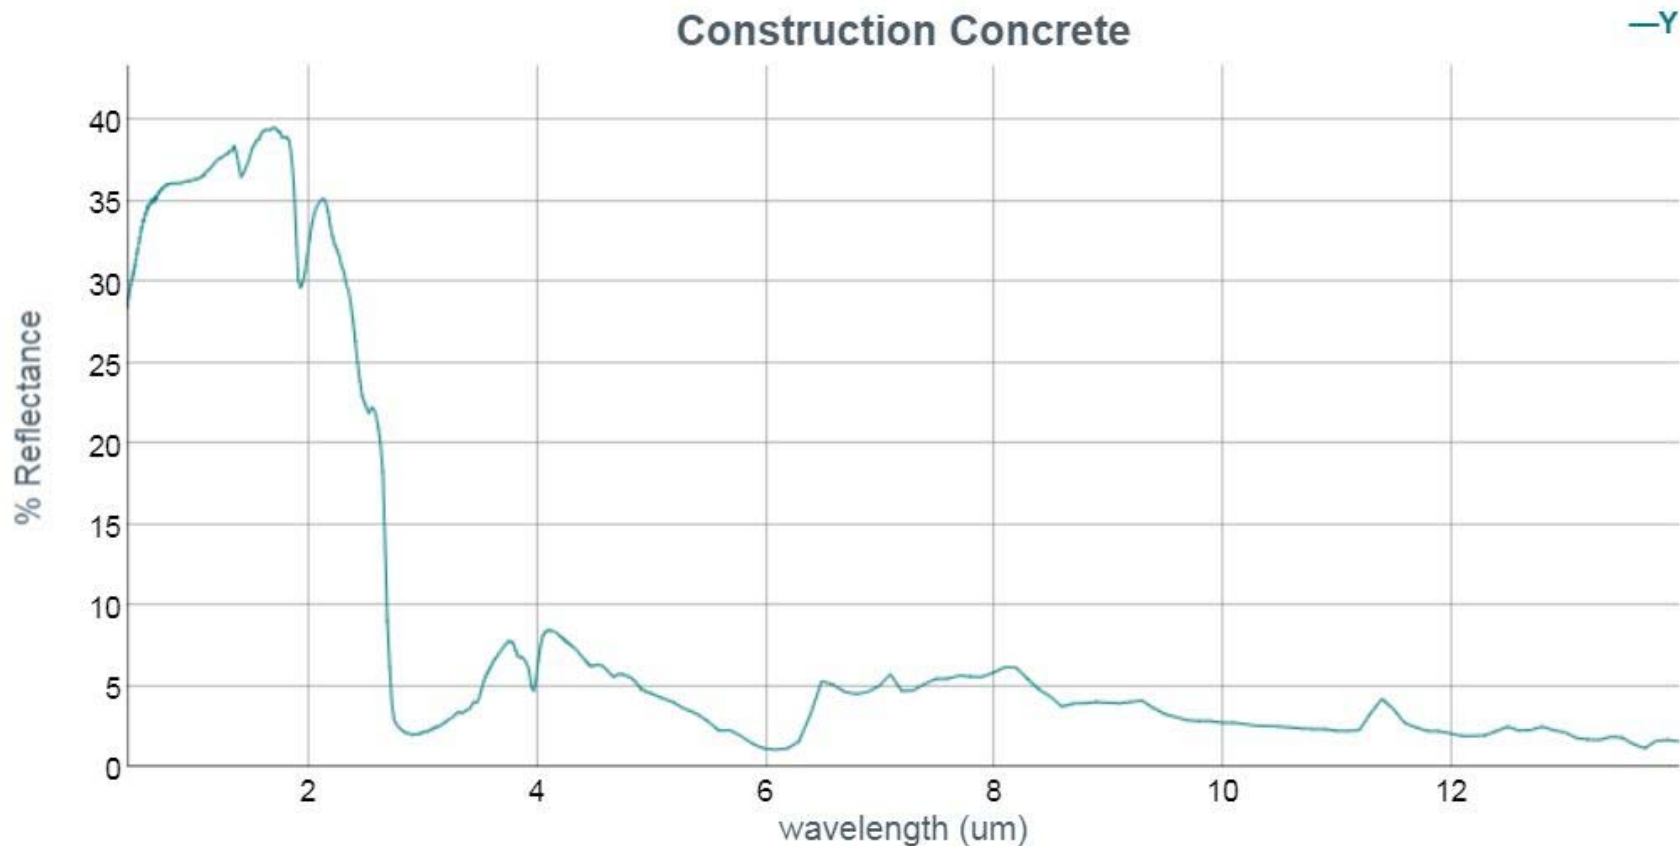
- **Characteristic Spectral Feature of Various Types of Materials (from Jet Propulsion)**

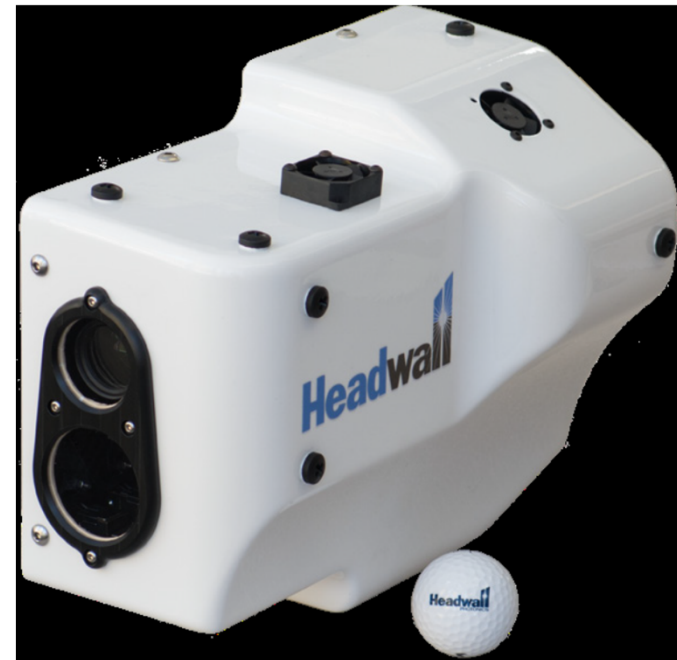
- **Specifications**

- The airborne sensor package measures approximately 10.7" x 8.2" x 6.5" in size and weighs approximately 6.25 lb.
- **Spectral range**
  - ✓ 400-1000 nm (VNIR)
  - ✓ 900-2500 nm (SWIR)
- **Max frame rate**
  - ✓ 330 Hz (VNIR)
  - ✓ >100 Hz (SWIR)

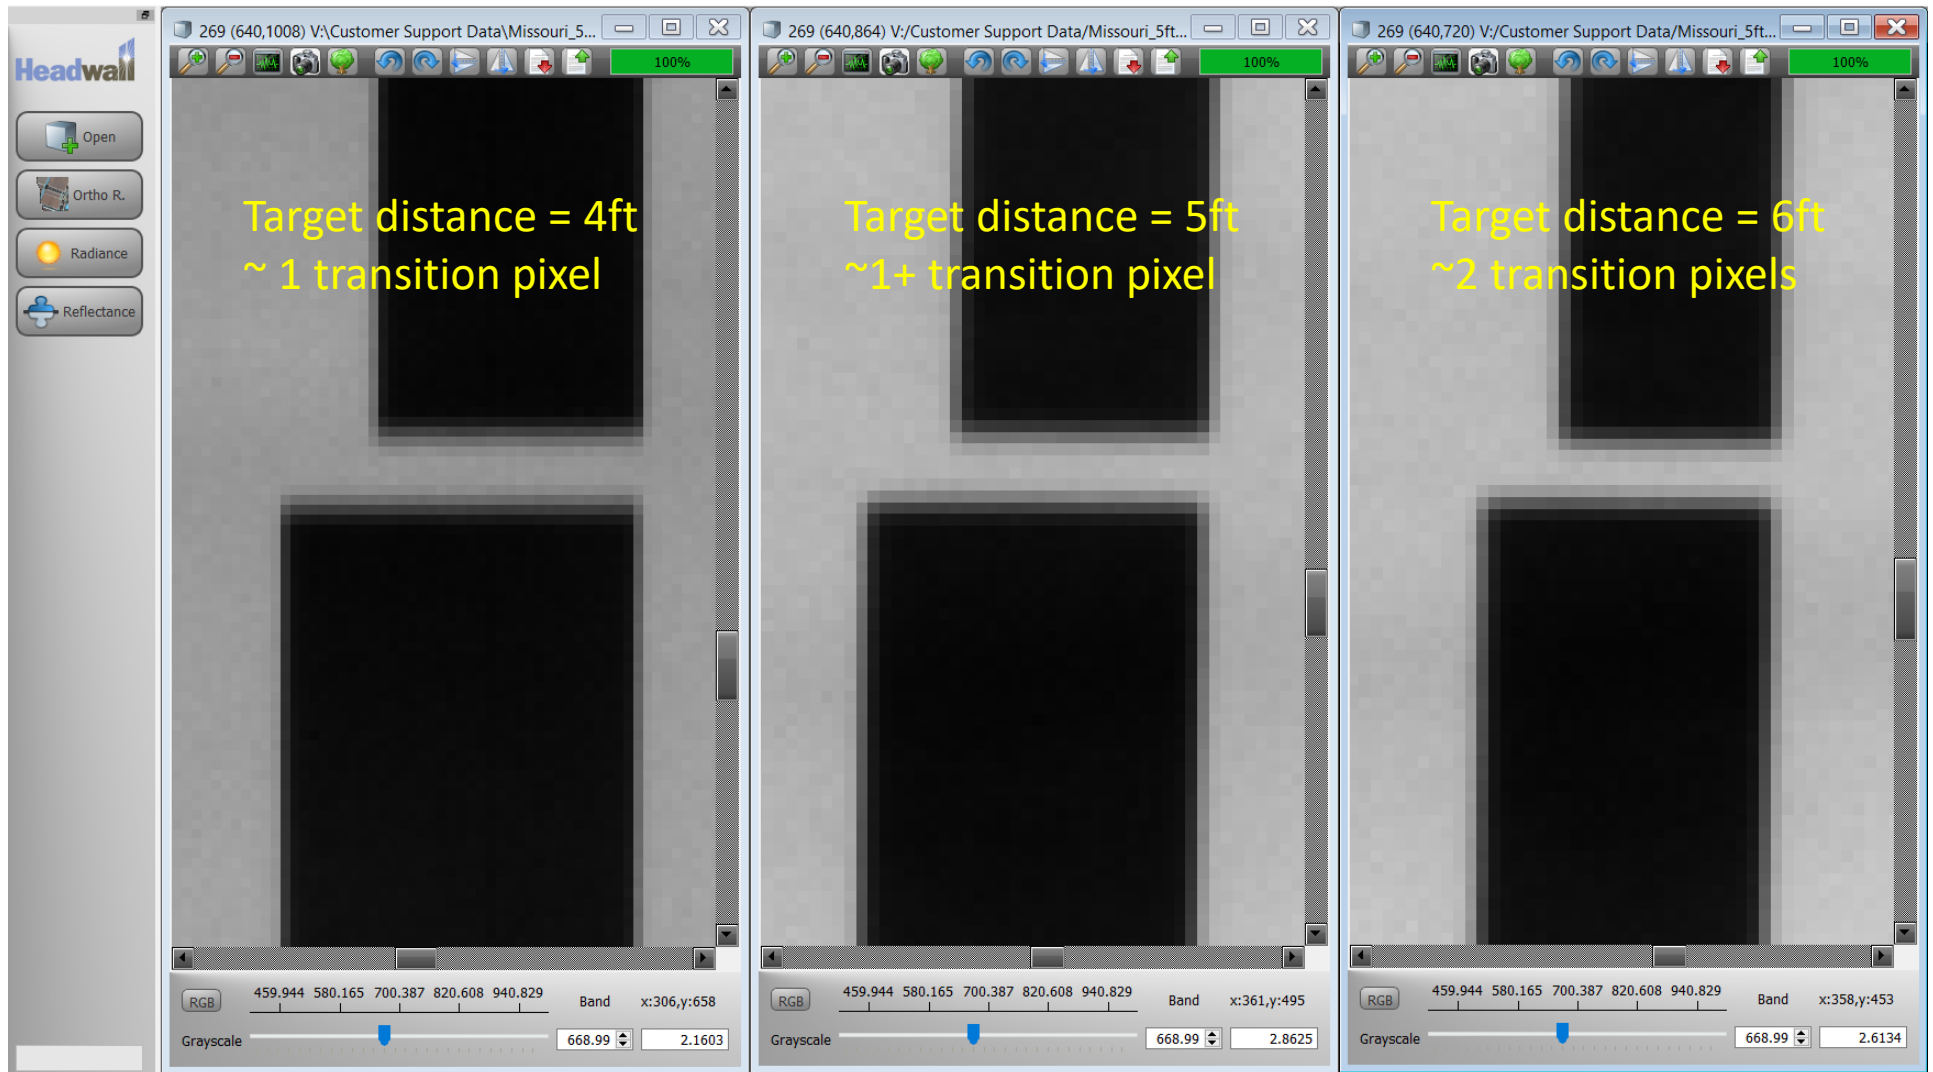
- VNIR Lens Focused at ~4 Ft

- **Focus of imagers set at 4 ft. NOTE: airborne lenses are designed for infinity focus.**
- **Hyperspectral scans of high contrast targets taken at 4 ft, 5 ft and 6 ft**
- **Images zoomed in to show the quality of focus at vertical edges**
- **Metric: best focus = 1 transition pixel from white to dark**
- **VNIR images show “good” focus for 4 ft, 5 ft and a little worse for 6 ft**
- **SWIR images show a quicker loss of focus than VNIR. For sharp SWIR imagery, it is recommend to remain within 6” of optimal focus distance.**

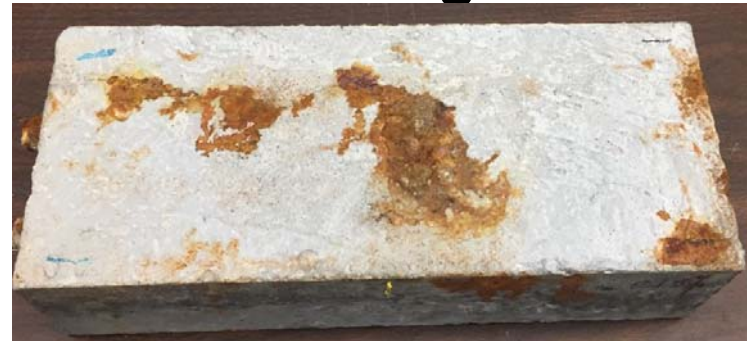
- **Corrosion Test Setup**

- The bottom  $\frac{1}{4}$  height of each 36 cm × 18 cm × 9 cm specimen was immersed in salt solution.
- Accelerated corrosion test was carried out by applying a constant current to steel bars with a current density of 500  $\mu\text{A}/\text{cm}^2$  until the mass loss of the steel bars reached 2%.
- Steel bars with impressed current were corroded, resulting in concrete cracking and appearance of corrosion dust due to increasing volume of corrosion products.

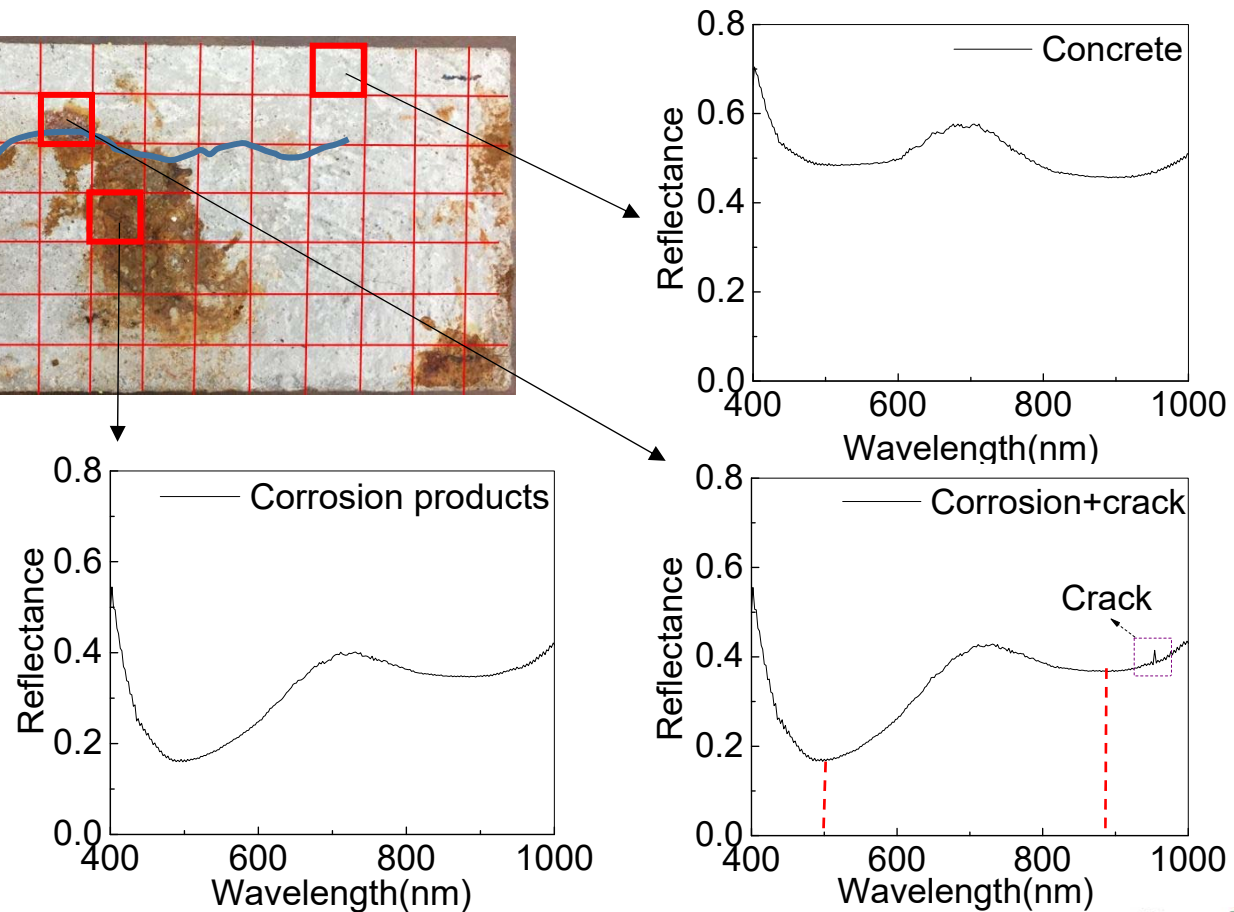
- Reflectance Spectra of Representative Pixels on the Top Surface of Specimen

Corrosion-induced longitudinal crack

Reflectance Wavelength	Concrete	Corrosion Products
510 nm	0.48	0.16
890 nm	0.46	0.35

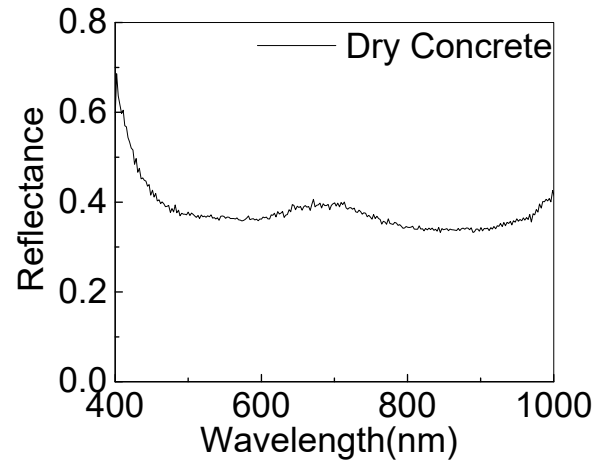
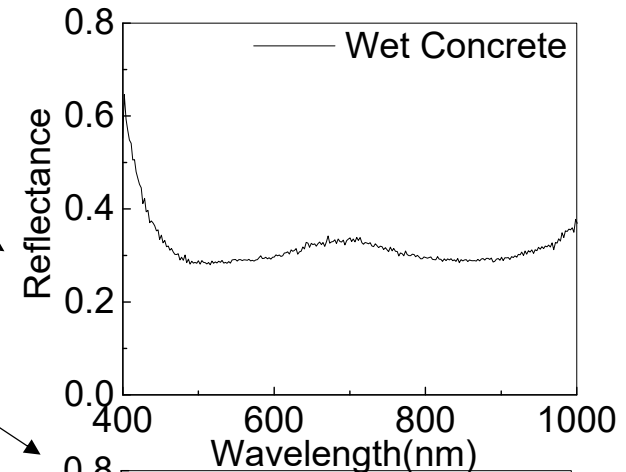
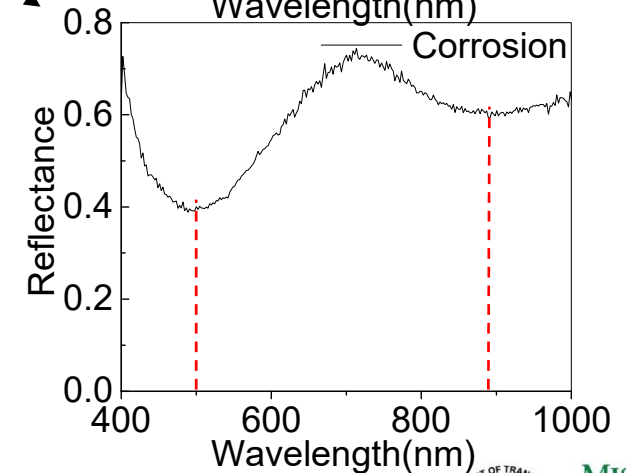
- Reflectance Spectra of Representative Pixels on the Side Surface of Specimen

Corrosion-induced longitudinal crack

Reflectance Wavelength	Dry Concrete	Wet Concrete	Corrosion Products
510 nm	0.37	0.28	0.39
890 nm	0.33	0.29	0.59

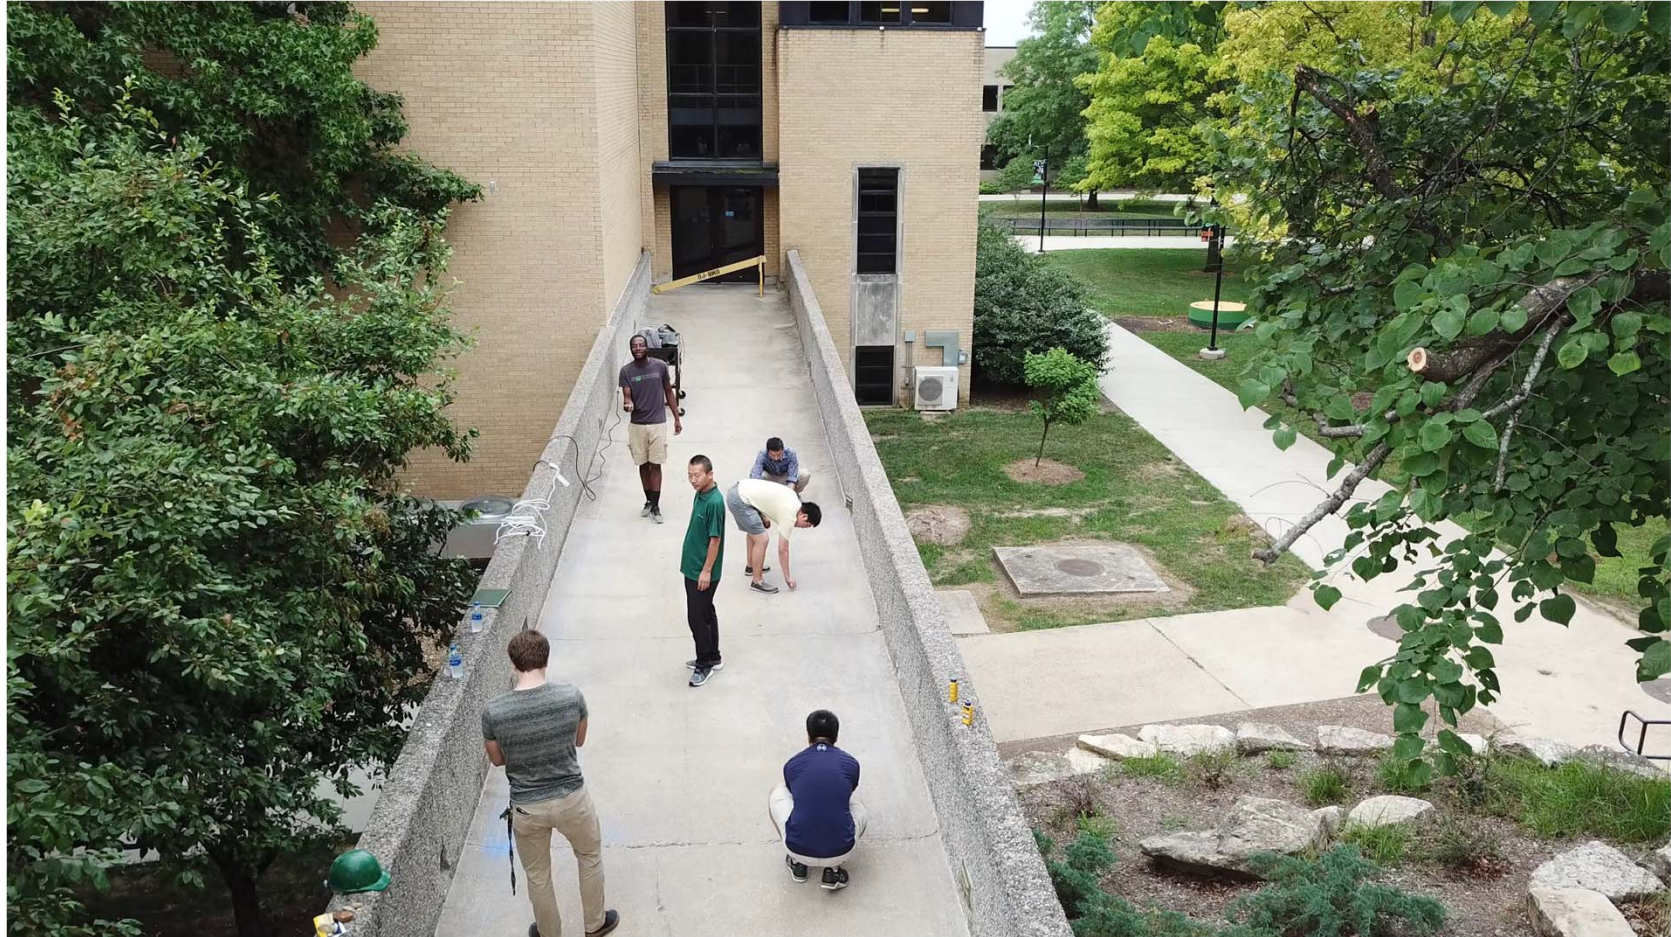
- Bridge Deck Markup for Nondestructive Tests
