3-B/2014

HENRYK NOWAK\*, ŁUKASZ NOWAK\*

## THE USE OF ACTIVE THERMOGRAPHY TO DETECT MATERIAL INCLUSIONS IN THE WALLS

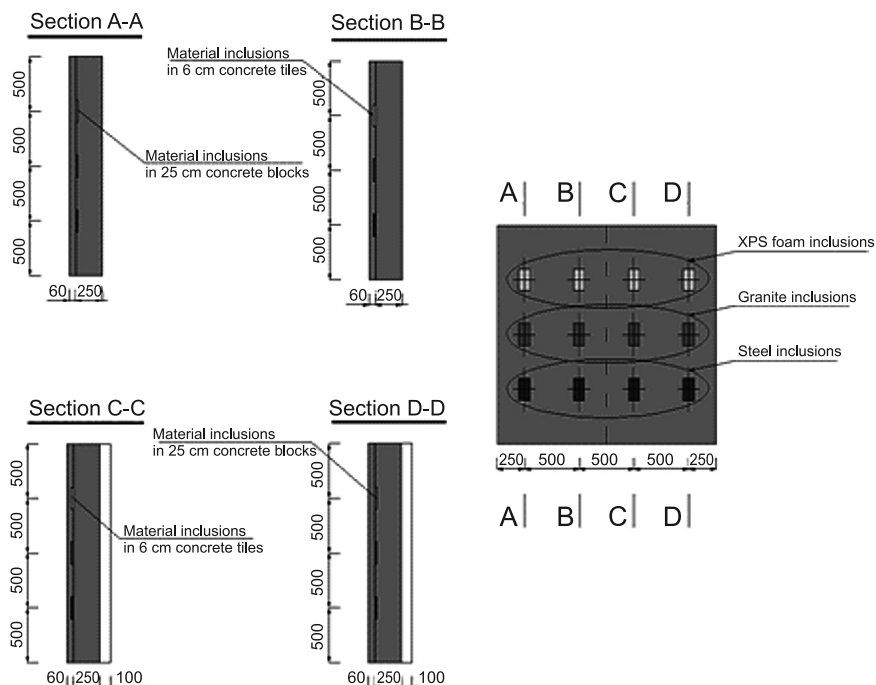
These were placed at two different depths in the concrete block wall. Inclusions were located, at two depths, 6 cm – in the existing wall layer, 4 cm – in the glued after thinner plate layer of the same material. Schematic layouts of material inclusions are shown on Fig. 2 and 3. During the measurements, the following were recorded:

Fig. 3. Placement of XPS foam, granite and steel inclusions in wall made of concrete blocks

Material inclusions in the wall were made by placing materials with significantly different thermal conductivity coefficient  $\lambda$ . Materials used:

- extruded polystyrene (XPS foam) ,  $\lambda = 0.033$  [W/(m K)],
- granite,  $\lambda = 3.500$  [W/(m K)],
- steel,  $\lambda = 50.000$  [W/(m K)].

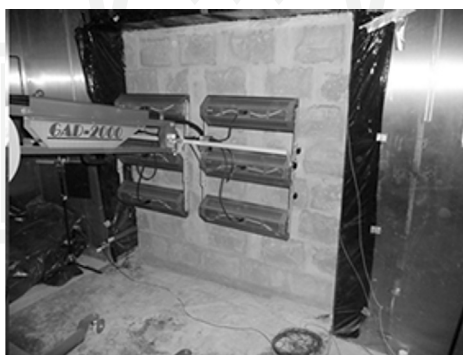
The research of the wall with inclusions started with heating their surface from the inclusions side (warm side) with infrared radiators with the summary power of 7.2 kW, shown on Fig. 4. The time of wall heating was 40 min and the uniformity of the heating surface of the wall of  $2.0 \times 2.0$  m was carried out by placing an arm stand with infrared radiators in three positions in 5 min cycles.

Fig. 4. Heating surface of the test wall by infrared radiators with power 7,2 kW
