THE PERFORMANCE OF LOW COST CUTTING TOOLS WHEN MACHINING HARDENED STEEL OF 60 HRC

ABSTRACT: Hard turning is a topic of great interest in today's industrial production and scientific research. The hard turning technology has the potential for improving productivity against grinding in the manufacturing process. Today, tool manufacturers are constantly developing new combinations of coatings and substrates to precisely match different workpiece materials and operations. Nevertheless, the suitability of coated mixed ceramic (Al₂O₃ + TiCN) cutting tools when hard turning AISI D2 cold work tool steel (60 HRC) is yet to be investigated. An understanding of the tool life and wear mechanisms, surface integrity produced by coated mixed ceramic cutting tools will give an alternative to the manufacturing industries to exploit low costs cutting tools in hard turning of AISI D2 (60 HRC). The noticeable trend of the tool life was observed at test conditions where the cutting speed is at 100 m/min instead of 140 m/min or 200 m/min. The wear mechanism of coated mixed ceramic cutting tools with TiN is subjected to abrasion, adhesion, chipping and notching, especially when machining at high cutting

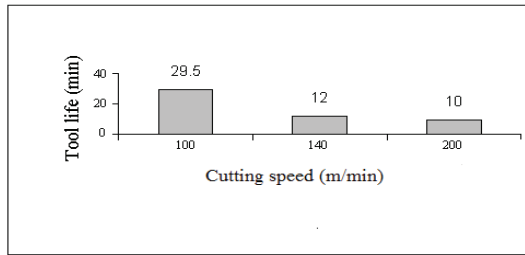
At a cutting speed of 140 m/min, Mixed ceramic coated with TiN still gives the longest tool life of 12 min. At the highest cutting speed 200 m/min, tool life is 10 min. The noticeable trend of the tool life data is shown in Fig. 1. The tool life improves dramatically at test conditions where the cutting speed is at 100 m/min instead of 140 m/min or 200 m/min. It can be clearly seen that the tool life decreases with increasing in cutting speeds. When the cutting speed is increased from 100 to 200 m/min, there is a significant change in the tool life.

Figure 1. Tool life of mixed ceramic ($\text{Al}_2\text{O}_3 + \text{TiCN}$) coating with TiN

This can be explained by the increased in cutting speed, which has resulted in an increase in temperatures at the cutting zone. The effect of cutting speed on the tool life was previously observed by Galoppi, *et al.* (2006) in their study on hard turning of tempered DIN 100Cr6 steel with coated and uncoated CBN inserts. Their results showed that the cutting speed influences the tool life more significantly than the feed rate, and a significant reduction in the tool life is observed at high cutting speeds. Perhaps the temperature effect is the main factor affecting tool life. Wang and Rajurkar (1997) found that the temperature rise during cutting could significantly reduce the strength of the tool and hence the wear resistance of the tool. Temperature has a more harmful effect on the tool because it directly conditions the tool life by a fast evolution of wear (Ay and Yang, 1998). The dependence of the cutting temperature on the cutting speed was rather large, since an average temperature increase of two hundred degrees (from 1100 to 1300 $^{\circ}\text{C}$) has been recorded when changing the cutting speed from 400 to 600 m/min when machining steel with an alumina ceramic tools (Narutaki, *et al.*, 1997). On the other hand, hard coatings such as TiN, TiC and Al_2O_3 have been used and claimed to improve significantly the tool-life, enabling components to be machined at higher “economic” speeds, and able to reduce the forces and power due to the lower frictional coefficients on the rake face (Wang, 1999).

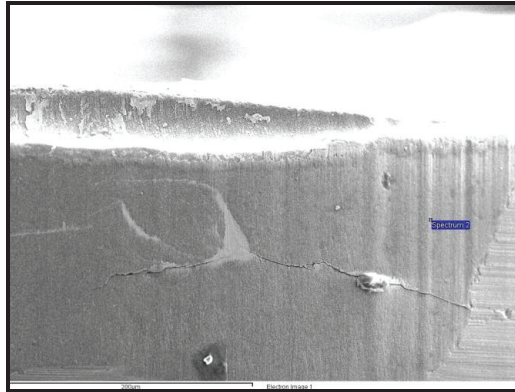
King and Wheildon (1966) are among the earliest reports of the machining of hardened steels up to 61 HRC with geometrically defined alumina cutting tools. As a class of materials, ceramics possess high melting point, excellent hardness and good wear resistance. Unlike most metals, hardness levels in ceramics generally remain high at an elevated temperature (Narutaki, *et al.*, 1997). Major failure forms of ceramic tools are tool wear and tool fracture. Usually, tool wear is the dominant failure form in continuous machining, while a tool fracture is the main failure form in intermittent machining (Casto and Valvo, 1993; Gwidon and Stachowia, 1994). At all cutting speeds tested the early stage of cutting, initial breakdown in cutting edge with the edge rounding is observed with only a flank wear which increases rapidly. Then the flank wear becomes stable and stays constant, while a crater wear appears on the rake face which is typical of abrasive wear. Under lower speed, crack's propagation perpendicular to the chip flow direction was observed (Fig. 2). If the cutting operation continues further on, tool fracture will possibly occur.

Fig. 2 The typical wear pattern of a mixed ceramic cutting tool at the end of tool life when cutting at VC = 100 m/min, $f = 0.06$ mm/rev and depth of cut = 0.4 mm

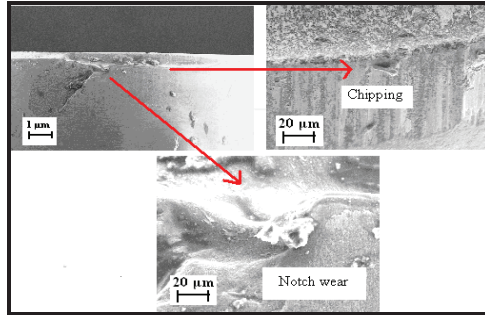
Fig. 3 Wears pattern of ceramic cutting tools at the end of tool life when cutting at VC = 140 m/min, f = 0.06 mm/rev and depth of cut = 0.4 mm

The flank wear of the mixed alumina tool increased with cutting speed and presenting a considerably higher tool wear rate when using a cutting speed of 200 m/min. Flank wear occurs on the tool flank, and it is generally attributed to rub of the tool with the work piece at the interface, causing abrasive wear. It was observed that the flank wear played a larger role at lower speeds and notch wear is significant at higher speeds (Fig.3). According to Kumar, *et al.*, (2006) in their study on the effect of tool wear on tool life of alumina-based ceramic cutting tools while machining hardened martensitic stainless steel (60 HRC), notch wear occurs by the rubbing process of the machined surface with the cutting tool at the boundary where the chip is no longer in contact of the tool. A machined surface may develop a thin work hardened layer which is hard and abrasive. This contact could contribute to notch wear. Notch wear is mostly observed in the ceramic cutting tools, which have low toughness values (Stachowiak, 1994). The mixed ceramic cutting tools wear mechanism is subjected to not only abrasion, adhesion but also to chipping, especially when machining at high cutting speed and the morphology of high magnitude of the chipping is indicated in Fig. 4. Chipping was ever observed in a mixed ceramic tool when machining at a higher speed (VC = 200 m/min). In

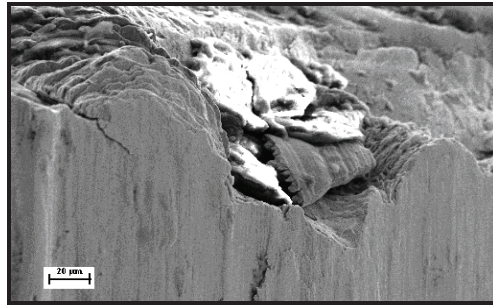
Fig. 4 Chipping of ceramic cutting tools when cutting at VC = 200 m/min, f = 0.06 mm/rev and depth of cut = 0.4 mm

fact, chipping is a kind of early fracture. The most often encountered modes for brittle fracture of ceramic tools can usually be classified into four cases: chipping, flaking, breakage and cracking (Ai and Zq, 1994).
