Categorization and experimental evaluation of anchorage systems for fiber-reinforced polymer laminates bonded to reinforced concrete structures

A THESIS

MASTER OF SCIENCE IN CIVIL ENGINEERING

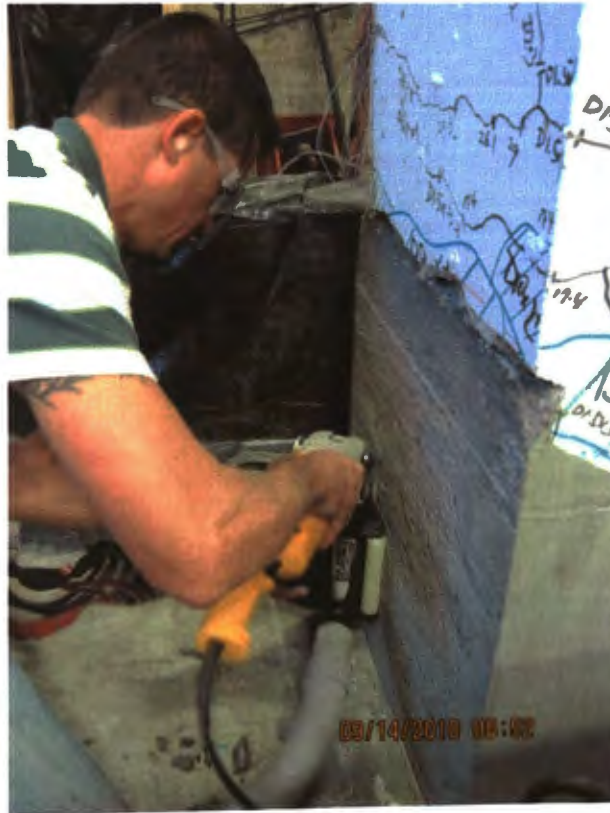
Figure 4.18. Concrete Surface Preparation

recommended by the CFRP system manufacturer and a diamond cup wheel. For Columns #1 and #2, the corners of the columns were rounded to a radius of approximately 1 in. with a diamond cup wheel. For Column #3, quarter sections of 3 in. diameter PVC pipe were placed in the corners of the formwork so that the corner radii were cast in place. Figure 4.18 shows the concrete surface preparation tool being used.

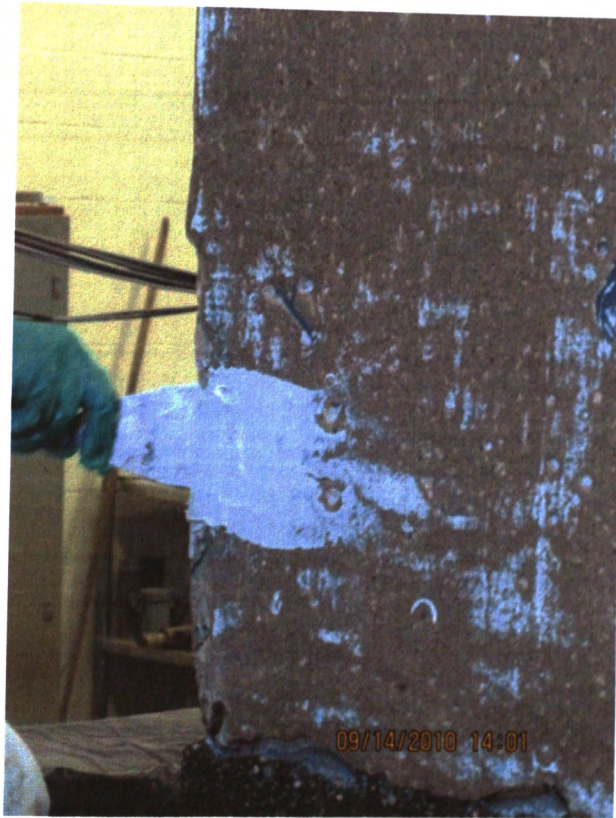
Figure 4.20. Application of MBrace[®] Putty

After the Primer became tacky on the concrete surfaces, MBrace[®] Putty was mixed per manufacturer's recommendation and applied to the surface using drywall taping knives. The Putty was applied lightly to all surface to fill the small voids. In some cases where a larger discontinuity in the flat concrete surface was present, the Putty was applied more liberally to flatten the surface. Application of MBrace[®] Putty is shown in Figure 4.20.

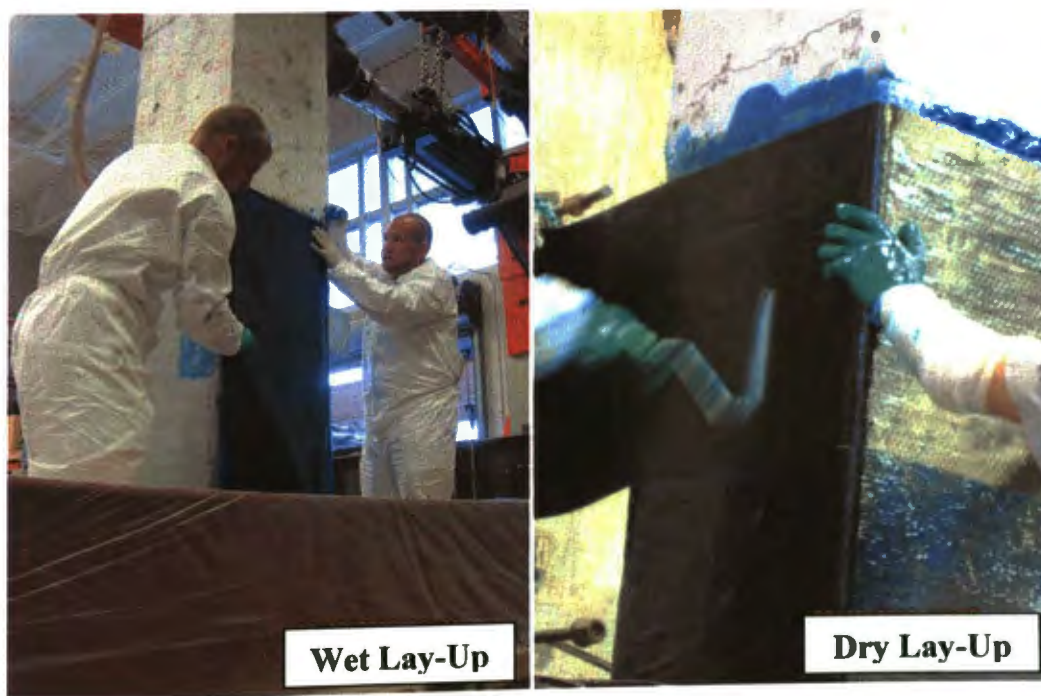
Figure 4.21. Installation of CF 130 Carbon Fiber Sheets

the CF 130 Composite Strengthening System showed that “wet lay-up” was more effective in impregnating the fibers and creating a sound bond between the CFRP system and concrete surface. Transverse (horizontally oriented) CFRP sheets were installed using a “dry lay-up” process, which involved impregnating the fibers as they were laid on the concrete surface. “Dry lay-up” was used with the transverse CFRP sheets because initial attempts to wrap the column with “wet” sheets resulted in damage to some of the fibers. In both the “wet” and “dry” processes, Saturant was applied on top of and beneath the CFRP sheets using a 3/8 in. nap roller. The fibers were then impregnated using a grooved aluminum FRP roller.

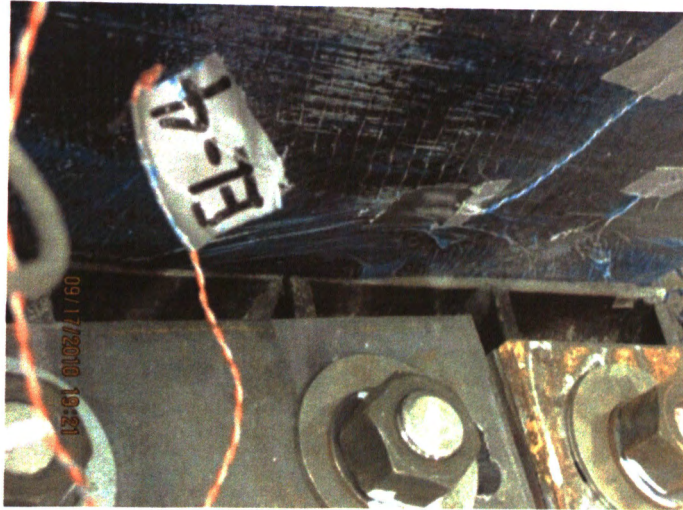
Figure 5.2. Contact Between CFRP and Novel Anchorage in Column #1 Test

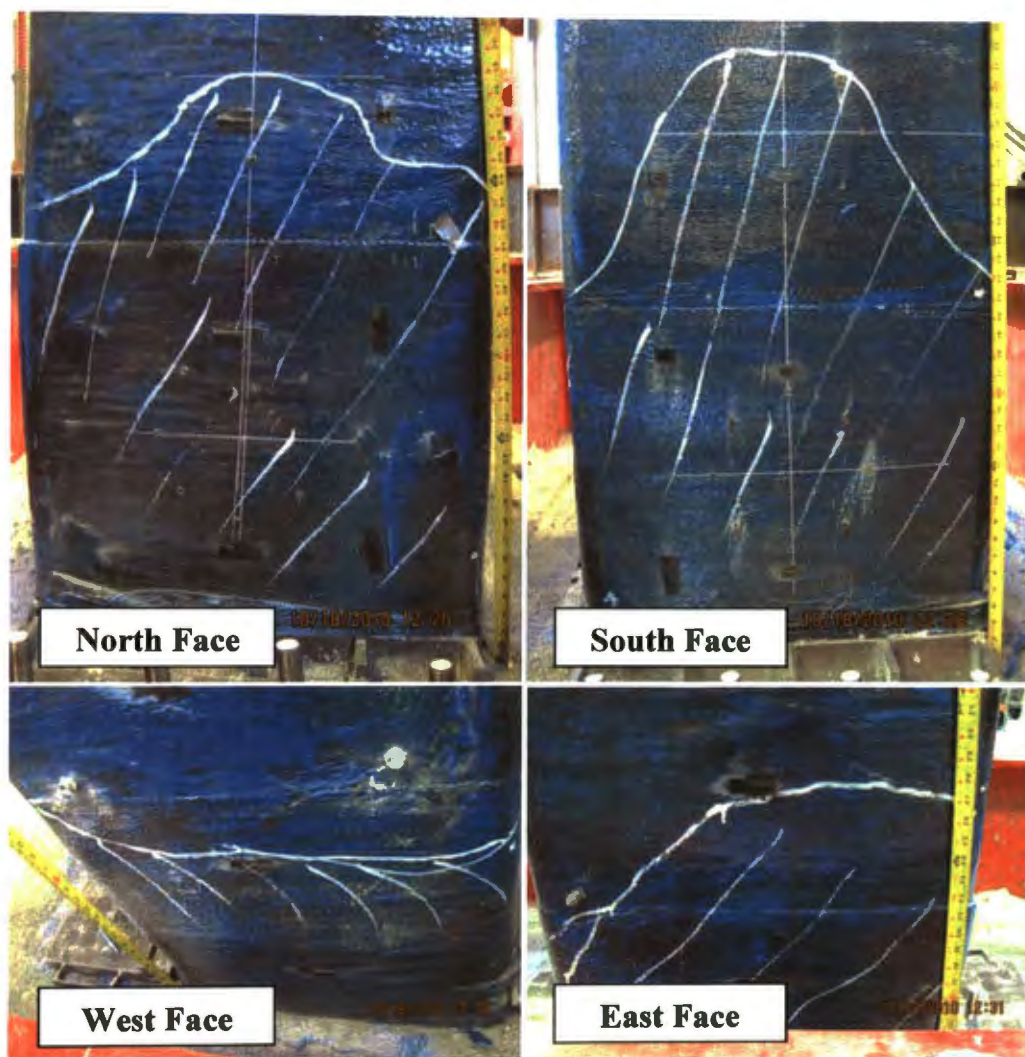
Figure 5.7. Debonded Areas of CFRP on Column #2 After Testing

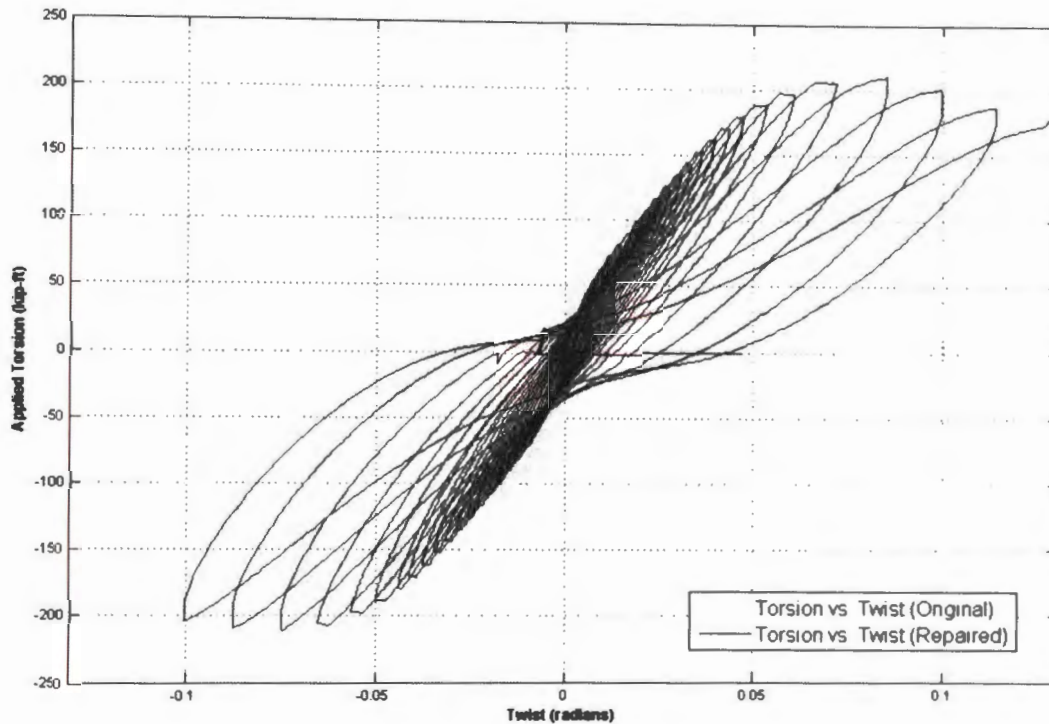
Figure 5.15. Torsion Versus Twist for Column #3

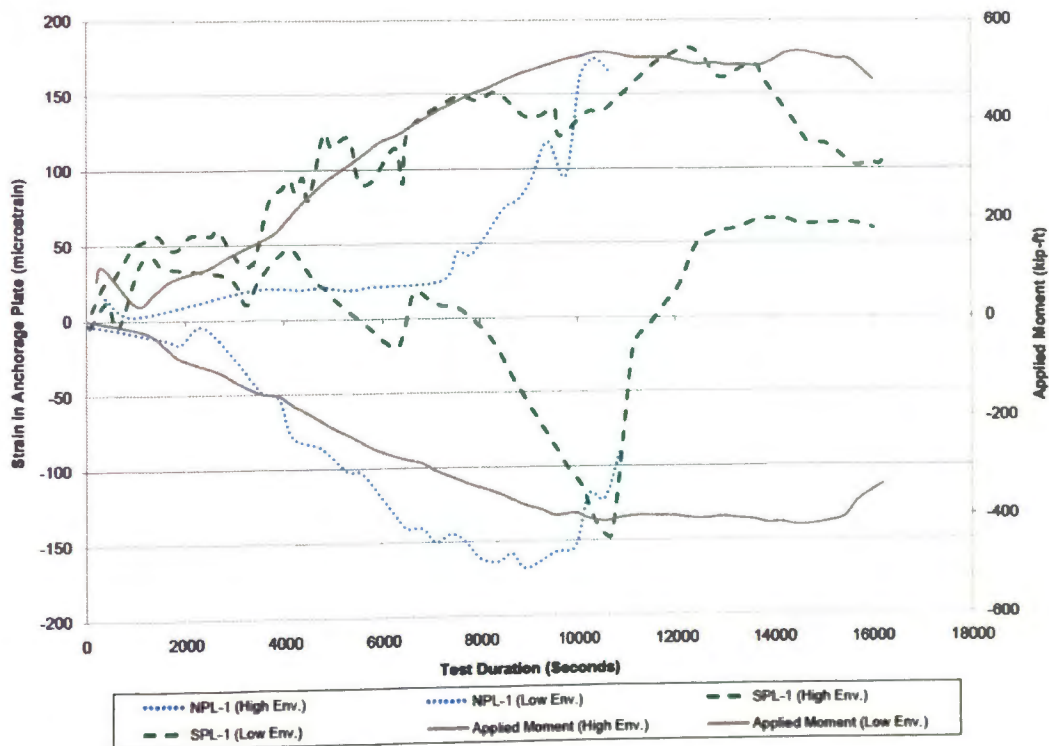
Figure 5.20. Strains Measured in Anchorage Plate for Column #1

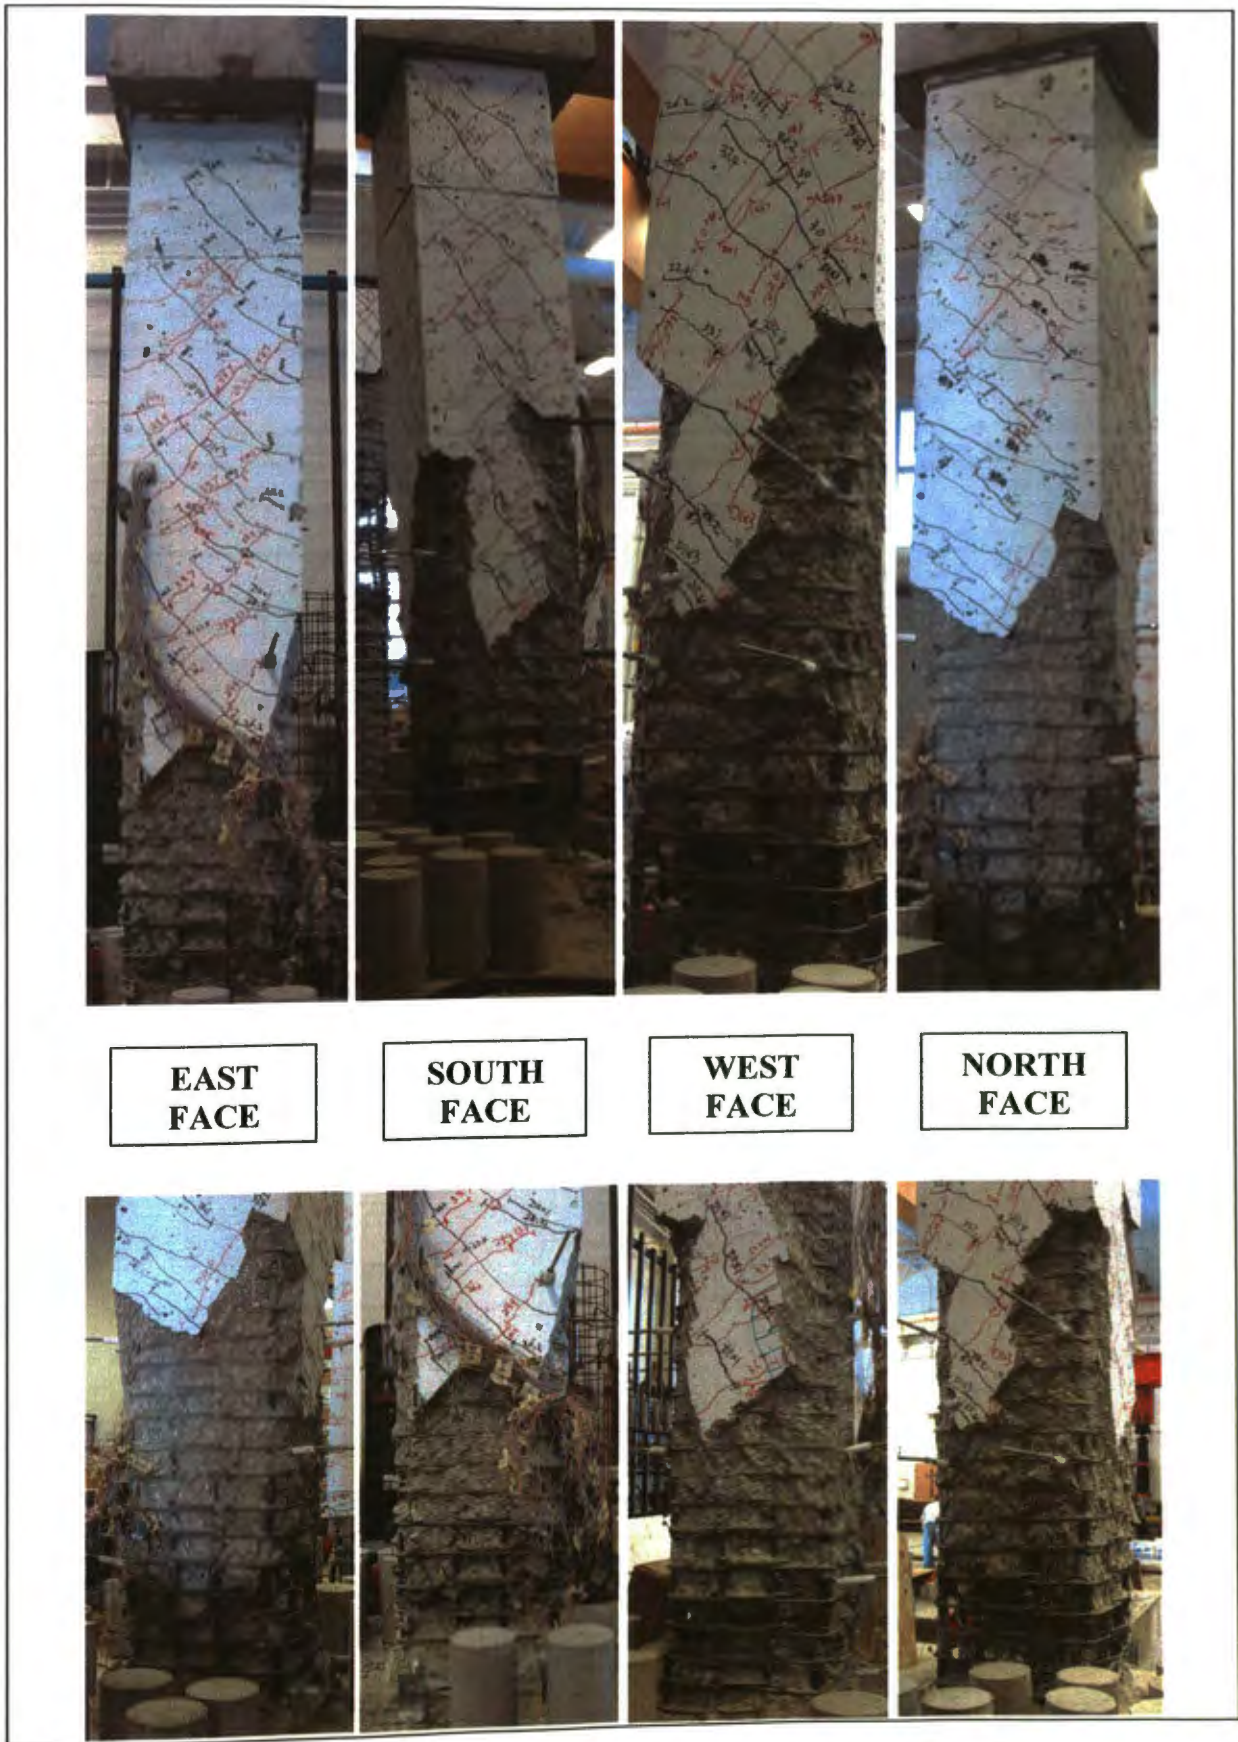
Figure A-3. Damage Photos of Column #3 Prior to Repair
