In-situ assessment of concrete bridge decks and pavements using stress-wave based methods

IN-SITU ASSESSMENT OF CONCRETE BRIDGE DECKS AND PAVEMENTS
USING STRESS-WAVE BASED METHODS

A DISSERTATION

GEOLOGICAL ENGINEERING

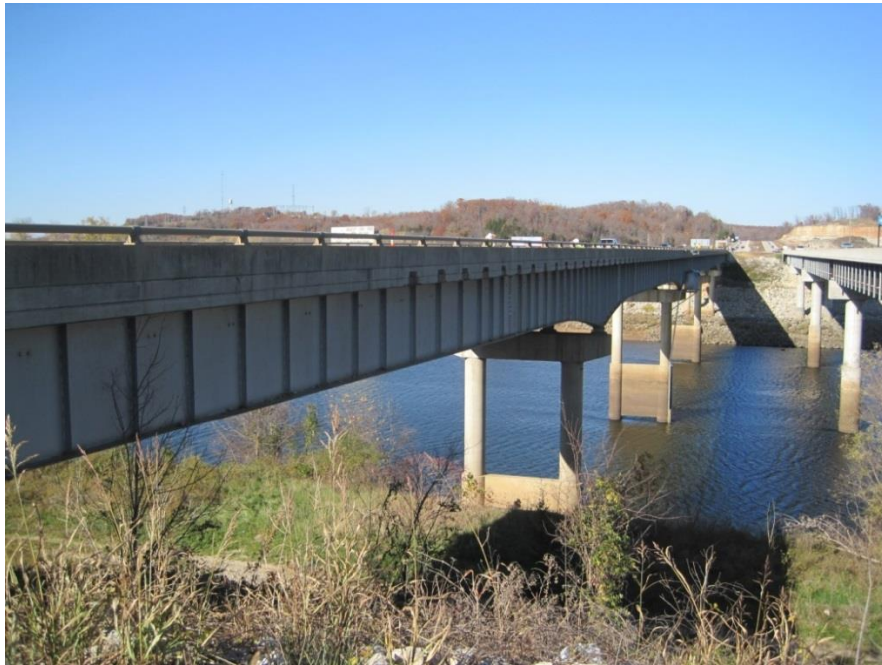
Fig. 1. Photo of the bridge.

In this investigation, USW data were acquired using a portable seismic property analyzer (PSPA) at multiple predetermined locations across a concrete bridge deck prior to milling and hydrodemolition (Fig. 1). The PSPA-USW data acquired at each test

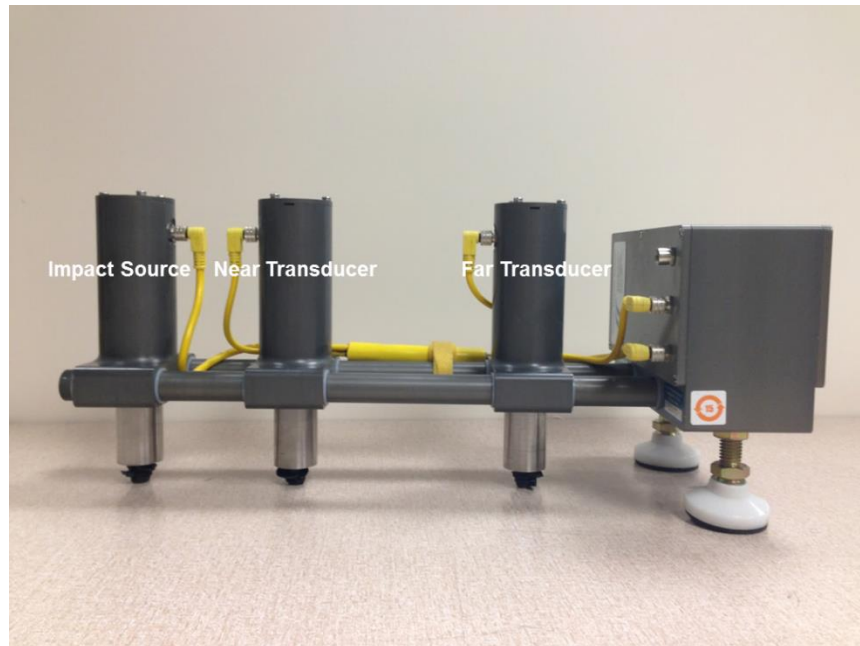
Fig. 2. Portable seismic property analyzer (PSPA).

measured, presumably because the receiver transducers are vertically polarized. In fact, it is very challenging to identify first arrival time of P-waves in waveform records due to the strong background noise generated from various sources in the field (e.g., traffic).

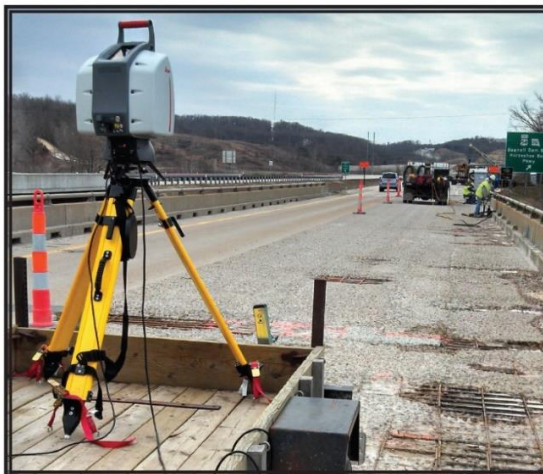
Fig. 5. LiDAR scanner set up to scan the bridge deck after hydrodemolition was used to remove unsound concrete.

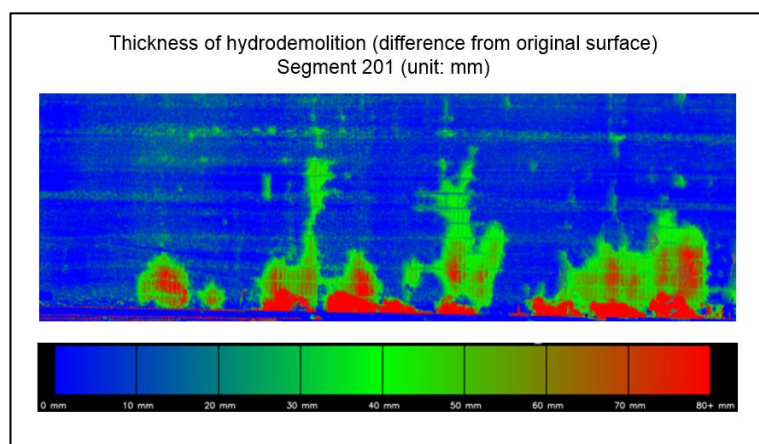
Fig. 6. LiDAR image of the bridge deck showing thickness difference between pre-rehabilitation and post-hydrodemolition.

area A was located in the far end of one LiDAR segment). Therefore, the error of the LiDAR measurements acquired in the PSPA study areas should be much lower than 0.24 in.

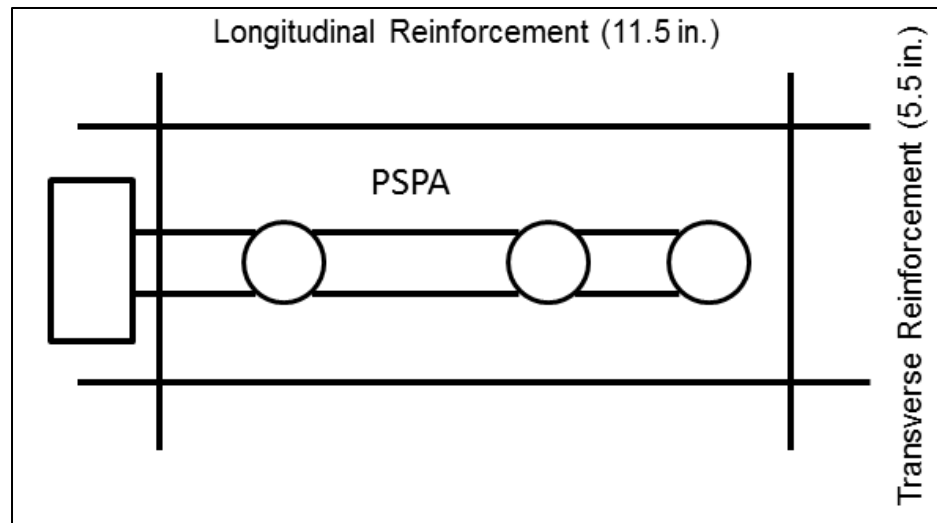
Fig. 9. Sketch of the test location of the instrument (PSPA) on deck surface.

test location as shown in Fig. 9. According to previous research conducted (Aggelis and Shiotani, 2007; Malhotra and Carino, 2004), the propagation of surface waves is insensitive to the presence of reinforcing steel if the diameter of the reinforcement steel is much smaller than the size of the test grid and minimum detectable wavelength. In this study, the diameter of the reinforcement steel bars (0.5 in. and 0.75 in. for the #4 and #6 bars, respectively) is much smaller than the size of the test grid (2x2 ft), as well as the minimum detectable wavelength of the PSPA-USW instrument (2 in.). Therefore, considering the remarks above and the placement of the PSPA instrument, the influence of the reinforcing steel on the PSPA-USW test results should be negligible.

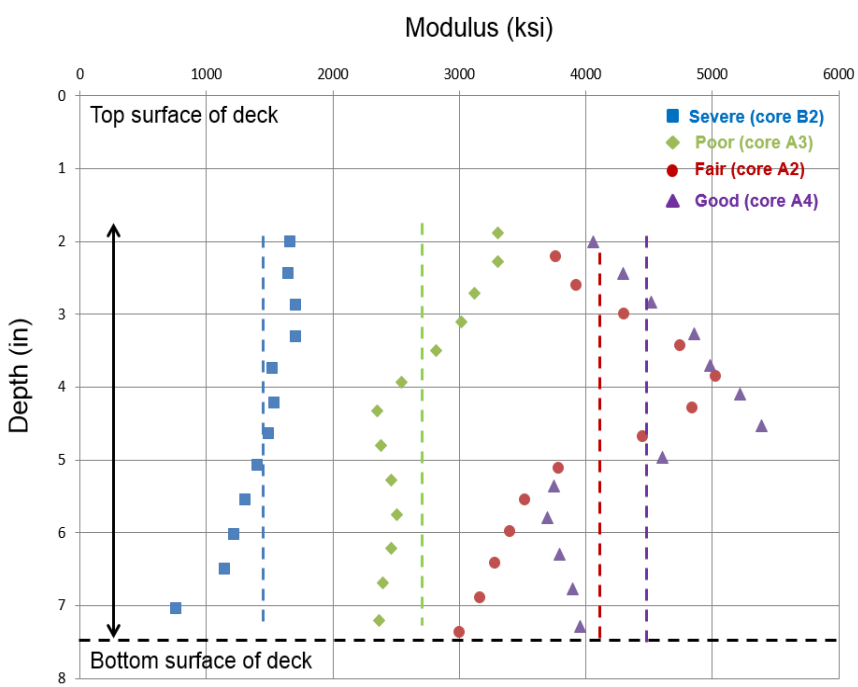
Fig. 11. Elastic modulus plots acquired in immediate proximity of core samples. Investigation depth is limited from ~2 in. to ~7.5 in. with 4 in. spacing between two transducers. The average elastic modulus for core samples with different core conditions: core B2 (Severe) = 1486 ksi; core A3 (Poor) = 2720 ksi; core A2 (Fair) = 4095 ksi; core A4 (Good) = 4470 ksi.

Core A2 (shown in Fig. 10) was retrieved from the concrete deck in an area with no visible evidence of deterioration (cracks at depth of 1 in.). The elastic modulus values obtained in immediate proximity to core A2 increase with depth from 2 in. to 4 in. then reduce from 4 in. to 7.5 in. The average value of elastic modulus is 4095 ksi, which is approaching the value associated with fair quality concrete (Table 1).

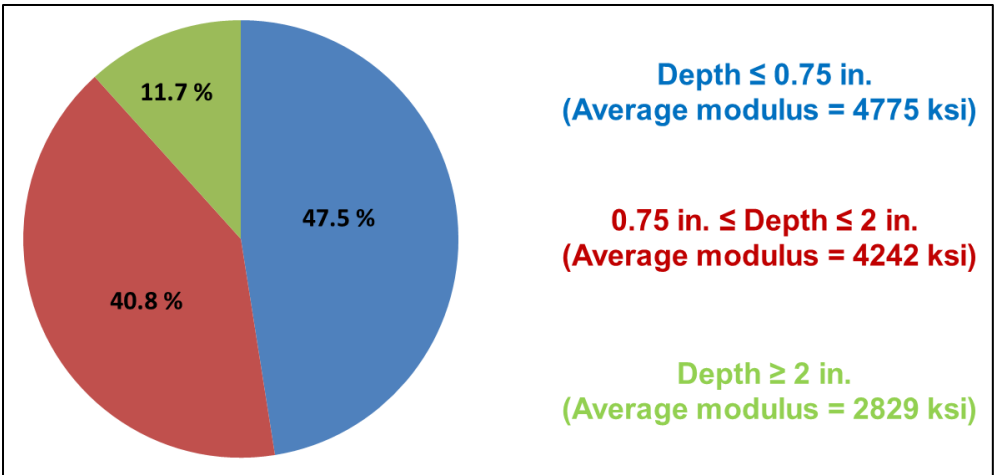
Fig. 15. Distribution of the removed concrete thickness for the entire study area.

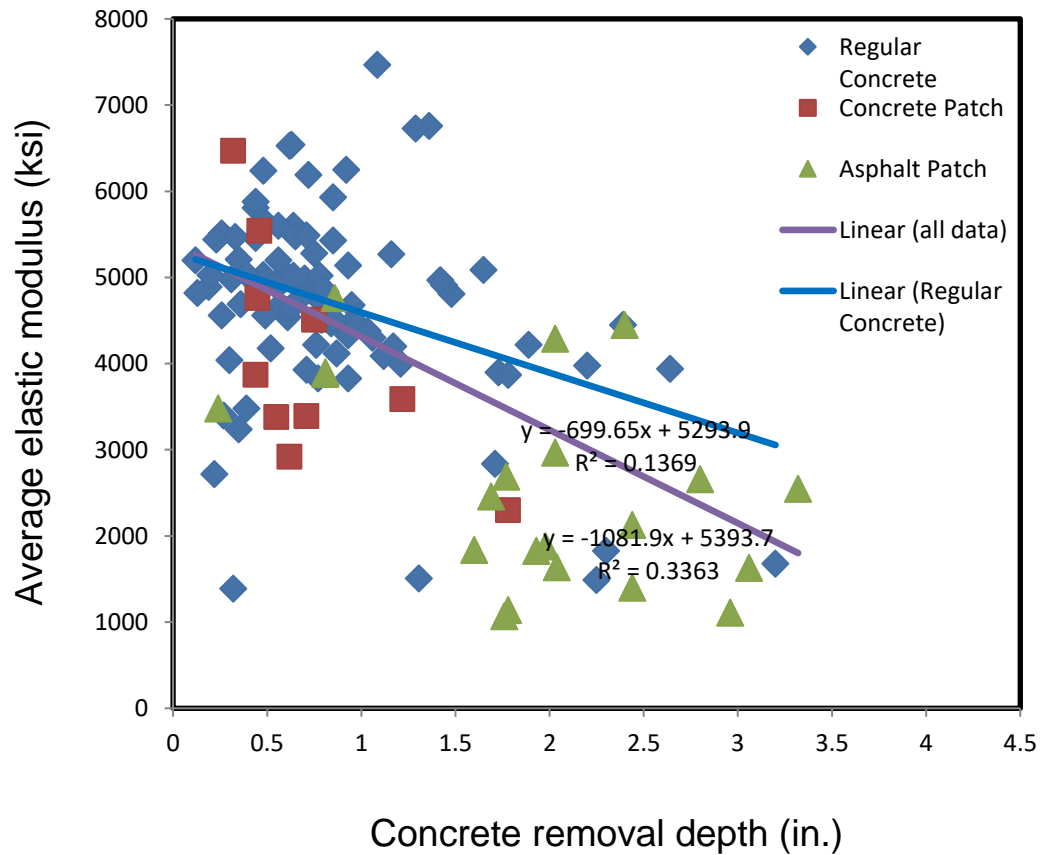
Fig. 16. Relationships between the average elastic modulus and the concrete removal depth values considering all PSPA data points and data points for regular concrete only.

The relationship between the concrete removal depth and the average elastic modulus values for all PSPA test points (120) is shown in Fig. 16. In general, Fig. 16 shows that locations where greater thicknesses of concrete were removed are associated with lower values of average elastic modulus values. However, a significant amount of scatter in the data is also observed in Fig. 16.

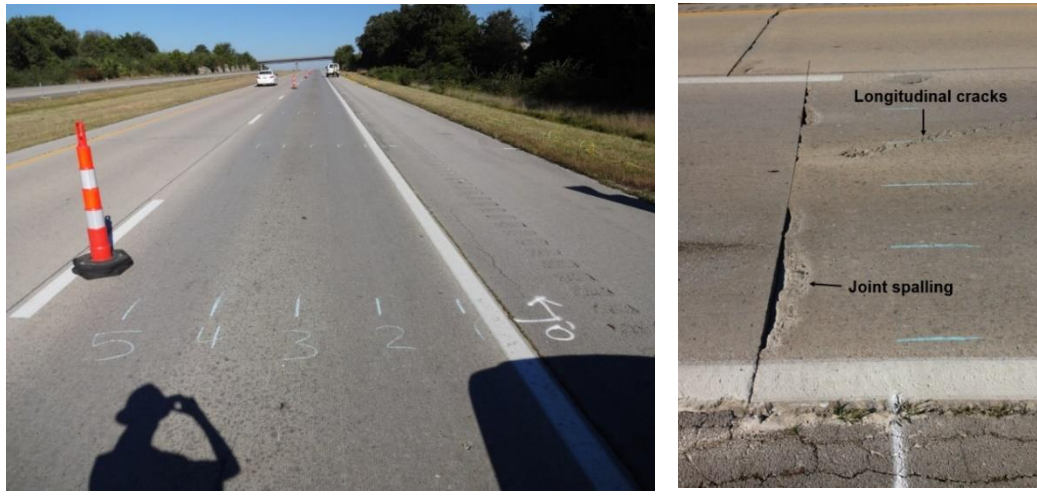
Fig. 1. Photo of the experimental segment.

The experimental segment is located in the north bound lane of interstate highway I-55 in Missouri (Fig. 1). The segment is composed of a 9 in. thick jointed reinforced concrete pavement (JRCP) overlaid on a granular base material. The rebar mesh was placed in concrete layer at depth of 4 in. and the spacing between each transverse joint is 61.5 ft. Visible evidence of deterioration including longitudinal and transverse cracks, transverse joint spalling, patches and faulting was identified in the experimental segment, which is an indication the existences of potential defects in the concrete and granular base layers.

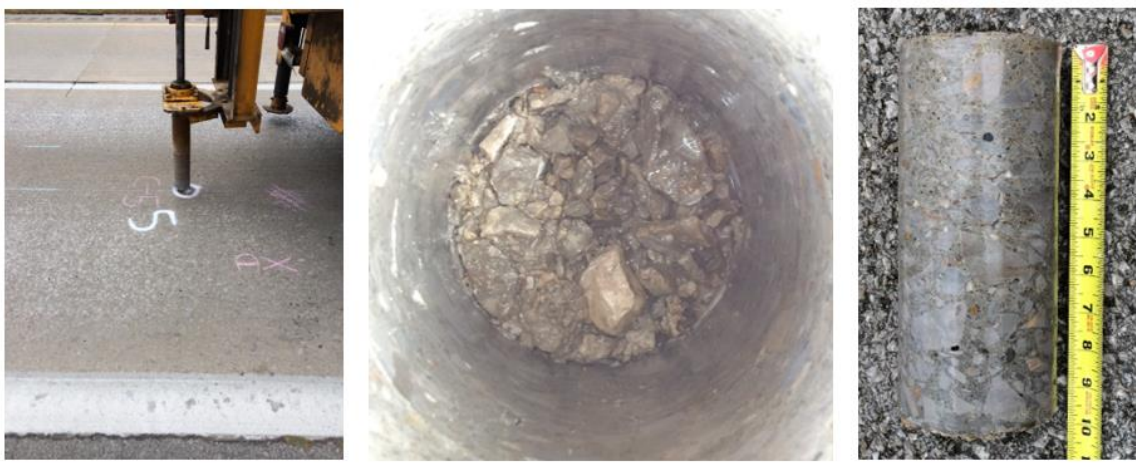
Fig. 5. Photos of core #5 retrieved from the experimental segment.

Core specimen #5 was retrieved at the same location as station No. 59, and photos of core #5 are illustrated in Fig. 5. In general, no visible evidence of a defect was identified in the concrete, however, small separations (air voids) between concrete and granular base layers were identified and measured (0.5 in. thick) in the field from the bottom of the borehole, which correlates well with the USW test results acquired at the same location.

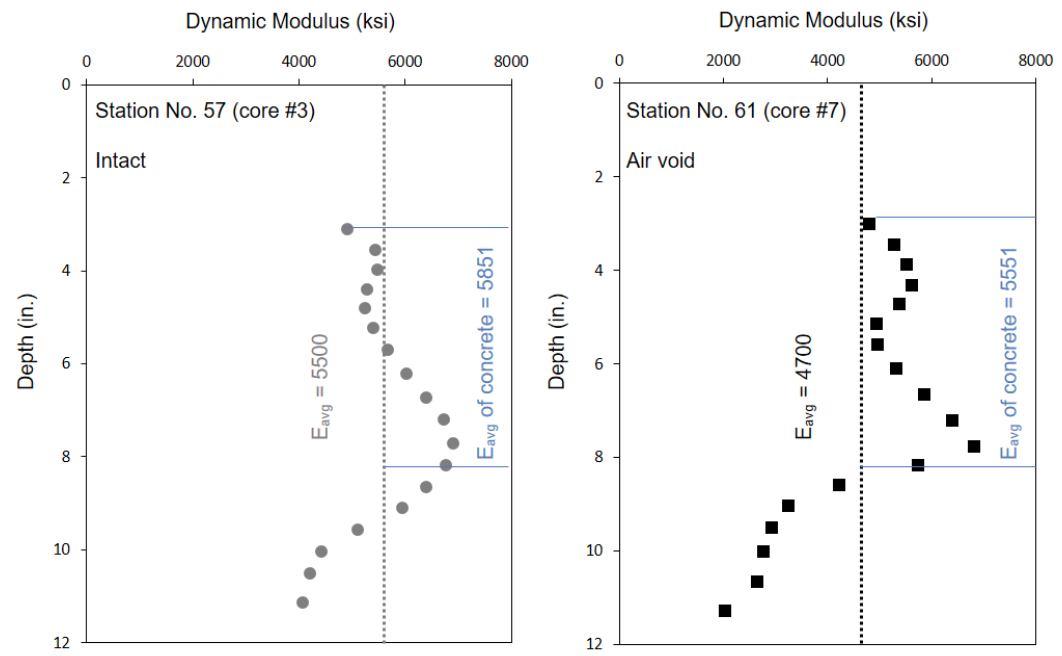
Fig. 6. Comparison of typical modulus curves acquired at intact and deteriorated pavement locations.

calculated based on full wavelength range since the influence of the under layer material (granular) and the deterioration (air voids) identified between their interface are excluded.

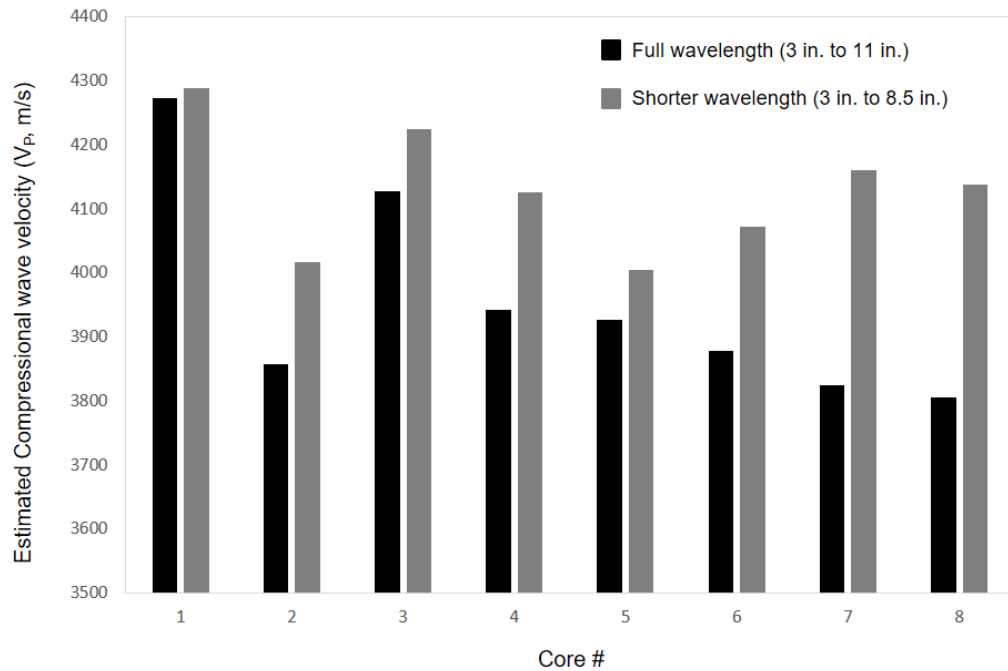
Fig. 11. The estimated P-wave velocity at each core location.

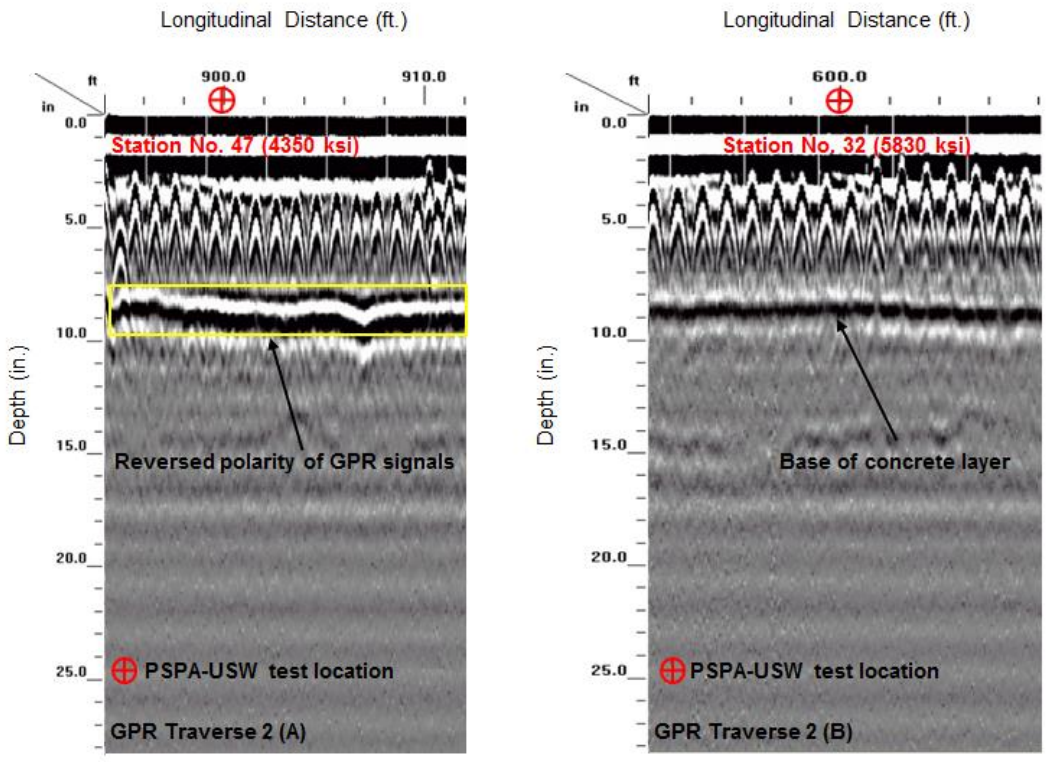
Fig. 12. Typical GPR data acquired at experimental site: A) deteriorated B) intact.

PSPA-USW tests at station No. 47 is significant lower than that at station No. 32, which could be the cause of the air voids identified in GPR profile.

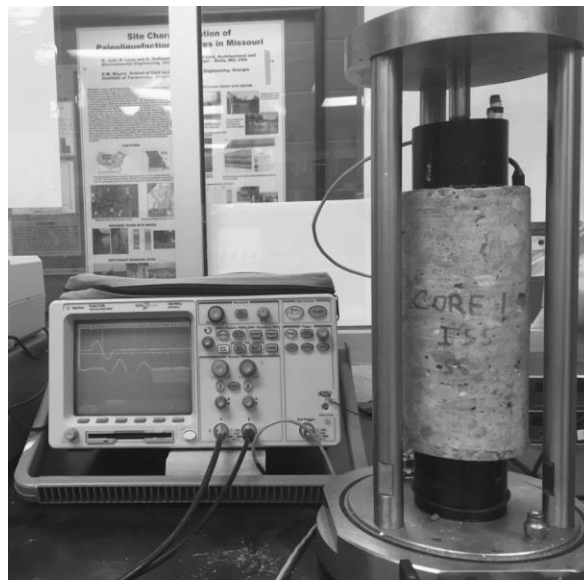
Figure 2. Ultrasonic velocity testing system.

The Ultrasonic Velocity Test System (Fig. 2) was employed in this study to perform the ultrasonic velocity measurements on concrete overlay core specimens.

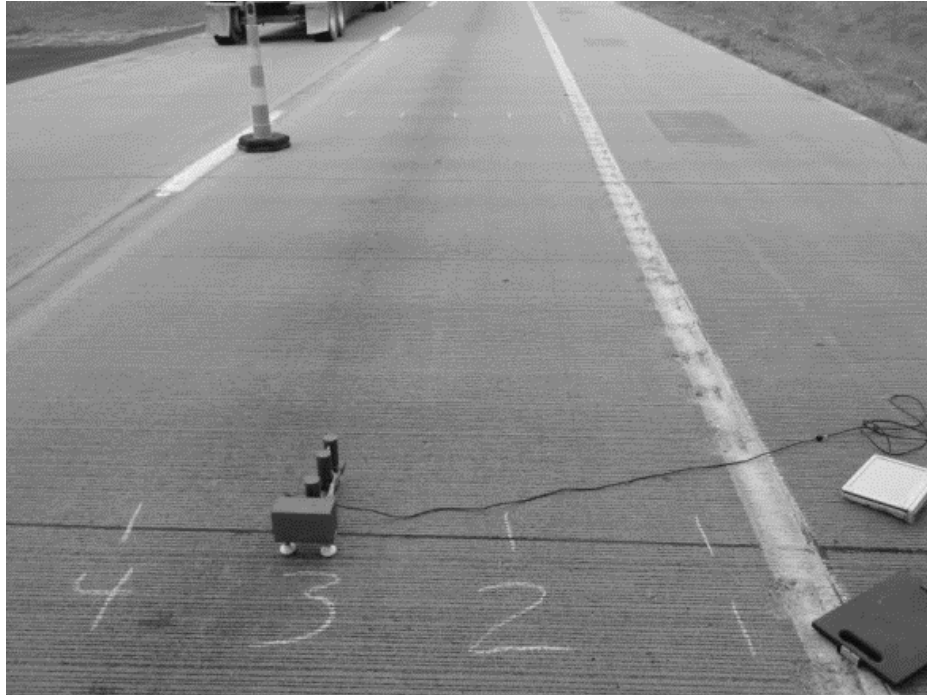
Figure 4. Photo of experimental site.

The test site was a 305 m segment of a two-lane roadway located in southeast Missouri shown in Fig. 4. The tested pavement consists of a ~220 mm of portland cement concrete (PCC; herein referred to as concrete) overlay above a ~220 mm thick unbonded basal concrete layer. A ~60 mm thick layer of hot mix asphalt (HMA; herein referred to as asphalt) is embedded between the two concrete layers. The concrete overlay displayed no visible evidence of surface cracks. However, possible degradation was suspected in the intervening asphalt layer based on results of previous investigations.

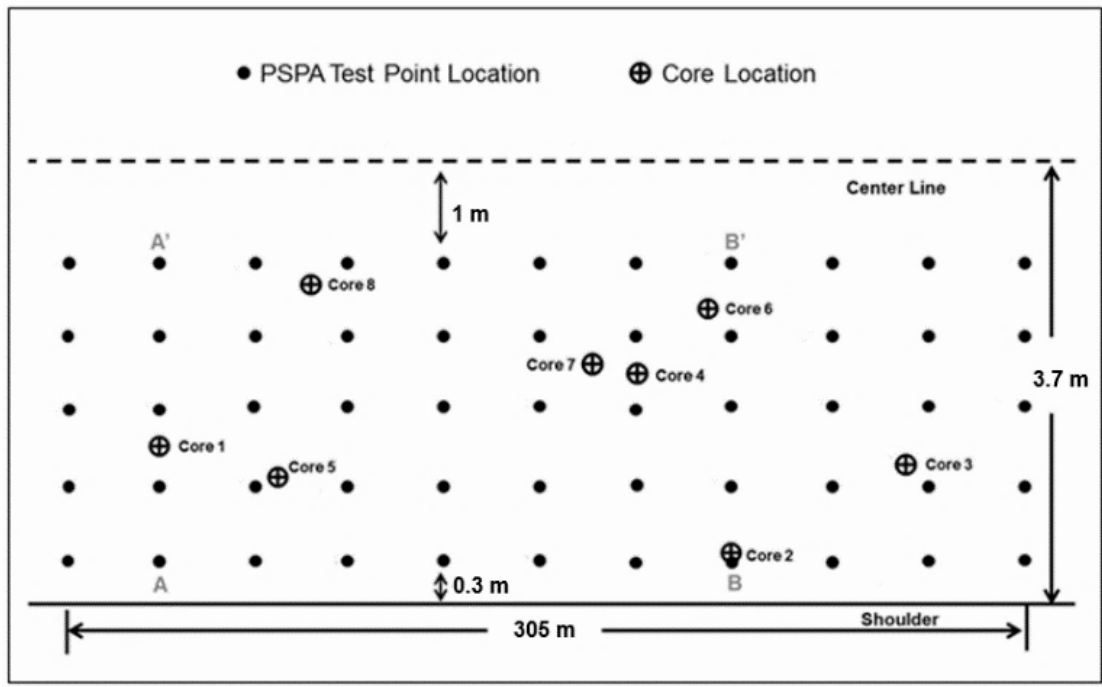
Figure 5. Schematic of PSPA test point locations at experimental site.

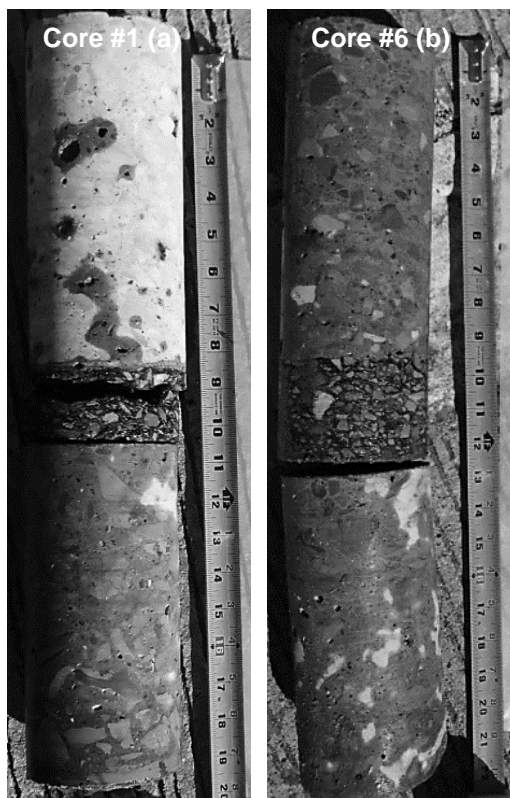
Figure 6. Photos of typical deteriorated (a) and intact (b) core specimens retrieved from experimental site.

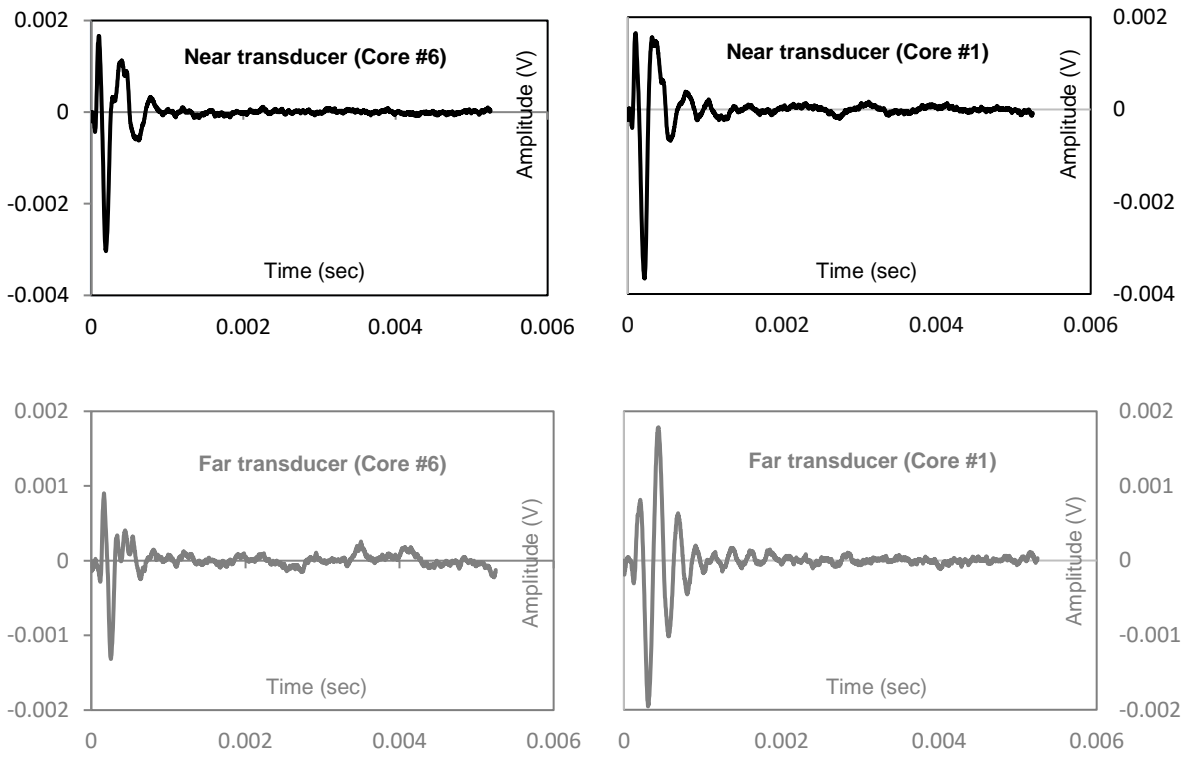
Figure 7. Typical full waveform records of intact (Core #6) and stripped (Core #1) core specimens.

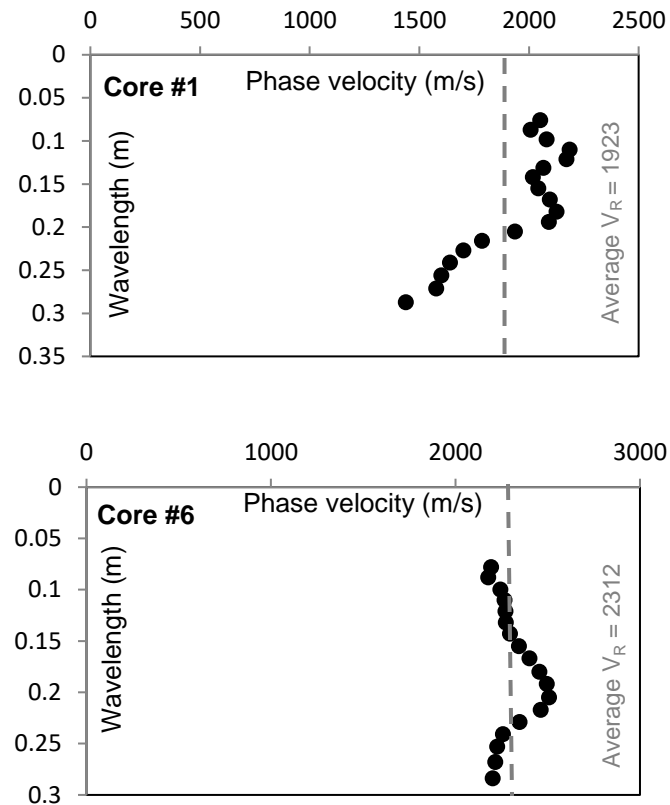
Figure 8. Typical dispersion curves of intact (Core #6) and stripped (Core #1) core specimens.

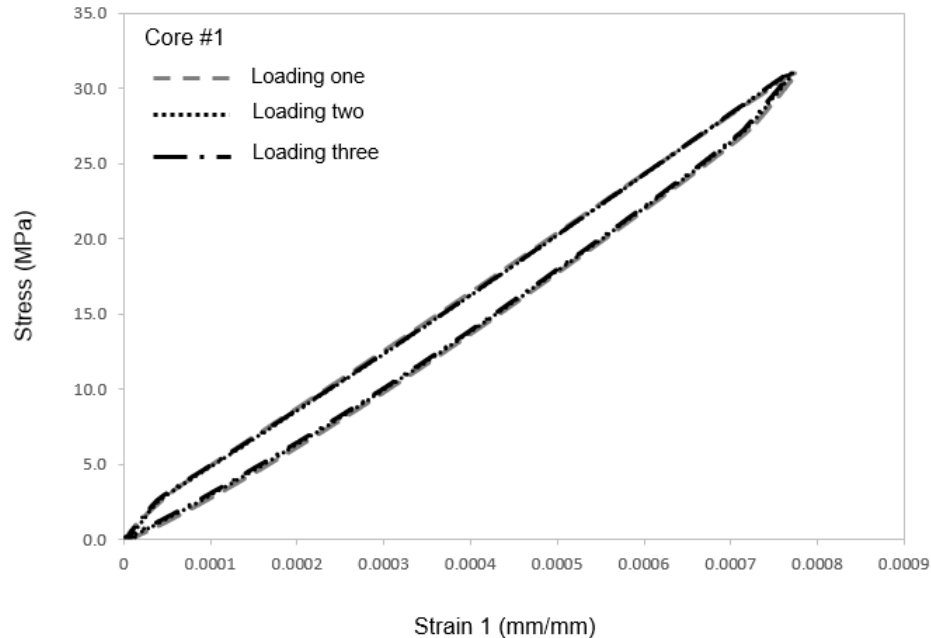
Figure 12. Typical stress-strain curve of concrete overlay core specimen under a constant loading rate (227 kg/sec).

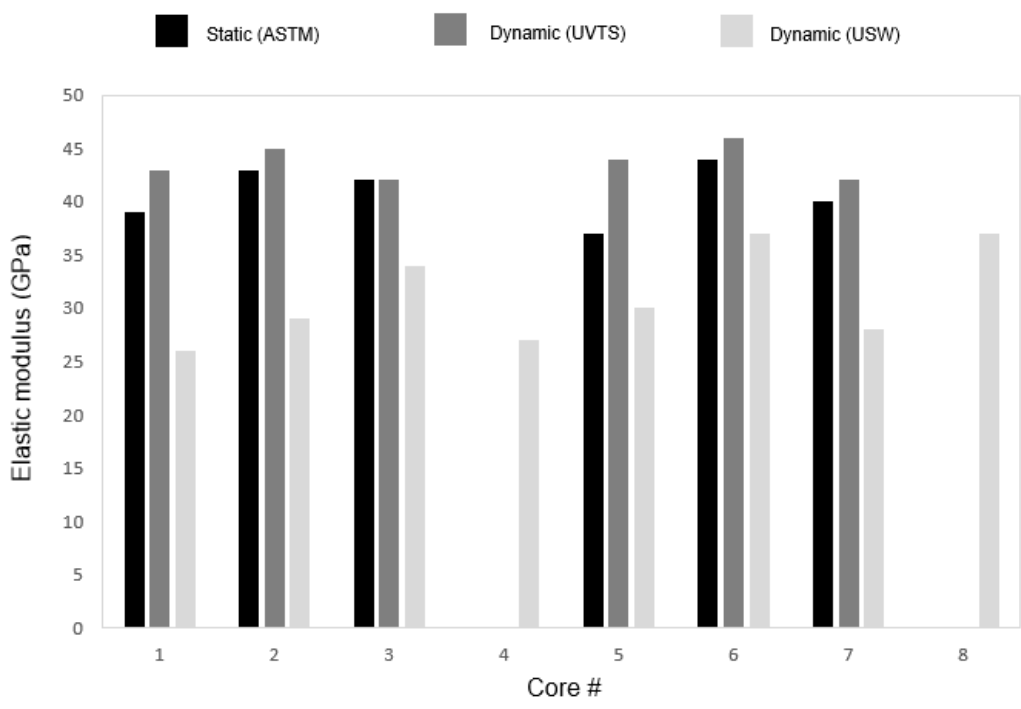
Figure 13. Comparison of elastic modulus of core specimens determined by different test methods.
