## INTRODUCTION

Corrosion of embedded steel reinforcement bars (rebars) in concrete leads to concrete cracking and delamination, which in turn leads to increased salt and moisture permeation and further damage. This study aims to evaluate the effectiveness of **microwave imaging** for the characterization of this **corrosion** and **delamination** of **steel rebar** embedded in concrete.

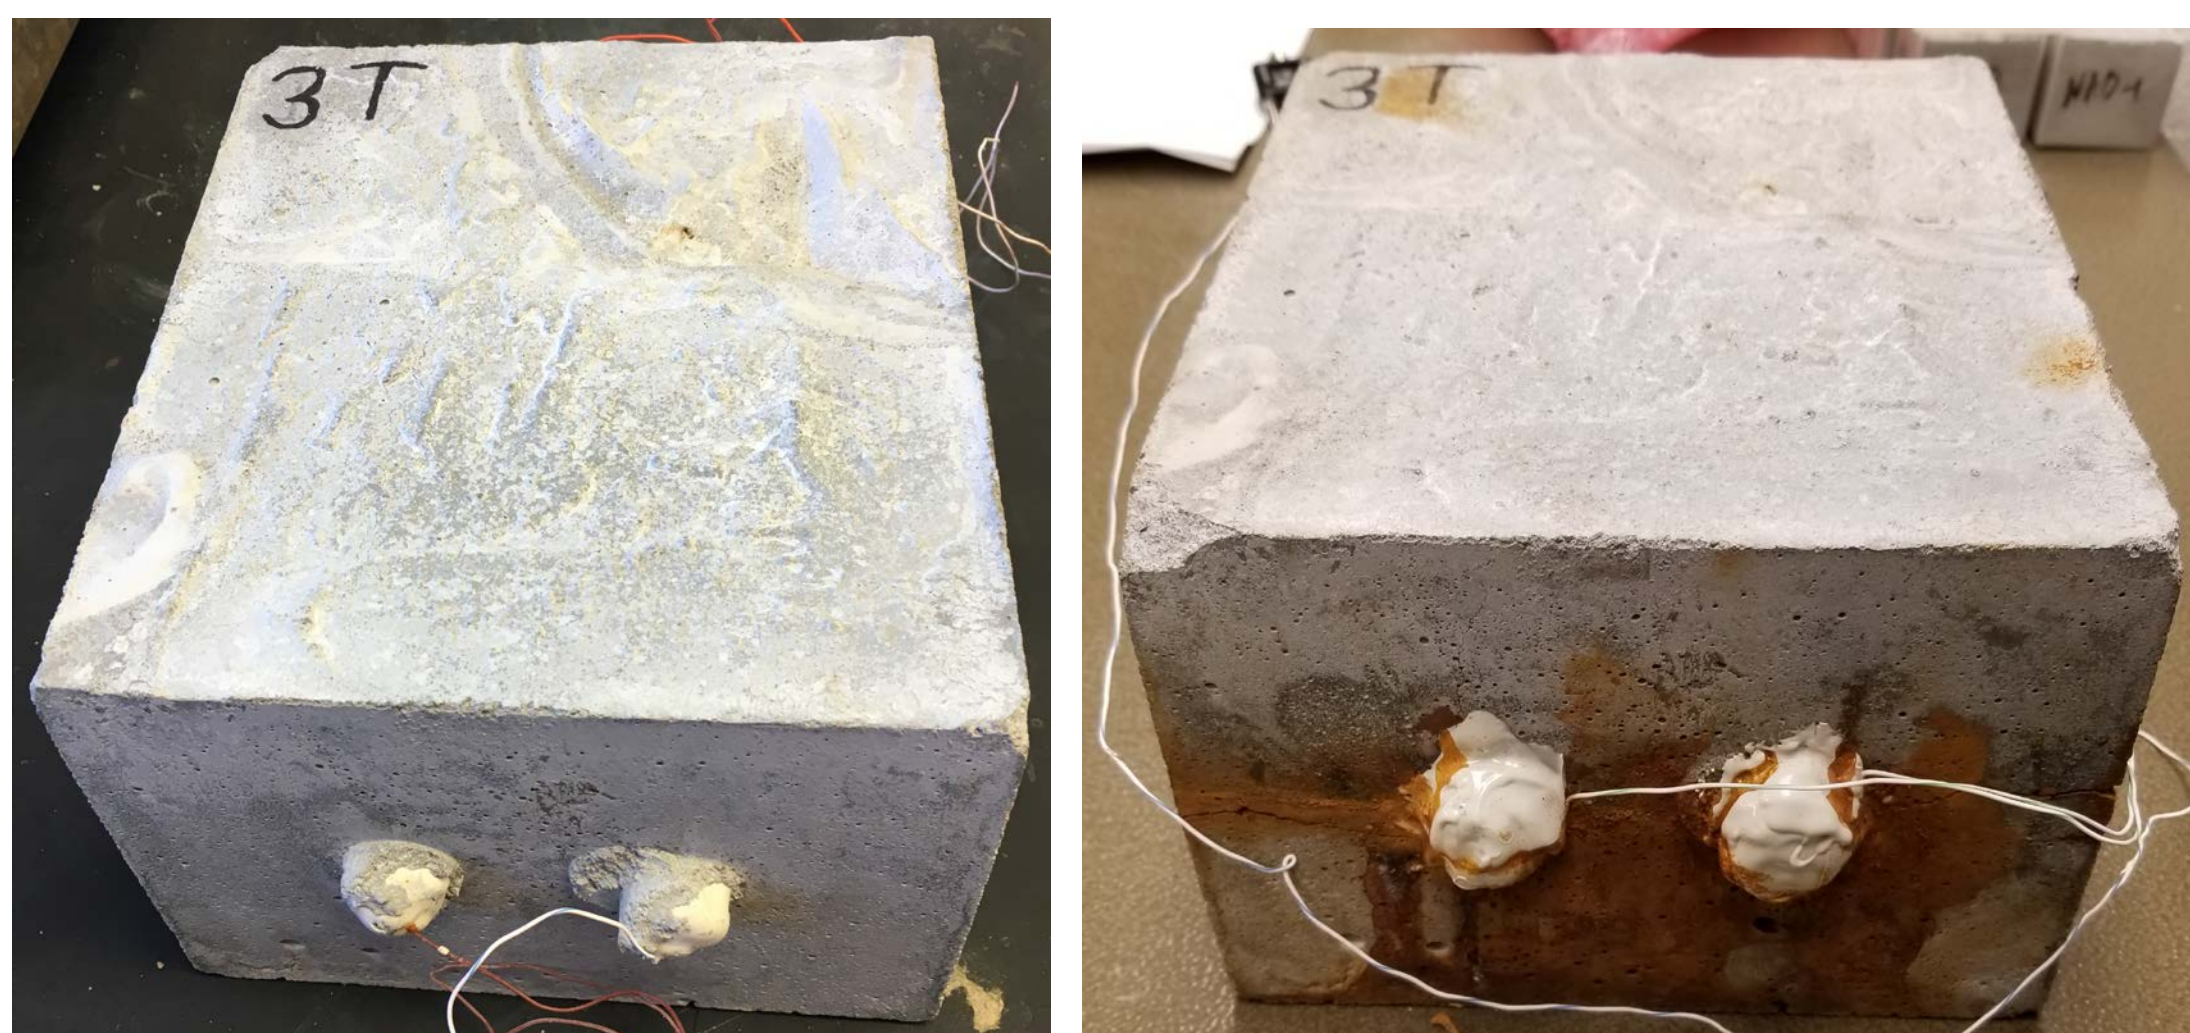
Concrete blocks with embedded steel rebars were produced and imaged using microwave Synthetic Aperture Radar (SAR) imaging technique. The blocks were then soaked in saltwater and current was passed through the rebars to promote **corrosion**.

Figure 1: A concrete block before (left) and after (right) being soaked.

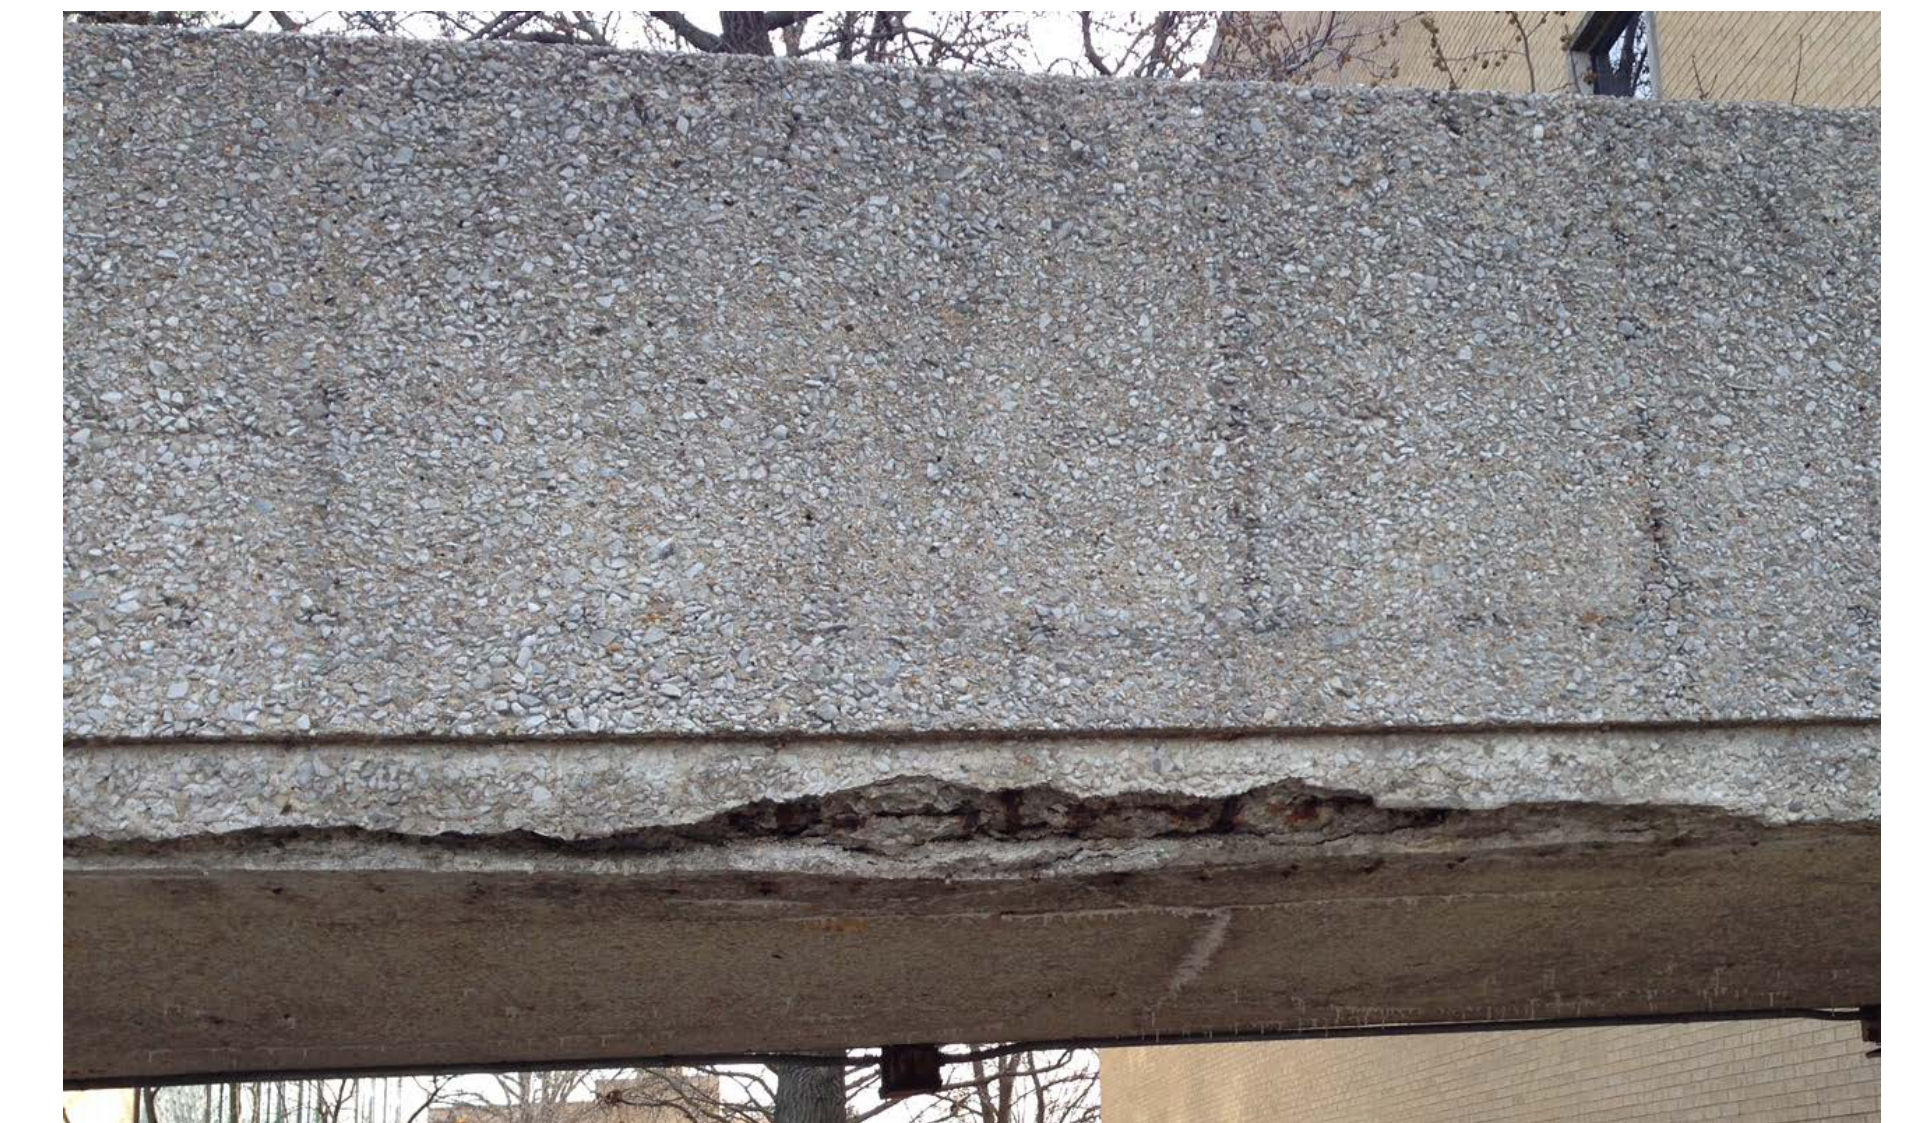
Initiated scanning a pedestrian bridge on campus with potential corroded rebars and delamination. Initial scans showed some potential, but additional imaging works need to be conducted.

Figure 5: Pedestrian bridge with potential corroded rebars and delamination.

The pedestrian bridge will be scanned at several frequency bands and the results will be compared with those using different methods.
