Bridge deck assessment using visual inspection, ground penetrating radar, portable seismic property analyzer-ultrasonic surface wave, hammer sounding and chain drag

A THESIS

GEOLOGICAL ENGINEERING

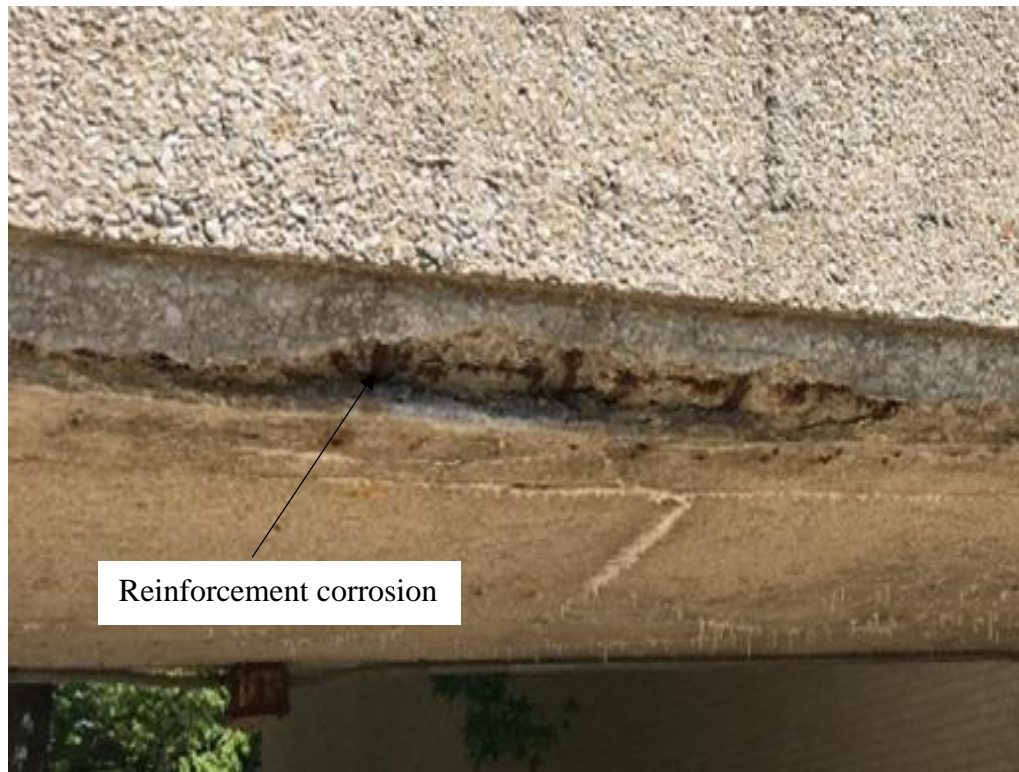
1.2.2. Reinforcement Corrosion. Reinforcement corrosion is the rusting of embedded steel rebars, which creates an expansion of steel and concrete interface until the concrete breaks away from the steel rebar creating cracking and spalling as shown in (Figure 1.3). Reinforcement corrosion is caused by the chloride ions and carbon dioxide (carbonation) reach the rebar through pores and fractures in concrete, lower the pH and

destroys the protective film on rebar [6, and 7]. Reinforcement corrosion can negatively affect the integrity of the bridge deck by enhancing further cracking, delamination or spalling on the concrete structure[1 and 8].

Figure 1.3. Bridge deck deterioration shows reinforcement corrosion.

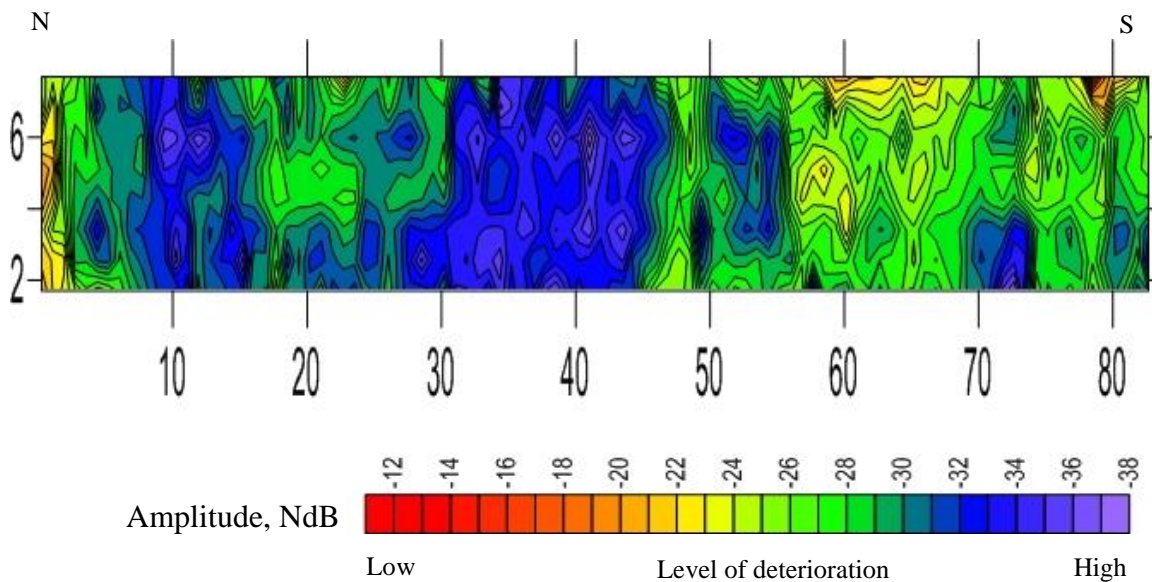
A given example of GPR normalized amplitude variations map is shown in (Figure 2.4) illustrating a relative concrete condition along the bridge deck. Where highest amplitude range indicates of good concrete condition (no evidence of deterioration) and lowest amplitude range indicates of severe concrete condition (severe evidence of deterioration).

Figure 2.4. Example of GPR amplitude variations map shows level of deterioration on bridge deck.

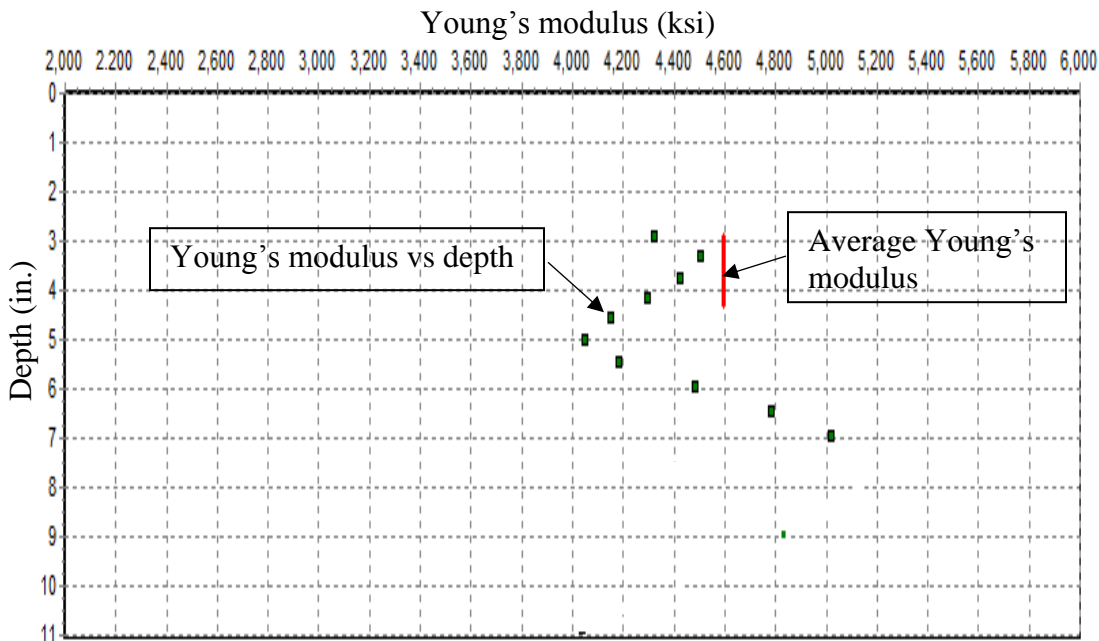
It is usually recommended to acquire PSPA-USW data point at least four times at each test location for a 95% confidence. The 1D plot of Young's modulus (ksi) vs concrete depth (in.) shows the strength of concrete material as shown in (Figure 2.7).

Figure 2.7. 1D plot of Young's modulus (ksi) vs. depth (in.)

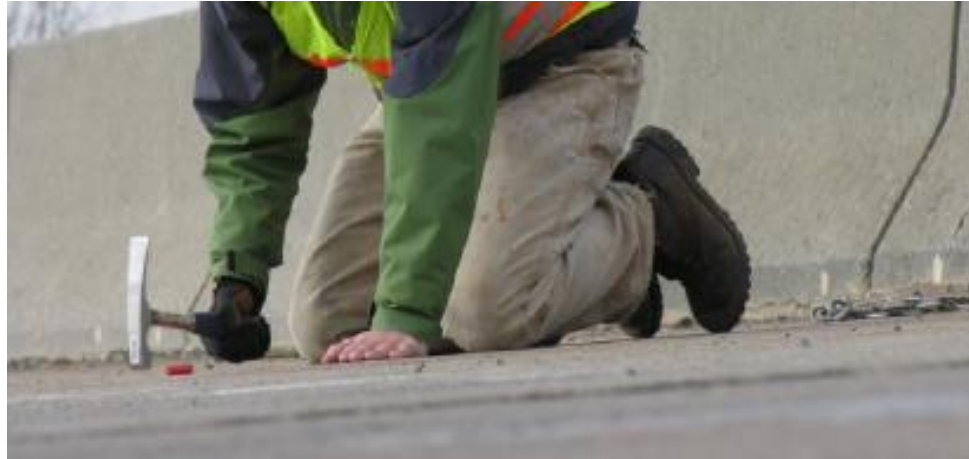
Using hammer sounding and chain drag for bridge deck assessment should follow standard practice [3 and 29]. The standard, ASTM D4580-12, includes setup of the geometry along particular areas or the whole area of the bridge deck, and then tapping the hammer or dragging the chain over the concrete bridge deck. Hollow or solid sound can be heard during implementing these methods, where hollow sound is indicative of delamination and solid sound is indicative of non-delamination [22 and 24]. Eventually, the delaminated areas are mapped along the bridge deck. Hammer sounding and chain drag can provide inexpensive and rapid data that can be used for bridge deck assessment. However, the data interpretation is subjective or qualitative [20, 31, and 19].

Figure 2.8. Hammer sounding [1].

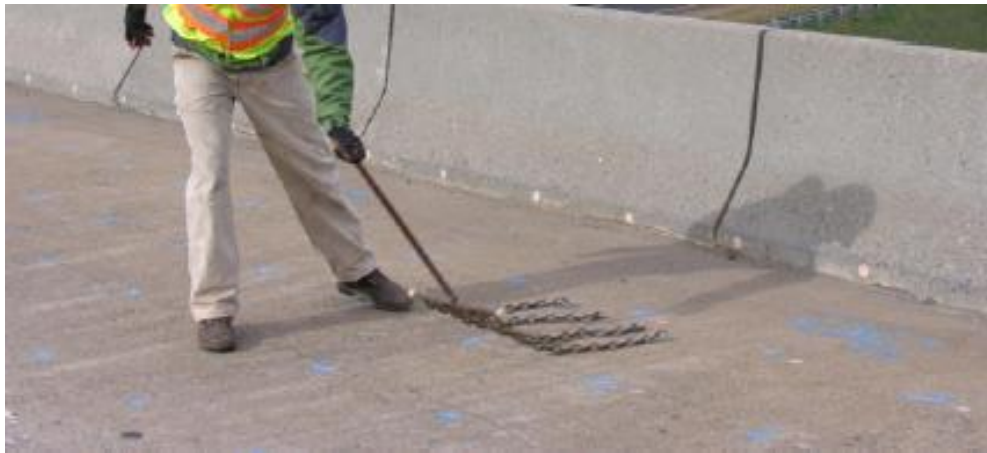
Figure 2.9. Chain drag [1].

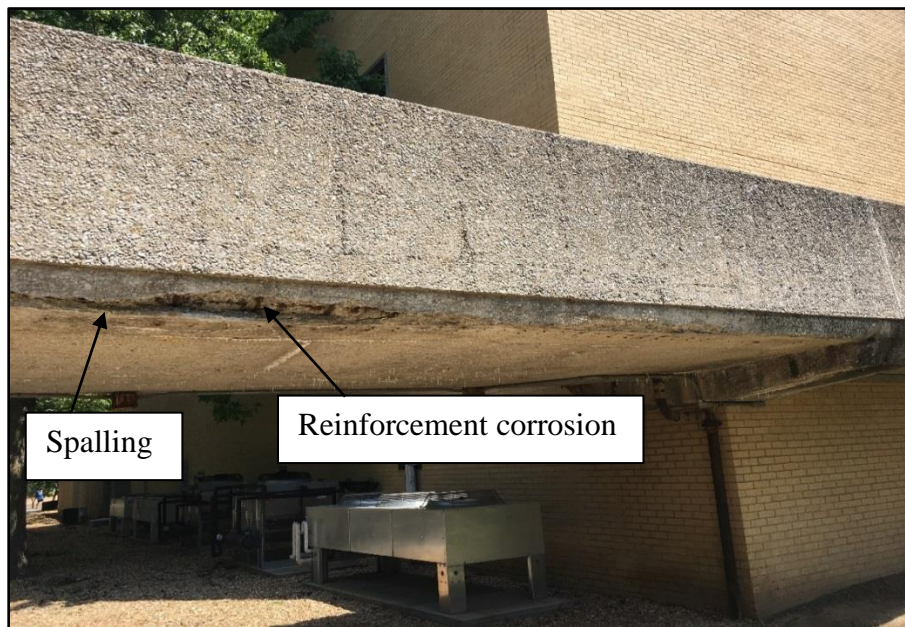
Figure 5.2. Spalling and reinforcement corrosion at the bottom surface of the bridge deck.

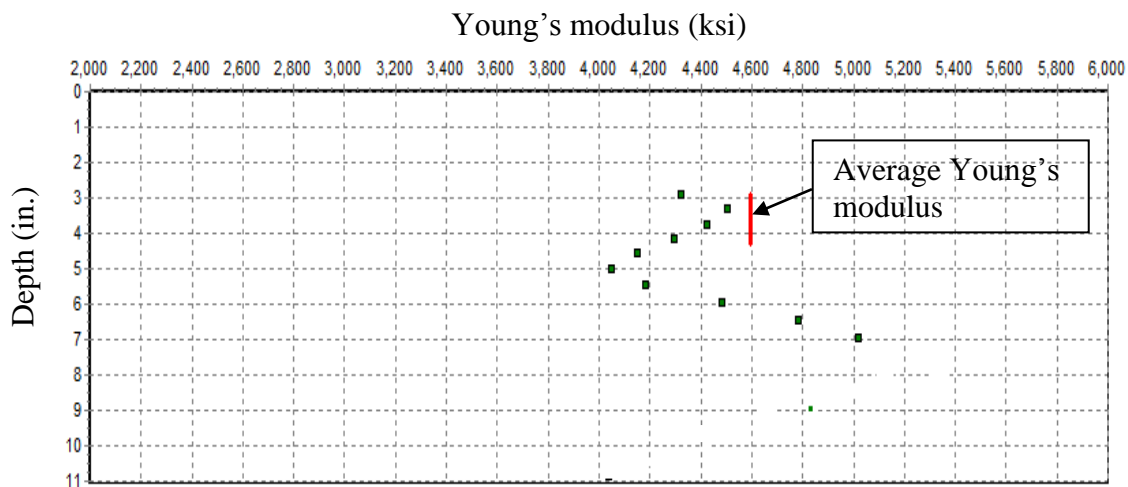
Figure 5.7. Example of PSPA-USW data point depicting average Young's modulus (ksi) vs. depth (in.).

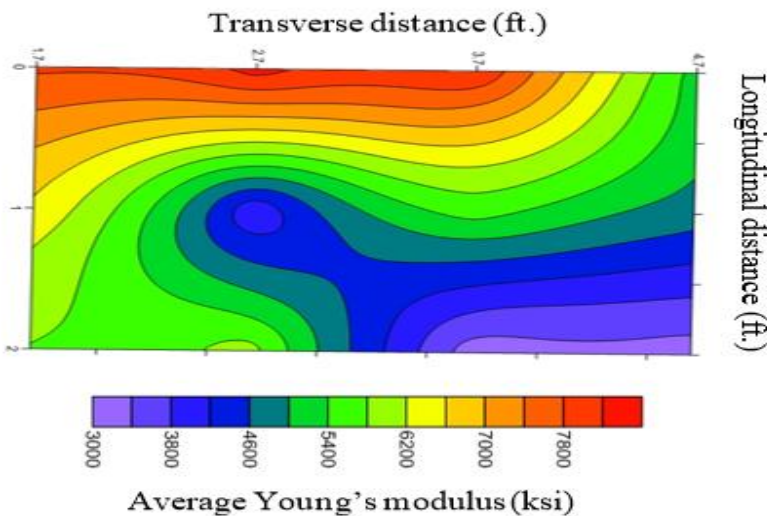
PSPA-USW data were acquired at five sections with a grid map of 2 (ft.) by 3 (ft.). The spacing interval was 1 (ft.) and spacing between far and near receiver was set at 4 (in) to get to depth of approximately 2 (in.) to 7.5(in.). Each section location contains 12 PSPA-USW data set. The automatic output of each test location was 1D plot of average Young's modulus vs depth. A contoured map of PSPA-USW data was generated to illustrate the average Young's modulus variations of concrete section in the bridge deck as shown in (Figure 5.8).

Figure 5.8. Example of contoured map showing variations of average Young's modulus at PSPA-USW section on the bridge deck.

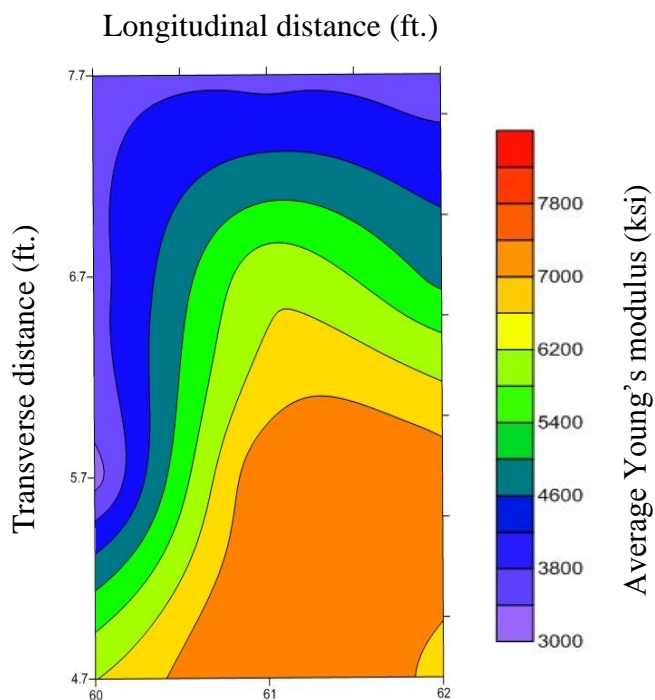
Figure 6.8. Contoured map shows average Young's modulus variations for section (D).

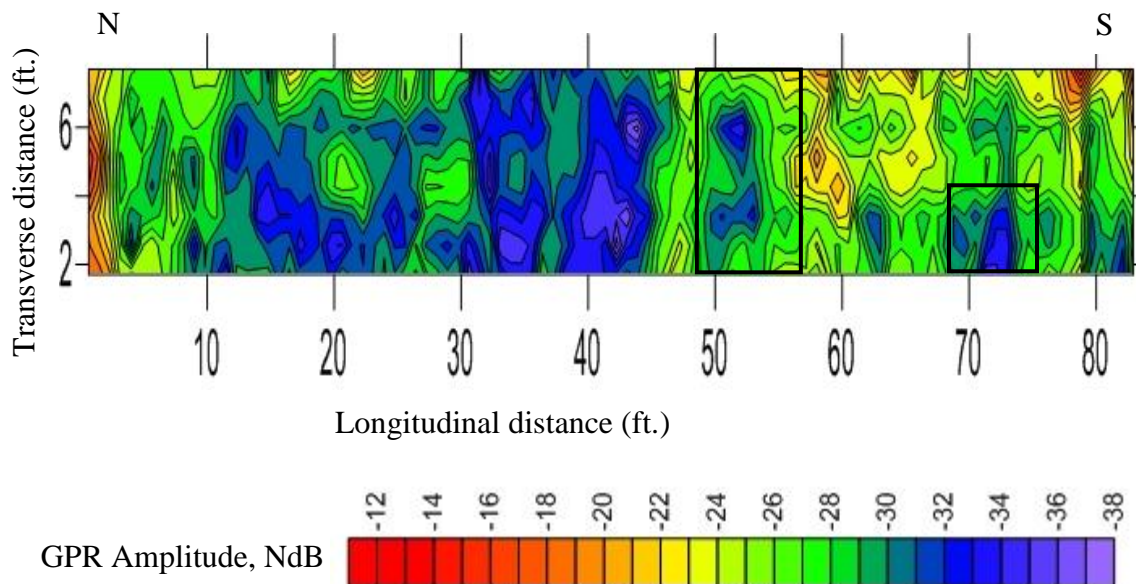
GPR signal amplitude maps showed the effect of moisture content changes on GPR signal amplitude with stable temperature of (70 °F) as shown in (Figures 6.20,6.21,and 7.22). For example, GPR signal amplitude tended to a high attenuation of energy during the high moisture content as shown in (Figure. 6.20) the areas marked with black boxes shows an increase in the amplitude compared with the low moisture content change effect. GPR signal amplitude tended to a low attenuation of energy during the low moisture content as shown in (Figure 6.21) the areas marked with black boxes shows a decrease in the amplitude compared with the high moisture content change effect.

Figure 6.20. GPR amplitude variations map at temperature of 70 (°F) and precipitation of 0.7 (in.).
