Bogusław ŁADECKI*, Sławomir BADURA*, Filip MATACHOWSKI*

STRENGTH ANALYSIS OF A GANTRY CRANE OF A COATING STRUCTURE

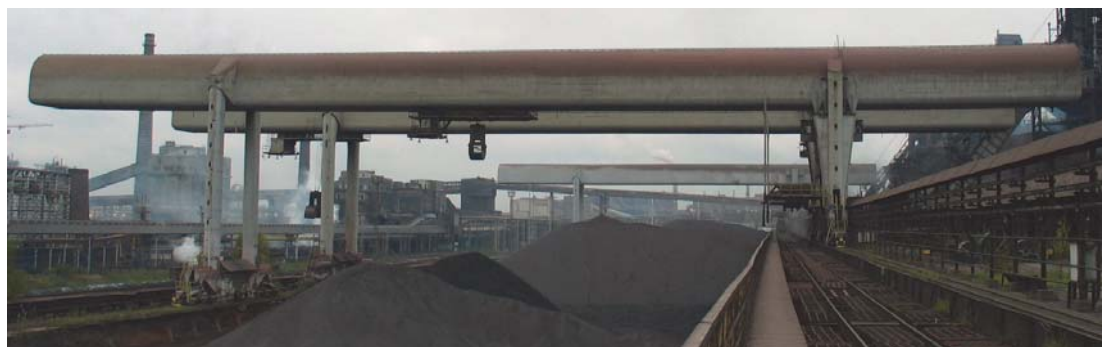
of 350 kN, operating in one of the Polish steelworks. The bearing element for these cranes constituted the span, 133 m long, of the coating structure, made of steel plates strengthened by axial and transverse ribbing (Fig. 1).

Fig. 1. Gantry cranes of a coating structure

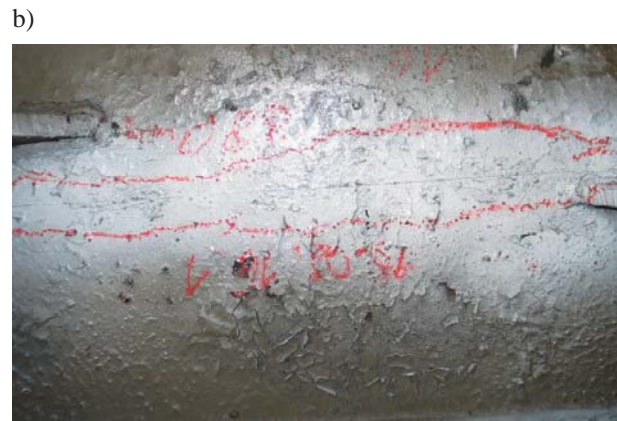
Fig. 3. Cracks of the crane beam revealed by means of the magnetic-powder method: a) type „Z₁” joint 120 mm long; b) type „O” plate under the rail, 380 mm long

The performed non-destructive tests revealed several areas of crack occurrence (the most often of a fatigue character) and other damages of crane structures. The most intensive occurrence of fatigue cracks was found for the beam truck crane pad, for which identified types of damages are illustrated in Figures 2, 3 and 4.

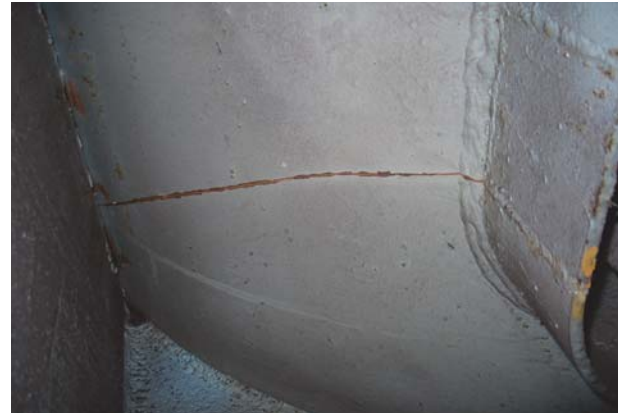
Fig. 6. Crack of the short support tube buffet – at app. 1/3 of a perimeter

The occurrence of fatigue cracks were also detected in other areas of cranes, out of which the most dangerous were found near the long support (Fig. 5), and in the short support tube buffet (Fig. 6).
