## Low fatigue response of crest-fixed cold-formed steel drape curved roof claddings

### Abstract

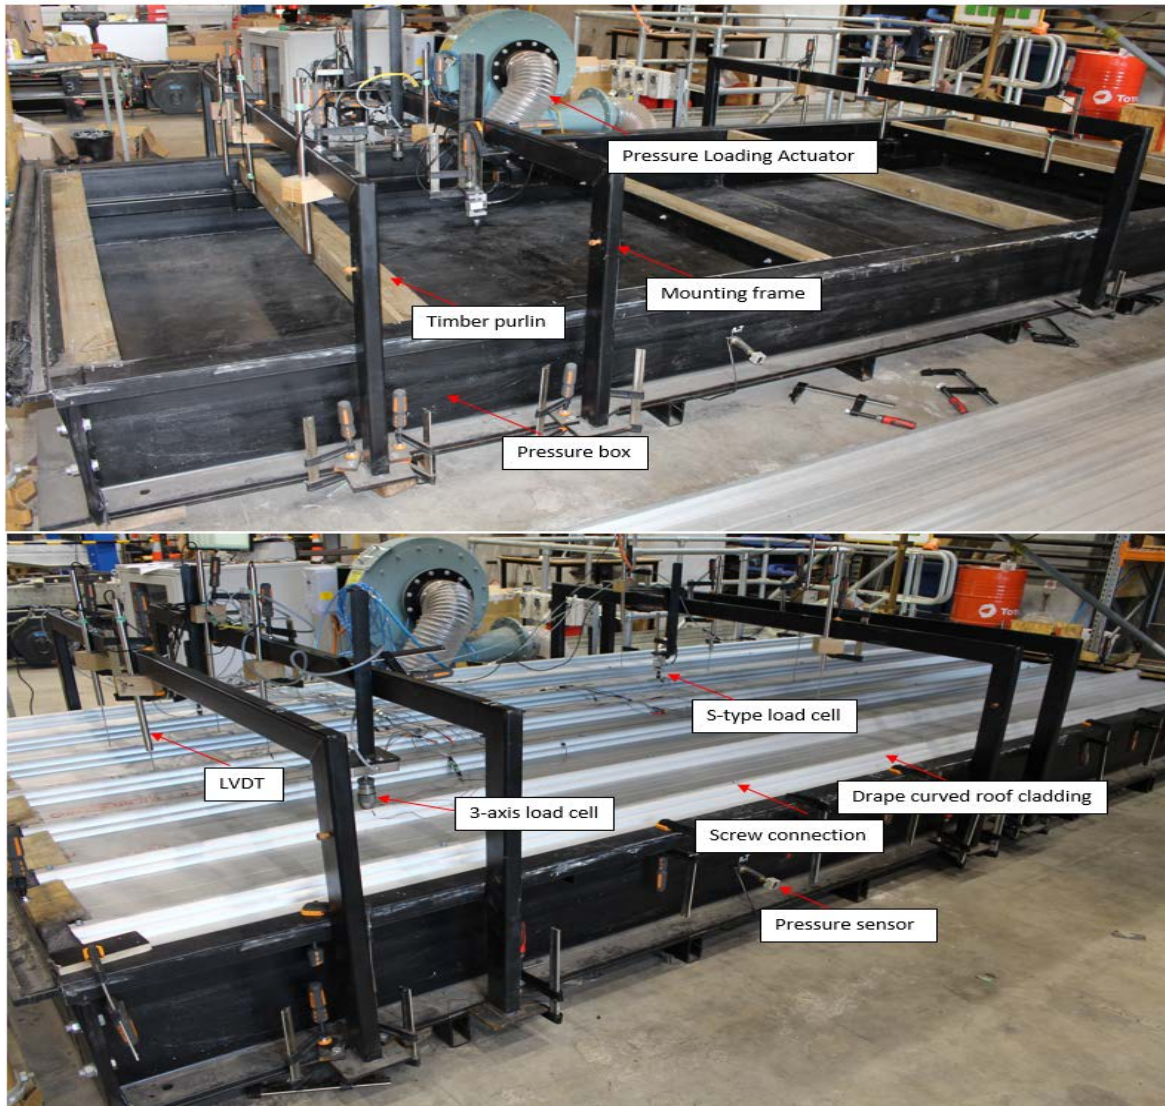
**Figure 3:** Photograph of the pressure box

Simply supported crest-fixed drap curved roof claddings were tested under static and cyclic wind-uplift pressures in a rectangular pressure box of dimensions 5000 mm×2000 mm×320 mm. Four-span roofing assemblies were tested as shown in Fig. 3. The end spans were taken as two-thirds of the intermediate span according to the manufacturer's recommendation. A vacuum pump and pressure loading actuator (PLA) was

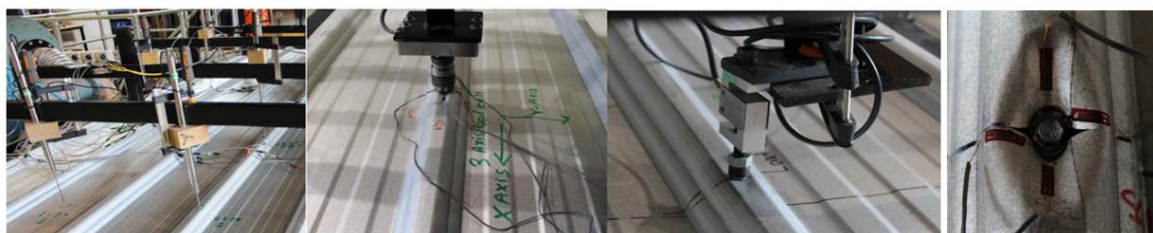
(a) LVDTs

(b) 3-Axis load cell

(c) S-type load cell

(d) Strain gauges

**Figure 4:** Locations of sensors

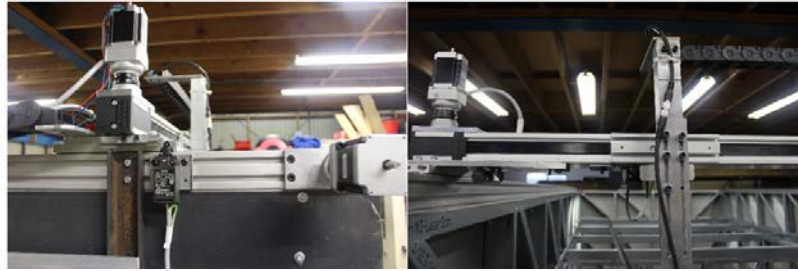
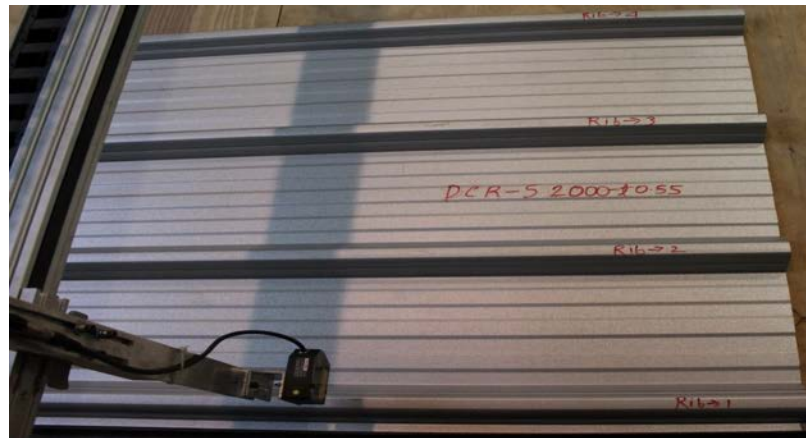
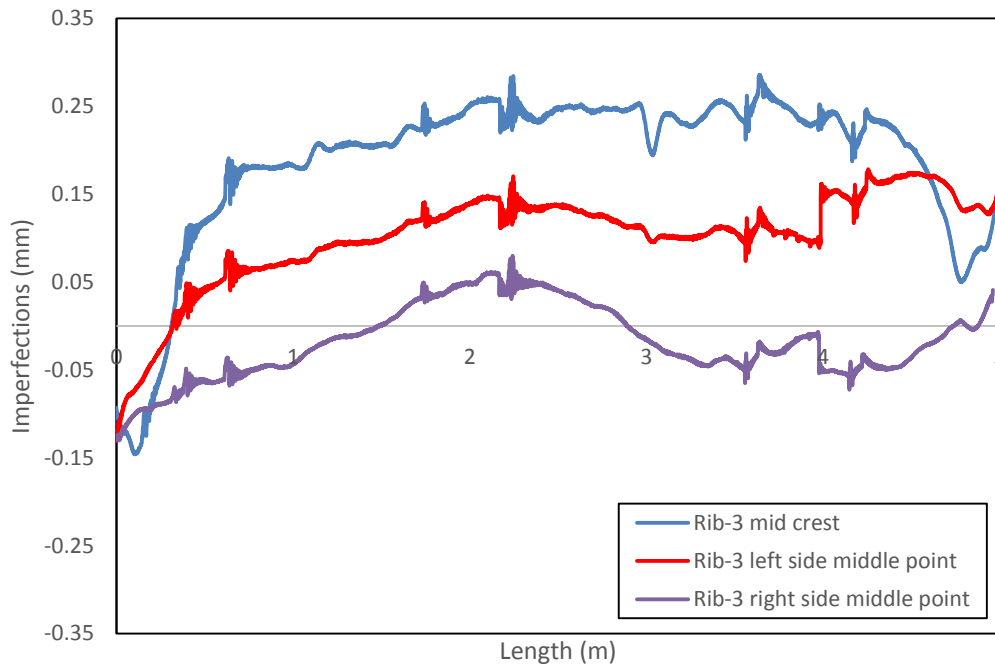
(a) Stepper motor

(b) Laser scanner assembly

(b) Photograph of imperfection measuring setup

(c) Typical imperfection profile (DCR-S2000-t0.55)

**Figure 5:** Measurement of initial geometric imperfections using a laser scanner**Table 1:** Measured initial geometric imperfections

Fig. 5 shows the details of the laser scanner assembly used to measure the initial geometric imperfections present in the drape curved claddings. As can be seen in Fig. 5, it is comprised of a 5500 x 2500 x 1500 mm steel frame which supports a travelling platform mounted on precision rails in the longitudinal (5500 mm) direction. The platform supports a stepper motor (see Fig. 5(a)), which allows displacement controlled motion using a rack and pinion system. The platform is designed to have a precision shaft in the transverse (2500 mm) direction which guides a moveable laser scanner. The laser scanner records reading at every 0.0001 mm along each of the mid-crest and mid-pan of the cladding profiles. A typical plot of the initial geometric imperfections versus length is shown in Fig. 5(c). The maximum initial imperfections of the cladding specimens are shown in Table 1.

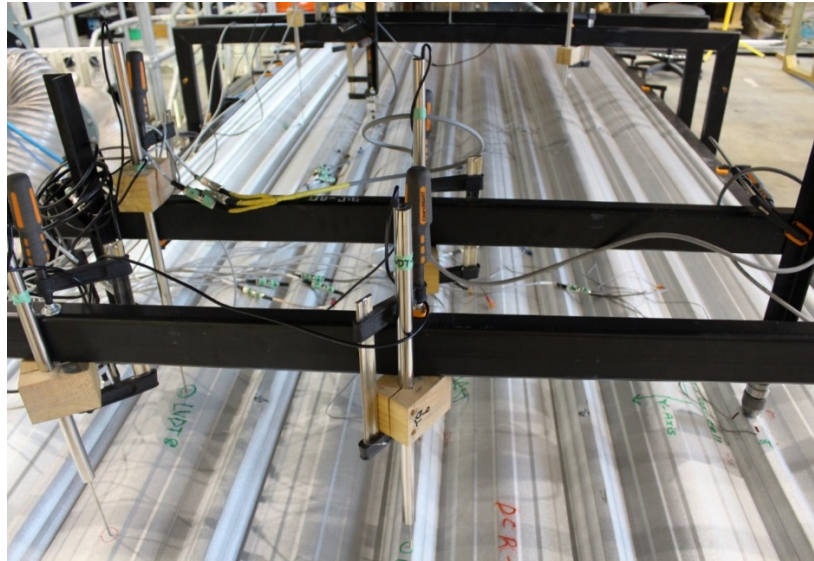
**Figure 7:** Deflected shape of the drap curved roof cladding (DCR-S800-t0.55)

Fig. 7 shows the deflected shape of the DCR-S2000-t0.55 under static wind-uplift pressure. The load in the screw fastener along the Z-axis is given by the equation below:

The deflected shape of the DCR-S2000-t0.40, subjected to wind uplift pressure is shown in Fig. 7. The screw fastener loads,  $F_X$ ,  $F_Y$  and  $F_Z$  in x, y and z directions were measured by the 3-axis load cell at the fastener  $F_3$  (see Fig. 2a) for a stepped static applied pressure and the results are shown in Fig. 8. As can be seen from Fig. 8, first spike in  $F_X$ ,  $F_Y$  and  $F_Z$  happened at 44.8 seconds when the cladding adjacent to the fastener dimpled. The lateral load ( $F_X$ ) on the “fastener” is approximately 8% of  $F_Z$ . Another spike is seen in  $F_X$ ,  $F_Y$  and  $F_Z$  values at 75 seconds when the cladding profile starts splitting transversely at the fastener hole. This reduces the stiffness of the cladding profile and hence reduces the reaction coefficient. During the fourth load step, the cladding splits completely at the fastener hole. Pull-through failure loads as fastener loads and wind uplift pressures are shown in Table 2 for all cladding specimens tested under static uplift wind pressures.

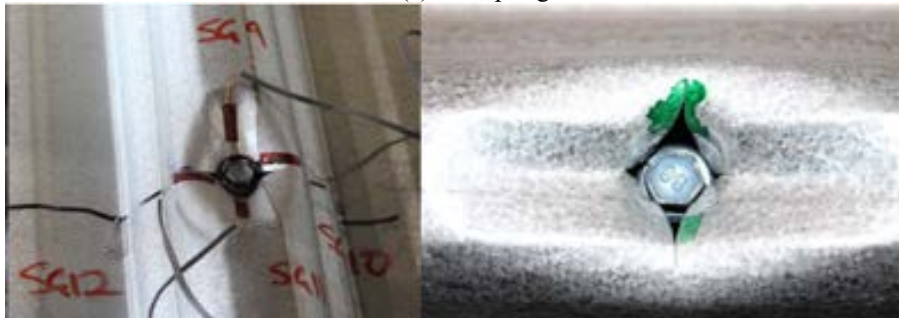
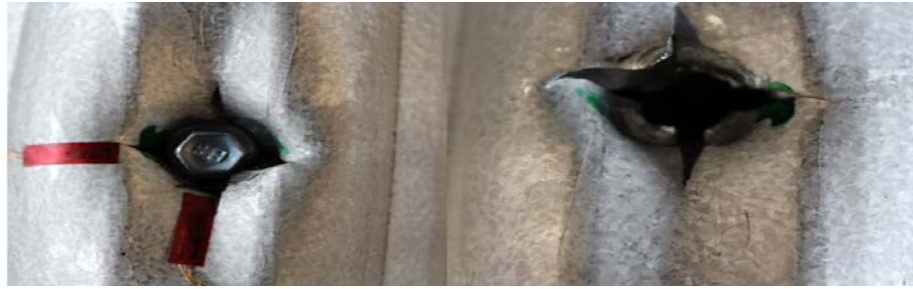
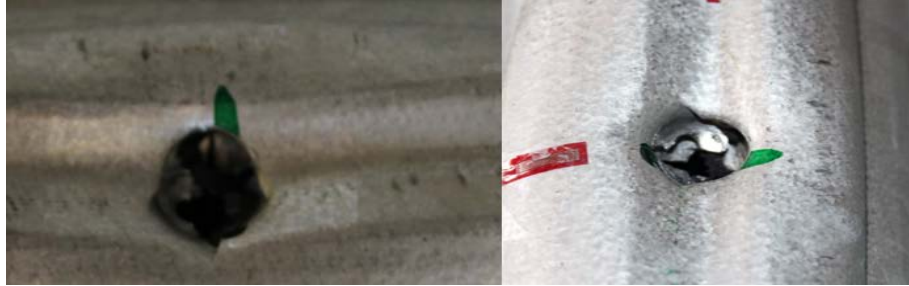
(a) Dimpling failure

(b) Splitting failure

(c) T-type crack

(d) Star-type crack

(e) O-type crack

**Figure 12:** Different types of failures and cracks patterns in drape curved claddings under and cyclic loading

For cyclic tests, dimpling failure (see Fig. 13) occurred at number of load-cycles less than 3500 and at a minimum pressure of 2.58 kPa. Fig. 12(a) shows the picture of dimpling failure occurred in cyclic tests for DCR-S2000-t0.55. Cladding deflection was linear up to a wind pressure of 1.6 kPa, after which non-linear behaviour was observed i.e. the longitudinal and transverse bending was observed near the fastener hole. The bending action resulted in large cross sectional deformation around the fastener holes, when the wind pressure was increased up to 2.58 kPa, leading to the dimpling failure of cladding profile.

When the wind load was increased beyond 5.42 kPa for cyclic tests, the cladding profile started splitting in both X and Y directions around the fastener hole (see Fig. 12(b)). As a result of this, the fastener load in X direction ( $F_x$ ) increased by around 16%. The longitudinal and transverse strains were recorded from the strain gauges installed near the fastener holes to develop a suitable strain criteria for drape curved steel claddings (see Fig. 12(c)). Two dimensional splitting of drape curved steel claddings occurred at load cycles in the range of 5500 to 10000, as shown in Fig. 13. As expected, splitting failure was observed for DCR-S800-t0.55, DCR-S1200-t0.55 and DCR-S1500-t0.55 at the highest load ratio (0.5).

T-type cracks were initiated near the screw head of the fastener in the cladding profile under sinusoidal loading (cyclic loading). T-type cracks are shown in Fig. 12(c). X and Y fastener loads i.e.  $F_x$  and  $F_y$  varies linearly up to 3.5 kPa, after which non-linear behaviour was observed until T-type cracks were formed. T-type cracks were formed in between the load-cycles of 4500 and 8,200 for DCR-S1500-t0.55 and DCR-S2000-t0.55

Star-type cracks were formed in the drape curved steel claddings under cyclic loading, at the screw hole as shown in Fig. 12 (d). Star-type cracks formed at higher pressure than T-type cracks (in between 4 to 5 kPa). Longitudinal and transverse strain values were measured with the help of strain gauges, which were installed in the cladding, near the screw head (see Fig. 12(d)). Most of the star-type cracks were formed at number of load cycles in between 10000 to 14000 for DCR-S500-t0.55, DCR-S800-t0.55 and DCR-S1200-t0.55, when the load ratios ( $R$ ) were in the range of 0.1 to 0.3.

O-type cracks were observed in the cladding near the vicinity of screw head under cyclic loading. O-cracks were formed at much higher wind-uplift pressure than for star-type crack patterns i.e. in the range of 4.46 kPa to 7.36 kPa (see Fig. 13). Number of load cycles were also the highest (from 14000 to 17000) for O-type cracks to be formed. DCR-S500-t0.55 and DCR-S800-t0.55 showed this type of cracks during cyclic tests. For, DCR-S500-t0.55, load ratio ( $R$ ) was in range of 0.3 to 0.5 (maximum), while for DCR-S500-t0.55, O-type crack was observed at load ratio ( $R$ ) of 0.4. The lateral loads  $F_x$  and  $F_y$  increased linearly with pressure and increasing number of load-cycles until the O-type crack was formed (see Fig. 12(e)). However, non-linear variation of X and Y fastener loads were observed during the growth of crack as number of load cycles go past 14225.
