Long-period fiber grating corrosion sensors for life-cycle monitoring and assessment of reinforced concrete structures

Department: Civil, Architectural and Environmental Engineering

A DISSERTATION

CIVIL ENGINEERING

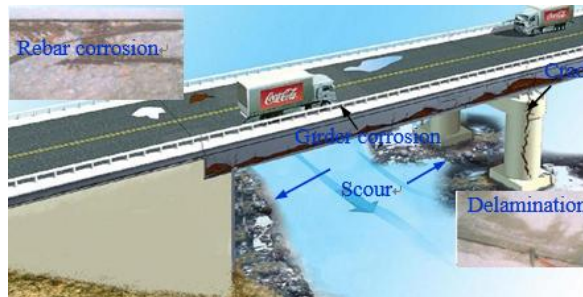
Figure 1.1. Schematic view of various structural behaviors.

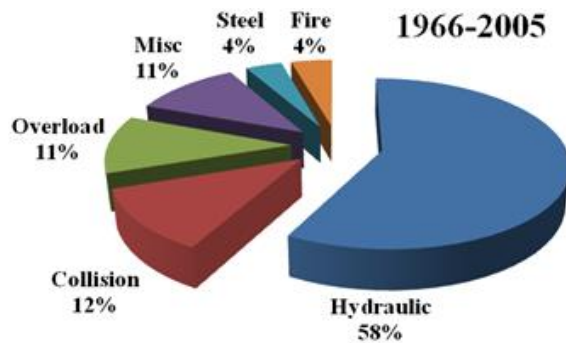
Figure 1.2. Causes of over 1500 bridge collapses.

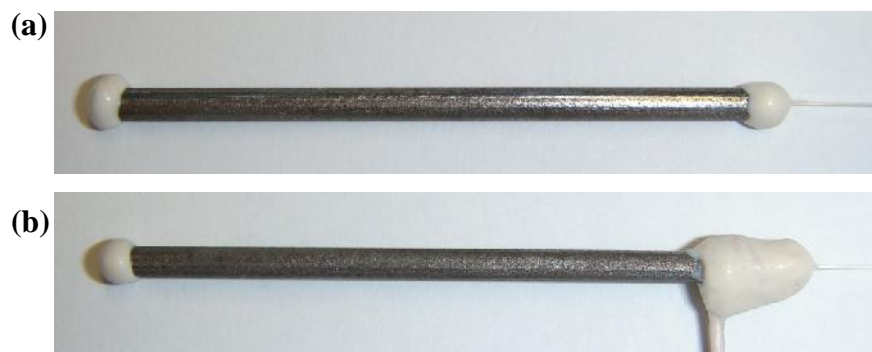
Figure 5.4. Steel tube encapsulated OP: (a) before and (b) after copper wire connection.

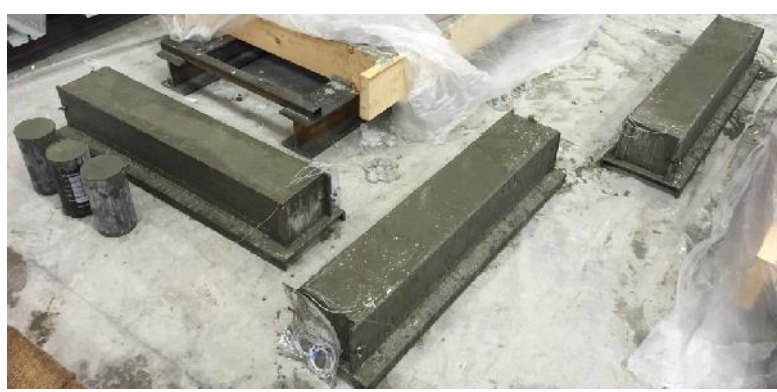
Figure 7.3. RC beams and cylinders for corrosion test.

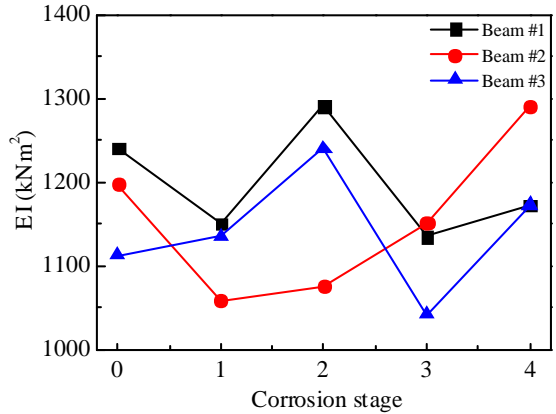
Figure 7.15. The EI of three RC beams at various corrosion stages.
