# Changing Shorelines: Adaptation Planning for Maine's Coastal State Parks

## Final Report - NOAA Project of Special Merit

Maine Department of Agriculture, Conservation and Forestry  
December, 2016

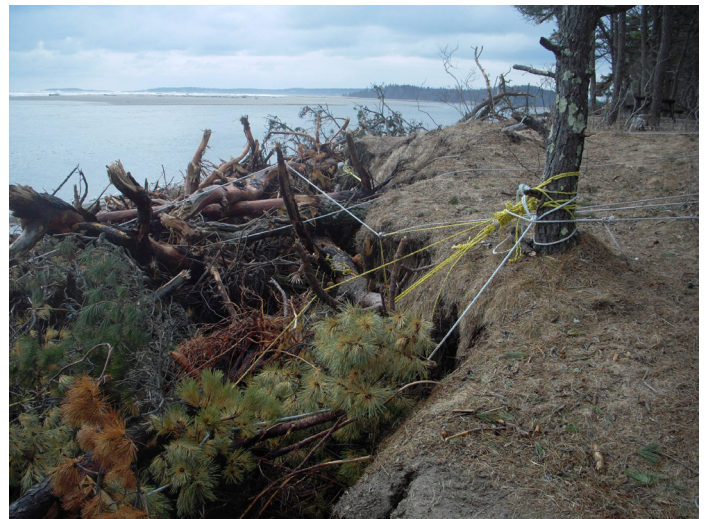
Figure 16a. Rafting of fallen trees to help stabilize the eroding bank along the bathhouse.

In order to combat the erosion immediately threatening the bath house, in 2010 and 2011 MGS worked with BPL to institute a temporary shoreline protection plan. This included using mechanical equipment to raft fallen pine trees together (Figure 16a) and placement of jersey barriers adjacent to the bath house for protection during winter storms (Figure 16b).

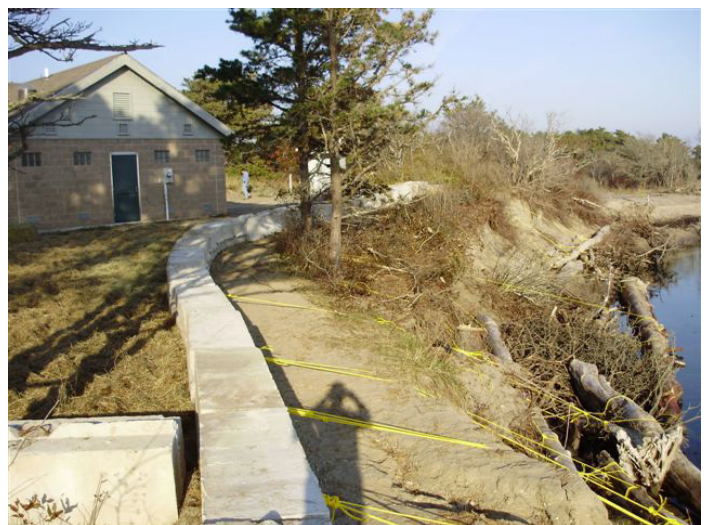
Figure 16b. Placement of jersey barriers for additional splashover protection and to temporarily help anchor rafted trees. Images by S. Dickson, MGS.

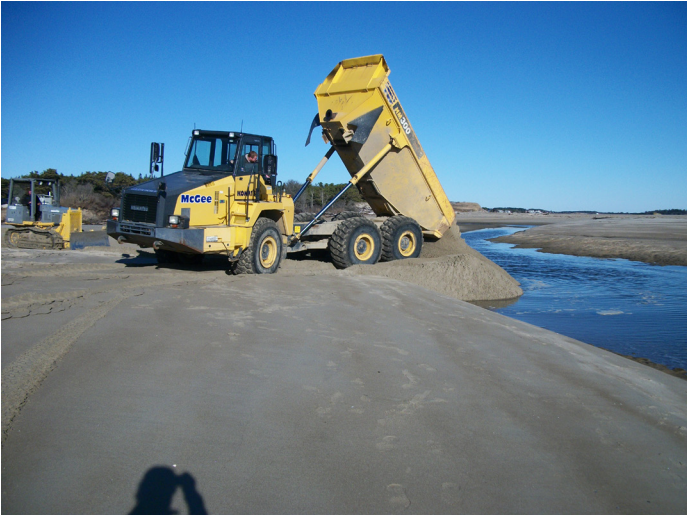
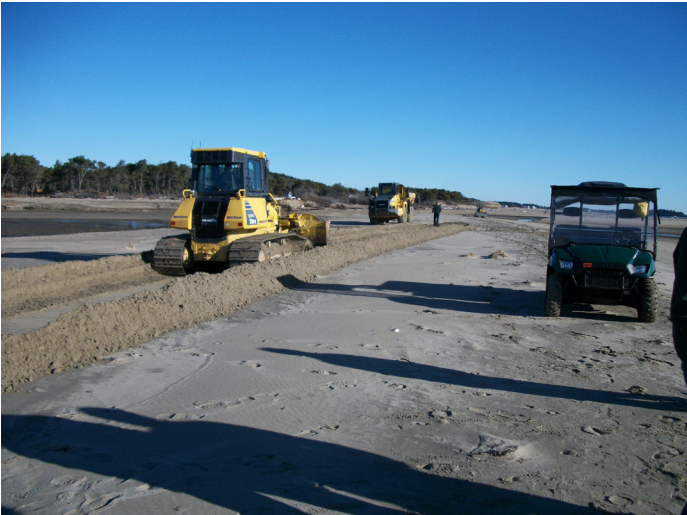
Figure 17a. Closing of the secondary channel in front of the bathhouse using beach scraping and mechanical equipment. Images by S. Dickson, MGS.

Figure 17b

Also during this time, BPL explored the potential strategy of mechanically opening the Morse River inlet back near Morse Mountain, and closing the existing inlet using excavated beach sand. Complicating this strategy were ownership issues of the sand spit at the Morse River inlet, and feedback from neighboring property owners which showed a preference for simply allowing natural processes to occur. Due to the immediate need for doing something, BPL chose not to pursue this effort at the time and instead chose to pursue a beach scraping project to help close the secondary inlet channel nearest the bath house (Dickson, 2012). During this week-long effort in 2011, mechanical equipment was used during low tides to scrape approximately 10,000 cubic yards of sand to close off the inlet, and add an area of sloped sand in front of the bath house (Figure 17a and 17b). This effort was successful in protecting the bath house from damage, and eventually helped mitigate some of the erosion caused by the Morse River channel, though it took several years to alleviate erosion hazards (Kelley, 2013). As the Morse River channel re-established at a more western location, the sand bar in front of the park continued to grow and vegetated dunes became more established, as is visible in the image from 2013. As this barrier island became more pronounced, significant wading bird habitat was created, which required additional management by BPL, IF&W, and Maine Audubon using fencing and signage. Since this time, the Morse River has started to migrate eastward again, and is now eroding this island at an estimated rate of 215 feet per year (Gordon and Dickson, 2016), as evidenced by more recent imagery from 2014 to 2016.

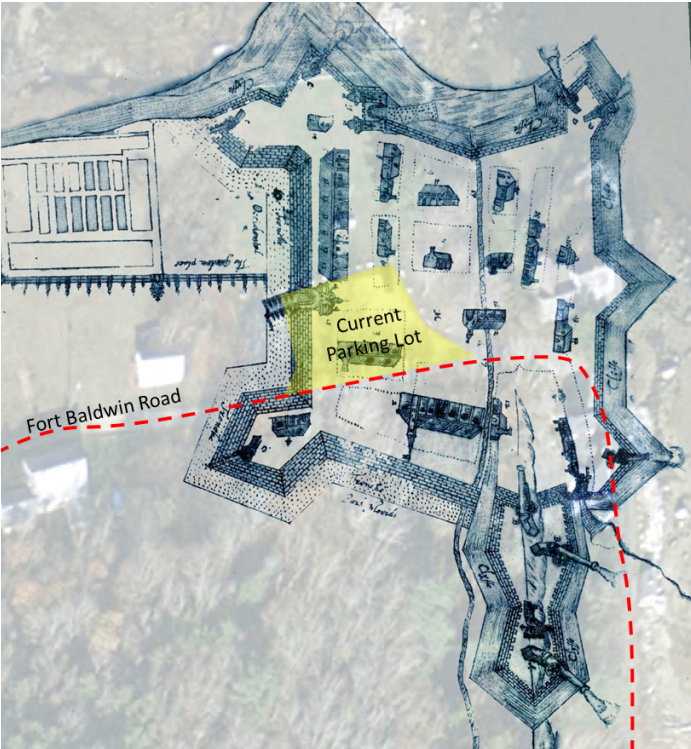
Figure 27. Cartographic depiction of Fort St. George (1607) overlain onto a 2012 base image. Fort Williams was at the northern end of the site.

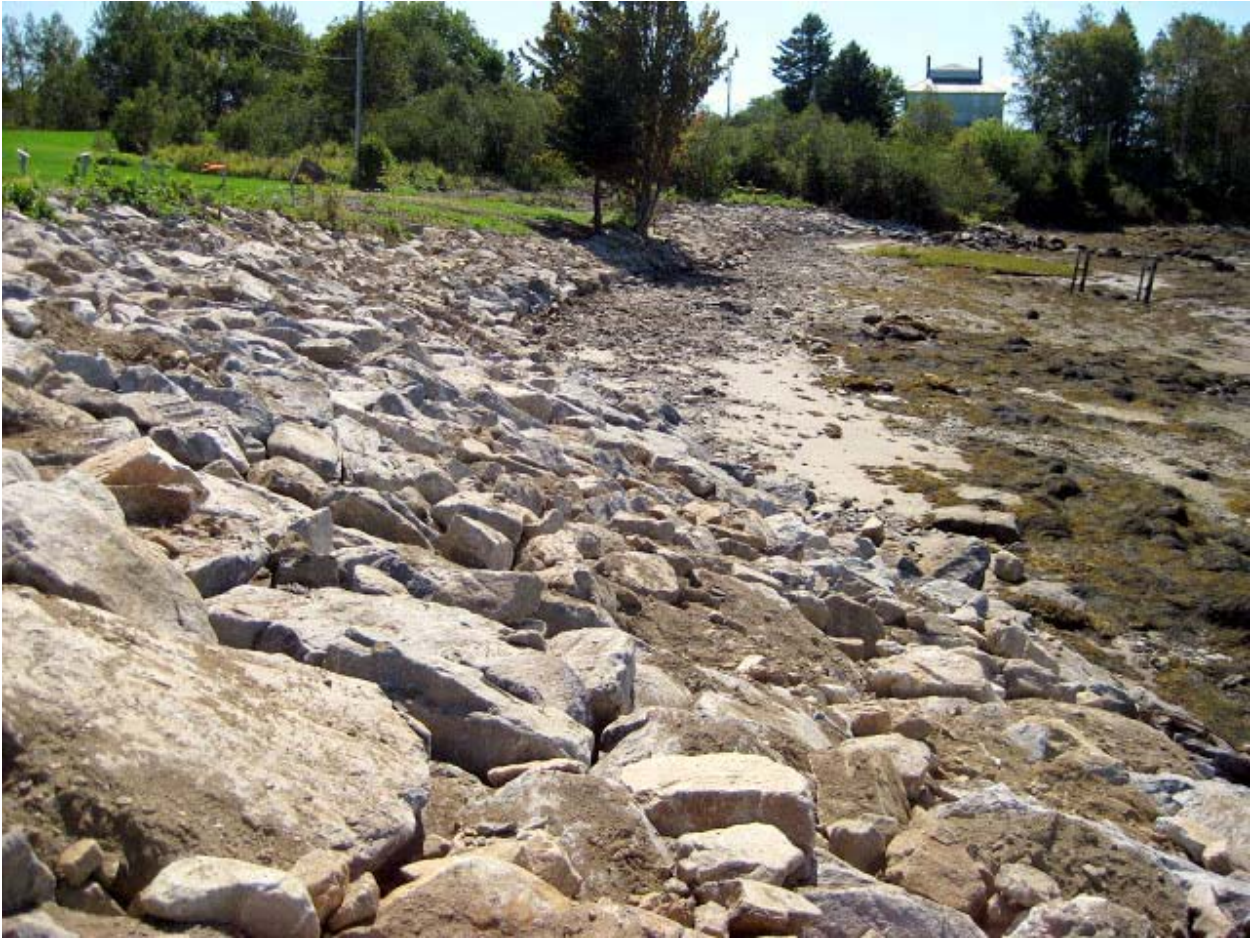
Figure B-4. Colonial Pemaquid Rip Rap on west shoreline (photo: Art Spiess).

*Historic and Cultural Features* - The threatened resources of concern at this site include circa 1650-1690 structure foundations and other features near the shoreline west of the restaurant. Shoreline stabilization (shown below in Figure B-4) was completed in 2009 at a cost of \$387,437 (including the septic system). This shoreline should be monitored and consideration given to evaluating the success of the stabilization project, including the design life of the improvement. Alternative designs could be considered if merited.

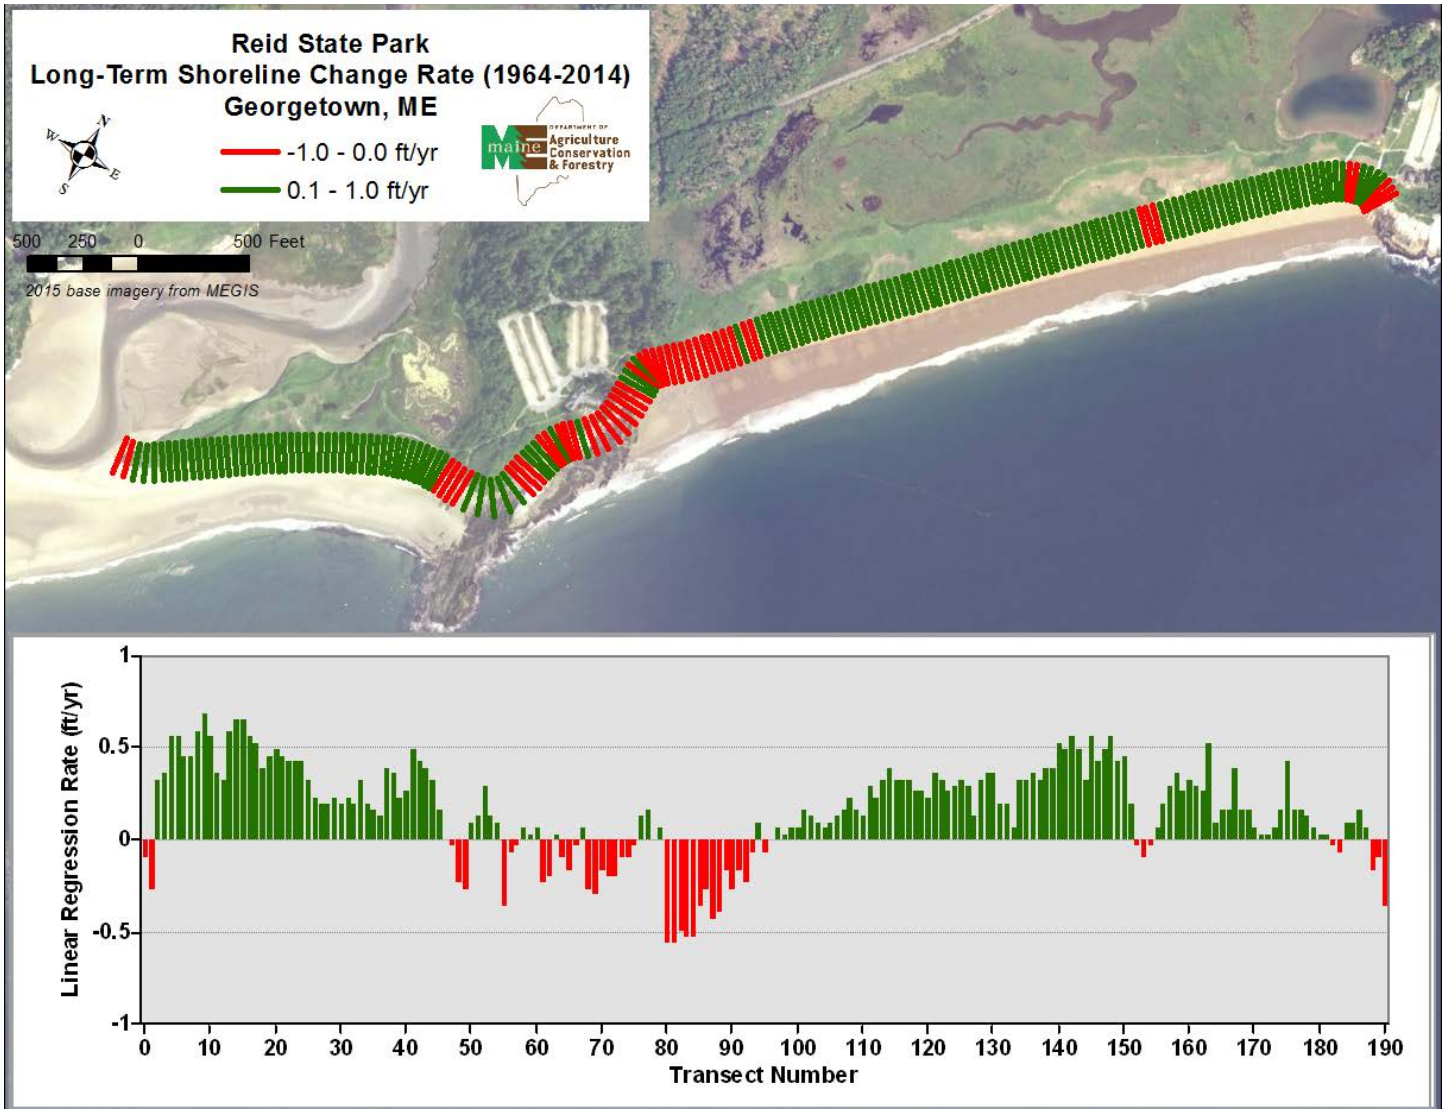
Figure C-3. Long-term shoreline change rates along Reid State Park.

*Long-term Shoreline Change Analyses* – Based on long term linear regression rates from shoreline position data from 1964 to 2014, the shoreline along the beaches has been markedly stable to slightly accretive. There has been some slight erosion at the southwestern end of Mile Beach. Overall, Mile Beach had a mean shoreline change rate of 0.1 feet per year, while Half Mile Beach had a mean rate of 0.3 feet per year. Based on this data, future 50-year shoreline change trends would have no impact to existing infrastructure or habitat at Reid State Park (Figure C-3)

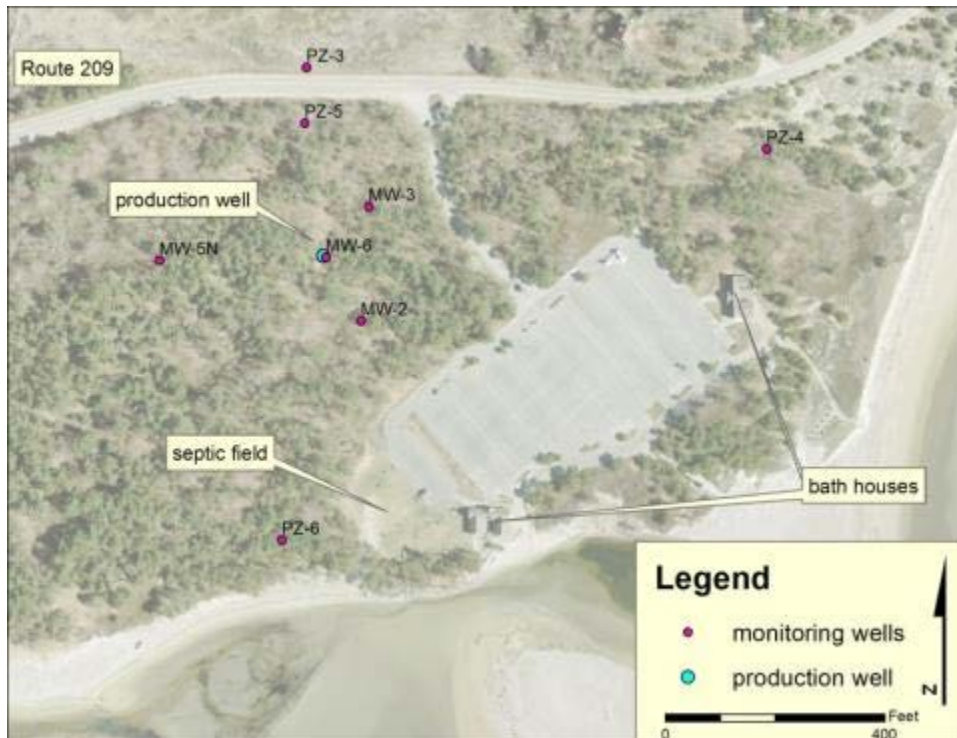
Figure F-2. Map of the well field and park infrastructure at Popham Beach State Park, showing the production pumping well and monitoring well locations. Aerial photograph from 2013.

Figure F-1. Topographic hillshade map of the Popham Beach State Park area, with labels for key features. Red rectangle indicates the approximate extent of the map in Figure F2.

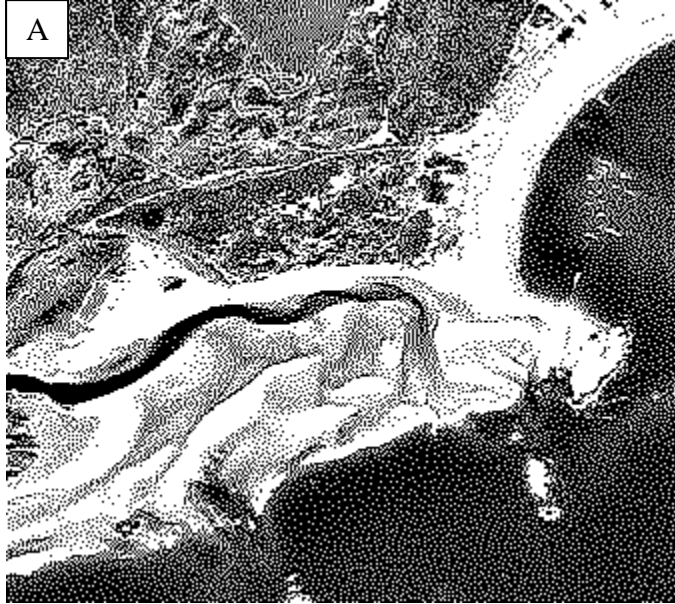
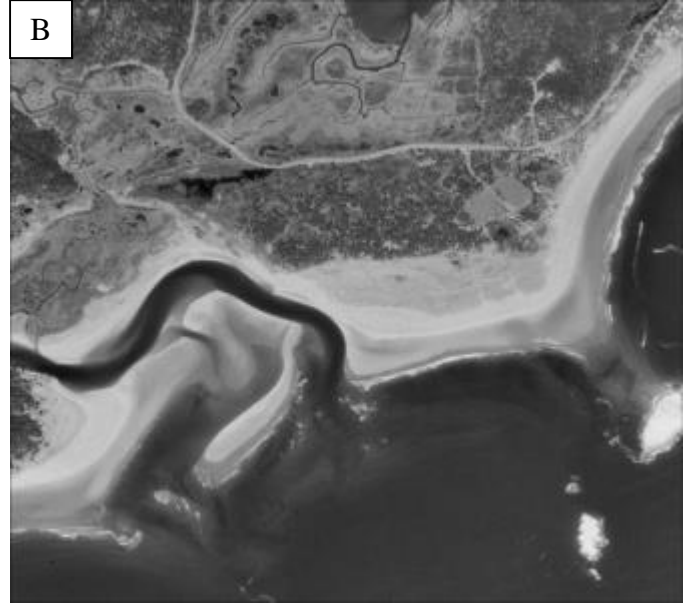
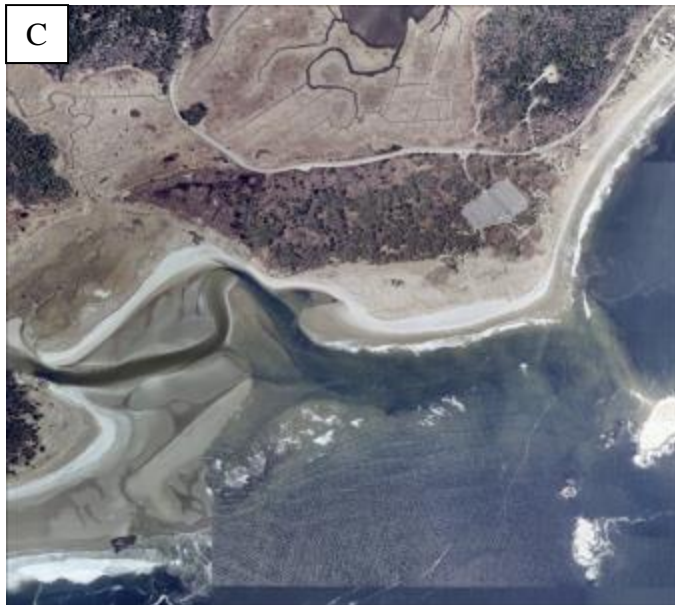
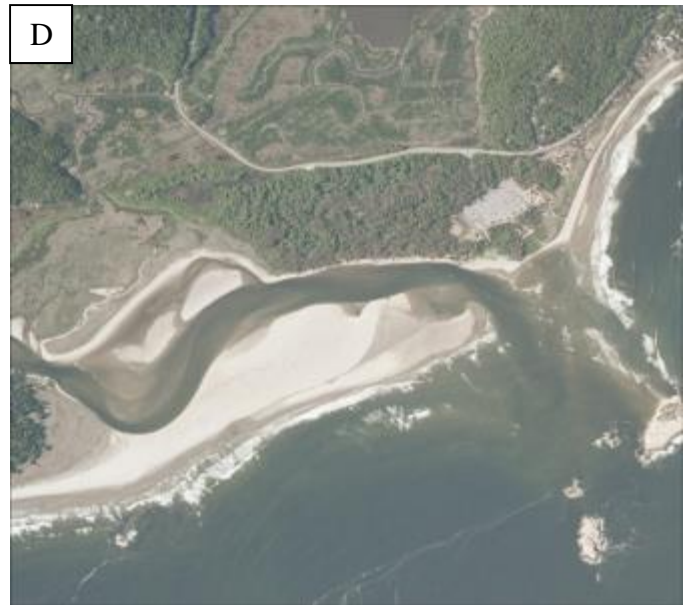
Figure 2. Chronology of Morse River migration at inlet. A: Image from 1953 showing the last severe erosion cycle, where dune systems were completely eroded away (image from Maine Geological Survey). B: Image from 1996, dune systems have recovered from previous erosion cycles. C: Image from 2003, when eastward channel begins to form. D: Image from 2009, Patriot's Day storm of 2007 causes the course of the Morse River to run parallel to the shoreline initiating extreme dune erosion. Bathhouse is constructed in the Spring of 2009. E: Image from 2011, showing breach of Seawall Beach by Morse River that occurred in March 2010. Tidal currents in eastern mouth of Morse River continue to erode area in front of parking lot and bathhouse, toppling trees and threatening structures. F: Image from 2013. Beach scraping performed in December 2011 has closed off east mouth of the Morse River. Risk to park infrastructure is greatly lowered until the next erosion cycle.

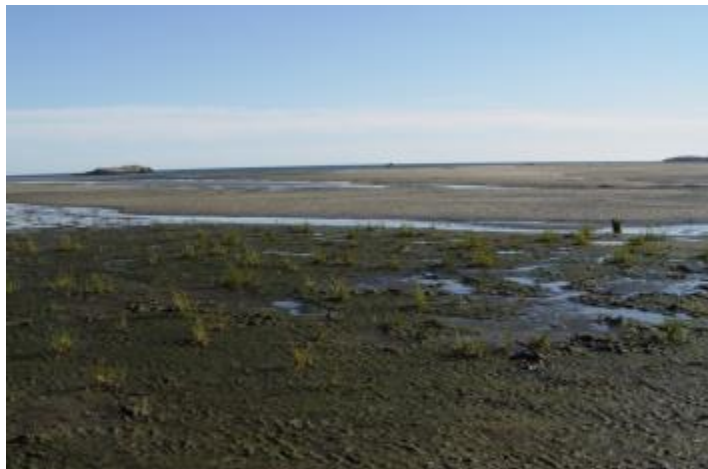
Sparseley vegetated Beach Strand a Popham Beach State Park.

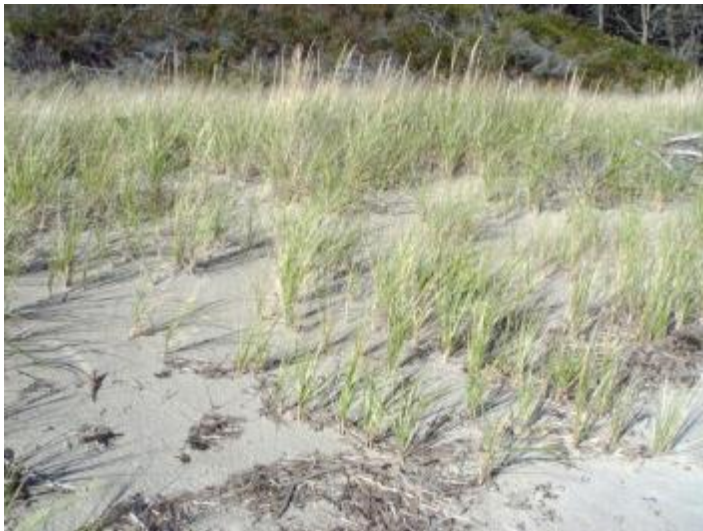
Beach grass (*Ammophila breviligulata*) colonizing new dune area at Popham Beach State Park.

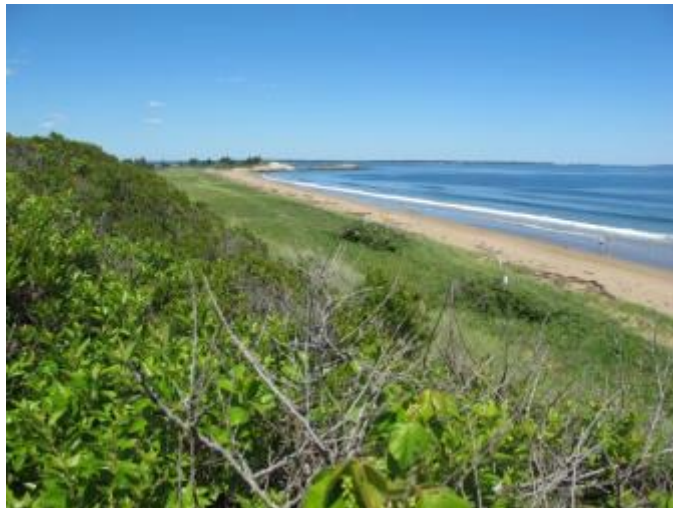
During the latter part of World War II, just prior to the establishment of the park, Navy fighter pilots from Brunswick Naval Air Station used the area for training, firing rockets at floating targets moored offshore of Mile Beach as they flew landward from over the ocean. A section of the existing dune toward the south end of the beach was built up at that time to provide a ‘back-stop’ for stray ordinance (S. M. Dickson 2002). The artificially tall dune still persists today, and is largely covered with a dense mix of shrubby vegetation.

Foreground: Area of dune historically built up for W.W. II aerial target practice. Background: Mile Beach.

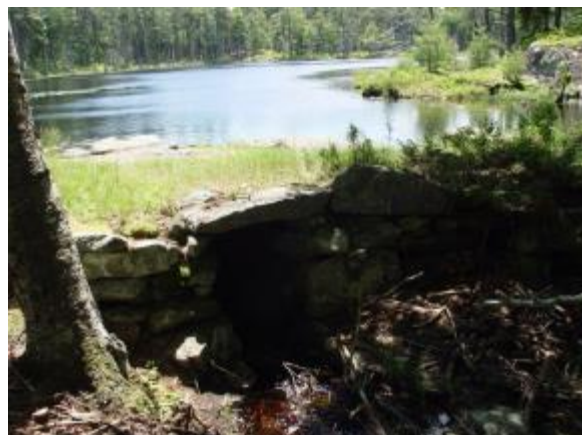
Ice Pond is a relatively small, freshwater pond located in the northern most part of the park adjacent to Seguinland Road. The pond is dammed with large quarry stones near where it drains toward the road, and subsequently is deeper and probably greater in area than it was prior to impoundment. The open water area of the pond is approximately five acres, and there is an adjacent grassy marsh of about 14 acres that is likely also influenced by the artificial water level caused by the dam. Beaver use the pond and likely have also influenced water levels, causing mortality of some trees on the pond margins. A narrow band

Ice Pond with quarry stone dam in foreground

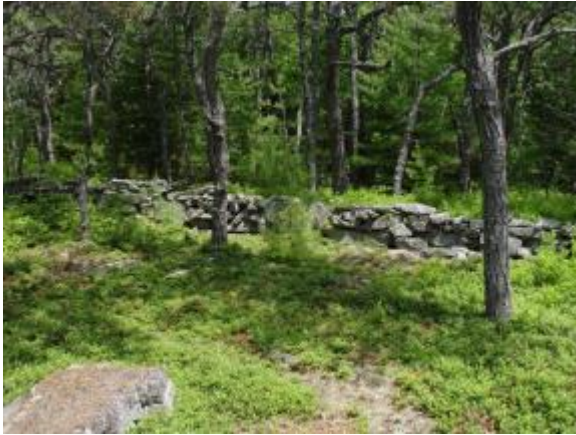
A relict stonewall is evidence of past agricultural use, in this Pitch Pine Woodland at the park

The majority of the area of this type within the park is undisturbed. One large patch is bisected by a stonewall suggesting past agricultural uses (~ pasture), but the community is well developed and characteristic for the type, and evidence of the historic disturbance is limited to the persistent stonewall. Two other areas have been impacted by powerline corridors. The clearing for the relatively narrow

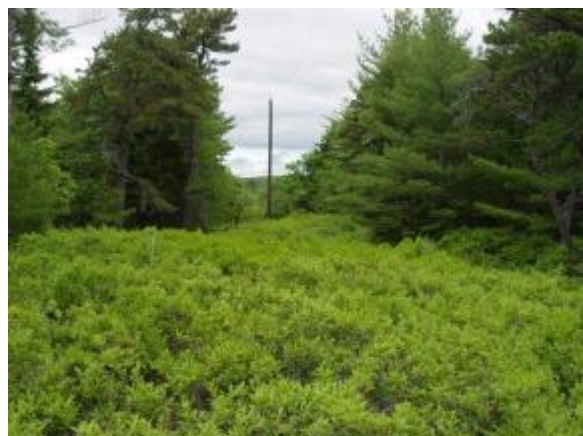
A small powerline corridor passes through an area of Pitch Pine Woodland

powerline corridors has resulted in loss of the pitch pine canopy but mostly allowed for

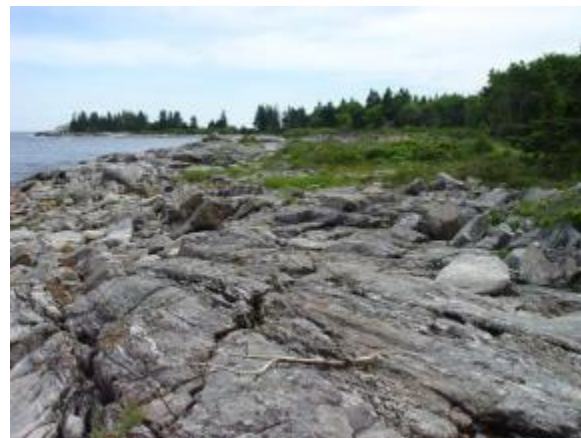
Open Headland at Reid State Park

Open Headland occurs along the majority of the shoreline between the north end of Mile Beach and the north end of the park, and includes the shores of Outer Head Island. These bedrock outcrops and ledges provide the immediate coastline with excellent protection from the ocean, especially in high tide and

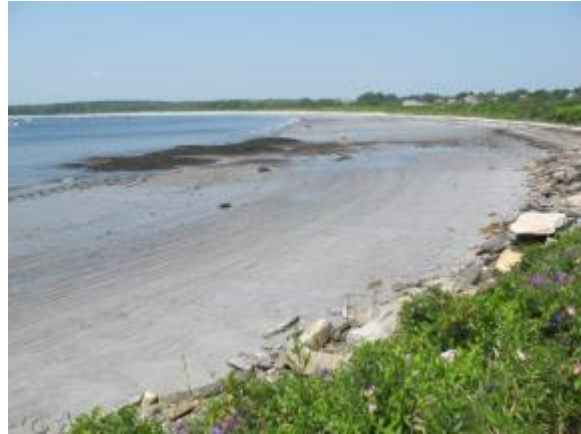
Sandy bottom area at Crescent Beach S.P., portion of beach that receives regular tidal submergence

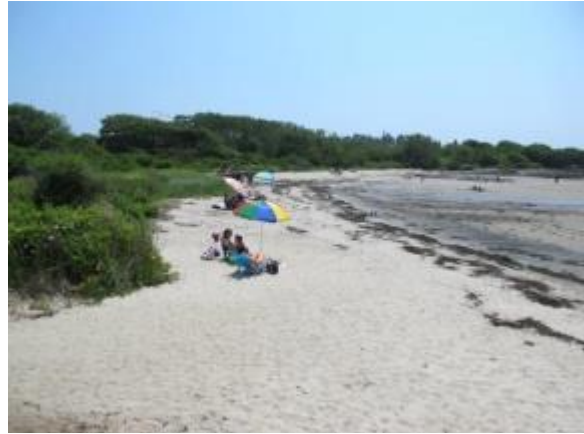
Beach Strand at Kettle Cove S.P., sparsely vegetated area above the regular tide

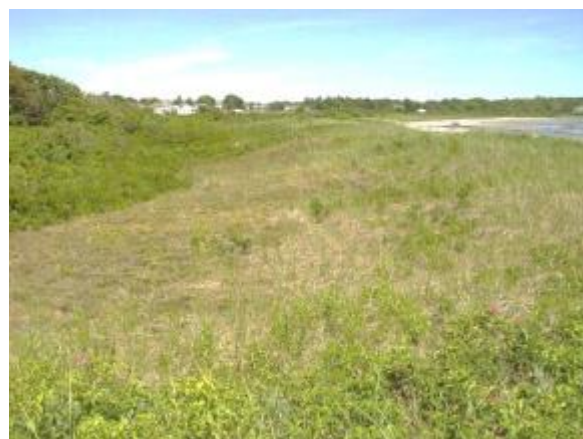
Dune Grassland - west end of Crescent Beach

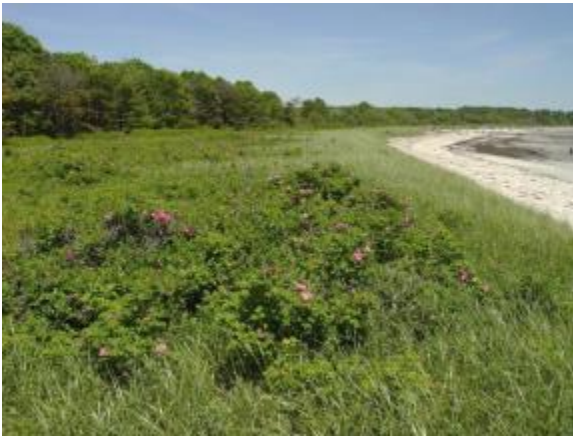
Large patch of the coastal invasive rugosa rose in the Dune Grassland at Crescent Beach

If resources and invasive species management technologies allow, some consideration should be given to limiting the impacts of invasive species in the rare Dune Grassland. Rugosa rose is already abundant at the west end of Crescent Beach and could, overtime spread throughout the Dune Grassland. Invasive shrubby honeysuckle is also capable of colonizing this community type but was not noted there during recent surveys. Periodic monitoring of the Dune Grassland could help prevent the colonization by this species.

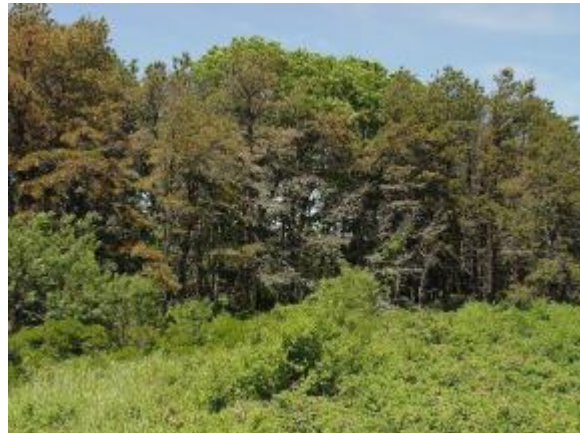
Pitch Pine Dune Woodland at Crescent Beach S.P. The noticeable brown color of the pitch pine needles indicates current tree stress at this site.

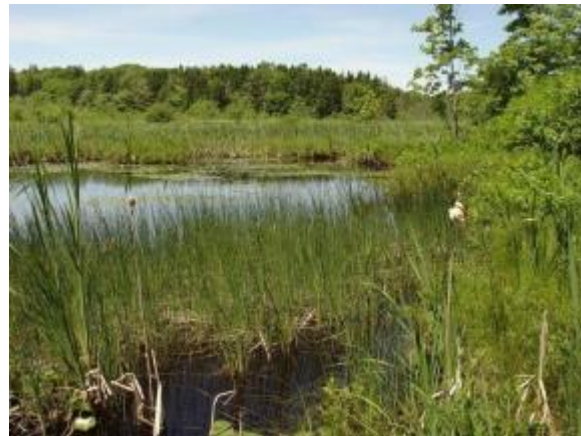
Cattail Marsh in the wetlands behind the west end of Crescent Beach

Cattail Marsh is present in three areas at Crescent Beach State Park. The largest, most intact area (~ 7 ac) occurs in a broad margin around the open water marsh on the west side of the park, just north of the pitch pine dune woodland. This area of marsh is dominated by high cover of broad leaf cattail (*Typha latifolia*). Given the low elevation of this area, and the direct connection of its drainage channel to the beach front, it is possible the marsh is subject to saltwater intrusion at astronomical high tides or during intense storm events. With two feet of sea level rise, about 15% of the large Cattail Marsh at Crescent Beach would be inundated by seawater at least on the highest annual tide. The More frequent tidal flow into the marsh will alter plant species composition, first to brackish tolerant species, and eventually to salt marsh species. At 3.3' of sea level rise the entirety of this cattail marsh, along with some of the adjacent shrub and forested swamp, will become tidal.

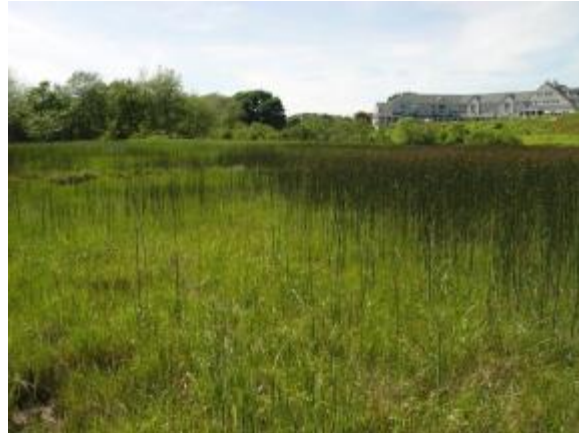
Brackish Tidal Marsh at Crescent Beach S.P.

At Crescent Beach, the Brackish Tidal Marsh is a level, tidally-influenced marsh located behind the dune grassland. It is likely only higher high tides reach the marsh through the relatively small, sinuous drainage channel that cuts through the dune and across the beach. Within the marsh, there are some low hollows and hummocks interspersed with occasional standing water that create varied microhabitats and consequently patch distribution of plant species. The low end of the marsh, closest to the ocean, is dominated by saltmarsh hay (*Spartina patens*). Farther inland narrow-leaved

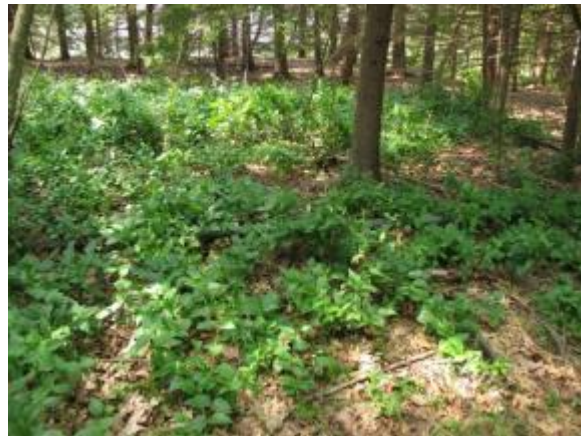
Invasive black swallowwort in the shade of a mixed forest at Two Lights S.P.

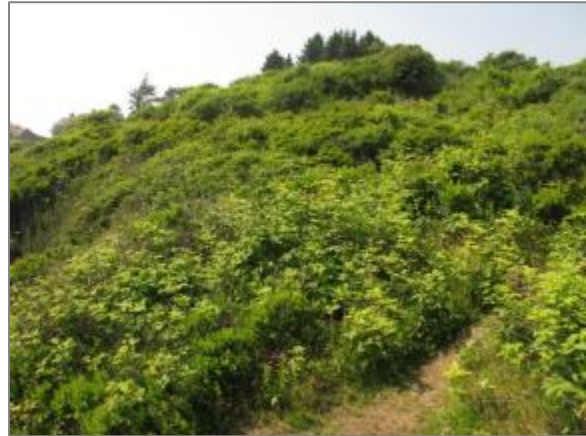
Maritime shrubland at Two Lights S.P.

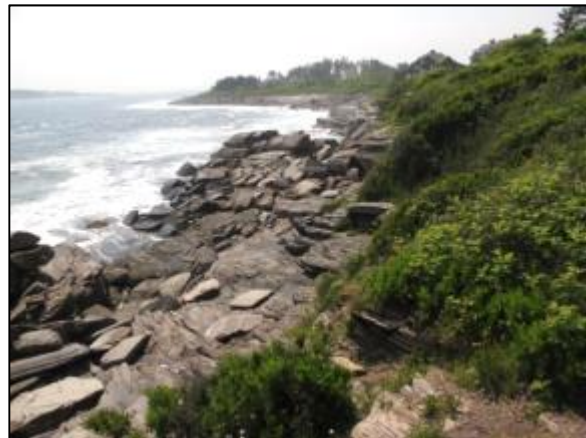
Maritime shrublands on wind swept slopes above rocky headlands at Two Lights S.P.

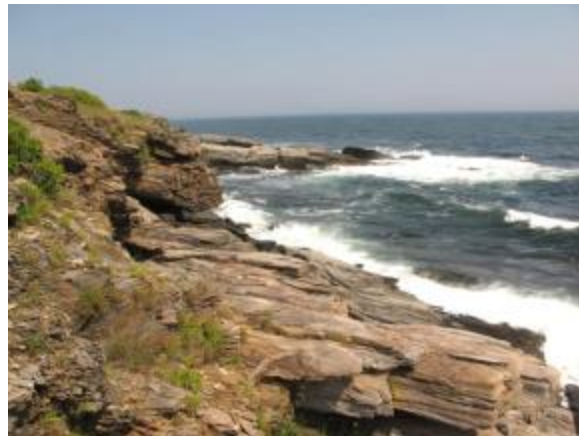
Rocky headland at Two Lights S.P.

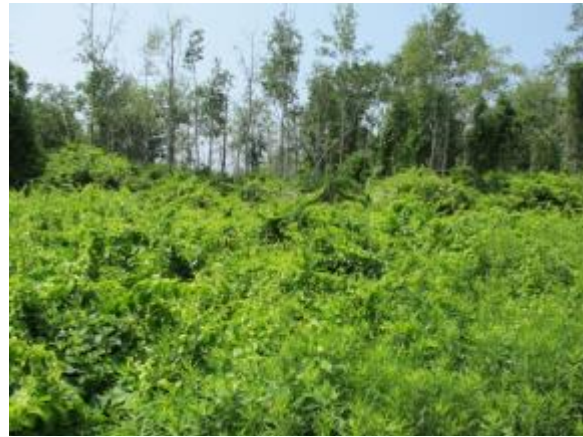
Successional shrubland at Kettle Cove S. P. with a heavy infestation of invasive Oriental bitter-sweet and shrubby honeysuckle

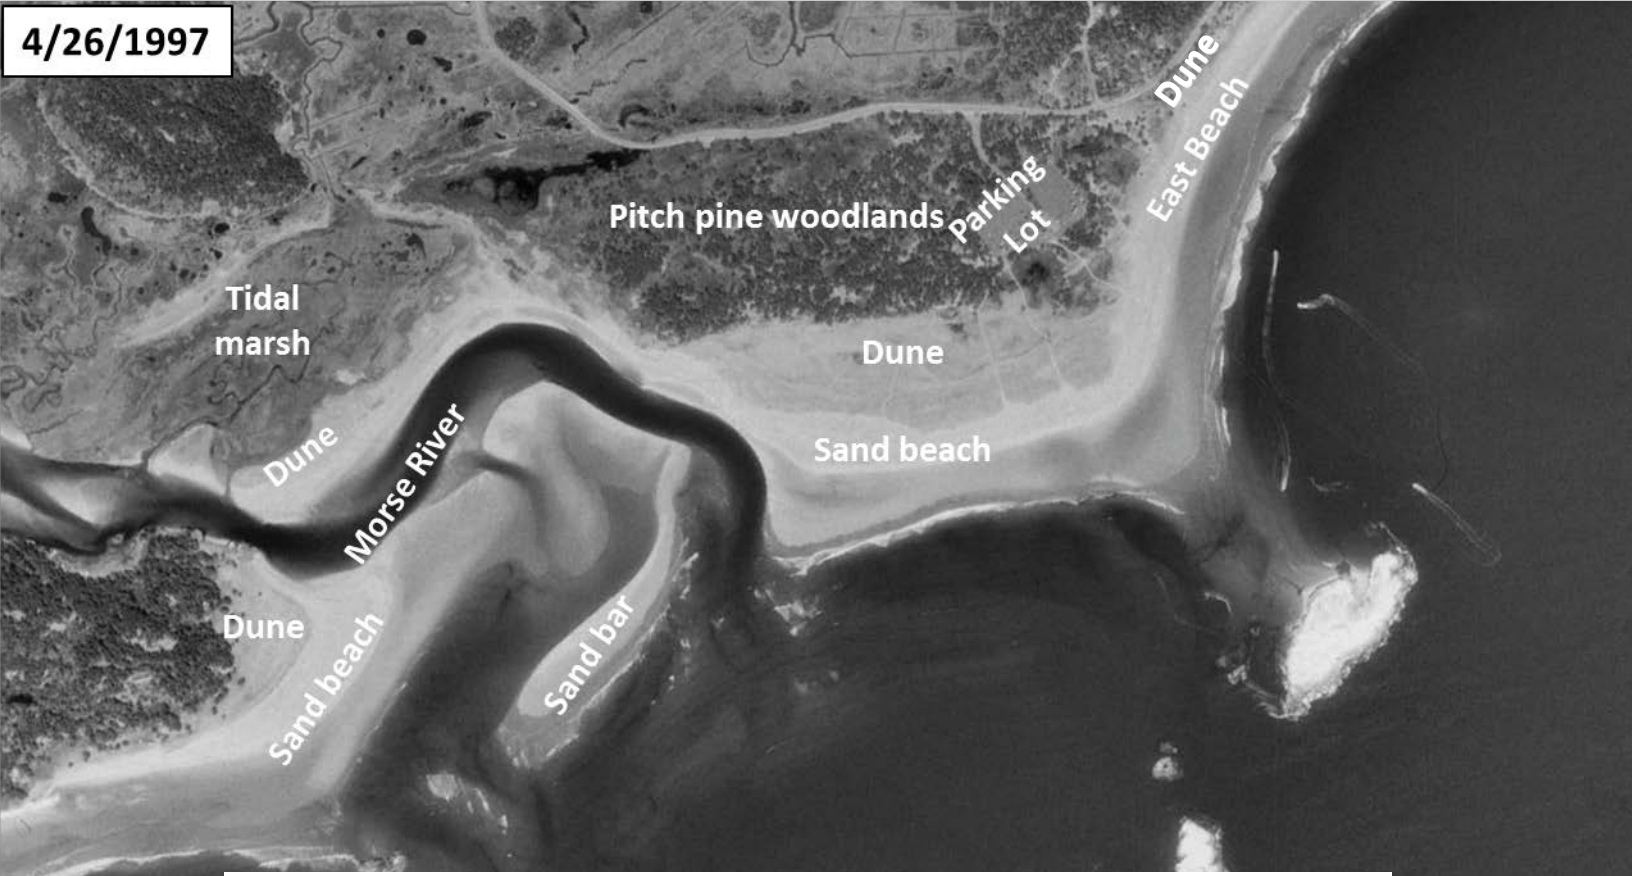
4/26/1997

Figure H-1. 1997 aerial image of the Popham Beach State Park area showing different habitat and beach features in reference to the Morse River main channel. Note the expansive dune system fronting the parking lot. Imagery from GoogleEarth.

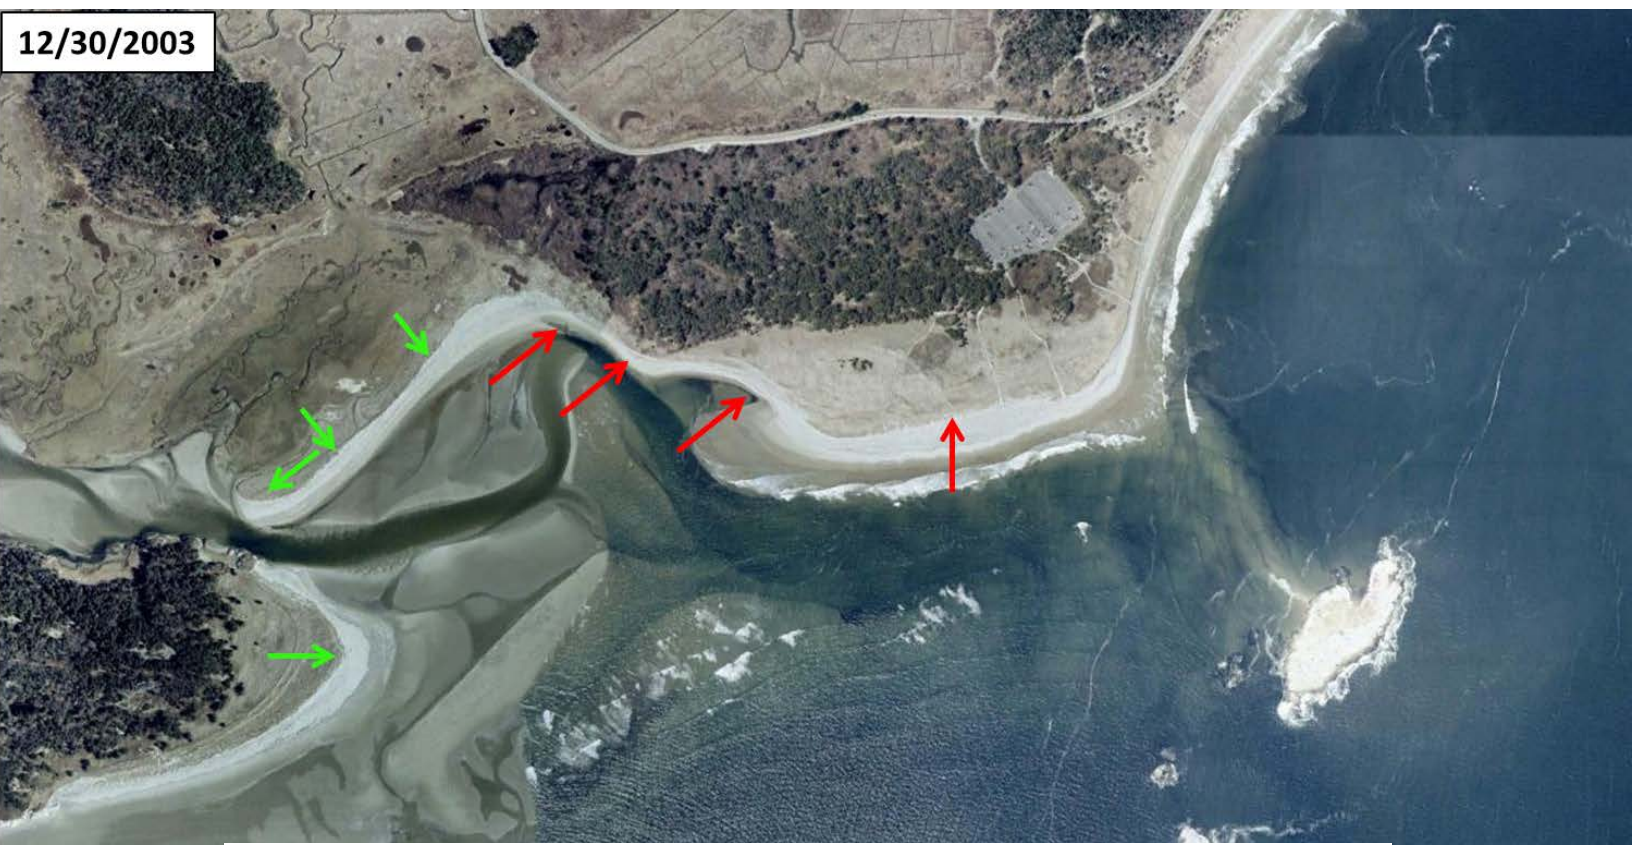
12/30/2003

Figure H-2. 2003 aerial image of the Popham Beach State Park area. Note northeastward migration of the channel and subsequent erosion of the beach and dune.. Note eastward growth of the sand spit at Morse Mountain. Imagery from GoogleEarth.

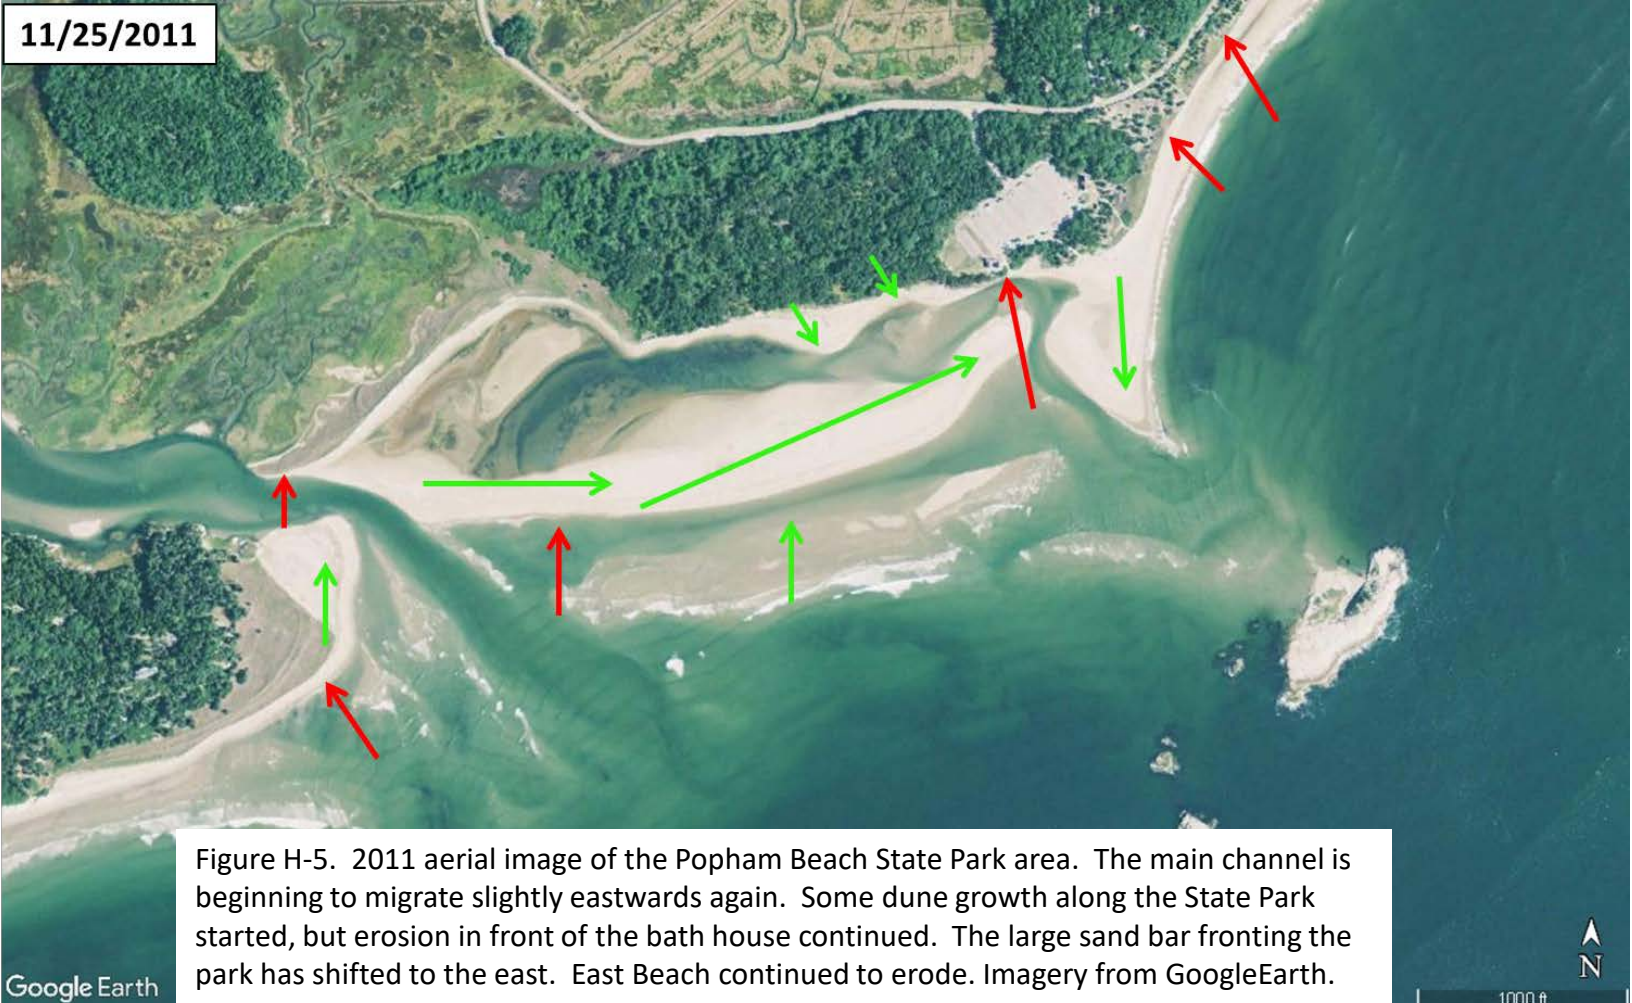
11/25/2011

Figure H-5. 2011 aerial image of the Popham Beach State Park area. The main channel is beginning to migrate slightly eastwards again. Some dune growth along the State Park started, but erosion in front of the bath house continued. The large sand bar fronting the park has shifted to the east. East Beach continued to erode. Imagery from GoogleEarth.

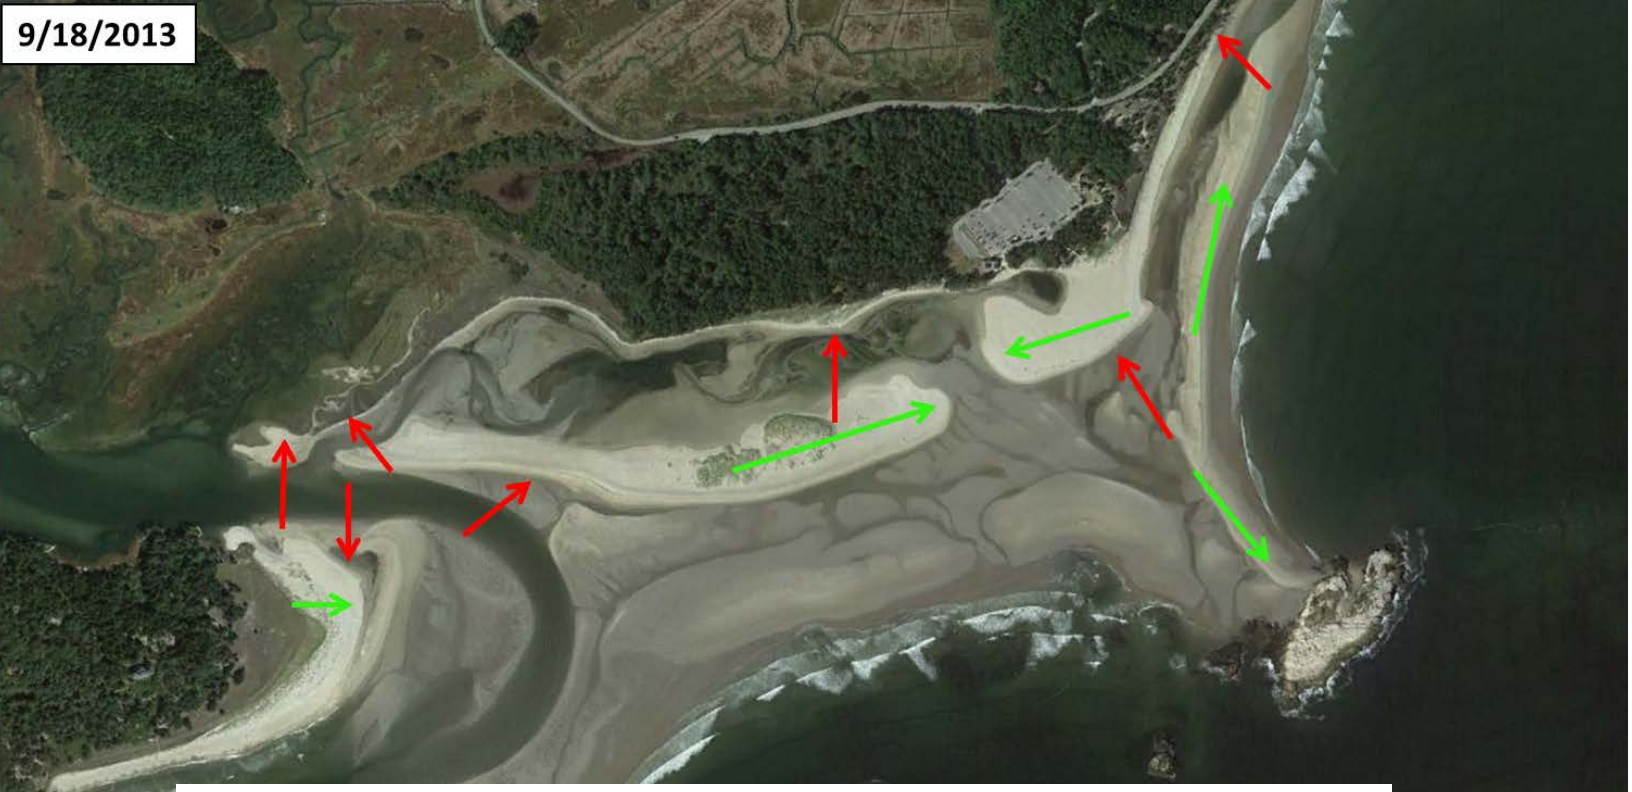
9/18/2013

Figure H-7. 2013 aerial image of the Popham Beach State Park area. The main channel has migrated eastward. The large sand bar has well established dune vegetation, and has moved eastward. The small side channel has appears to be closing. In front of the park, a sandbar has shifted to the west. Note deep trough in front of East Beach. Imagery from GoogleEarth.

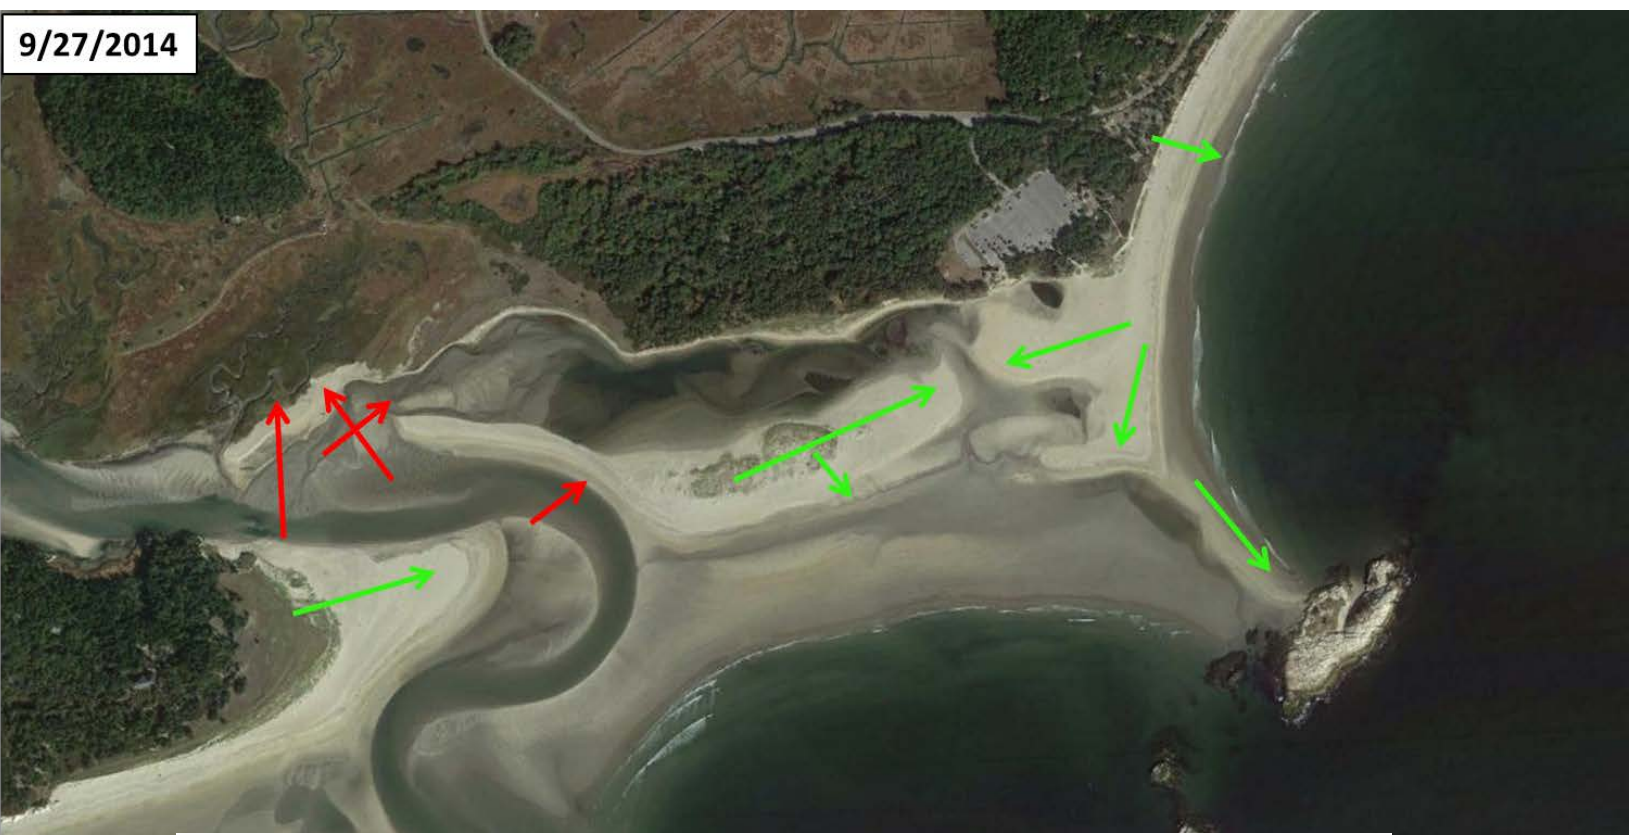
9/27/2014

Figure G-8. 2014 aerial image of the Popham Beach State Park area. The main channel is migrating farther eastward, and is eroding the large sand bar. The small side channel has almost closed. In front of the park, a sandbar has shifted to the west, and the beach at East Beach has grown. Imagery from GoogleEarth.
