**Documentary Research and Archaeological
Investigations at the Waite-Kirby-Potter Site,
Westport, Massachusetts**

**Prepared for:
The Community Preservation Committee
Town of Westport
Westport, MA**

**Prepared by:
Katharine M. Johnson and Christa M. Beranek
With contributions by Kathryn A. Catlin and Laura W. Ng
Fiske Center for Archaeological Research
University of Massachusetts Boston**

Cultural Resource Management Study No. 37

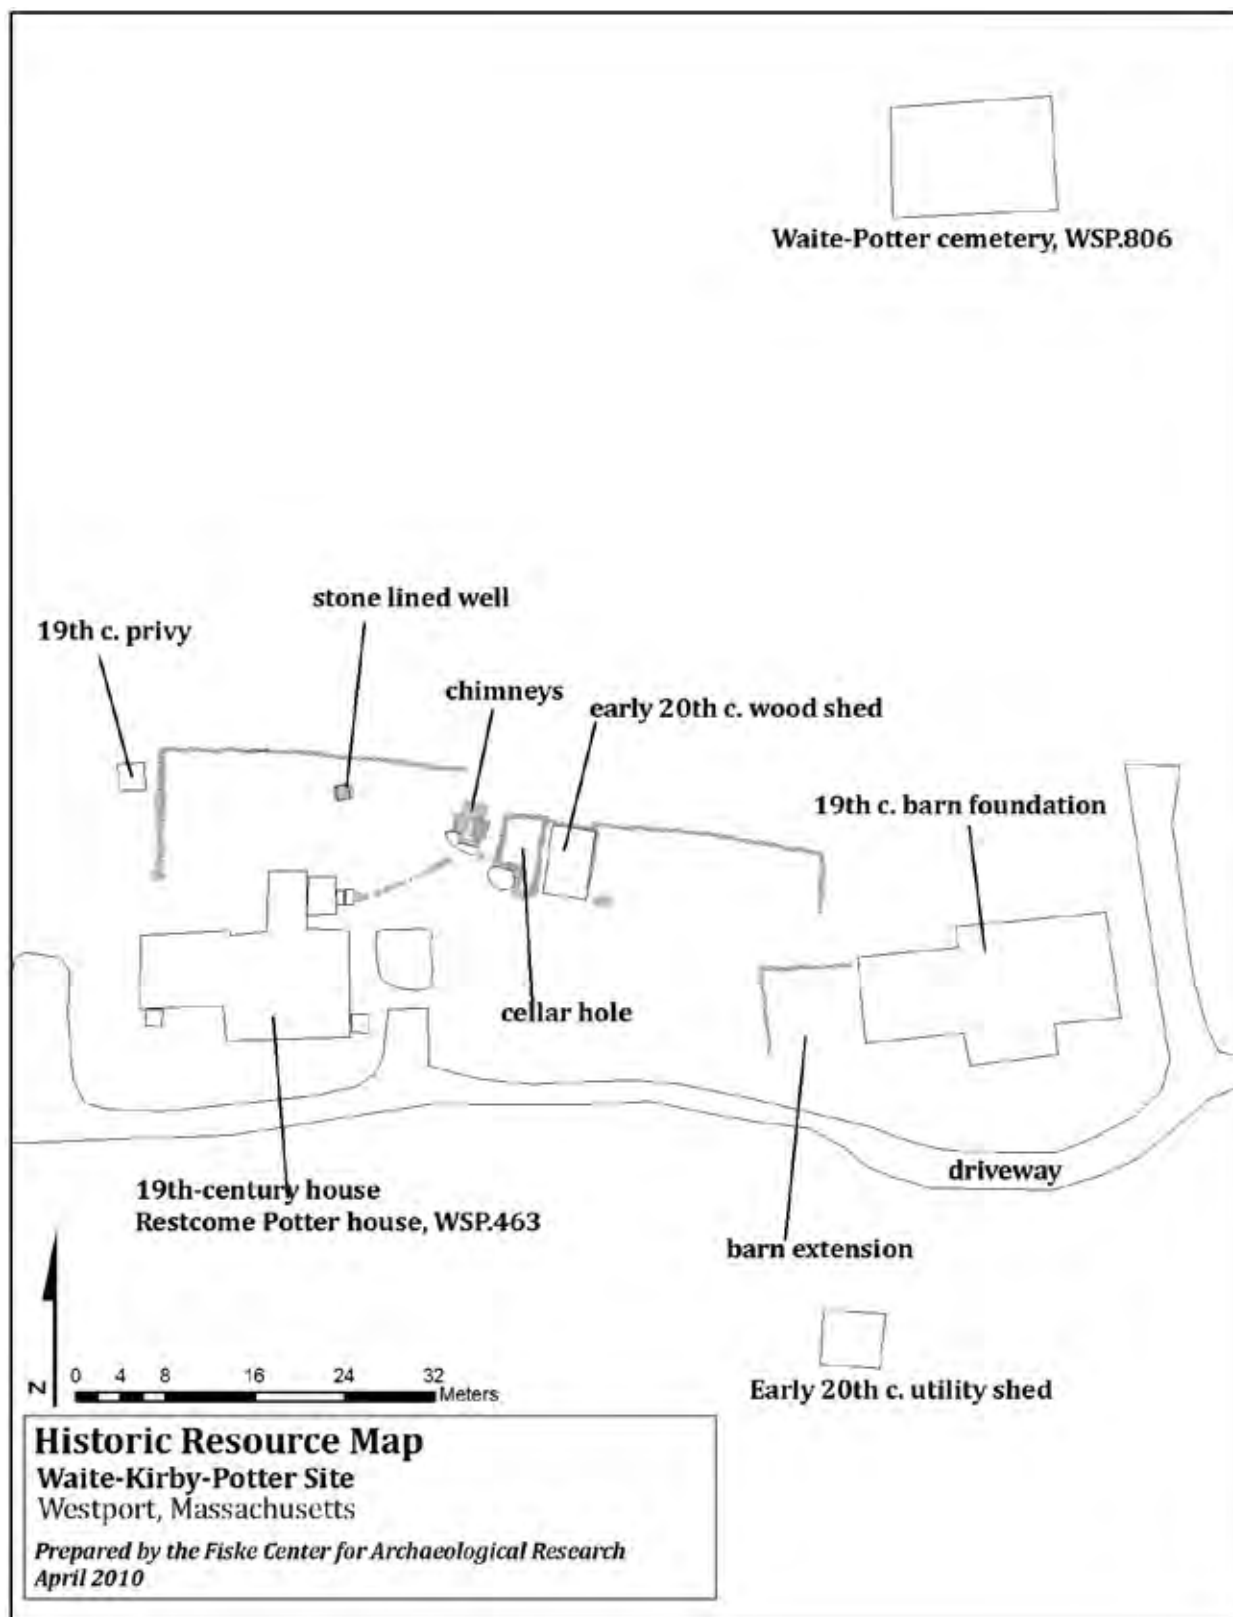
Figure 1.4: Overview of all above-ground cultural resources on property.

property that relate to its use in both agricultural and domestic contexts (Figure 1.4). These include a 19th-century barn foundation, privy (Muriel Bibeau, personal communication, 2009), and the farmhouse mentioned earlier. These elements are integral to the site because they exemplify the continued use of the property from the early 18th century to the present, a common characteristic of many farmsteads in this region.

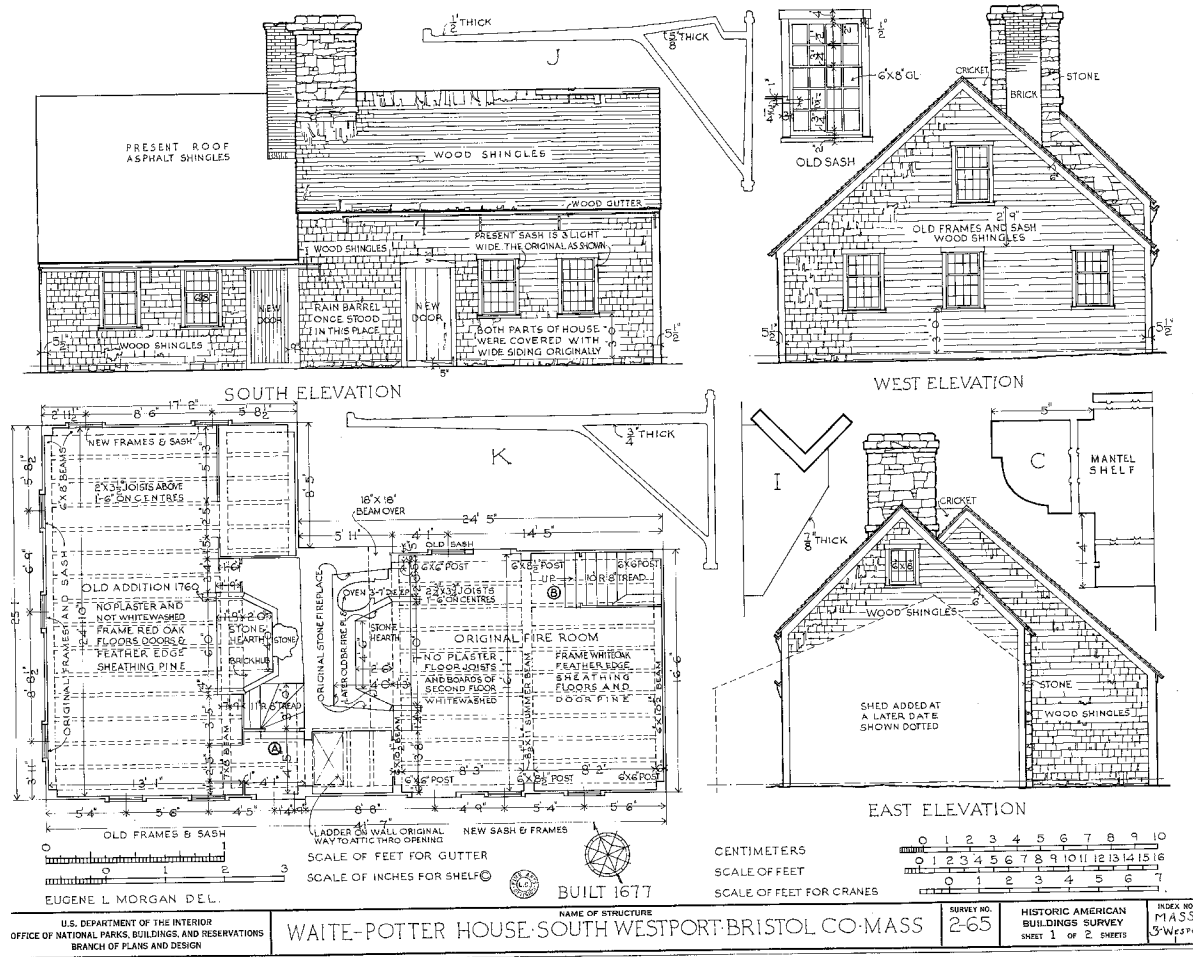
Figure 1.8: 1934 HABS plan of the Waite-Kirby-Potter House (HABS MASS 3, Wespos 1, plan 1 of 2).

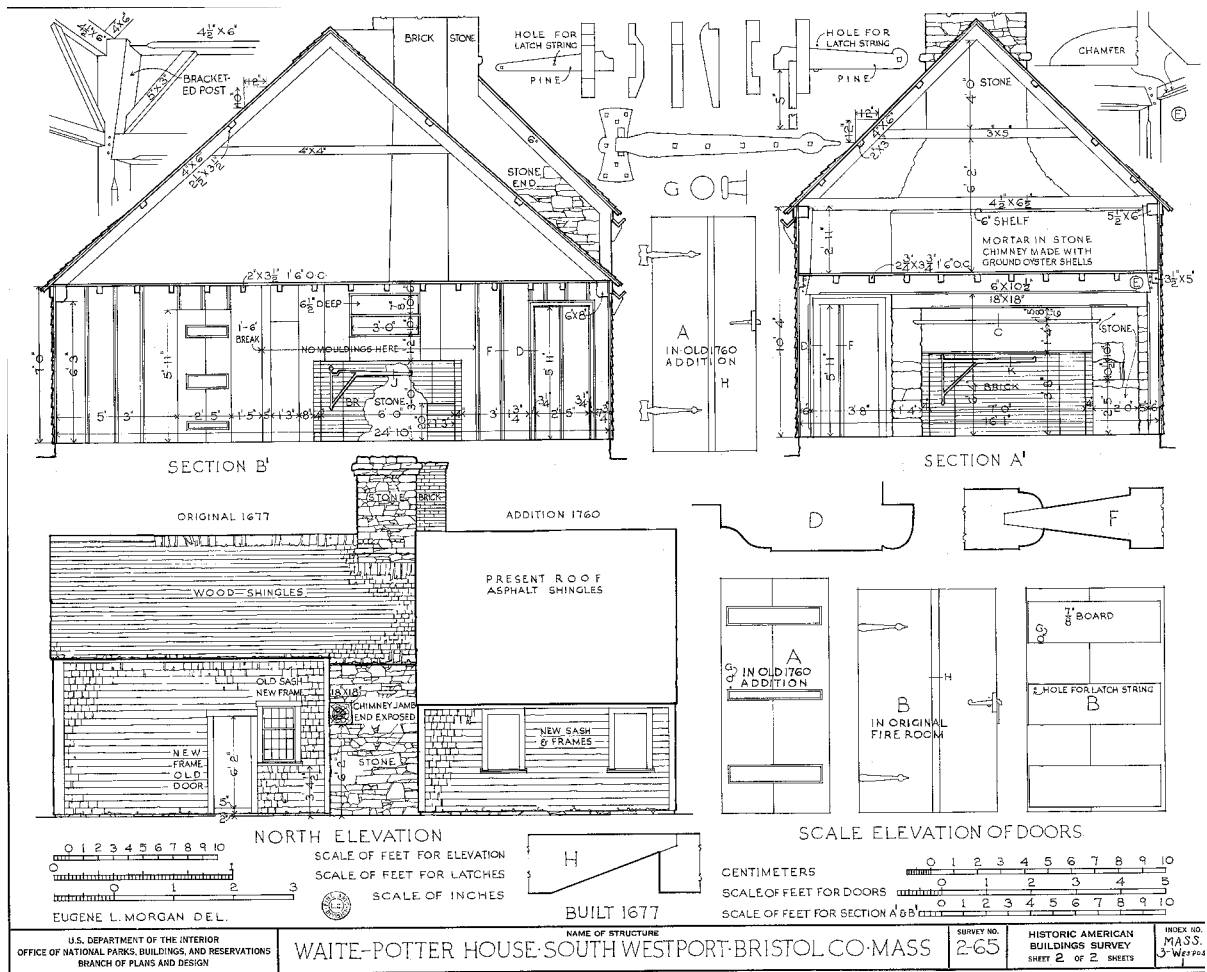
Figure 1.9: 1934 HABS plan of the Waite-Kirby-Potter House (HABS MASS 3, Wespos 1, plan 2 of 2).

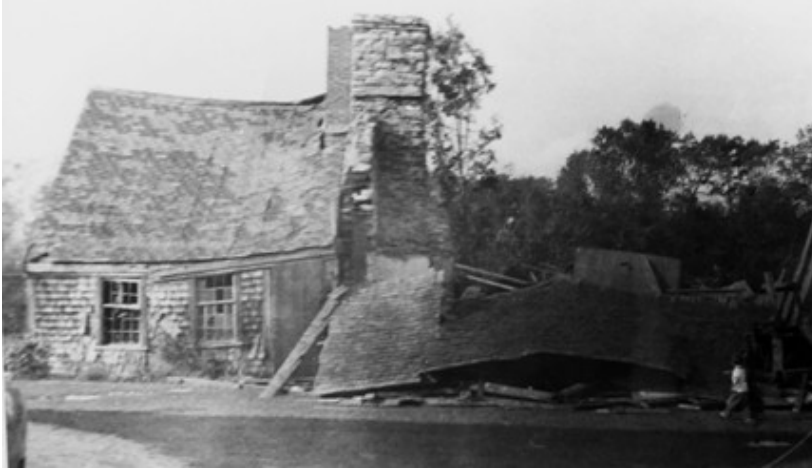
Figure 1.11: Waite-Kirby-Potter house after 1954 hurricane (Courtesy M. Bibeau).

In 1954, the eastern (older) half of the house was destroyed and the western half badly damaged by Hurricane Carol. The western half was taken down between 1956 and 1960 because it was so badly damaged and unstable (Figure 1.11). Some of the wood and other parts of the western half of the house were sold by Alice Potter to Carlton Brownell who at the time was President of the fledgling Little Compton Historical Society in that town just to the west (Muriel Bibeau, personal communication). By the 1950s Carlton was in the process of restoring the 17th-century Wilbor House to become a house museum, and he used many wood planks and doors in the Wilbor House that had once been part of the Waite-Kirby-Potter house (Carlton Brownell, personal communication). For example, large wooden planks now extant in the Wilbor House "long kitchen" were taken from the Waite-Kirby-Potter house's western addition and support the oral tradition that this part of the house may have been used as a workshop (Figures 1.12 and 1.13). At least one object from the house, a wooden chest marked P.G. Potter, also entered the collections of the Little Compton Historical Society (catalog #1979.119).

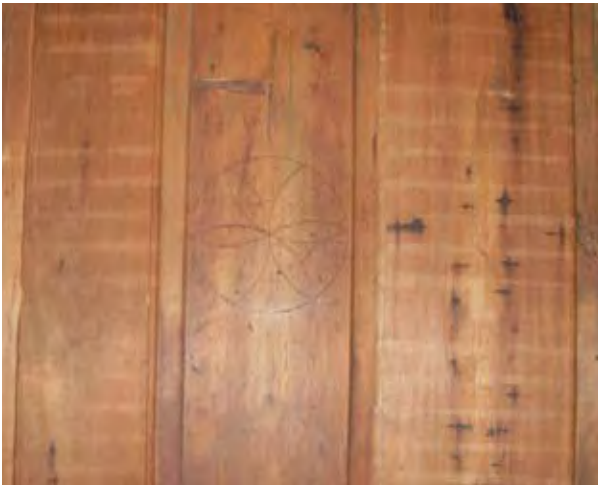
Figure 1.12: Compass carvings and lath/plaster marks on reused board sheathing currently in the Wilbor House in Little Compton, but salvaged from the Waite-Kirby-Potter house in the 1950s. (Courtesy Little Compton Historical Society).

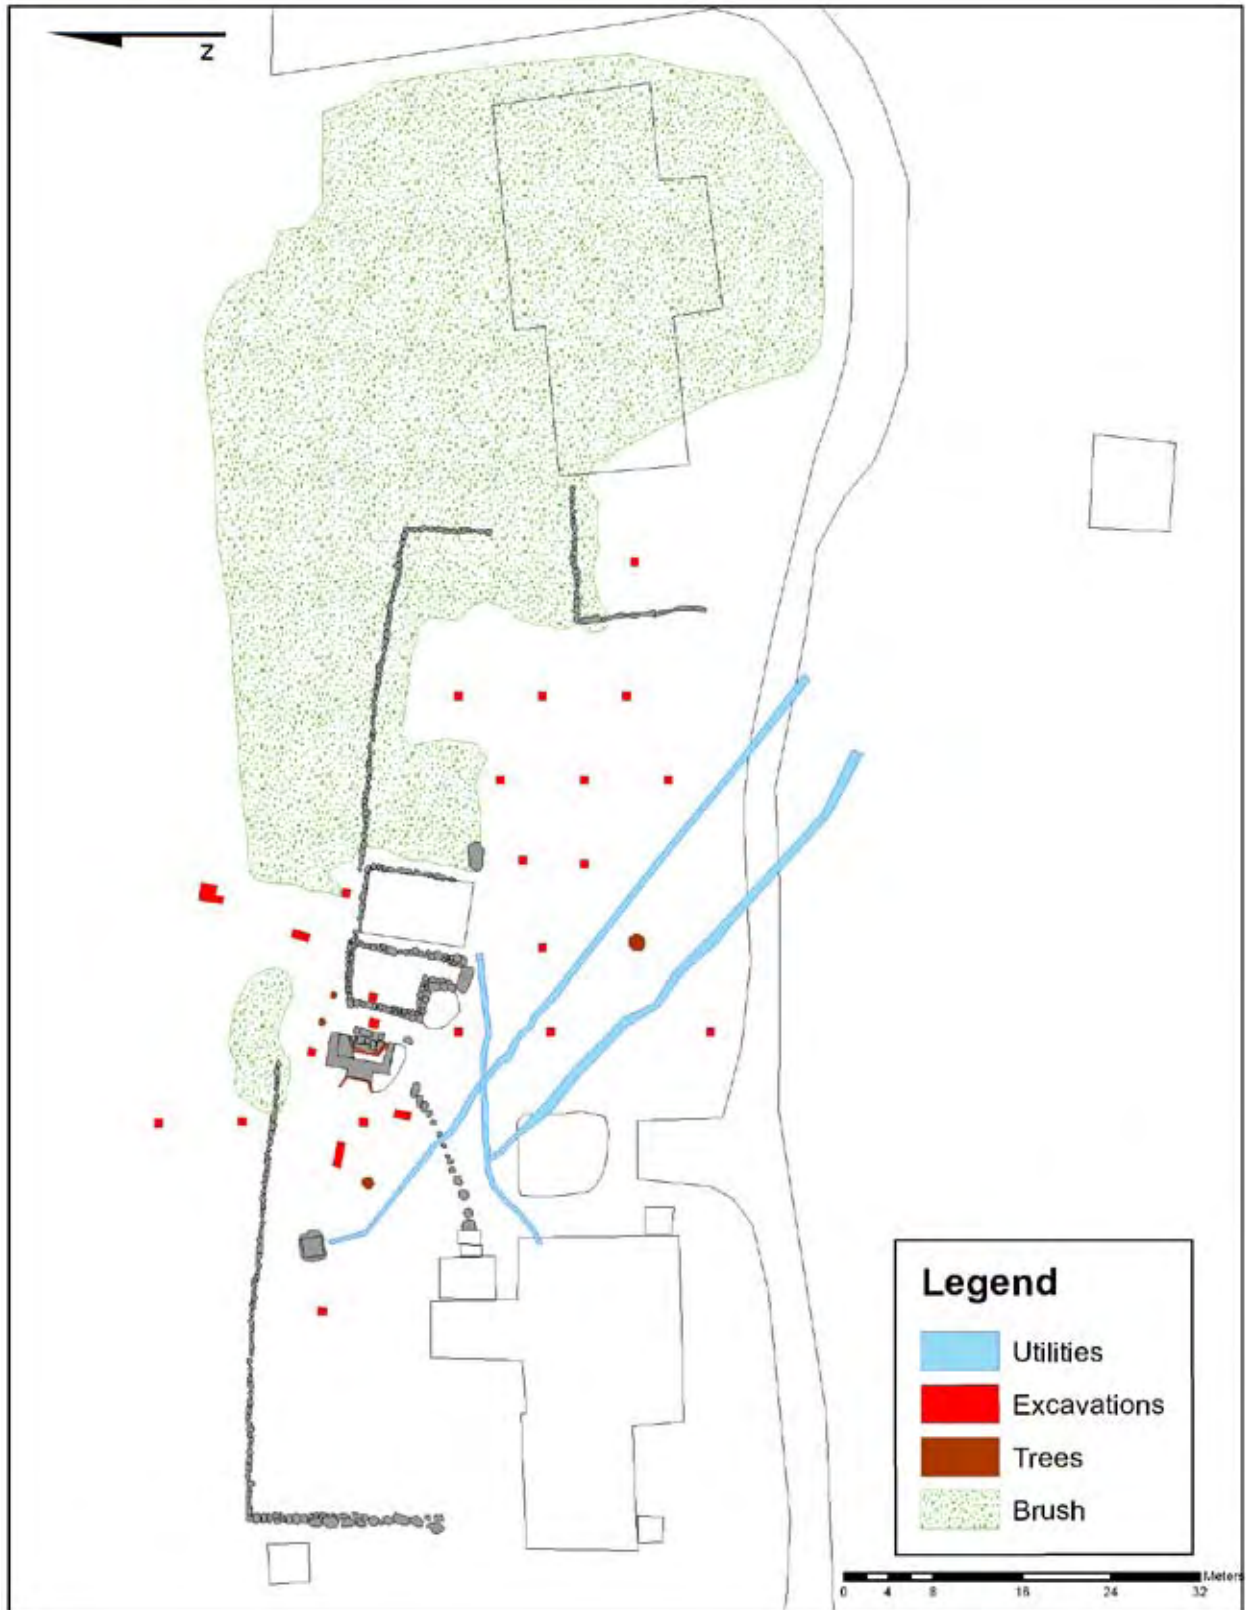
Figure 2.1: Map of excavation areas, utilities, surface conditions, and historic structures.

The survey, in addition to archaeological excavation, included a walkover of a larger area to assess other cultural resources visible on the surface (Figures 1.4 and 2.1). This also included a walkover of the two adjacent plowed fields. Surface features were then mapped using a Topcon single-operator transit and are included in our site plan. This part of the survey was successful in locating and digitally mapping the foundation of a 19th-century barn on the property, as well as the location of an early 20th-century utility shed, and the location of the Waite-Potter burying ground (WSP.806), containing members of the Kirby family.

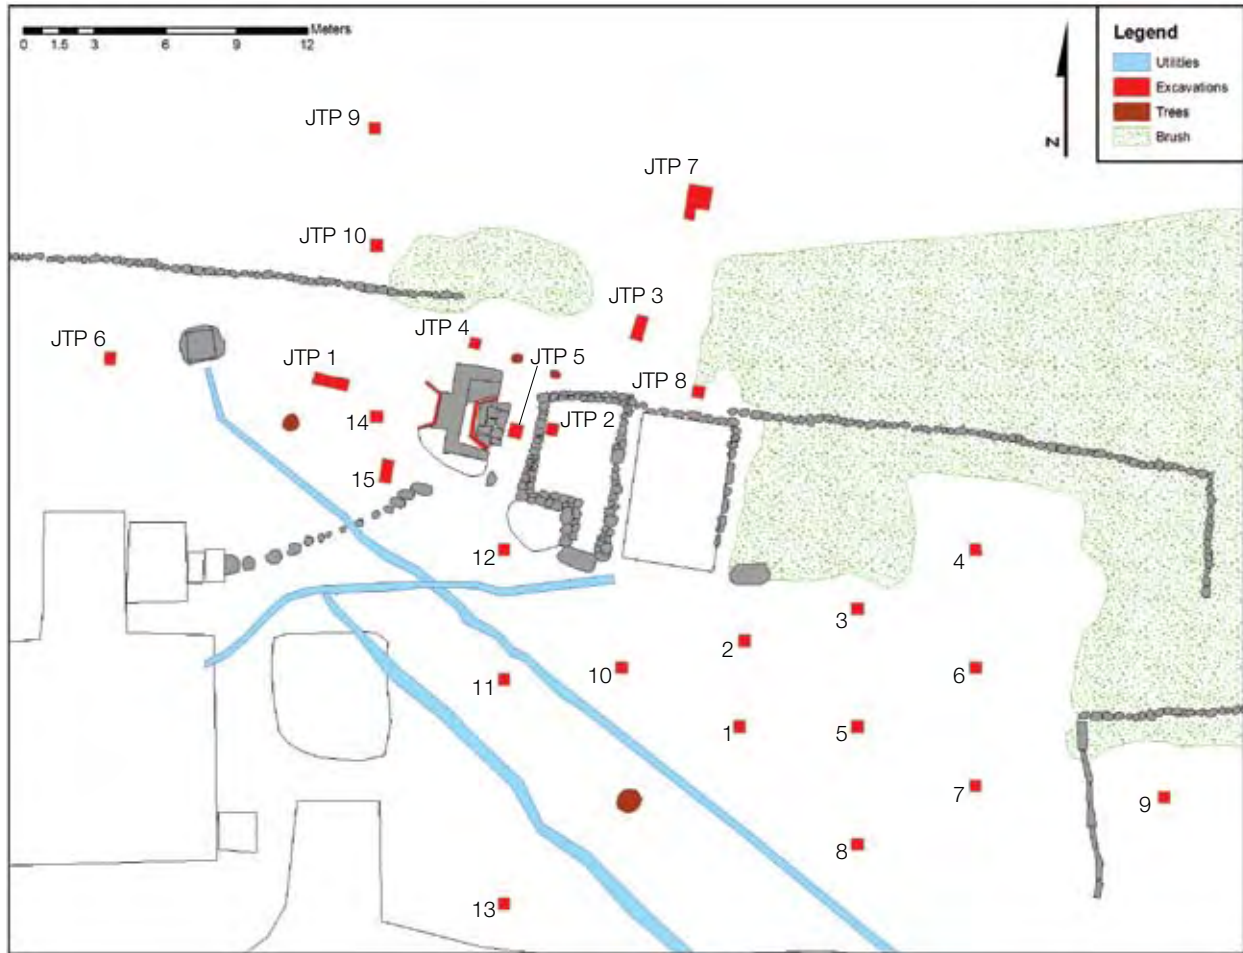
Figure 4.1: Locations of excavation areas.

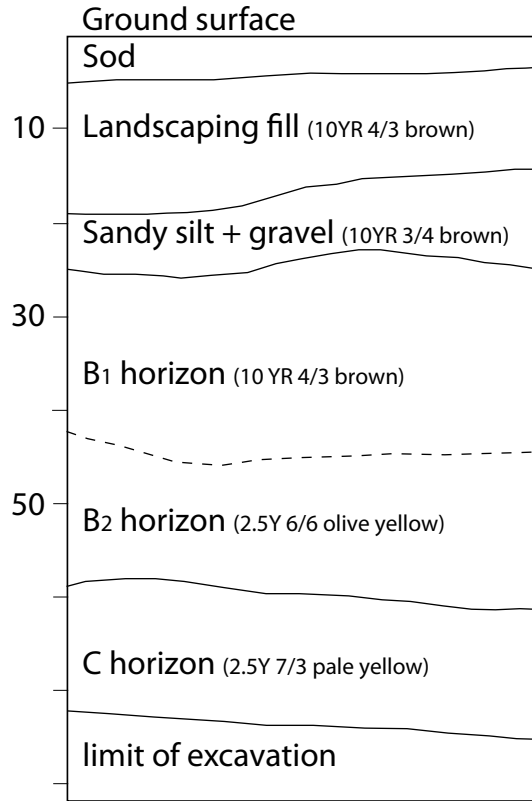
Figure 4.2: Representative profile of STPs in the front yard. The north wall of STP 2 is shown.

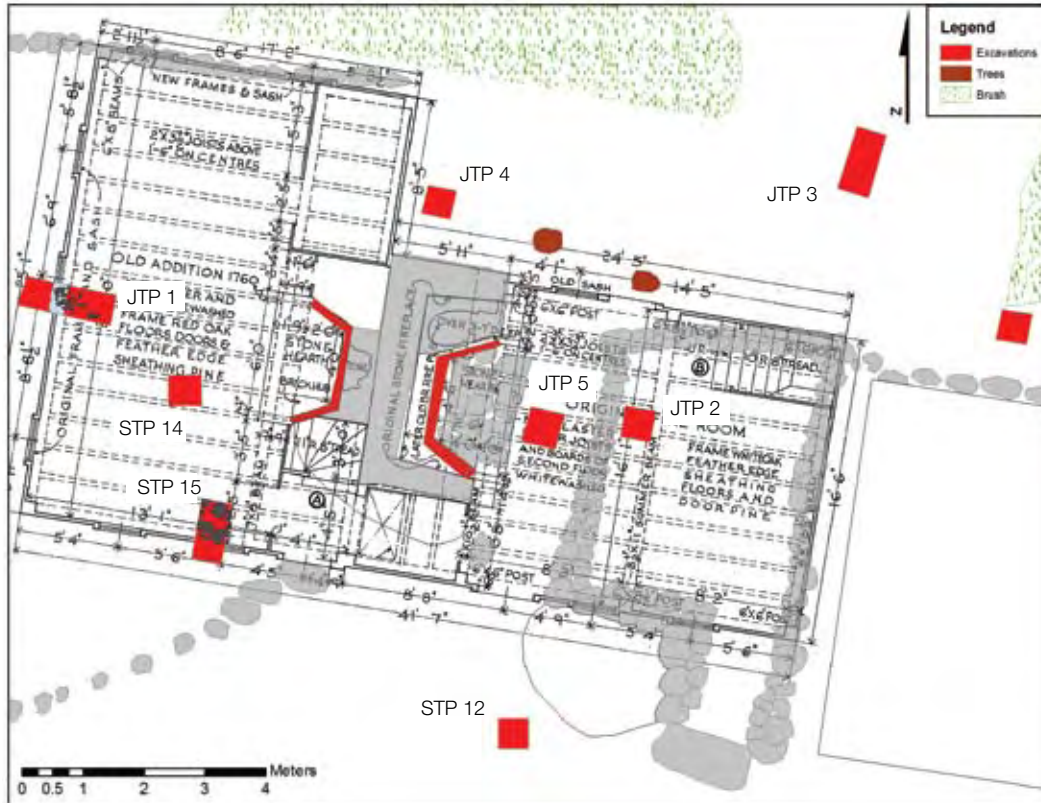
Figure 4.3: Plan of excavation areas near and inside the house with the HABS plan overlain.

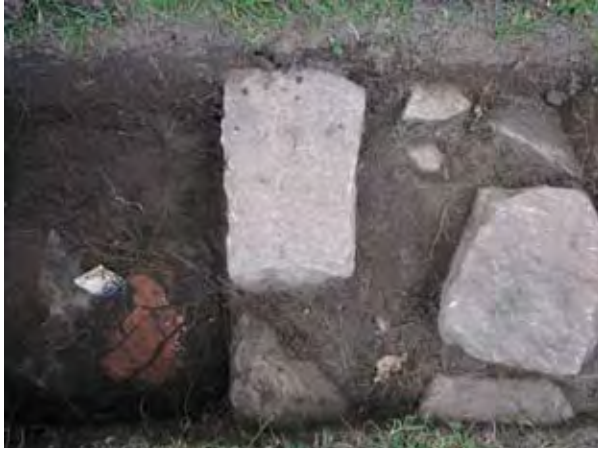
Figures 4.5: In situ ceramics against the exterior of the south foundation wall of the western addition, STP 15. North is to the right.

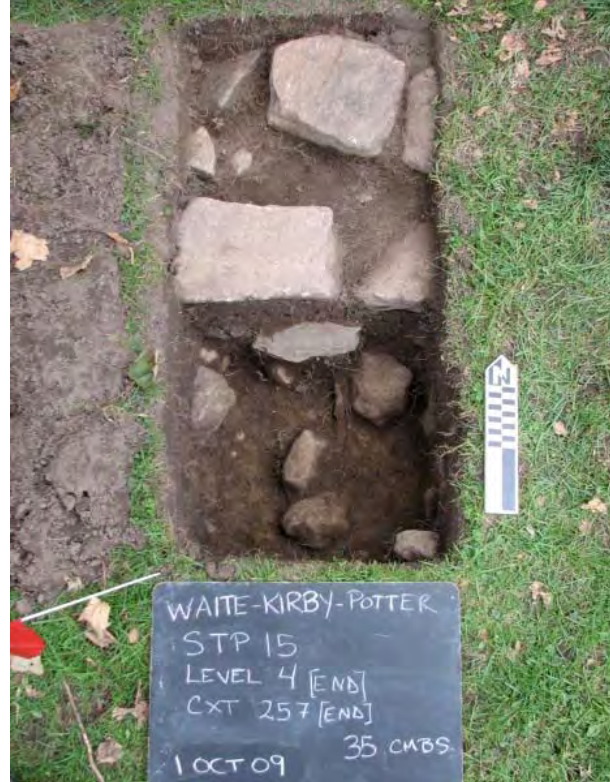
Figure 4.6: STP15 at the end of excavation.

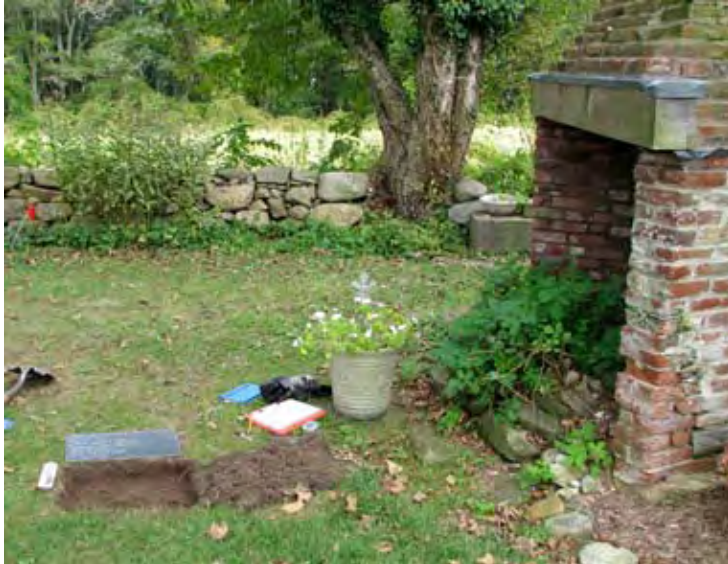
Figure 4.7: STP 14 inside the western addition, during excavation, facing north.

STP 14 was excavated directly west of the brick fireplace (Figure 4.7), in what would have been the interior of the western addition. Since there was no cellar in this part of the house, it was thought that perhaps there might be earlier deposits that had been capped by the 18th-century addition. Although no such deposit was found, the test pit was artifact-dense, likely from objects falling through cracks in the floorboards. The unit was excavated to the depth of 45 cmbs in three strata: topsoil (0-17 cm) which contained most of the artifacts, a mottled level containing charcoal flecks which might have been the old ground surface or the surface under the floorboards (17 to 27 cmbs), and a rapid transition to gravelly, yellowish brown subsoil (excavated to 45 cmbs). Again, most of the artifacts were architectural (nails, window glass, and construction materials). A silver plated spoon marked “Rogers Bros” of an inexpensive pattern manufactured between 1879 and 1915 and

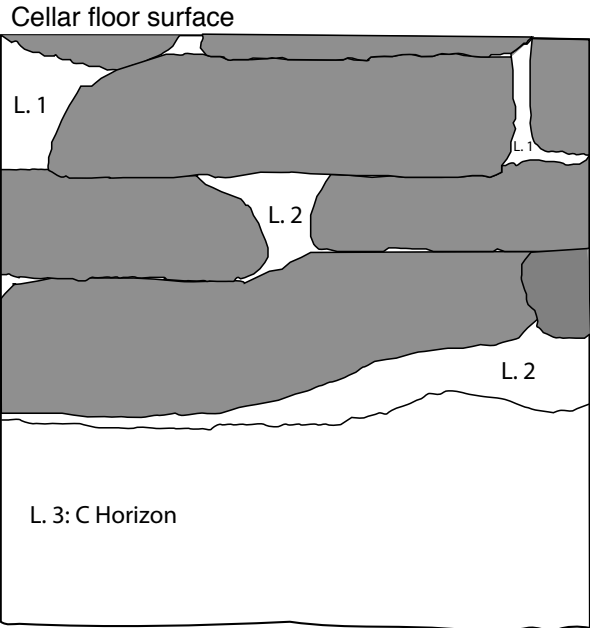
Figure 4.9: West profile of JTP 2 showing cellar wall construction and stratigraphy of the cellar floor.

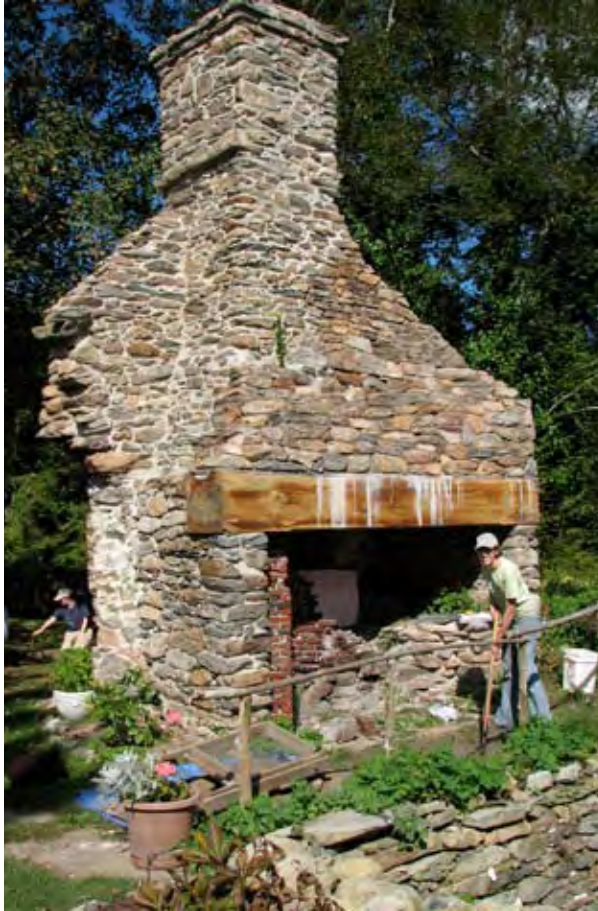
Figure 4.10: Excavation of JTP 5 in progress, facing northwest.

JTP 5 was excavated just to the west of the cellar hole in what would have been the interior of the stone end house. The unit was located between the cellar and the hearth stones of the stone fireplace (Figure 4.10). Although no distinct living surface was found, the top layer which extended to 25 cm below surface had a large amount of architectural debris including bricks marked “B B Co.” Mottling with the 10YR 5/6 yellowish brown subsoil began at approximately 35 cm below surface. Artifacts continued into the subsoil, and this is most likely due to the heavily bioturbated strata by roots and large glacial boulders. The eastern side of the test pit revealed stacked stones, which may be the western side of the cellar wall. This suggests that the hole for the cellar was dug first, and then lined with stones.

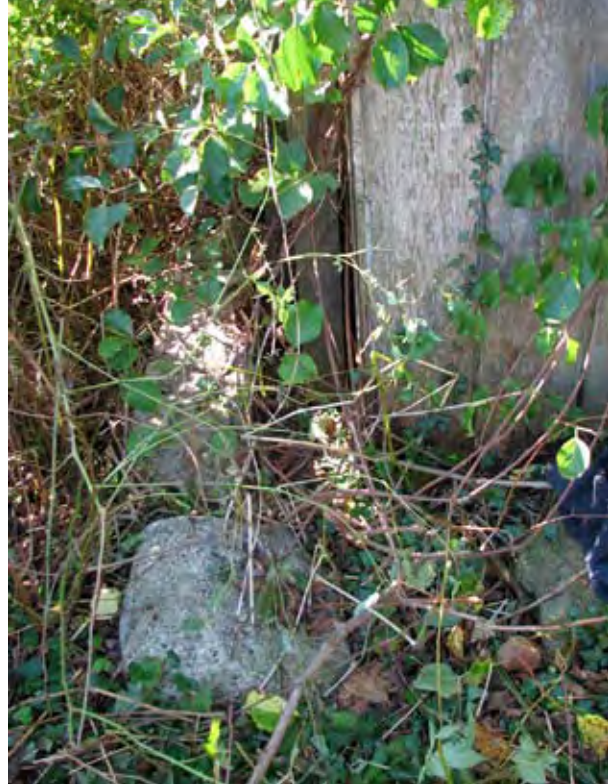
Figure 4.11: Foundation stones for previous shed just outside the northwest corner of the modern shed.

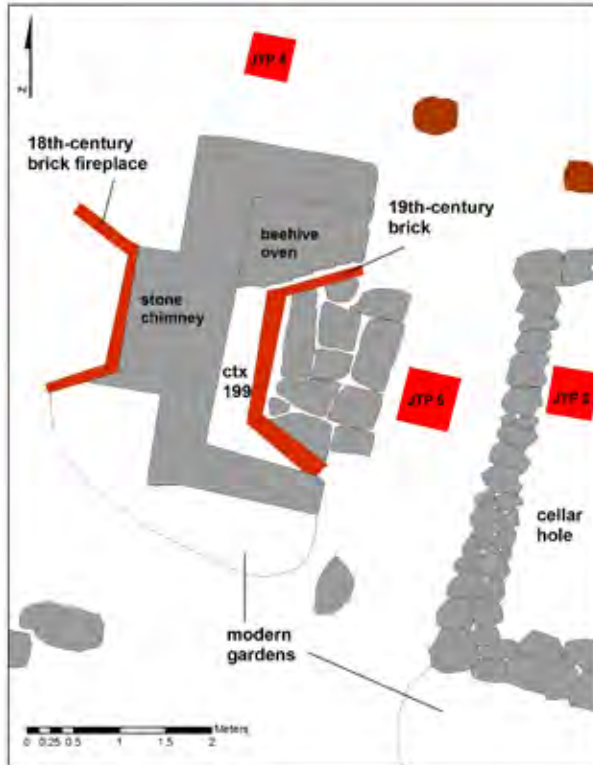
Figure 4.12: Plan of the chimney complex, showing elements from different time periods. North is to the top.

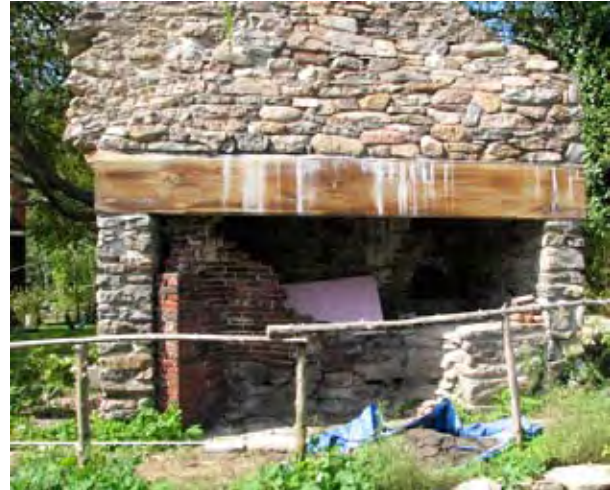
Figure 4.13: The current condition of the east side of the stone chimney with restored stonework and lintel and decaying later brick firebox, facing west.

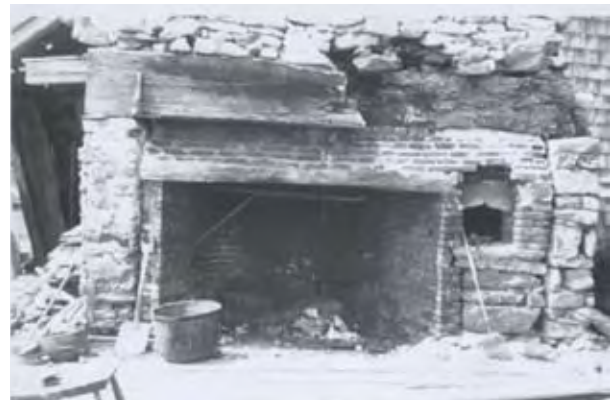
Figure 4.14: Historical photograph of the stone chimney, facing west, with intact smaller brick firebox and bake oven, date unknown, but post 1954. Courtesy of Muriel Bibeau.

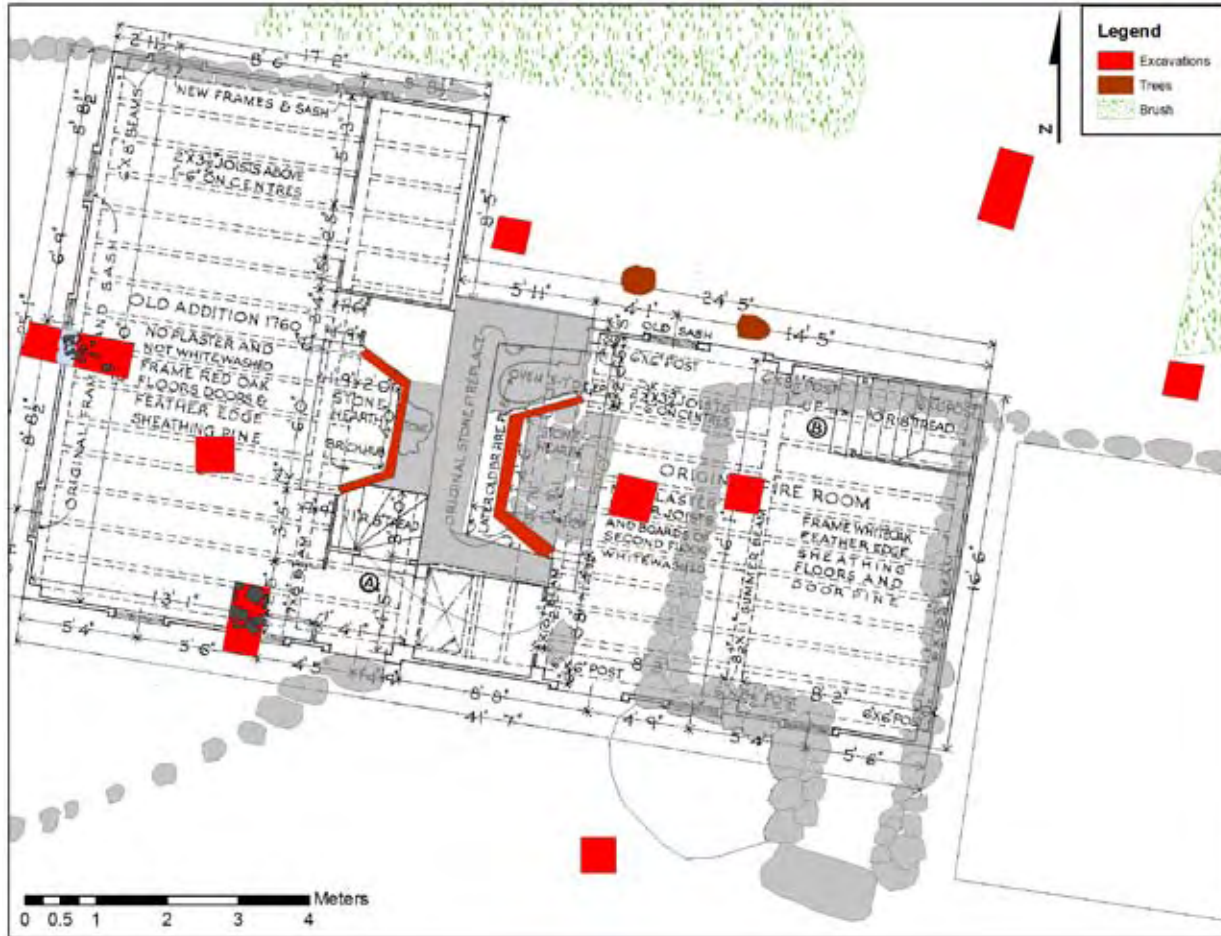
Figure 5.2: The HABS plan of the Waites-Kirby-Potter house superimposed on the map of the cellar hole.

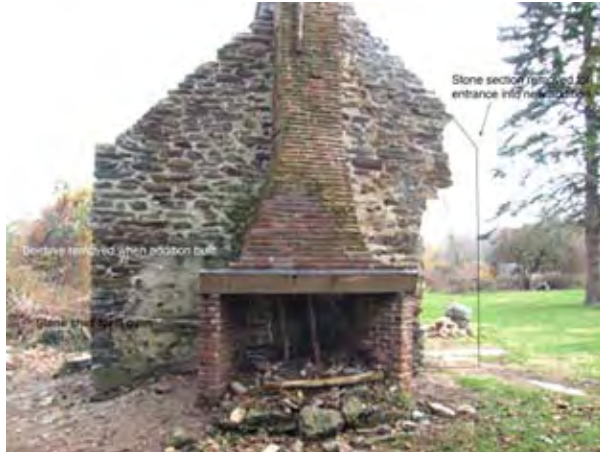
Figure 5.3: Anne Baker's annotated photograph of the west side of the stone chimney showing evidence of the original beehive oven (Courtesy of Anne Baker, 2009).

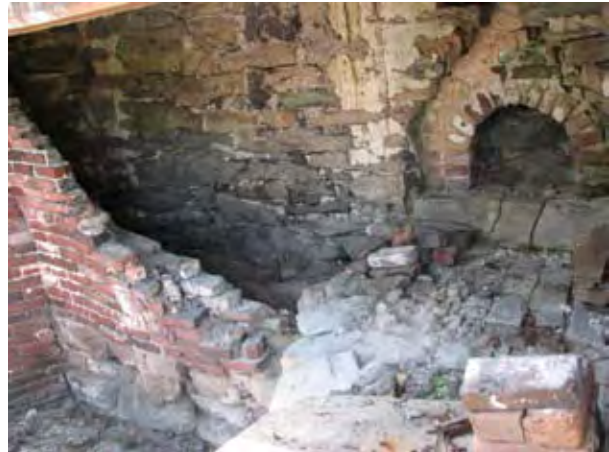
Figure 5.4: The opening for the original bake oven behind the later brick firebox insert in the east hearth.
