## Large Woody Debris on the Carmel River From Camp Steffani To Carmel Lagoon Fall 2015

MacCarter, L., Fields, J., Smith, D.P. 2016. Large Woody Debris on the Carmel River from Camp Steffani to the Carmel Lagoon, Fall 2015: Watershed Institute, California State University Monterey Bay, Publication No. WI-2016-05, 25 pp.

Publication No. WI-2016-05

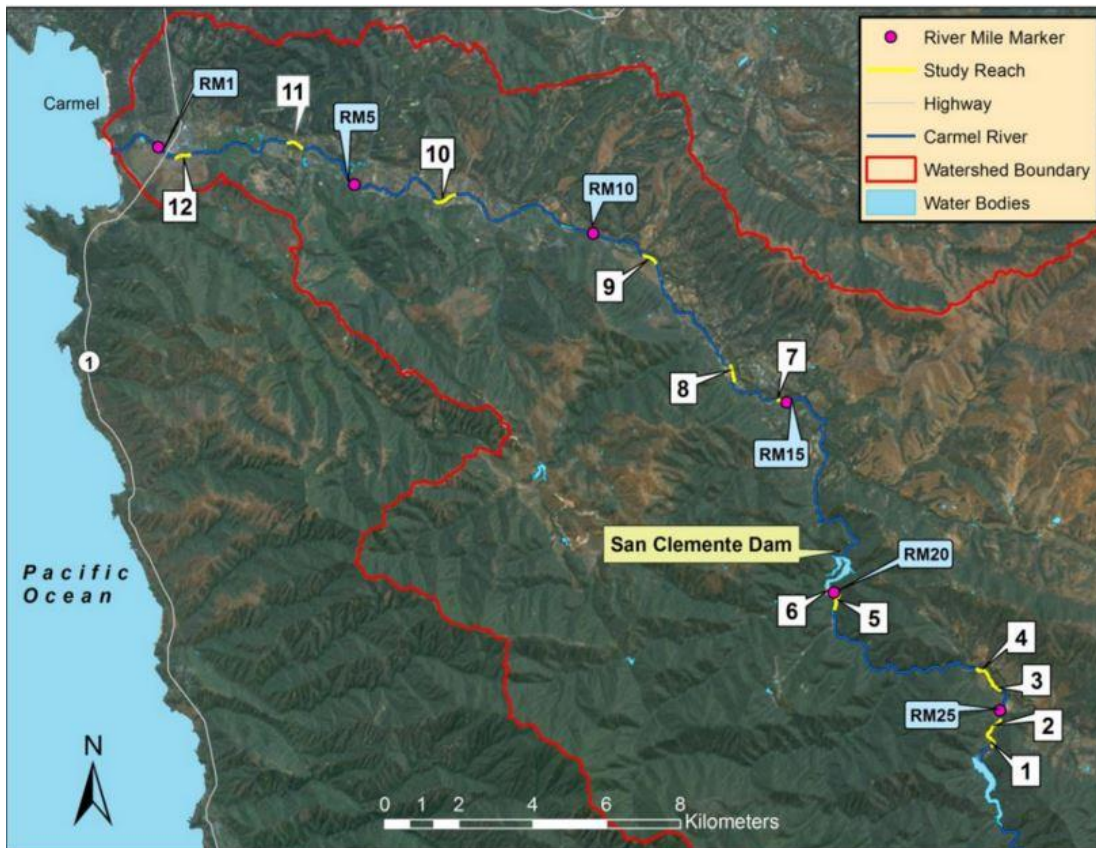
Figure 2. Sample sites of the 2013 LWD survey completed by CSUMB students. The 2013 LWD survey found significantly more wood upstream of the dam (CSUMB 2013).

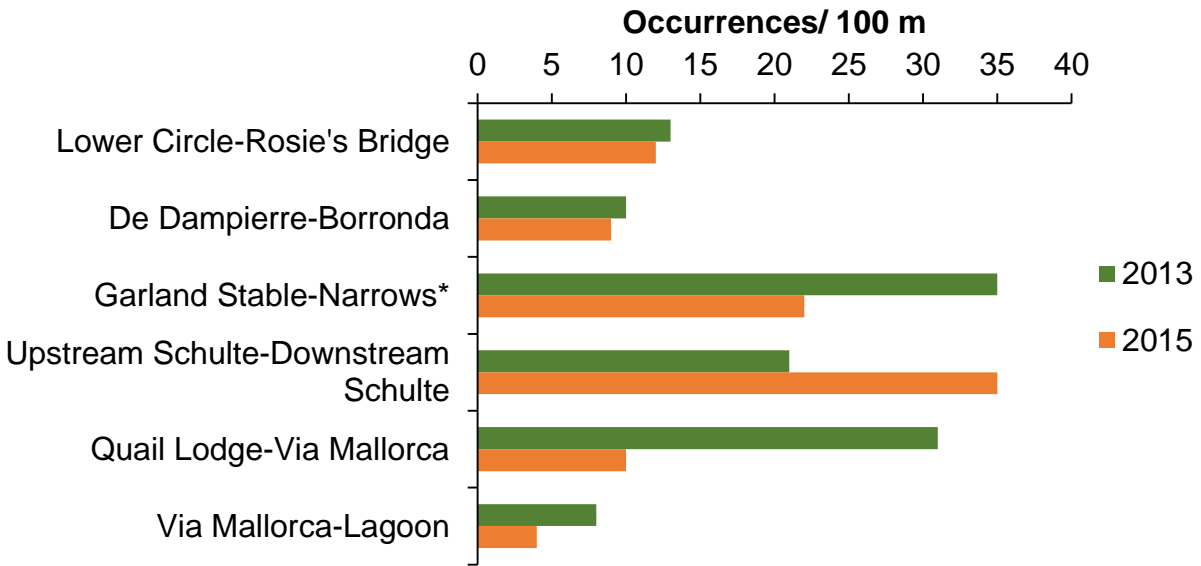
\*The Garland Stable–Narrows 100m reach surveyed in 2013 spanned the divide between two of the 2015 reaches.

**Figure 8. Occurrences of large woody debris (LWD) for 100 m stretches within the specified reach for 2013 and 2015. Accumulations were considered as a single occurrence.**

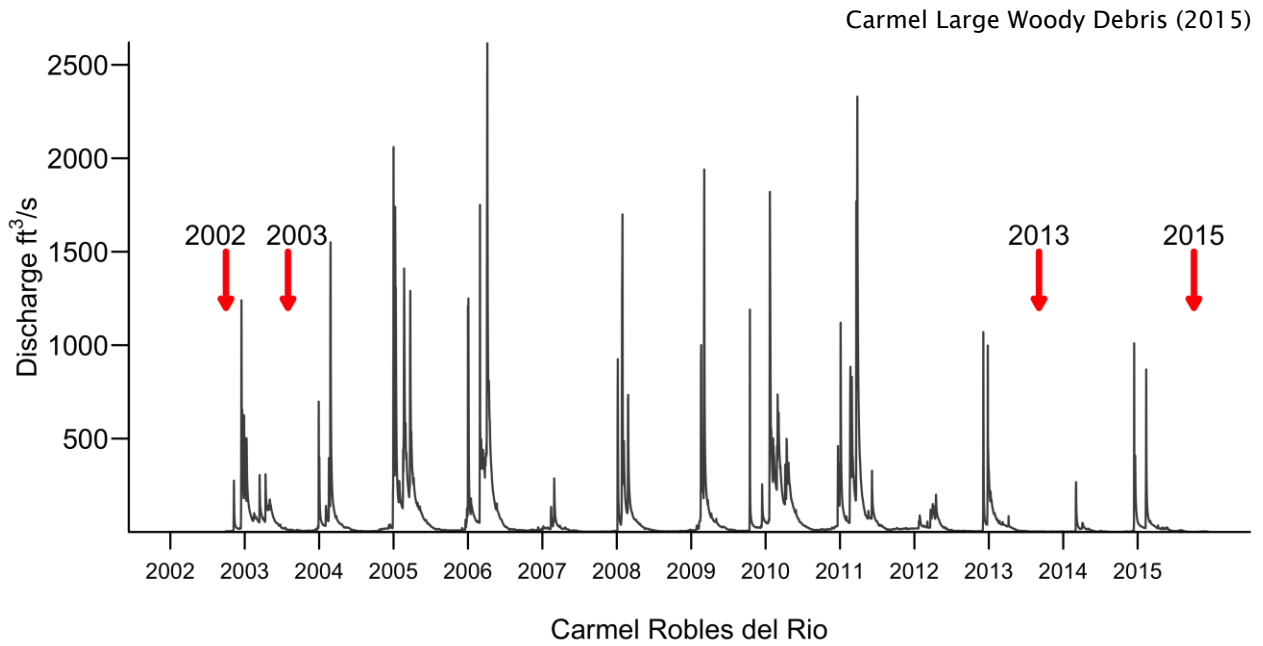
Figure 9. Hydrograph of mean daily stream flow for the Robles del Rio gage on the Carmel River. Red arrows indicate when LWD surveys took place.

LWD densities increased along the entire study area from 2003 to 2015; all reaches had more LWD present in 2015 (Fig. 7). The comparison between the 2013 and 2015 surveys was less consistent; Upstream Schulte–Downstream Schulte had more wood in 2015 and the other 100 m sections had less than 2013 (Fig. 8). Hydrographs of the Carmel River from gages at Robles del Rio (Esquiline Rd.) and Carmel (near Via Mallorca) depict discharge from 2002 to 2015 with arrows indicating the time that LWD surveys occurred (Fig. 9, 10).

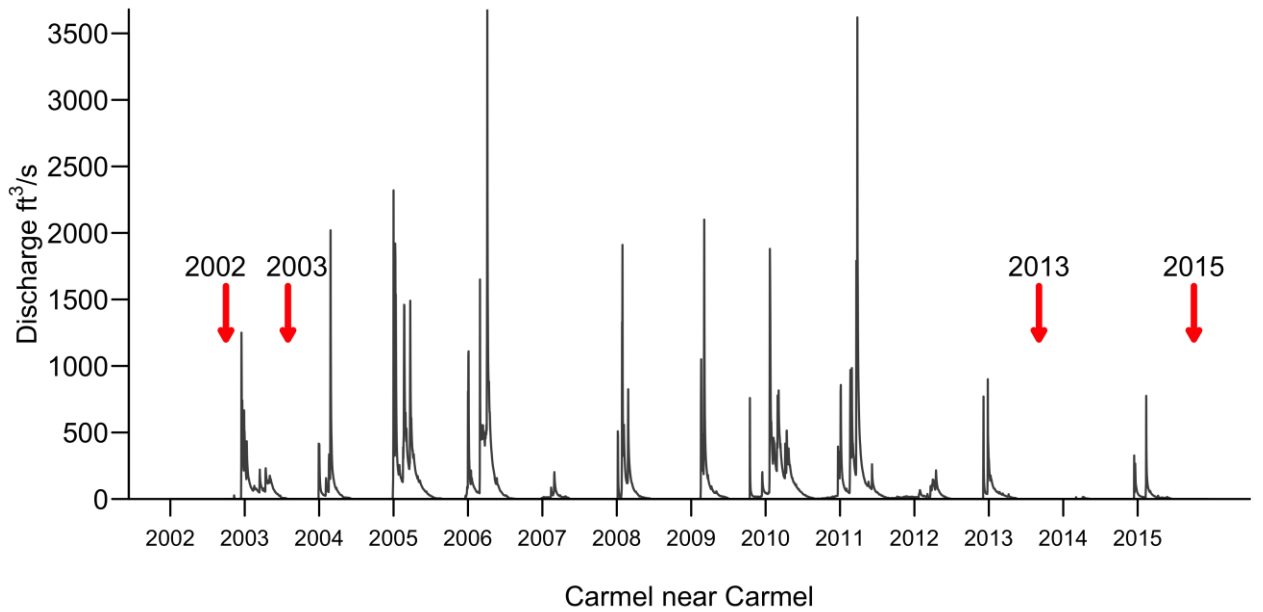
Figure 10. Hydrograph of mean daily stream flow for the Carmel gage at Via Mallorca on the Carmel River. Red arrows indicate when LWD surveys took place.

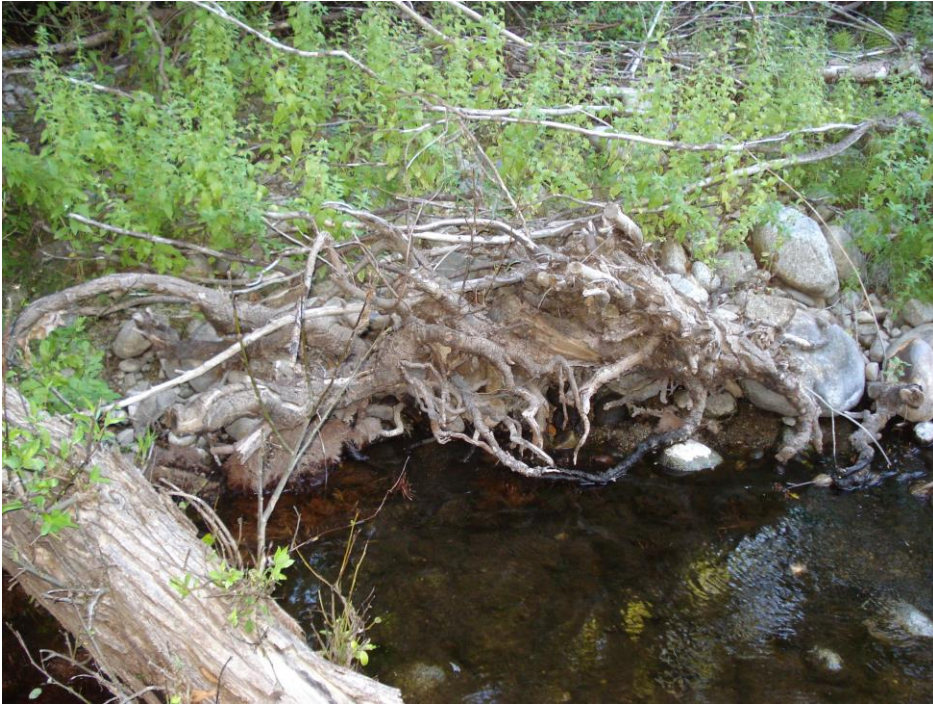
Figure 11. LWD Rootball located in the Camp Steffani to Rosie's Bridge reach.

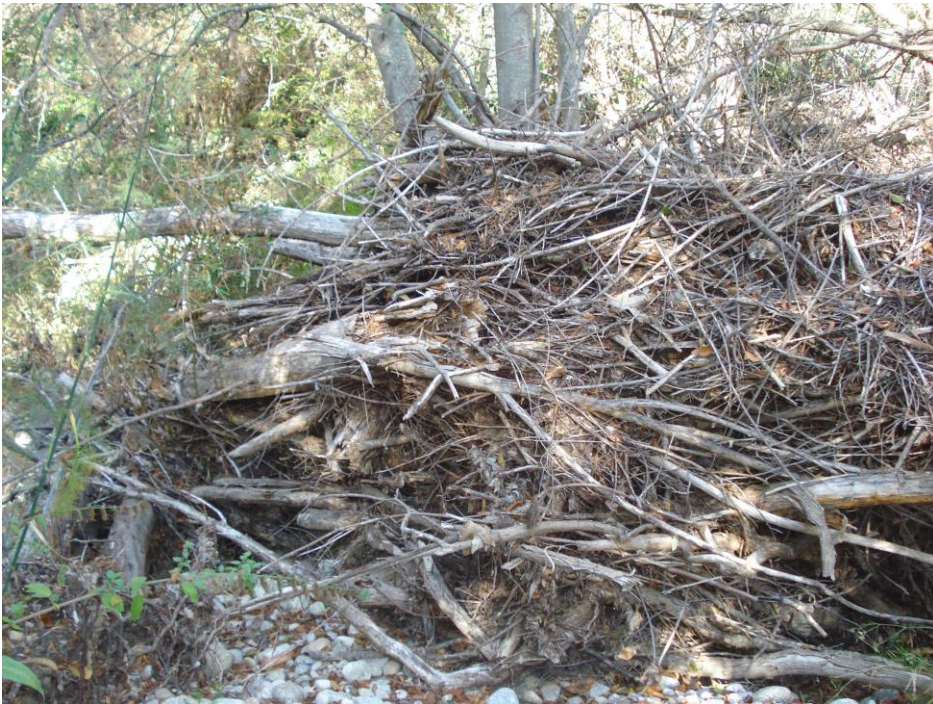
Figure 12. Multiple piece accumulation composed of nine pieces with an average length of 3.0–4.5. Dominant substrate type cobble.

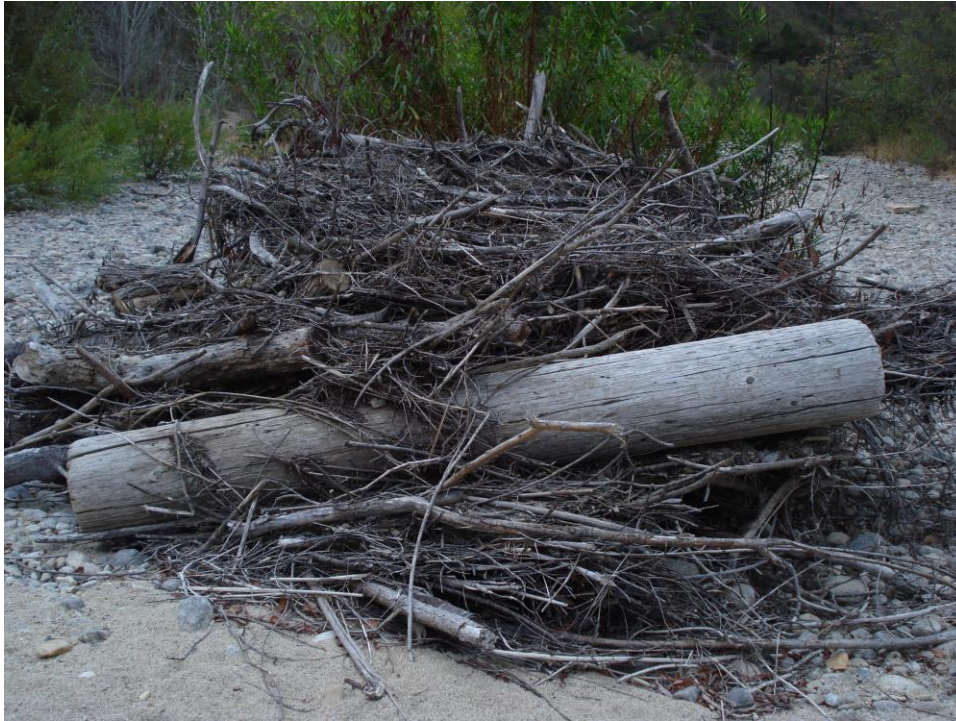
**Figure 13. Single piece observance in the main channel reach between Via Mallorca to Rancho Canada. LWD occurrences were documented as multiple pieces occurrences only when two or more qualifying pieces touched.**

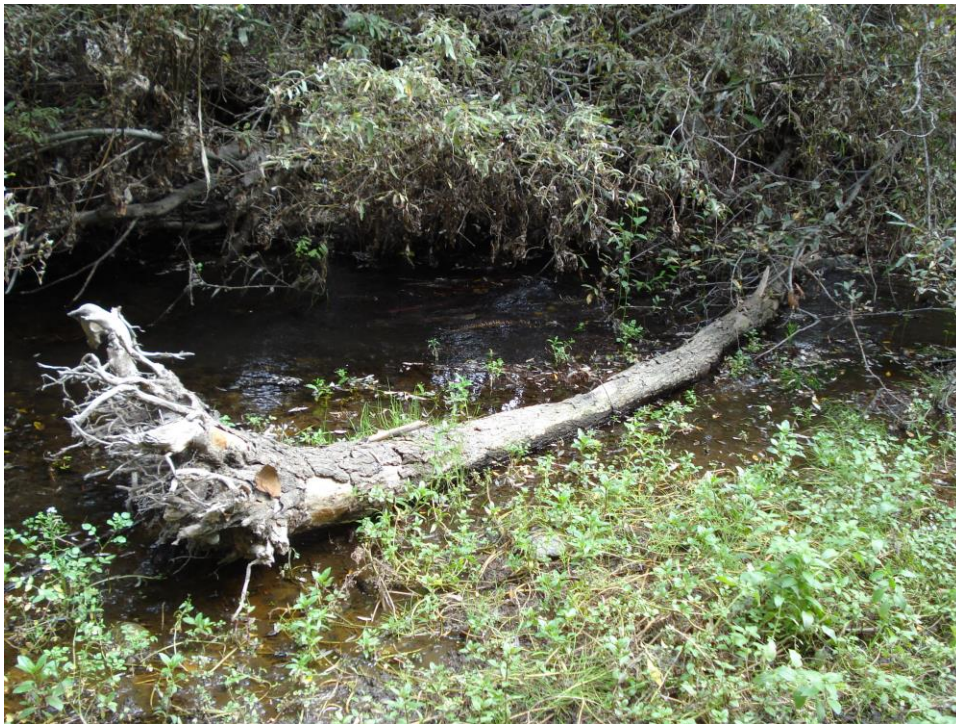
**Figure 14. Single piece with rootball located in the main channel in Garland Park.**

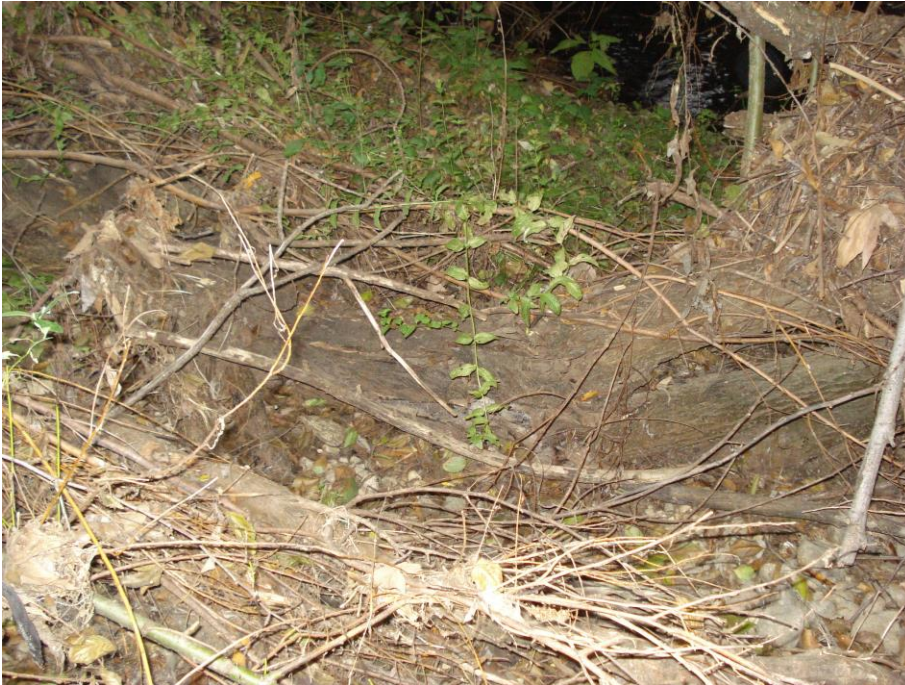
**Figure 15. Single Piece observance partially embedded in the vegetated bank. Recorded as  $\leq 50\%$  of the active channel and partially decomposed. Observed in the Borronda to Garland Park Stables reach.**

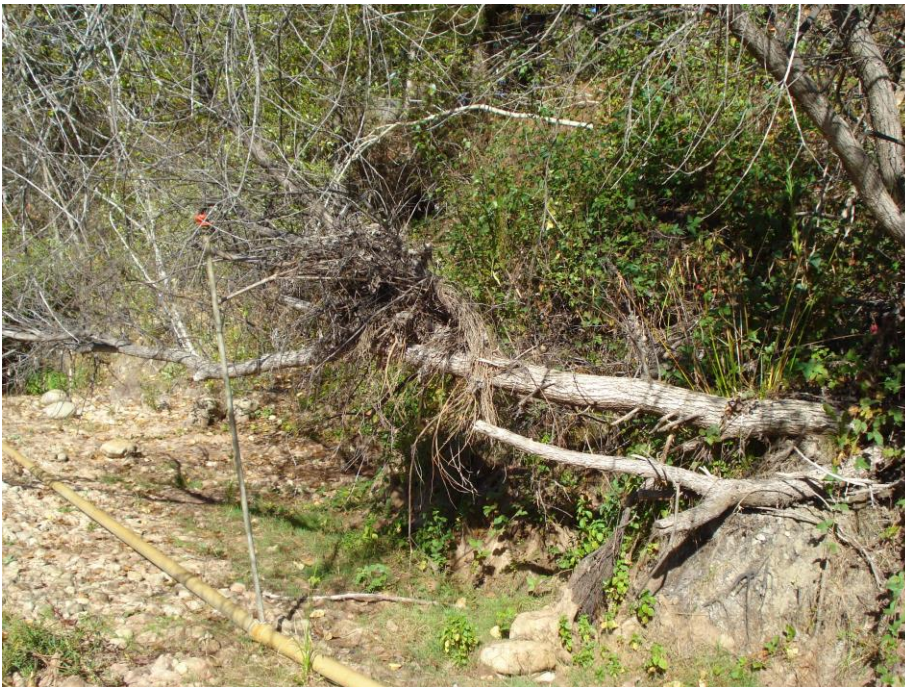
**Figure 16. Irrigation pipeline installed by the MPWMD as part of the RHP in the Quail to Via Mallorca survey area. The LWD on the right was outside the active channel, but recorded due to its high recruitment potential during a high flow event.**
