OPEN-FILE REPORT NO. NEIGC16C:A4.2

Title: *Stream Morphology and Water Quality in a Densely Developed Watershed, Topsham Fair Mall, Maine*

Guidebook for Field Trips along the Maine Coast
from Maquoit Bay to Muscongus Bay

STREAM MORPHOLOGY AND WATER QUALITY IN A DENSELY DEVELOPED WATERSHED, TOPSHAM FAIR MALL, MAINE

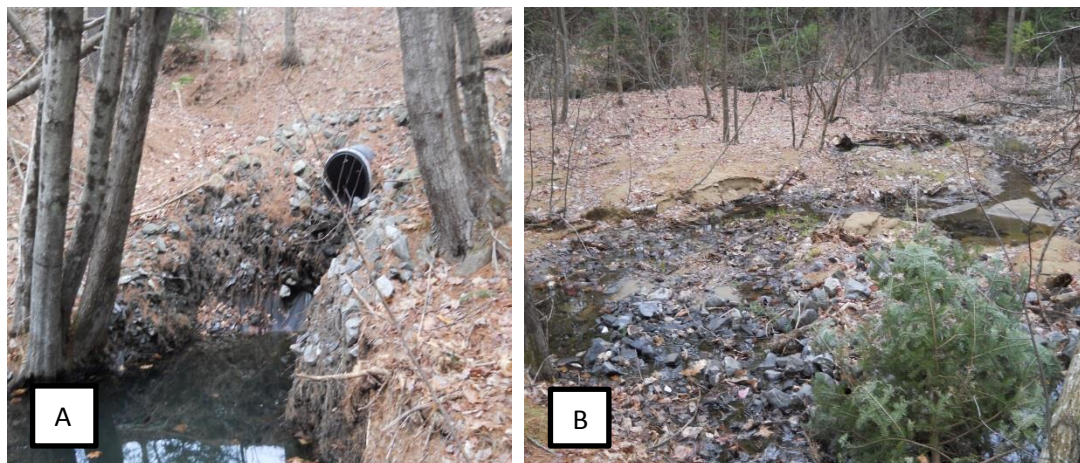
Figure 3: 3A: Scour at outlet of stormwater drainage; 3B: additional erosion and deposition of sediment downstream of the outlet shown in 3A. Note the rock washed out of the plunge pool at the outlet scattered down slope toward and in the eroded channel, suggesting that the outlet may be experiencing higher flows than anticipated in the design. Main channel of Topsham Fair Mall Stream is visible in the background.

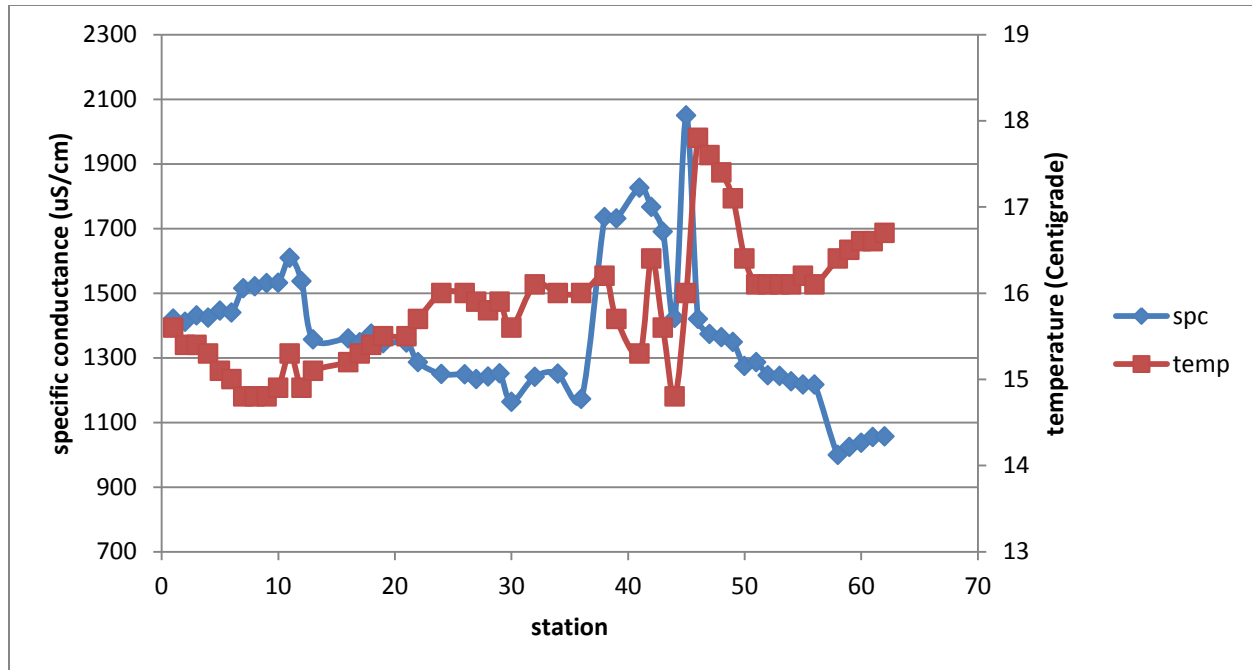
Figure 4: Longitudinal specific conductance profile of Topsham Fair Mall Stream; Station 0 is the most upgradient accessible location; Station 61 is near the upgradient end of the culvert seen at Stop 4. Data collected by Maine DEP in Spring 2016. The data suggest that inputs of baseflow with elevated specific conductance, considered to indicate elevated chloride concentrations, occur over two relatively distinct reaches of the stream. Temperature increases appear to be associated with exposure of the main branch and tributaries in areas of lower vegetation and ponding upstream of restrictions in the channel.

Terrain conductivity surveys conducted by Maine DEP have identified areas of elevated conductivity on the west side of the stream that are not clearly associated with the stormwater system but may be related to elevated specific conductance readings observed in the stream under low-flow conditions. Specific conductance profiles of the stream from Route 196 to Topsham Fair Mall Road show very localized increases and decreases in specific conductance (See, for example, Figure 4). Most, but not all, decreases in specific conductance appear to be associated with tributaries to the stream, while localized increases appear to relate to loci of high-conductivity baseflow discharge. Increases in temperature generally reflect ponding upgradient of flow restrictions at the major crossings, while decreases are related to tributaries or local increases in baseflow.

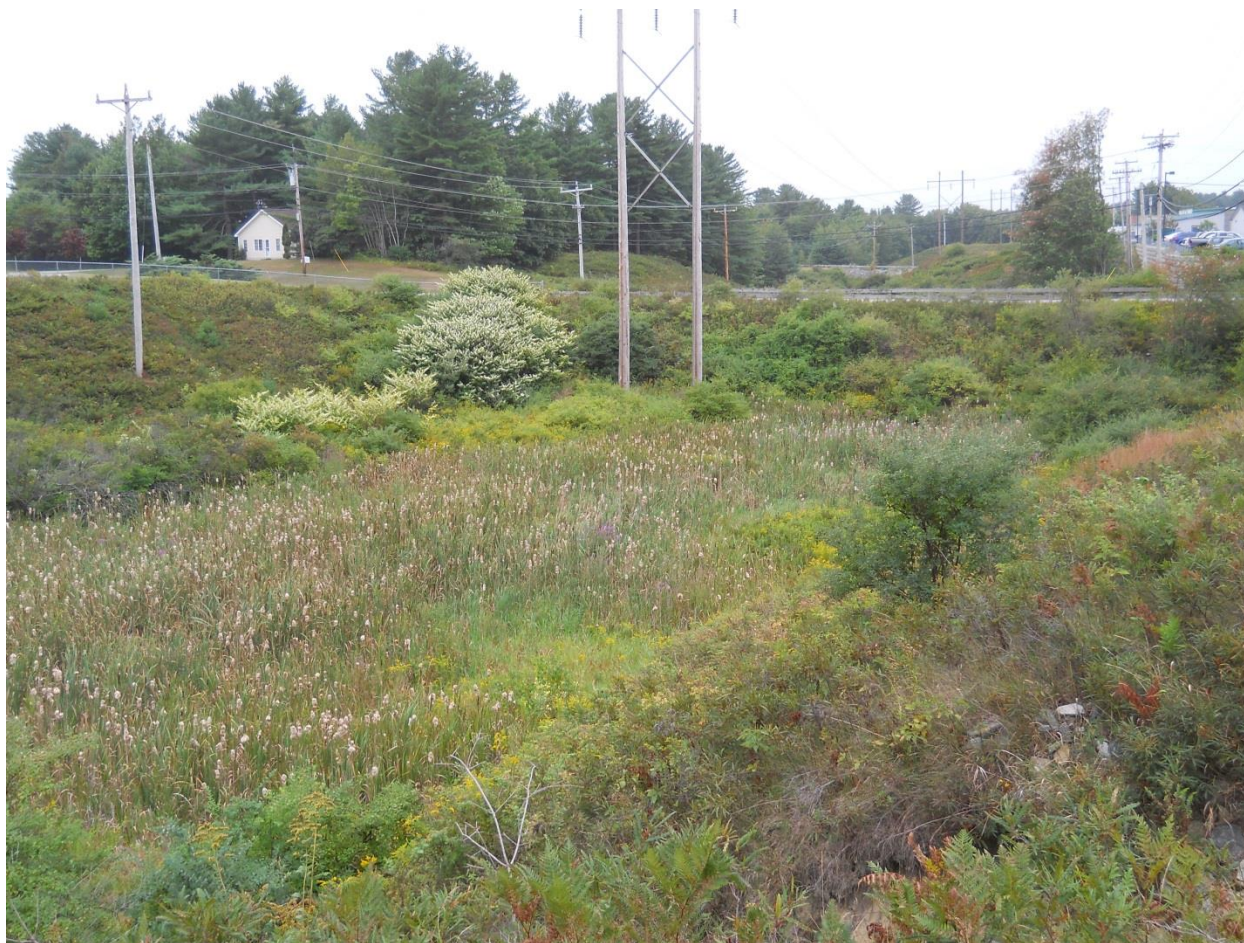
Figure 5: View looking south from approximate location of Stop 1, showing wetland developed in sediment deposited upstream of Park Drive crossing. Midway Drive crossing is visible in background. We will walk down the powerline beyond Midway Drive to the main stream and some tributaries draining the western half of the site and areas adjacent to the highway as part of Stop 3.

STOP 1. Stop 1 provides a general overview of the upper portion of the site, and, due to the low vegetation, is a good place to compare conditions upstream and downstream of this first major channel restriction south of Route 196. Prior to surfacing on the upstream side of this crossing, the stream travels through a long culvert under Route 196 after passing through an industrial area on the north side of the road. Historic monitoring data in Department files show elevated specific conductance in the stream but relatively low to moderate values of this parameter in groundwater within the industrial site. The headwaters of the stream are in an area bounded by this industrial site, Interstate 295, and Route 201. As shown in Figure 4, specific conductance in the stream is clearly elevated even before it enters the section of the watershed downgradient of the mall and associated development. If there is sufficient water in the channel, we will collect specific conductance and temperature data in the stream upgradient and downgradient of the crossing; Department geologists have shown (Maine DEP, unpub. data) that specific conductance in streams is often significantly elevated downgradient of road crossings even in late summer and autumn, hypothetically due, at least in part, to storage of dissolved salt in the fill. This has not been clearly demonstrated at this site, however.

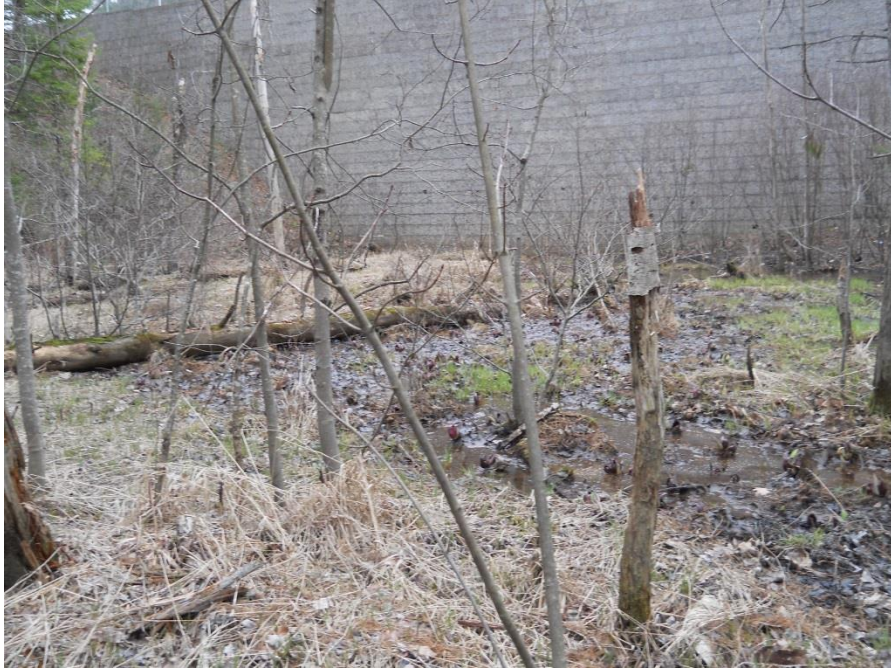
Figure 5: Wide floodplain sediment deposits at end of the reach of stream explored on Stop 3. Note lack of clearly defined channel and impact on vegetation.

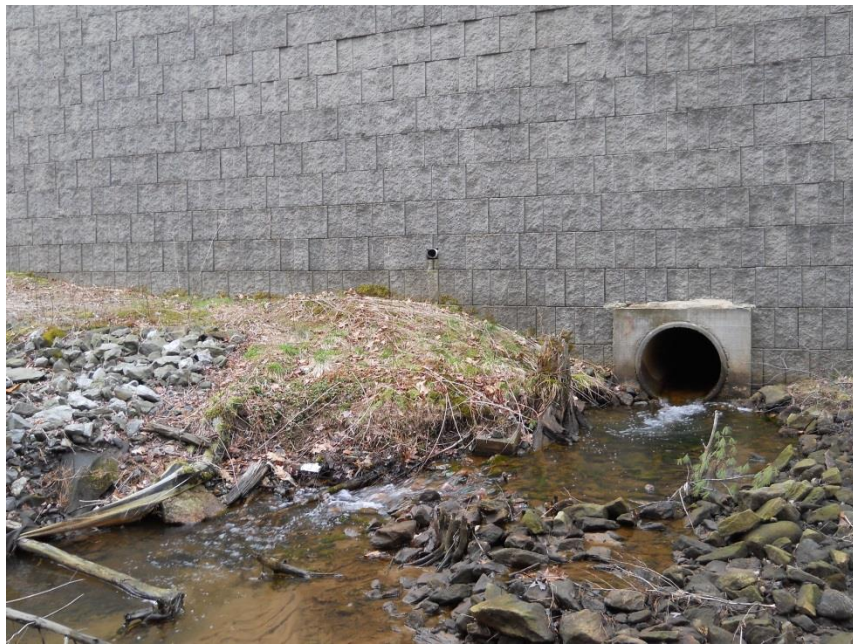
Figure 6: Culvert outlet at opposite end of the crossing seen in Figure 5; note definite channel and rocky substrate.

STOP 4. From here descend along the embankment adjacent to the road crossing, and walk downstream. We will examine the significant change in morphology at this location, shown in Figure 6, compared to the upstream side of the crossing, and will again be considering the gradual changes in the floodplain and channel due the restriction at the railroad culvert at the end of this reach. This railroad culvert was installed many years before the present development, and the morphology of the floodplain that resulted from this restriction is now being altered by the more recent changes to the stream hydrograph and floodplain. Sections of this reach are now relatively deeply incised into floodplain sediment accumulated upstream of the railroad culvert (Figure 7), and Field (2013) describes tree stumps and roots buried in this material that are now exposed in the channel bottom as a result of the more recent scour. We will proceed downstream as far as possible given time and conditions; this section of the floodplain is often difficult to traverse due to wet conditions and accumulated vegetation, particularly downstream of the outfall from the Target detention/retention pond. Return to the Target parking lot and the vehicles by climbing the slope adjacent to this outfall, considering the stability and water quality impacts of this structure as you proceed.

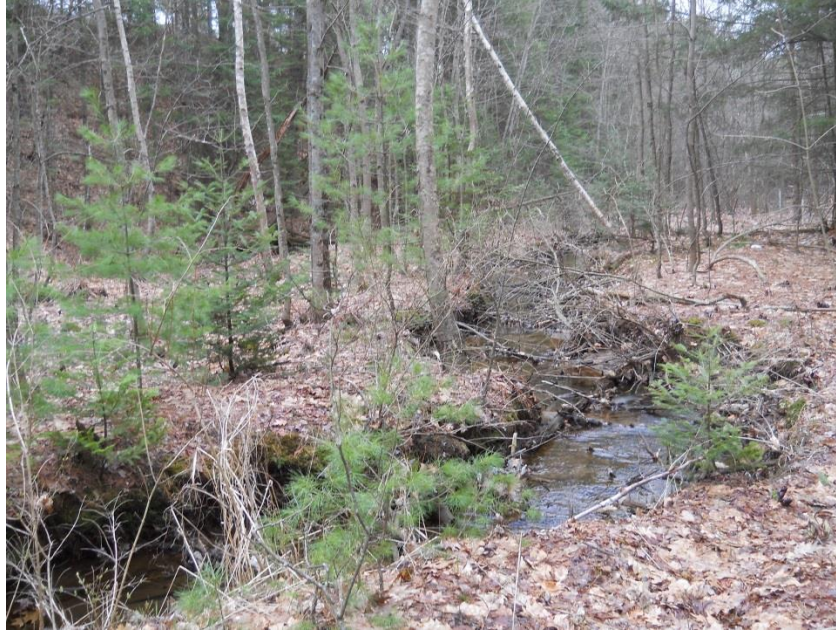
Figure 7: Incised channel typical of most of the main stem of stream in the area of Stop 4. Field (2013) describes tree stumps and roots exposed in this channel as evidence of sediment deposition upstream of a narrow railroad culvert at the downstream end of this reach and more recent erosion due to changes in flow volume and velocity.
