22nd CIPA Symposium, October 11-15, 2009, Kyoto, Japan

THE CHURCH OF SAN PABLO (VALLADOLID, SPAIN). THE SELECTION OF THE RECORDING TECHNIQUES: APPROPRIATENESS, SUITABILITY AND EFFECTIVENESS FOR THE DOCUMENTATION OF A CULTURAL HERITAGE PROJECT

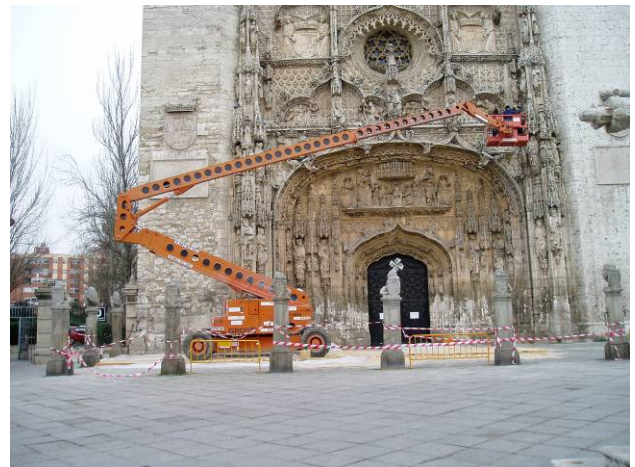
Fig. 4. Derrick used to place the targets and to take stereopairs

The topographic data was recorded with a four station traverse and a net of 150 control points on the façade (Fig. 5), homogeneously distributed. The stereopairs were 6x6 slides taken with a semi-metric calibrated camera, a Hasselblad 903 SWC. In total, 34 frontal pairs and 22 zenit and lateral pairs were made. The shots were taken from a 28 m height derrick giving a final precision of +/- 5mm (Fig. 4).

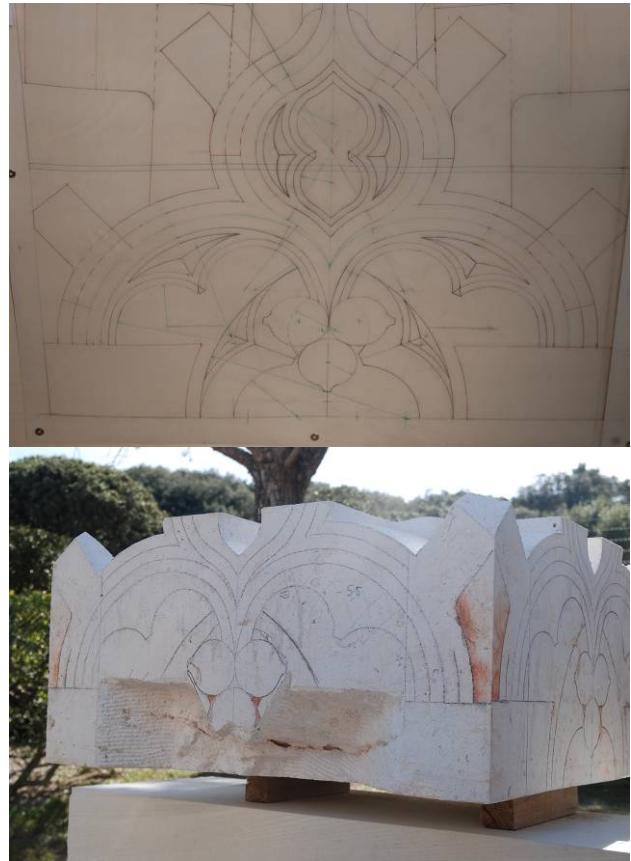
Fig. 10. Pinnacle detail hand drawing in 2D and the same drawing on the stone to be sculpted

documentation produced from the original pieces used to create the replica were just hand plans of the different levels of the piece that would then be used by the sculptor to carve the stone (Fig. 10).
