**Estimated Sediment Volume: Bridge Street Dam Impoundment,
Royal River, Yarmouth, Maine**

Estimated Volume of
Accumulated Sediment
Bridge Street Dam Impoundment
Royal River, Yarmouth, Maine

June 19, 2015

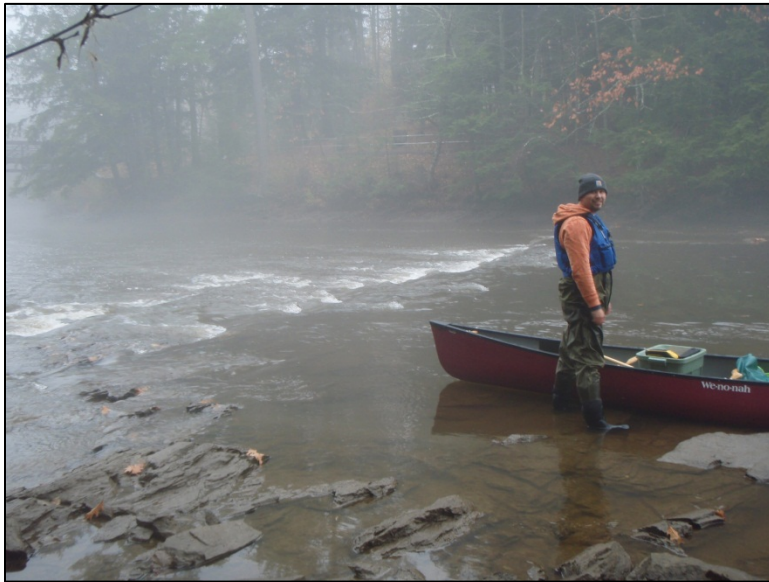
**Photo 1: Ledge Upstream from Beth Condon Memorial Trail Footbridge
(flow is from right to left)**

Depths were recorded relative to the water surface during the field studies and not to a specific elevation. The height of the water surface below the right upstream training wall of the fishpass was measured as 4.6 ft prior to the initiation of the sediment probing work at 7:10 AM and as 4.5 ft at 15:15 pm at the completion of the sediment probing field surveys. Of note is that the impoundment drawdown results in exposure of bedrock ledge (Photo 1) upstream from the footbridge over the Royal River along the Beth Condon Memorial Trail. When exposed, this ledge forms the hydraulic control for the upstream reach of the river to the base of Middle Falls and results in higher water surface elevations relative to the reach of the impoundment downstream from the ledge.

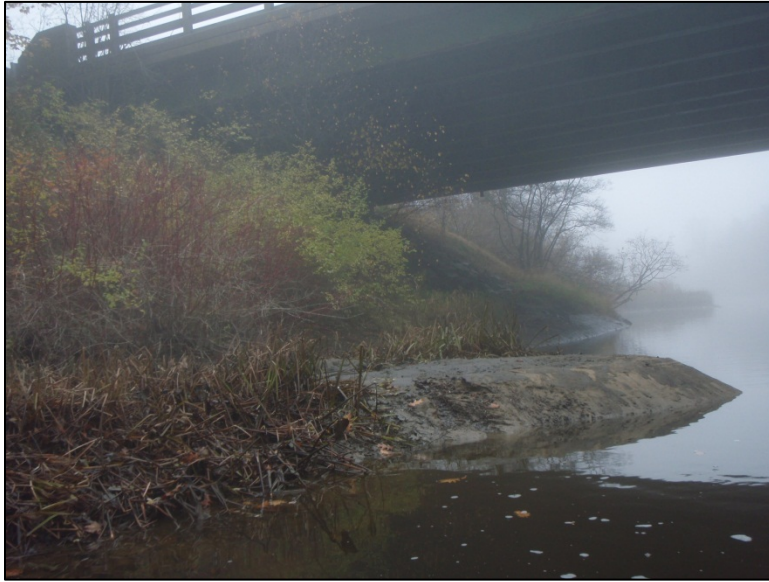
Photo 2: Accumulated Sediment at Stormwater Outfall (left side of river immediately upstream from U.S. Route 1 Bridge)

Following the sediment probing on November 12, 2014, Stantec canoed the perimeter of the impoundment between Bridge Street Dam and the exposed ledge to observe apparent conditions. Observations during this cruise confirm the presence of accumulations of fine sediment along the margins of the dewatered sediment, including benches that may support emergent vegetation, and a number of areas with localized accumulations of fine sediment (sand). Localized accumulations of fine sediment were observed immediately upstream from the Sparhawk Mill hydroelectric facility trashrack and at two locations where stormwater is discharged to the impoundment.

As previously noted, the estimated volume of accumulated sediment based on the sediment probing in the impoundment is 4,200 CY. Based on observed localized deposits of fine sediment, it is suggested that a contingency of 20% (840 CY) be added to the estimated volume of accumulate sediment to reflect observed localized sediment deposits, including the observed

material immediately upstream from the Sparhawk Mill hydroelectric facility trashracks and adjacent to stormwater outfalls and coarse-grained sediment that was not probed. The estimated volume of material based on the 20% contingency is therefore 5,040 CY.

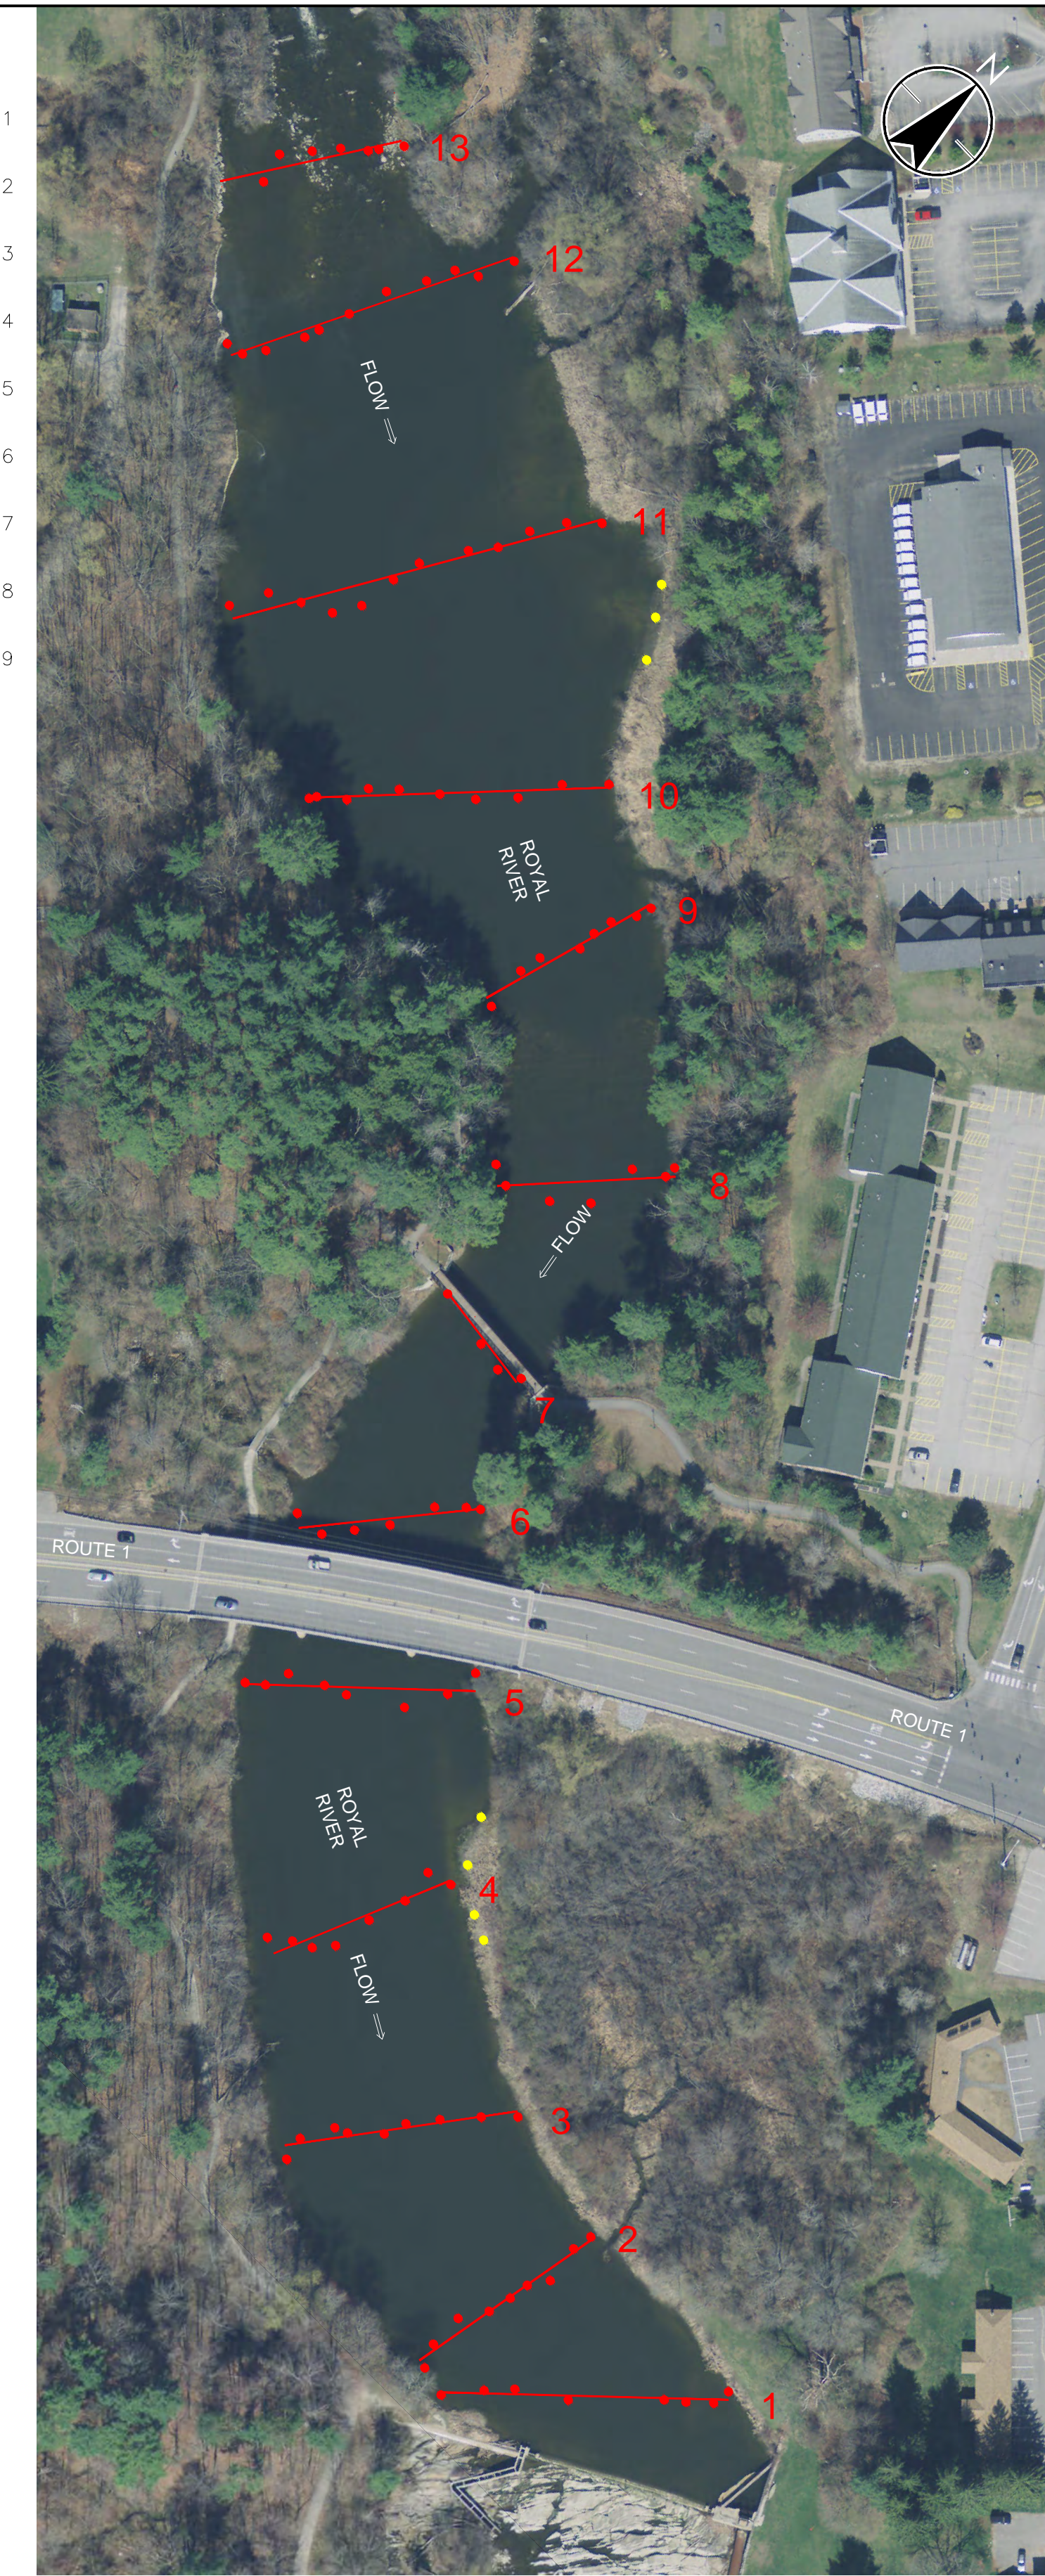
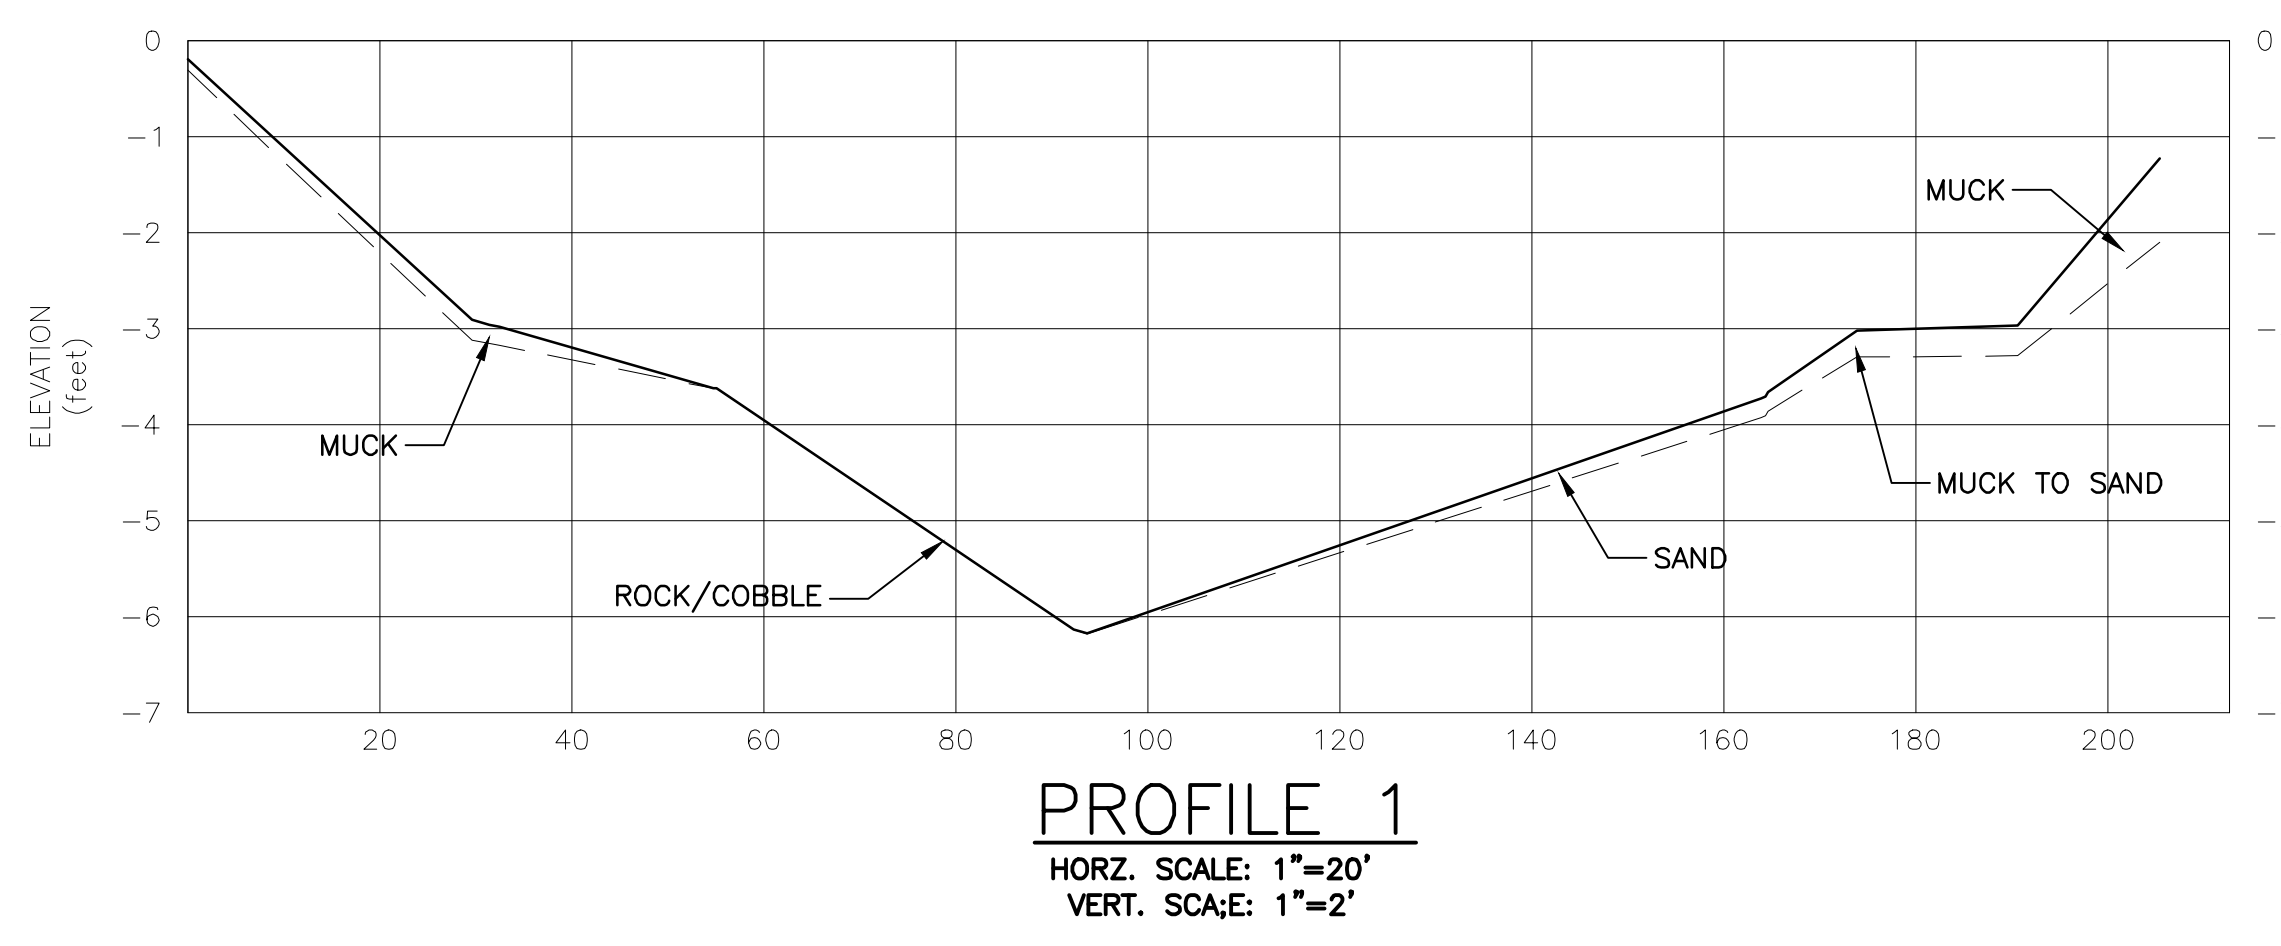
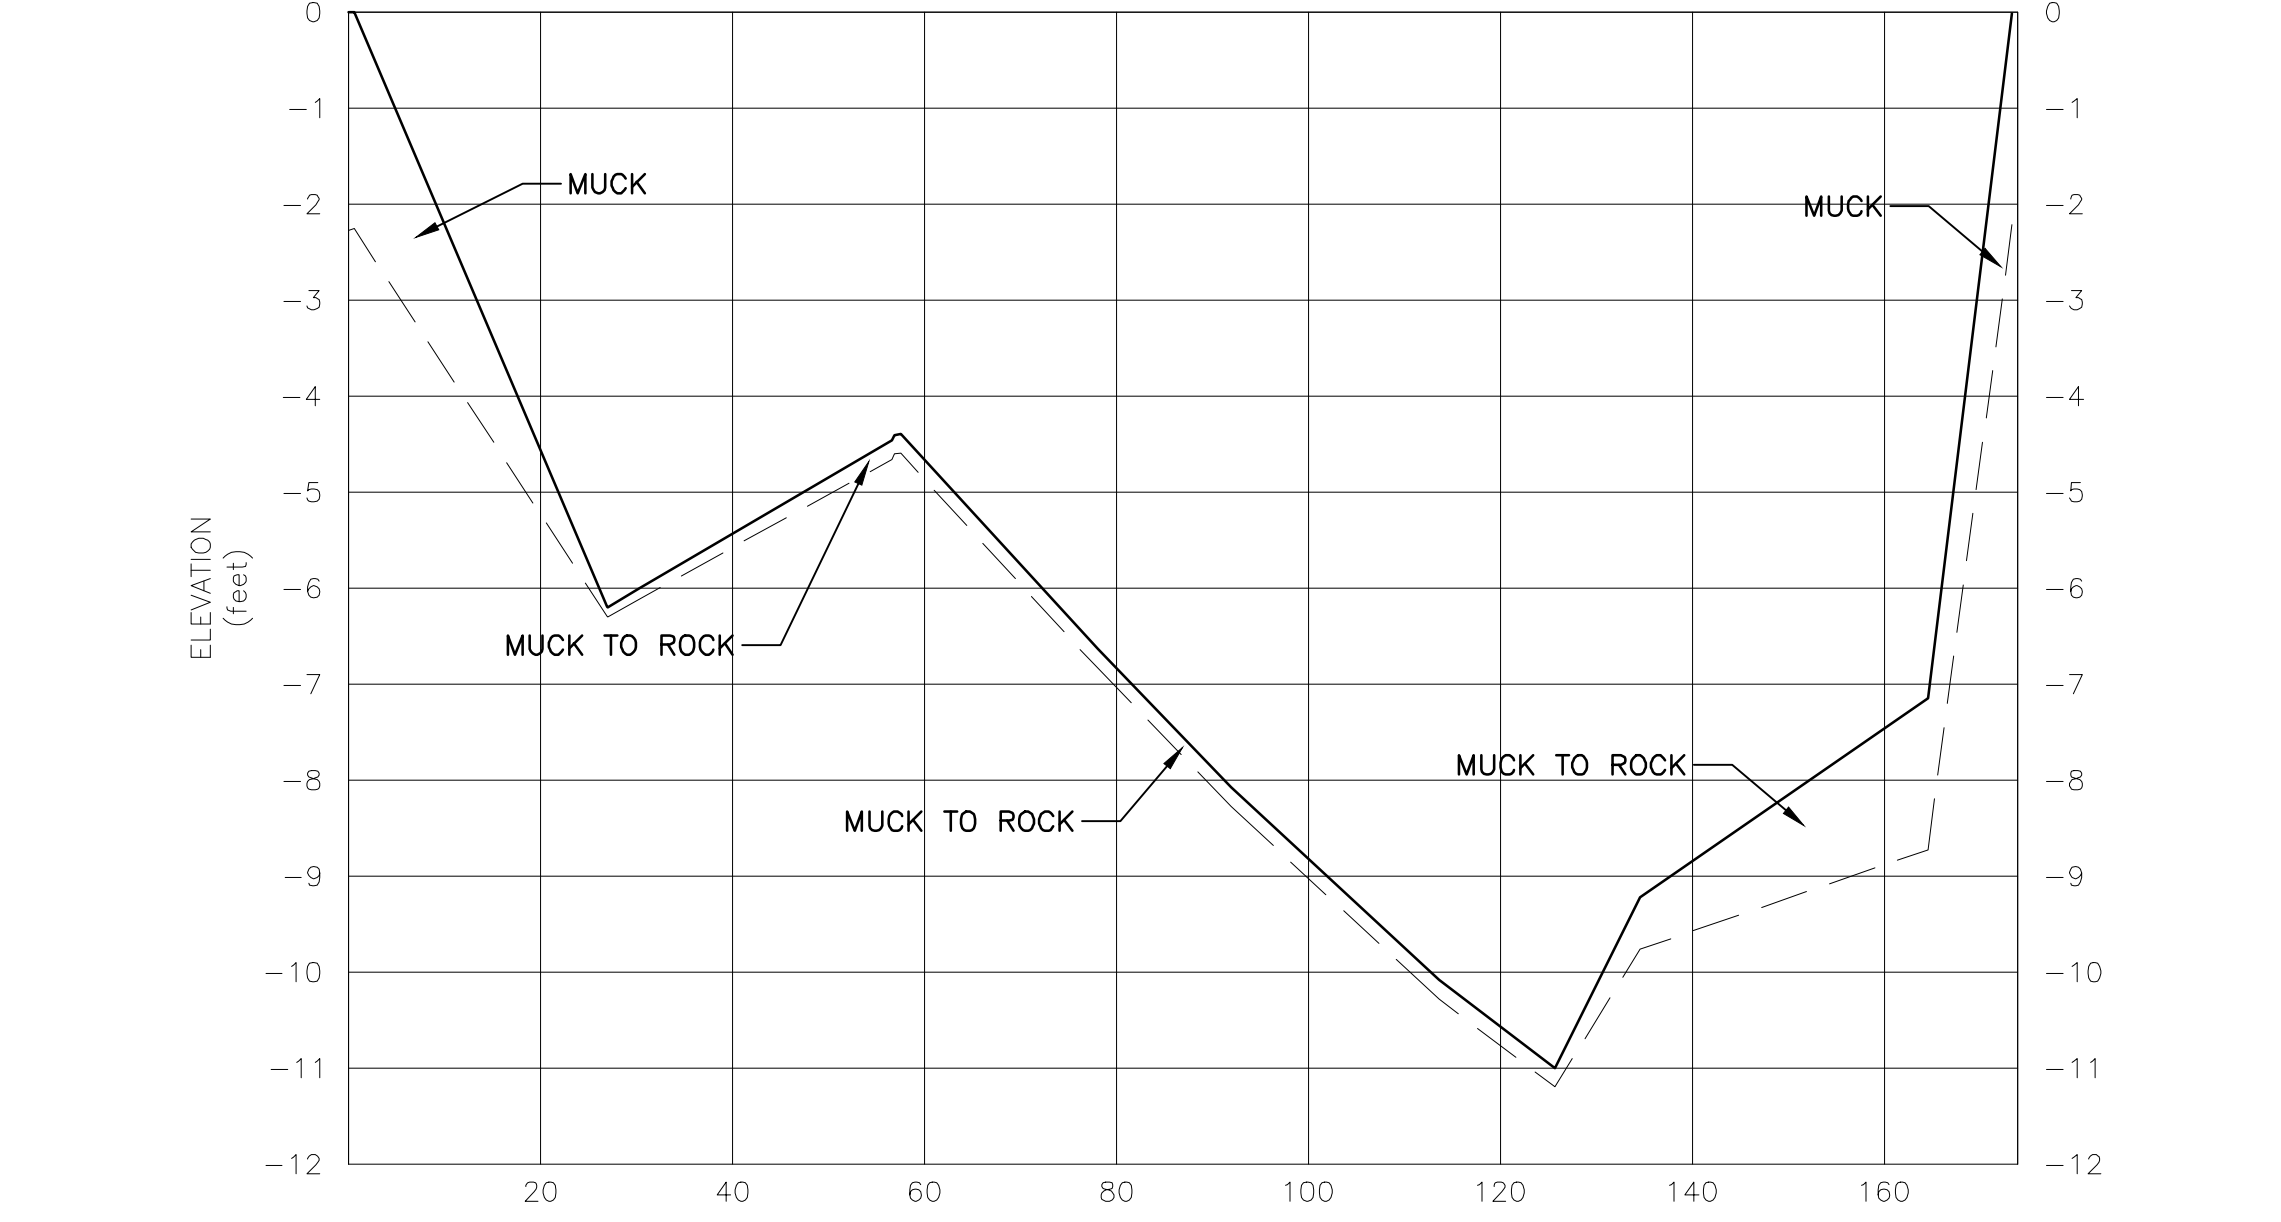
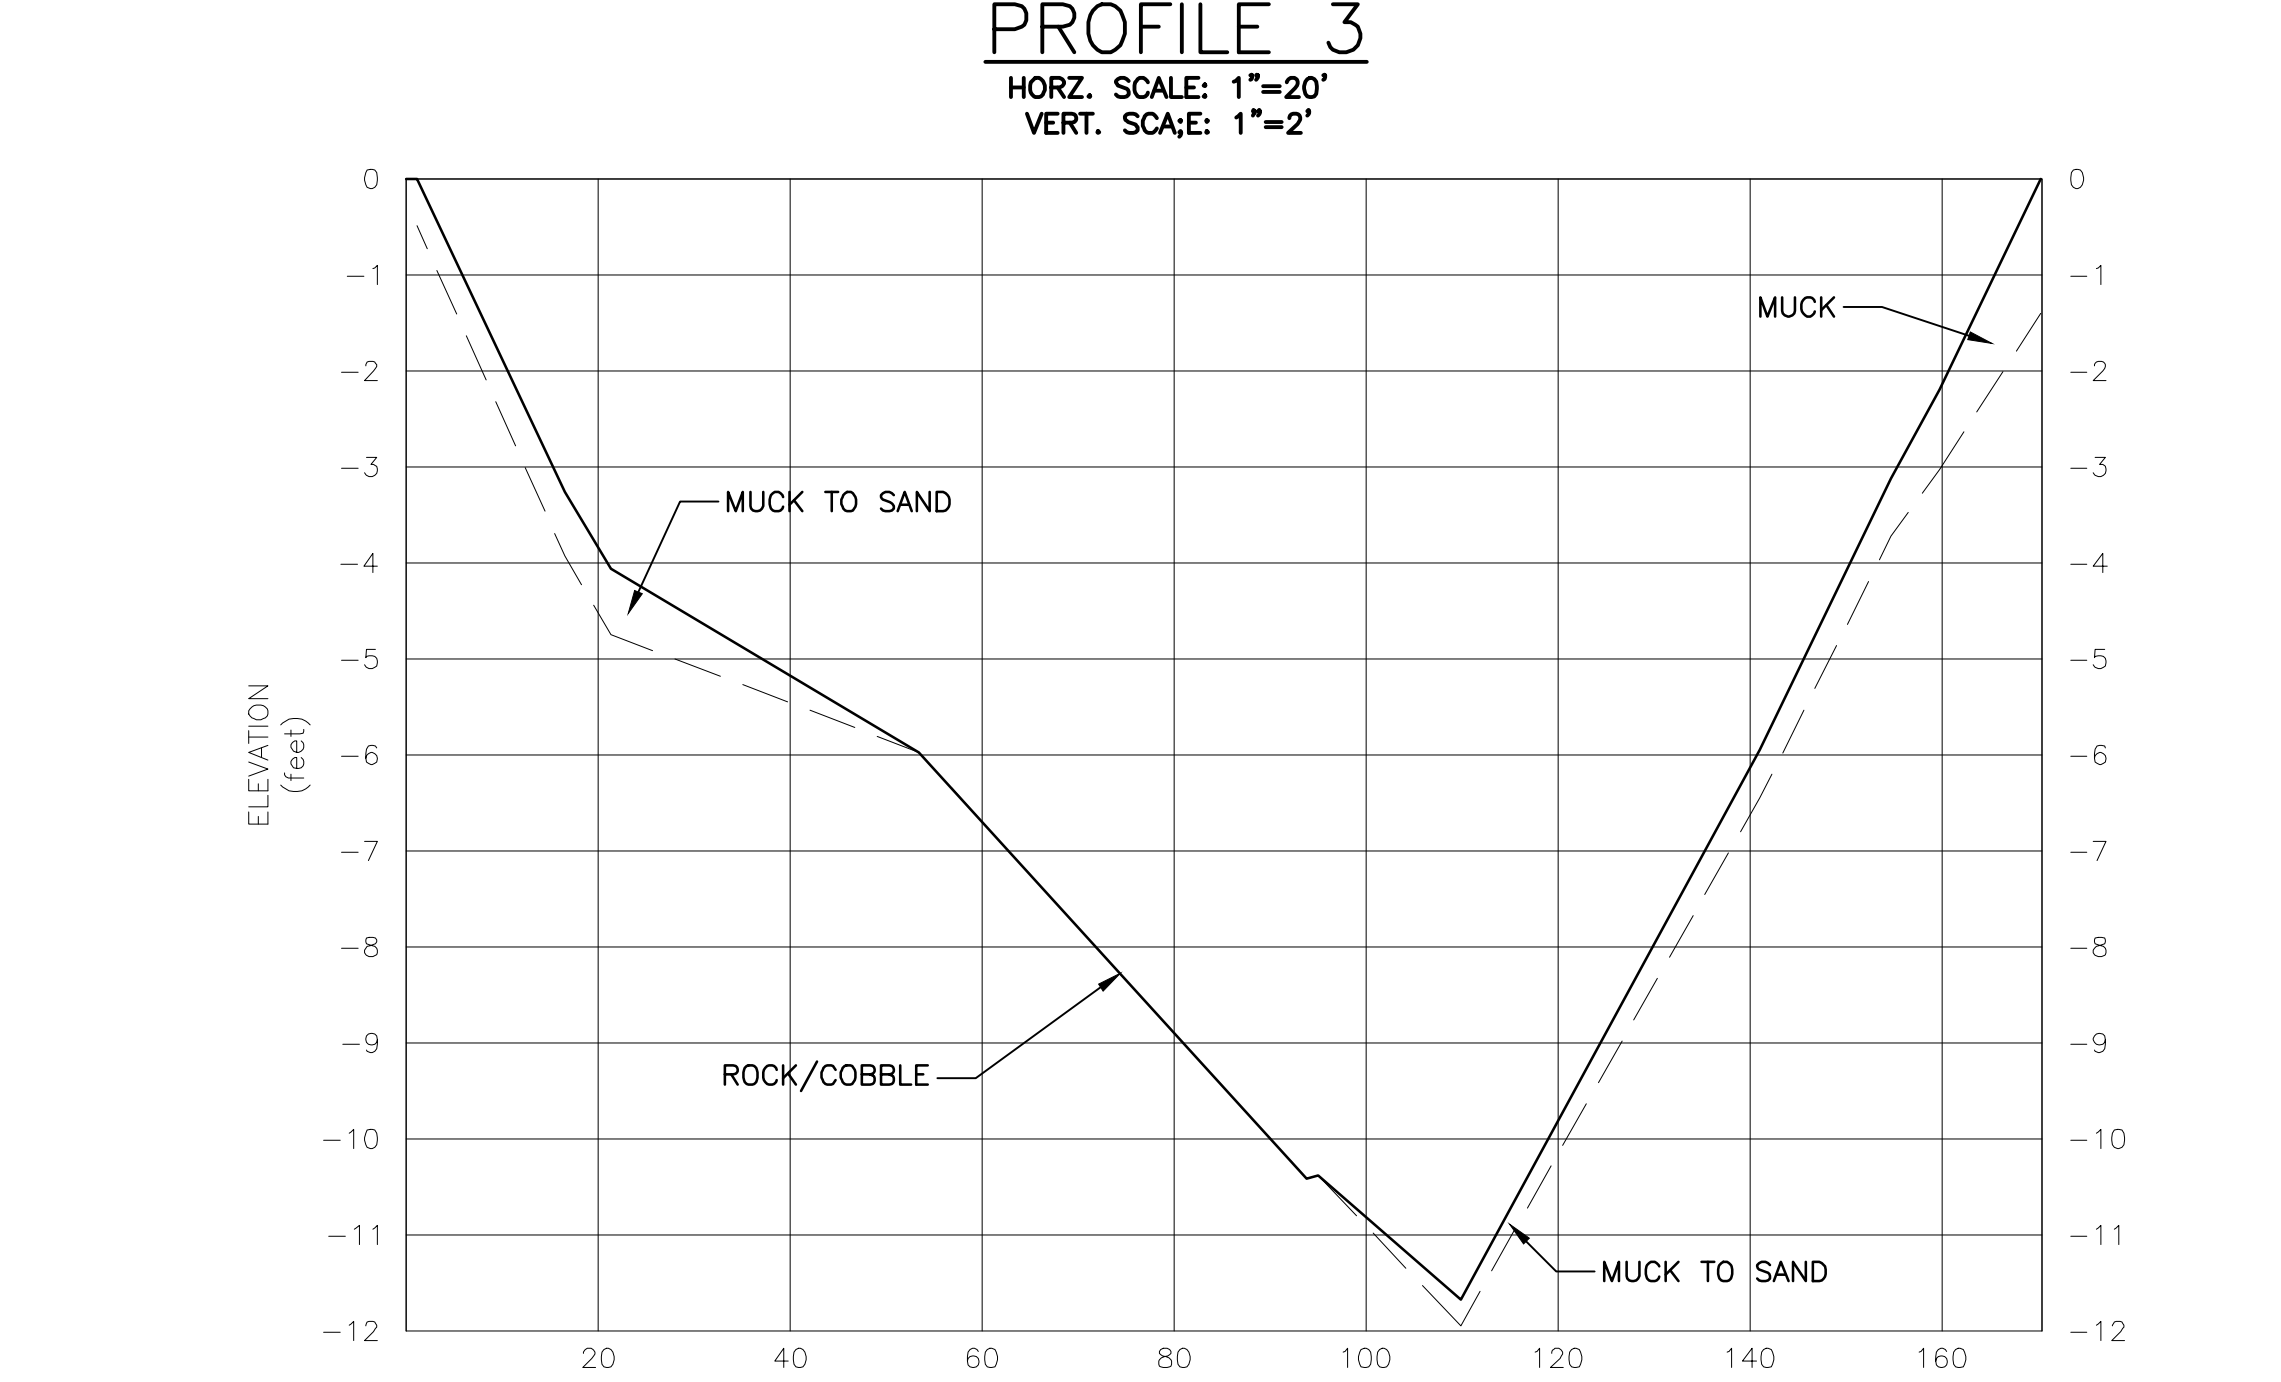
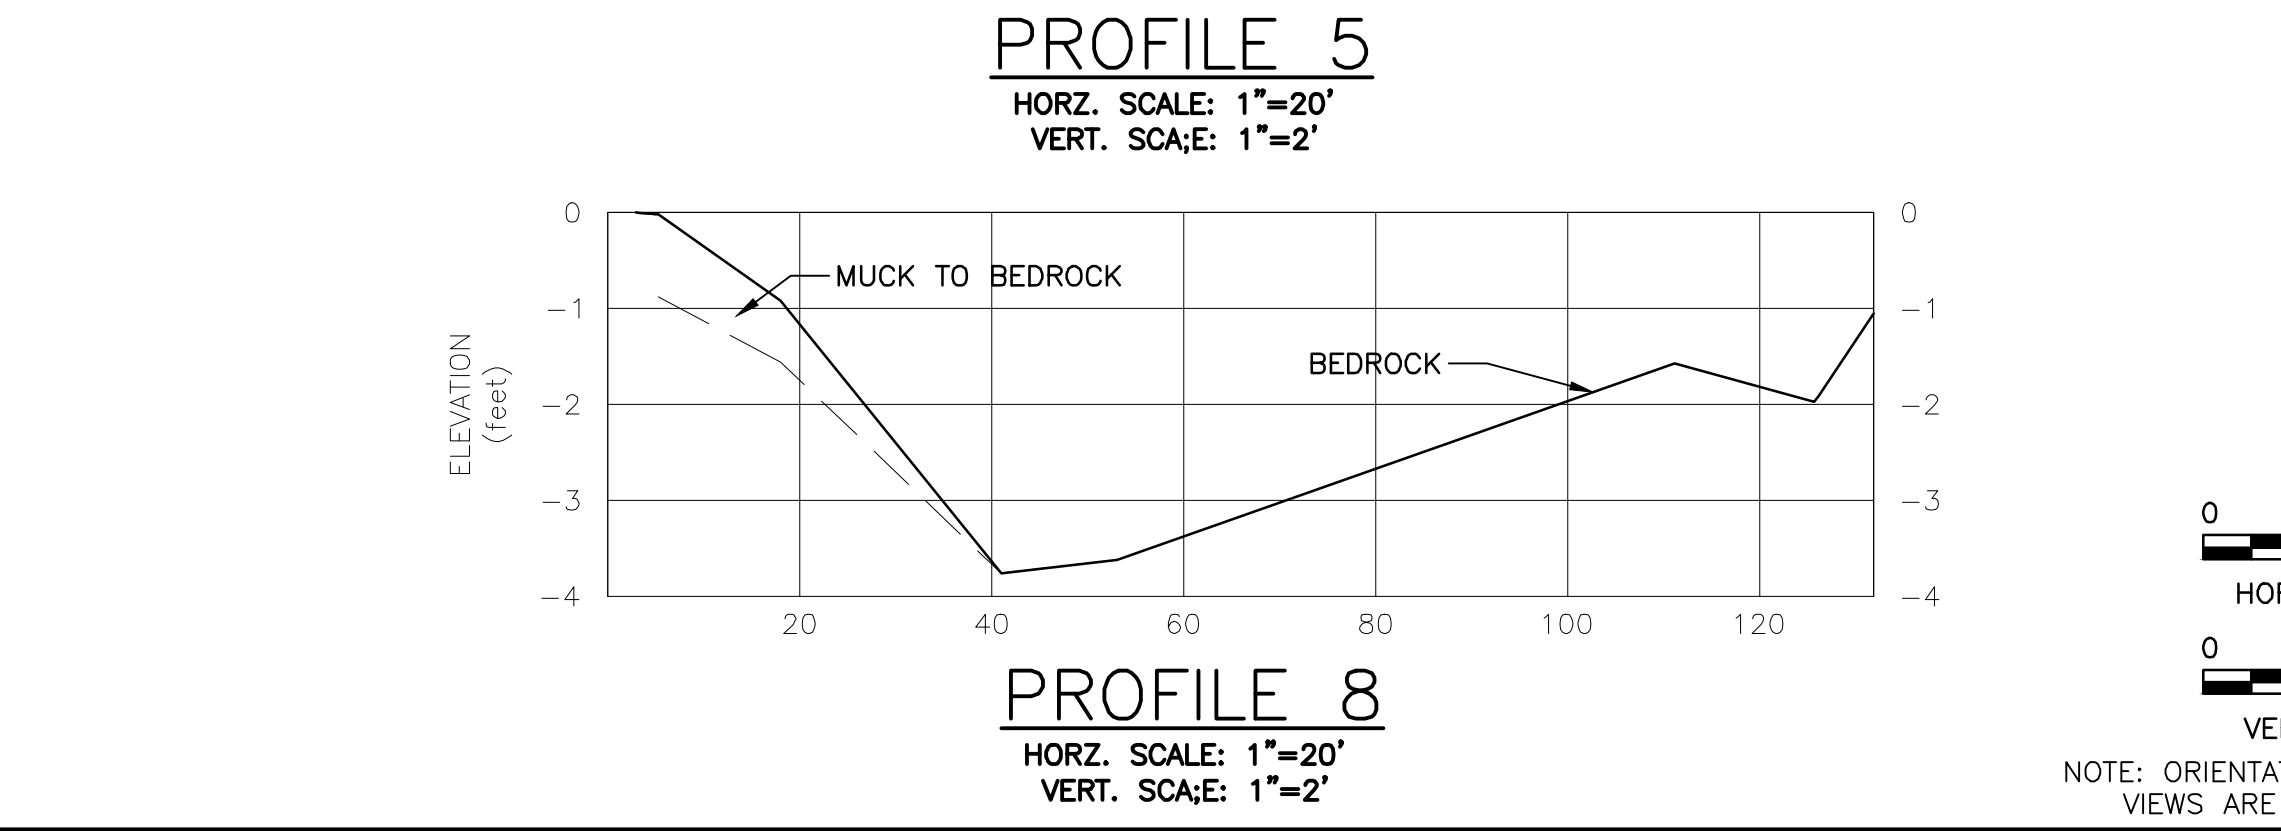
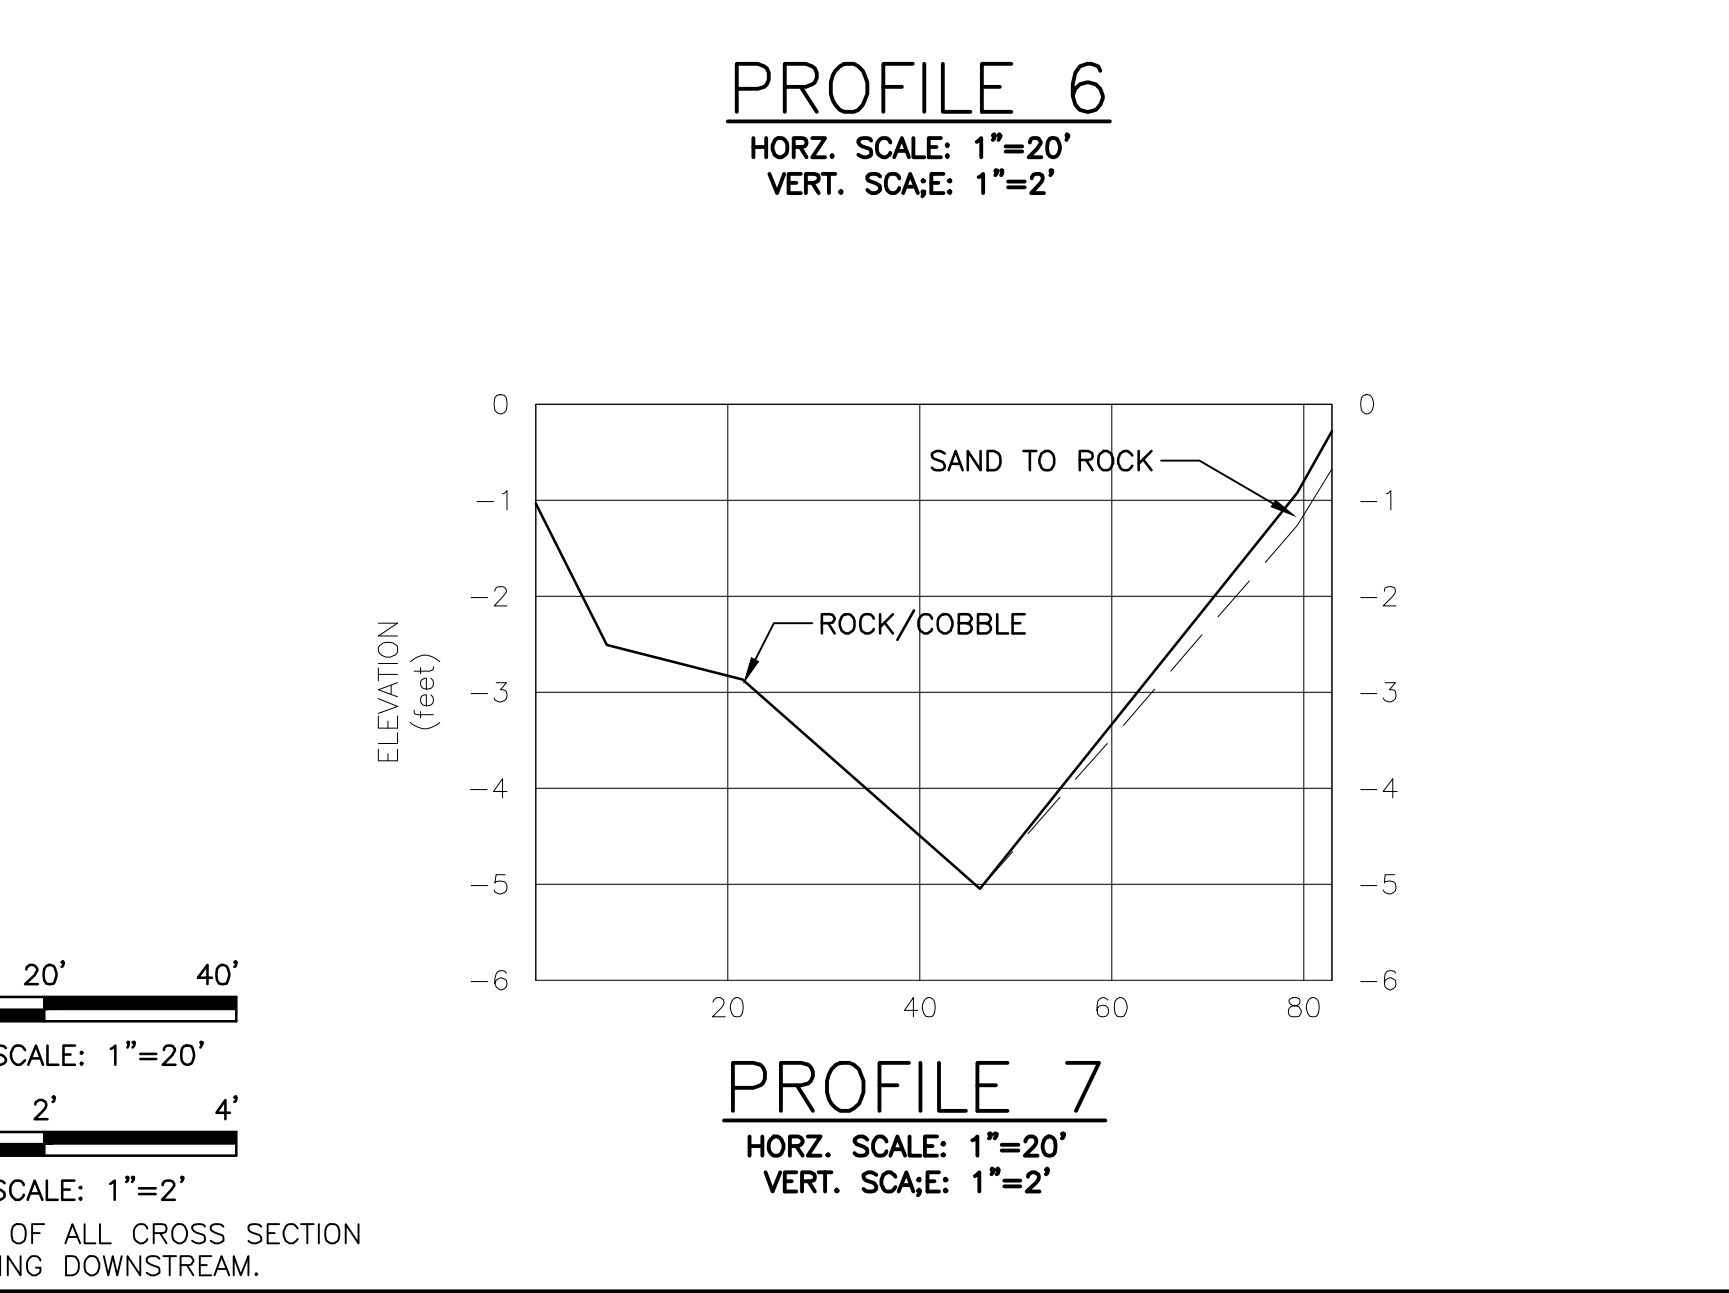
The locations of the 13 transects across the Bridge Street Dam impoundment are depicted in Figure 1. The survey transects (red lines in Figure 1) are numbered sequentially (1 – 13) progressing upstream from the dam, and the locations where sediment depths were measured to refusal are depicted (red dots) along each transect.

In addition to the measurements of sediment depth in the impoundment, 8 sediment probes were performed at two locations along the left¹ side of the impoundment in areas along the edge of the normal impoundment, including an area of emergent vegetation downstream from the U.S Route 1 Bridge. Probing in these locations was performed using a 4'-2" steel rod. These probe locations are depicted as yellow dots in Figure 1.

The sediment probing data was post-processed to provide graphical depictions of the sediment probing locations in plan and profile along each transect and to estimate the volume of probed sediment. Profiles along the 13 sediment probing transects are depicted in Figure 1 and annotated with the estimated sediment characteristics.

The volume of the probed sediment was calculated using a volumetric surface defined by a triangulated irregular network with horizontal coordinates at each probed location with heights at each measurement location represented by the measured sediment depth. The estimated volume of probed material in this volumetric surface is 4,200 cubic yards (CY), which includes approximately 750 CY between Middle Falls and the exposed ledge upstream from the Beth Condon Memorial Trail footbridge and approximately 3,450 CY between the exposed ledge and the dam. Note that this estimate does not include material located outside of the wetted perimeter of the impoundment, such as those points that are depicted as yellow dots on Figure 1.

The estimated volume of accumulated sediment does not include material located outside of the normal pool limits of the impoundment (i.e., along the margins of the impoundment), including material that was probed and denoted by yellow dots in Figure 1.

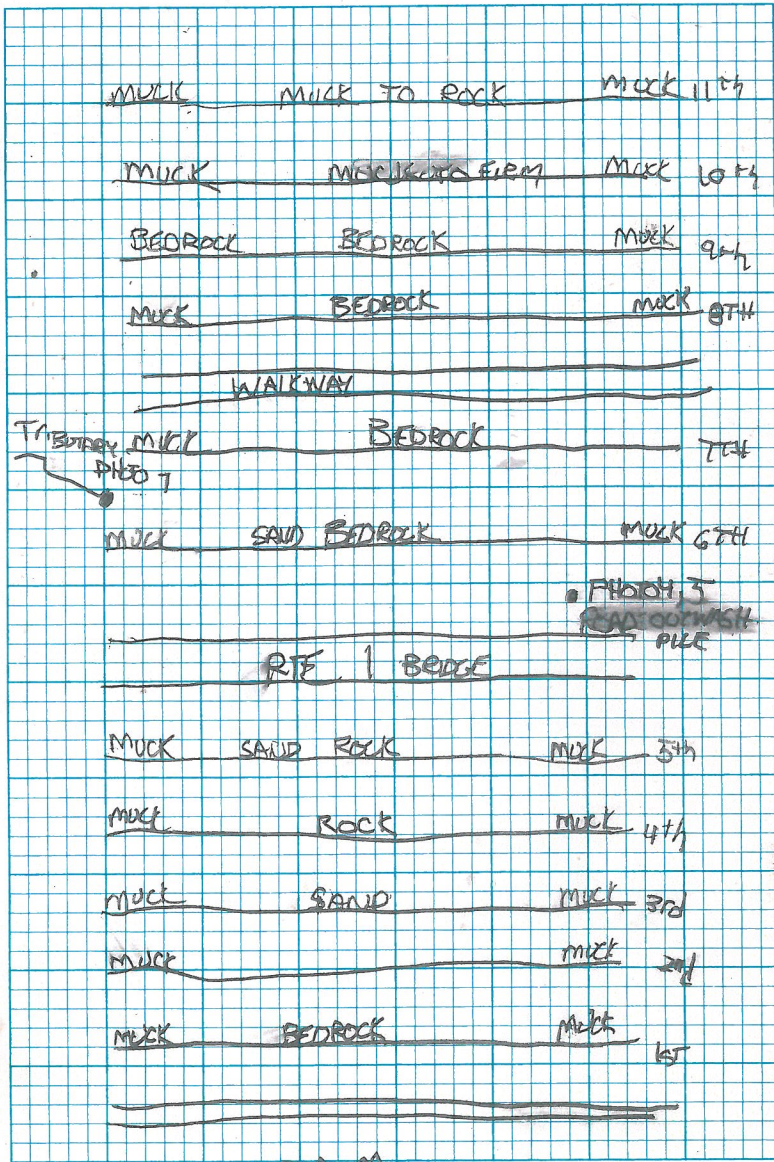
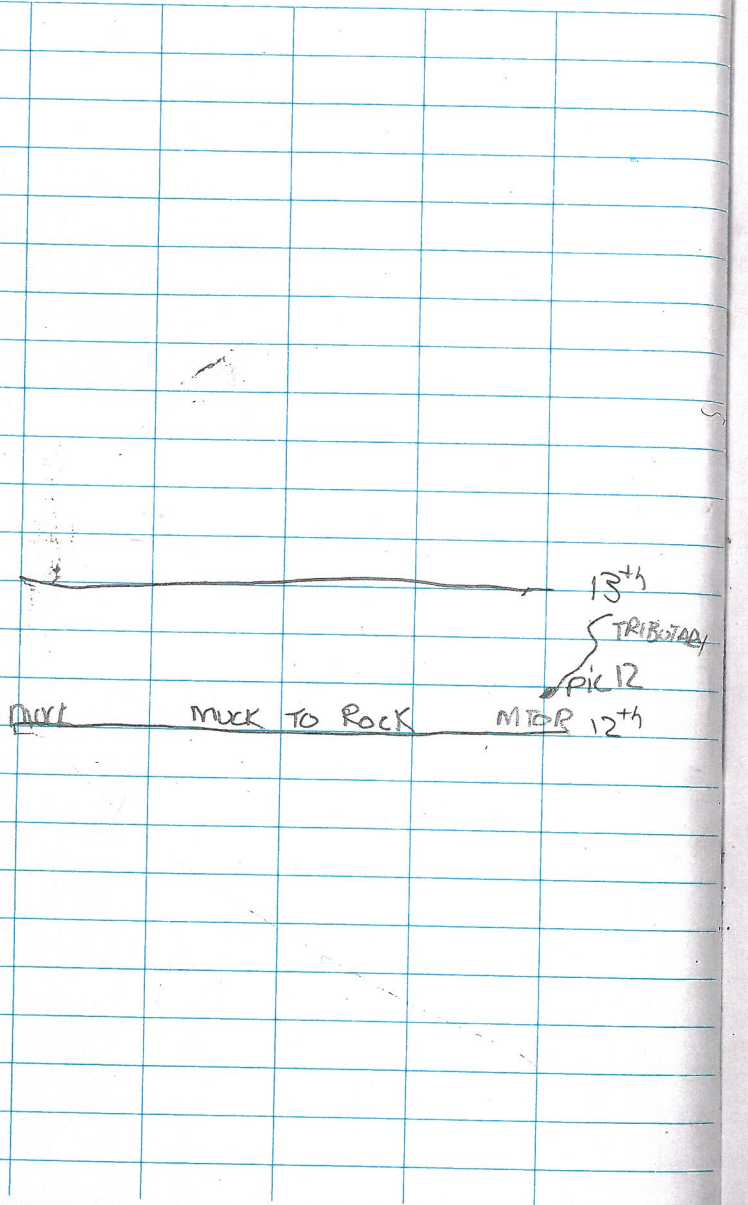
Appendix A FIELD NOTES

Sediment characteristics were estimated and recorded at selected sediment locations. The sediment characteristics were estimated based on the felt response during the sediment probe and referenced to each location in the field notes and in the codes entered into the GPS receiver at the selected locations. A copy of the field notes is included as Appendix A.
