## Long Reach Lane at Long Marsh, Harpswell, 2016 Post-Project Monitoring Report, Year 3 of 5

2016 Post-Project Monitoring Report:  
Long Reach Lane at Long Marsh, Harpswell

Year 3 of 5

Compensation for the Martin's Point Bridge Project, Falmouth-Portland  
(PIN 16731.00)

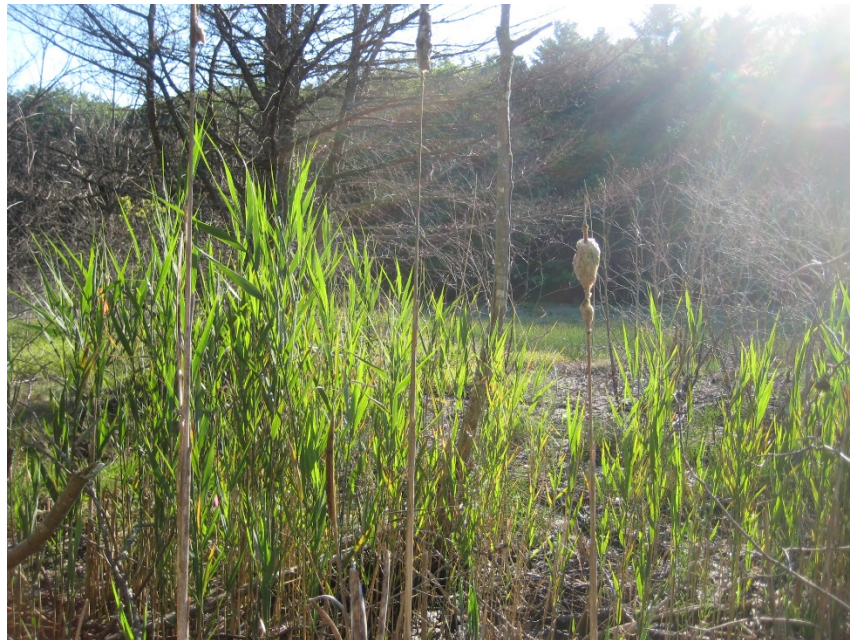
During an invasive species meander survey in early August, CBEP's seasonal field crew observed a small new patch of *Phragmites australis* in a southeastern portion of the Project Area, approximately 15m away from the upland edge of the marsh at Station 9. At subsequent site visits, the patch was estimated to include 390 stems in an area of approximately 100m<sup>2</sup>. The patch was located amongst standing dead alder, cattails, and white pine, in an ecologically disturbed area of the marsh that now experiences regular tidal inundation, post-project (photo below). CBEP contacted Deane Van Dusen of MDOT to report the discovery. Van Dusen subsequently applied a mixture of Glyphosate and Imazapyr as a control agent in a fall application. Monitoring and spot treatment will continue in Years 4 and 5.

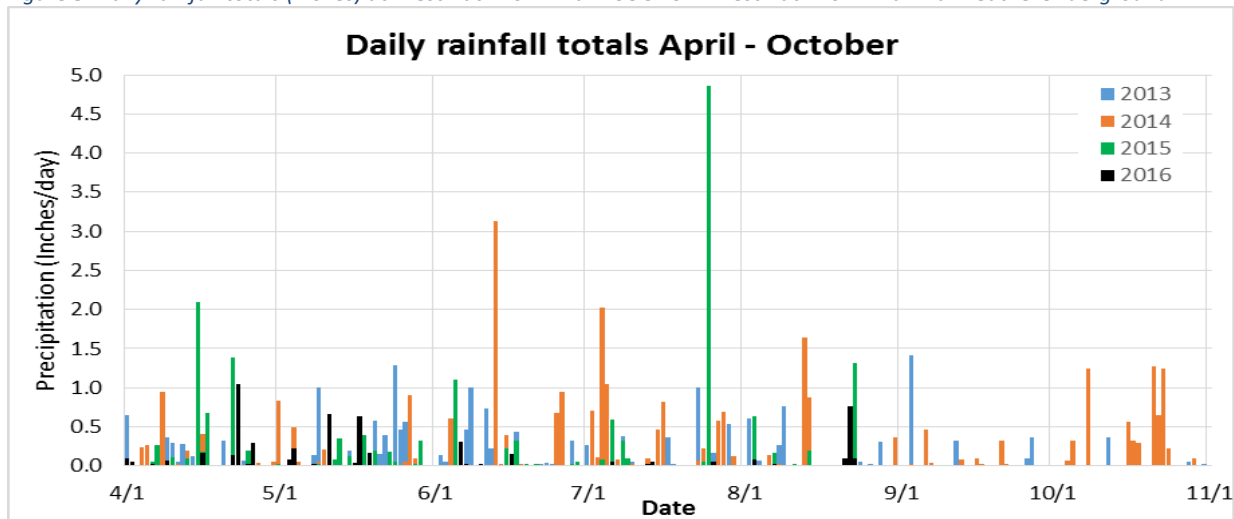
Figure 3. Daily rainfall totals (inches) at West Bath Town Hall. SOURCE: West Bath Town Hall via WeatherUnderground.

The West Bath Town Hall hosts a weather station that collects and records precipitation totals for the Maine Department of Marine Resources’ use in determining rainfall closures for local shellfish beds. These data are posted online at The Weather Underground and can be downloaded into Excel. Graphical display of daily precipitation data over the 2013-2016 monitoring seasons illustrates variations in rainfall patterns from year to year (Fig. 3). 2013 was relatively dry in comparison to 2014, while 2015 was closer to normal. 2016 was consistently drier than prior years, consistent with drought conditions. Heavy rains in 2014 (3.13” on 6/13; 3.89” 7/2-7/5), and 2015 (4.86” on 9/30) affected subsequent pore water salinity readings.

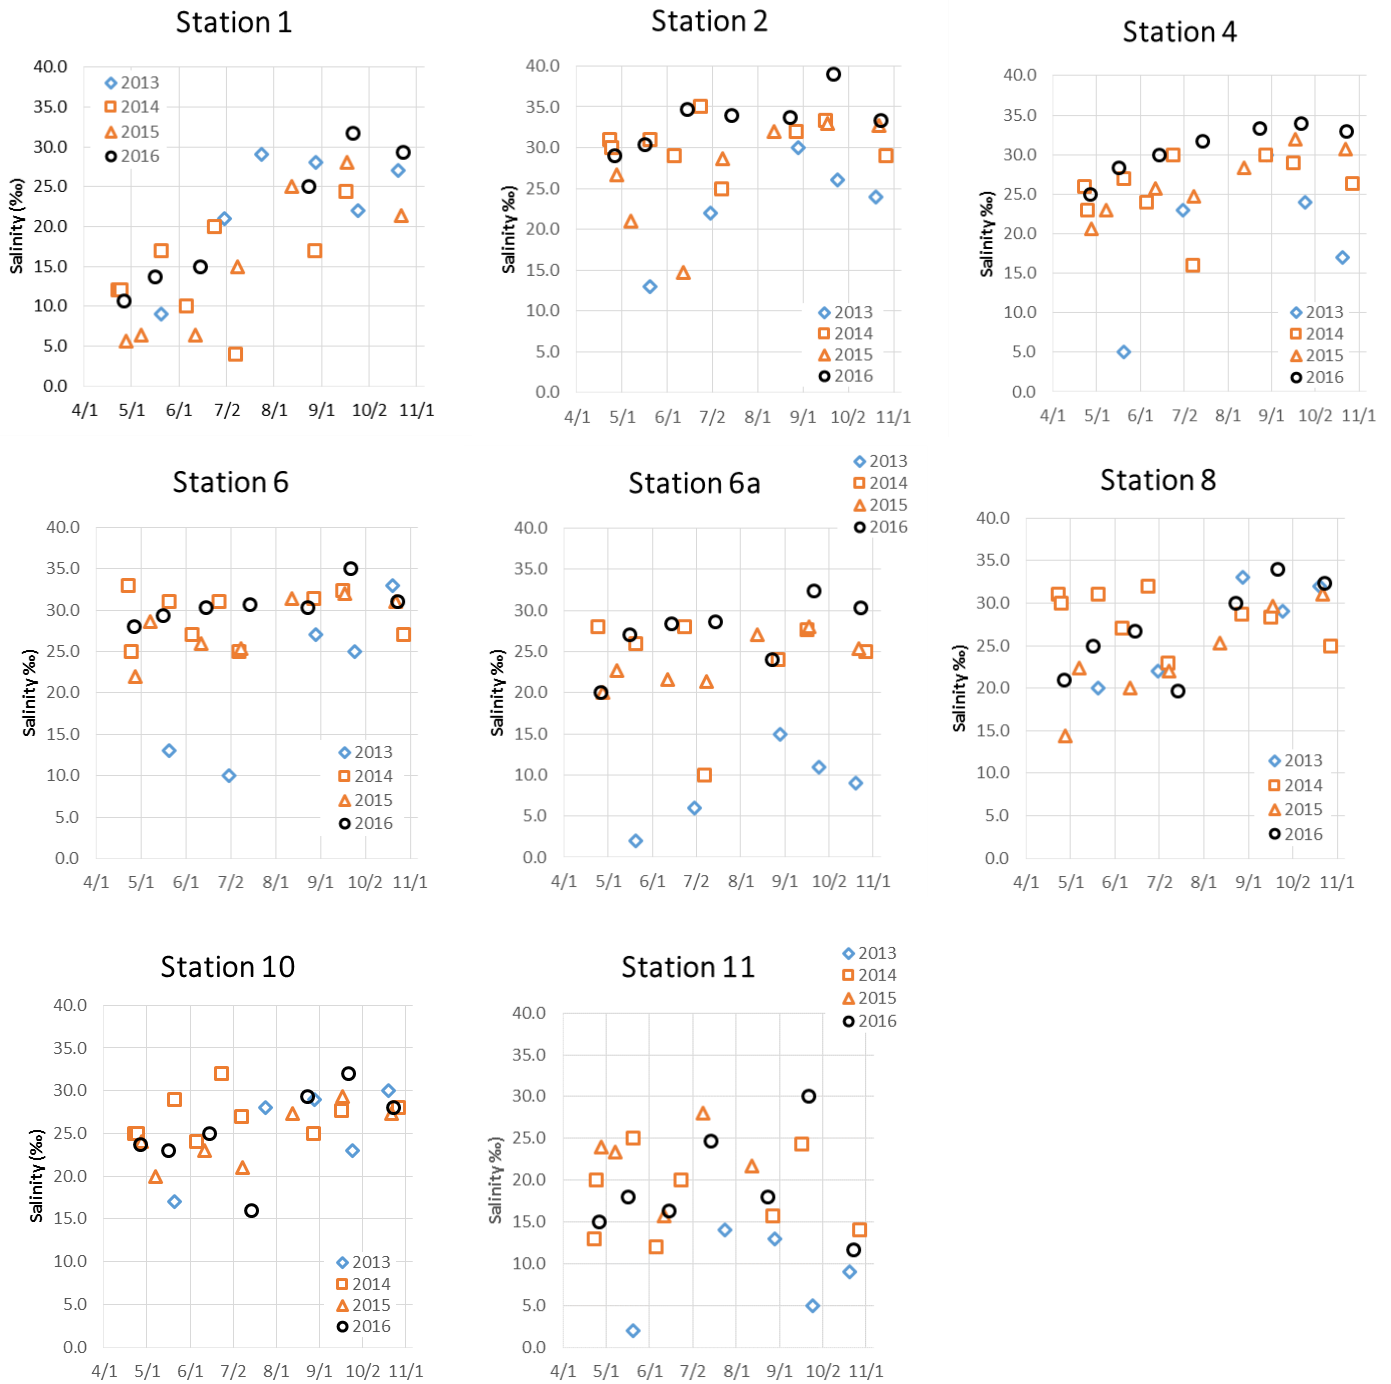
Figure 4. Plotted pore water salinity Stations 1, 2, 4, 6, 6a, 8, 10 and 11.

Figure 4 plots pore water salinity levels at Stations 1-11 per visit per year. Each point represents the mean of three readings taken per a given sample. Pre-project samples are shown in blue, and post-project samples in orange, differentiated by symbols. Station 11 is outside the Project Area but included for context.

Across all Stations in the Project Area, mean pore water salinity increased from 20.9 ppt. pre-project (2013) to 28.2 ppt. post-project (2014-2016). The greatest changes in pore water salinity has been observed at Station 6a, which of the stations in the Project Area, is furthest from the main channel. At 6a, mean pore water salinity increased from 8.6 ppt. in 2013 to 25.2 ppt. from 2014-2016 (Table 5, Figure 5).

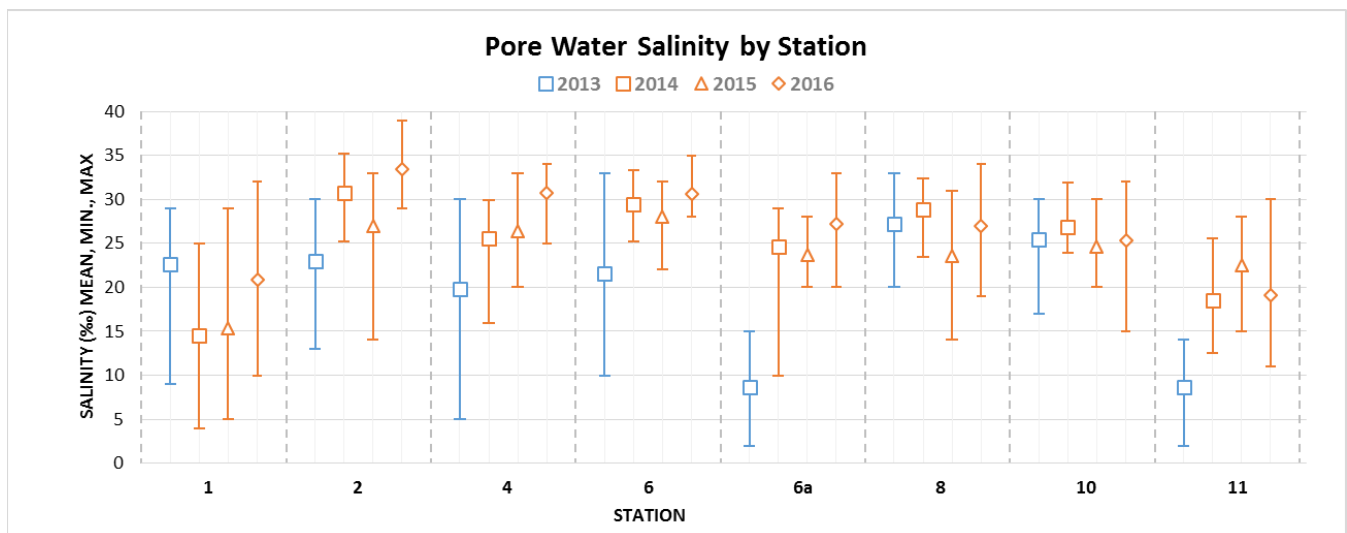
Figure 5. Mean (symbol), minimum (low bar), and maximum (high bar) pore water salinity (‰) for 2013-15.

Figure 5 graphically illustrates mean, minimum, and maximum pore water salinity levels per Station. Post-project readings have yet to drop below 10 ‰ in the Project Area. The largest increases from pre-project levels are at Station 6a, located approximately 5m from the upland edge, and at Station 11, which is south of the narrows and outside the Project Area. The abrupt increase at Station 6a is consistent with the results of vegetation monitoring, which documented that freshwater species present in 2013 were dead in 2014, and the vegetation community remains in transition. The increase at Station 11, which is adjacent to stands of invasive *Phragmites australis*, documents that the effect of the improved tidal exchange extends well south of the Project Area and the Narrows, into the southern reach of the marsh.

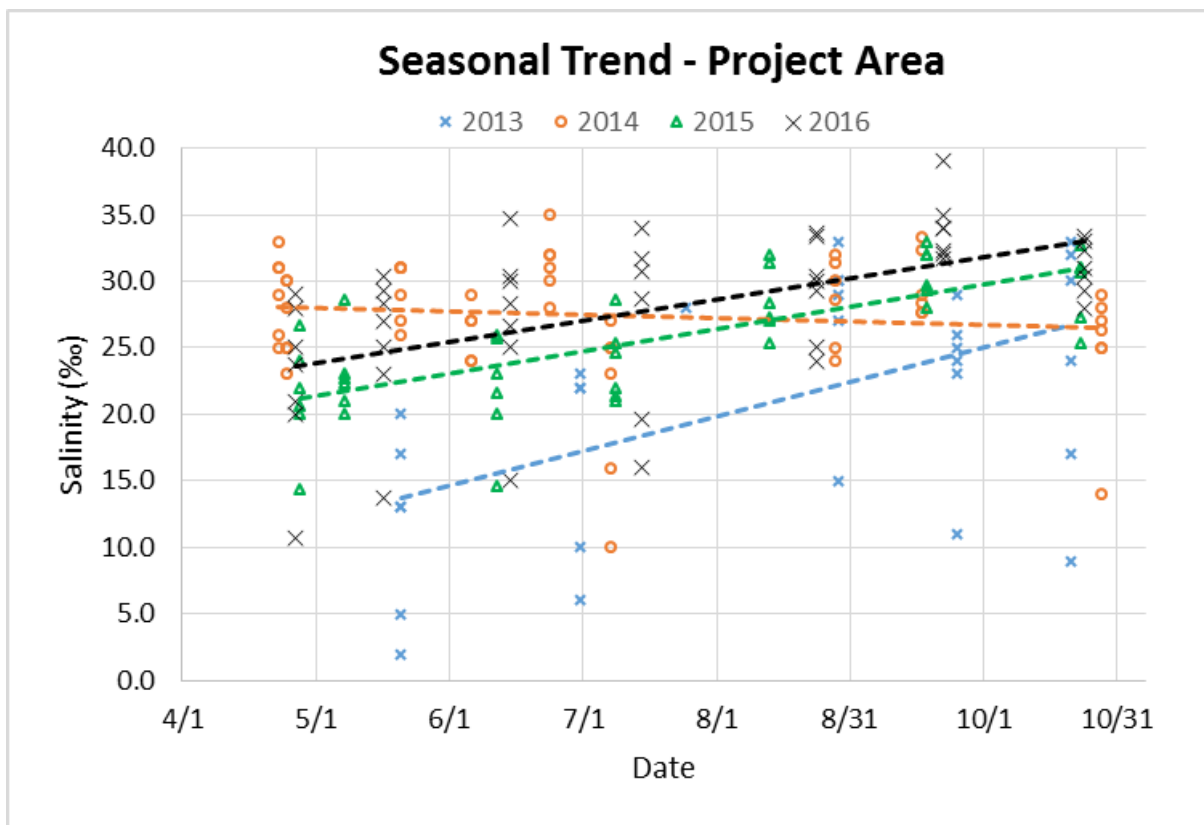
Figure 6. Year over year plot with trend lines of pore water salinity levels in the Project Area (excluding Station 1 & Station 11).

Figure 6 plots salinity measurements in the Project Area with linear trendlines for each year of data points. Based on trendlines, pore water salinity may be higher post-project earlier in the growing season than pre-project due to the increased tidal exchange and freshwater drainage out of the marsh. In 2013, pore water salinity at Stations 2-10 trended upward over the course of the summer into fall, whereas in 2014, pore water salinity at Stations 2-10 was consistent, other than the July samples, across the season. In 2015, pore water was lower than in 2014 early in the season, possibly reflecting the influence of snow and ice melt, but increased to higher levels later in the season. The similarity in slope of the lines in 2013, 2015 and 2016 is interesting as an illustration of the effect of tidal restoration, which in this visualization, has increased pore water salinity throughout the Project Area by at least 5‰.

Overall, post-project pore water salinity is higher within the Project Area in years 1-3 as compared with pre-project levels in 2013. Pore water salinity was also observed to be higher earlier in the growing season in 2014-2016 than in 2013, consistent with expectations that the marsh is draining more quickly through the new culvert. This is illustrated by the dip and recovery of pore water salinity levels following heavy rain events in late June and early July 2014 and October 2015, following a 5" rain event on 9/30/15.

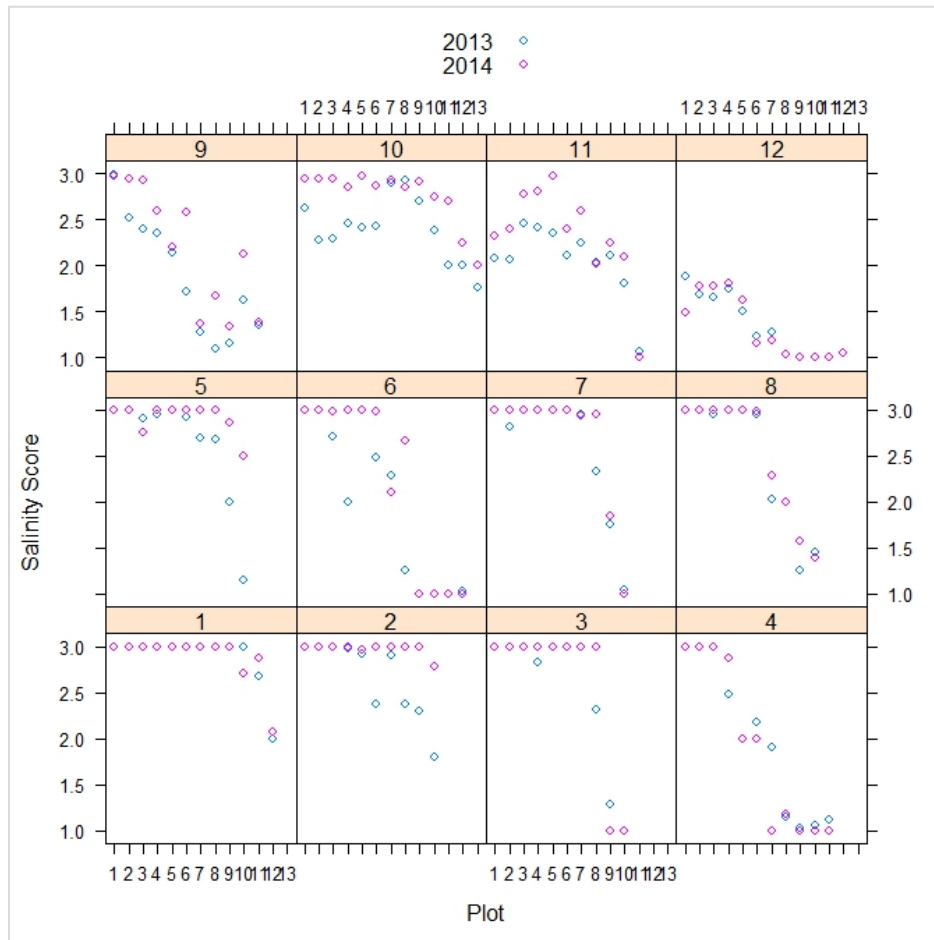
Figure 7. Salinity index scores of vegetation plots, 2013 to 2014.

project clearly extend beyond the Project Area, as a marked shift toward halophytic plants is evident at Station 11, adjacent to invasive *Phragmites australis* stands, in the first several plots away from the channel. Station 12 appears to not yet have been affected by the change in hydrology.

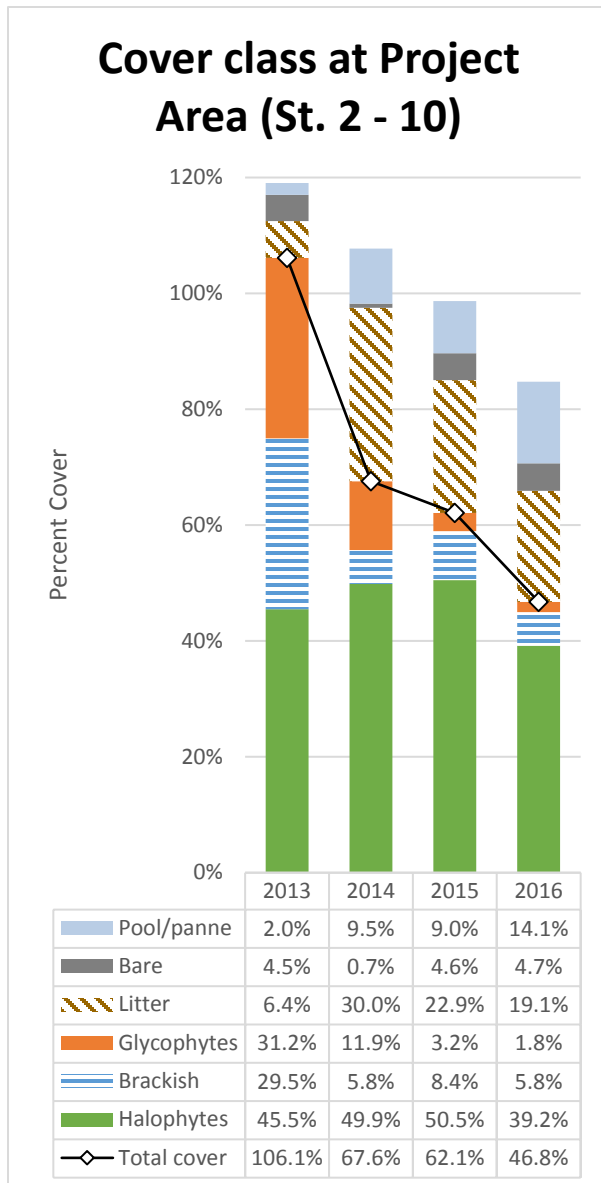
Figure 9. Comparison of mean percent cover of plots within the Project Area (Stations 2-10).

Figure 9 compares yearly mean percent cover types of plots within the Project Area (Stations 2-10) from 2013 to 2016. Overall, 2016 data suggest a decrease in general plant cover on the marsh across all community types. Halophytic species cover increased from pre-project levels of 27.7% in 2013 to 49% during the second growing season post-project; however, a decline in halophytic species coverage to 39% is apparent in 2016. Plot coverage by glycophytes declined from over 31% in 2013 to just 1.8% in 2016, and coverage by brackish plants decreased from over 29% in 2013 to nearly 6% in 2016. Litter (standing dead plant matter) remains prevalent

within plots, consistent with the loss of freshwater and brackish species over pre-project levels. The decline in brackish and glycophytic species is consistent with increased salt delivery into the marsh, and improved freshwater drainage out of the marsh. The continued declines in these community types in 2016 is also consistent with drought conditions and elevated pore water salinity levels.

The observed decline in halophytic plant cover within the Project Area in 2016 is a departure from increases observed in 2014 and 2015 and is lower on a percentage basis than pre-project levels from 2013. The cause of this decline is not clear, but in the context of declines in glycophytic and brackish community cover, it could be cause for concern if halophytic species cover continues to decline. Overall living plant cover has steadily declined within the Project Area since the project was implemented (Figure 9). Figure 10 compares mean percent cover of plots in the Project Area with plots at Station 1, which can be considered a reference site due its proximity downstream from the project site, in 2016. The transect location for 2016 was in a physically different location than in prior years due to the prevalence of wrack and litter on the marsh surface downstream of Long Reach Lane. Comparison with prior results is therefore complicated by a shorter transect length and fewer plot samples over prior samples. With this caveat, it is interesting to note the apparent decline in the cover of halophytes at Station 1 in 2016, which appears to mirror the decline in halophytic plant cover within the Project Area. Future monitoring results may provide clues as to whether the drought, and the corresponding elevated pore water salinities observed at Long Marsh in 2016, affected the abundance of halophytes and plant cover, generally.

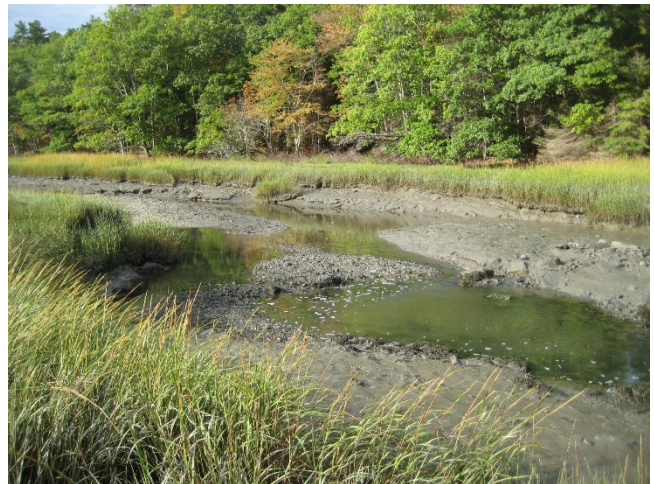
The 2016 profile shows mudflat downstream of the road, with elevations comparable to 2013. Rip-rap at the base of the outlet remains, but the new culvert invert is lower. A series of sediment deposits are evident upstream of the culvert inlet, resulting in a series of shallow ripples and pools in the former upstream scour pool. A head cut is migrating up the channel, which is being tracked using stakes at the channel edge. Upstream of the head cut, the channel bottom levels off, but at an elevation over a foot deeper than prior to the project, indicating significant movement of fine sediments.

View of channel and scour pool upstream of culvert inlet.

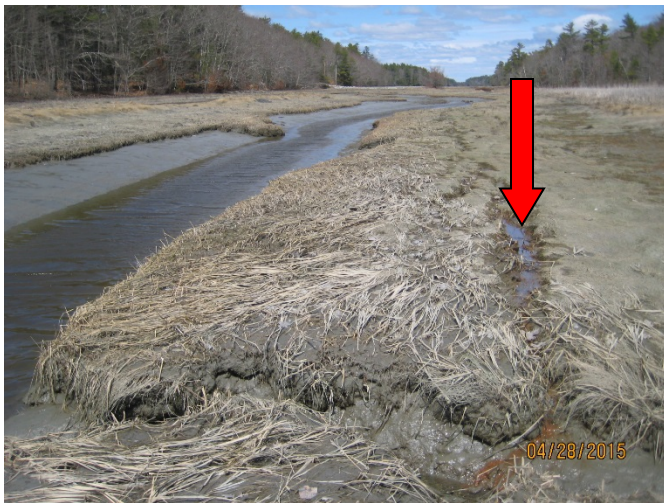
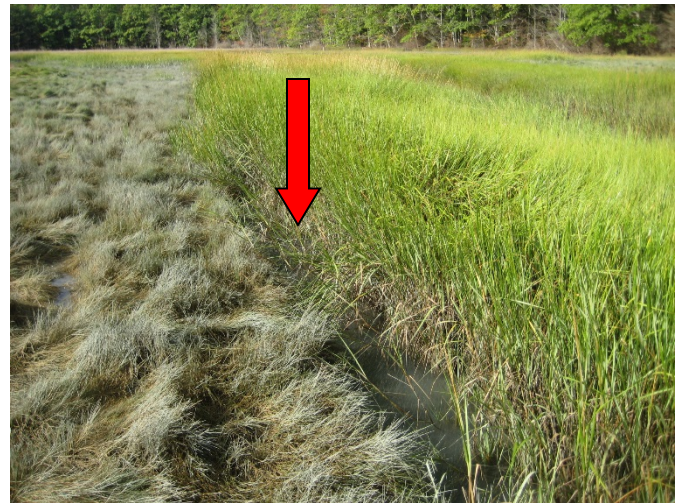
*Channel response to increased tidal exchange was not always captured in surveys. A long and expanding rill along the east side of the channel near Station 4 (left, view N) could indicate future dimensions under the new hydrologic regime. The same site is shown in 2016 (right, view S). Standing water in the rill co-occurs with an abrupt transition from low marsh to high marsh.*

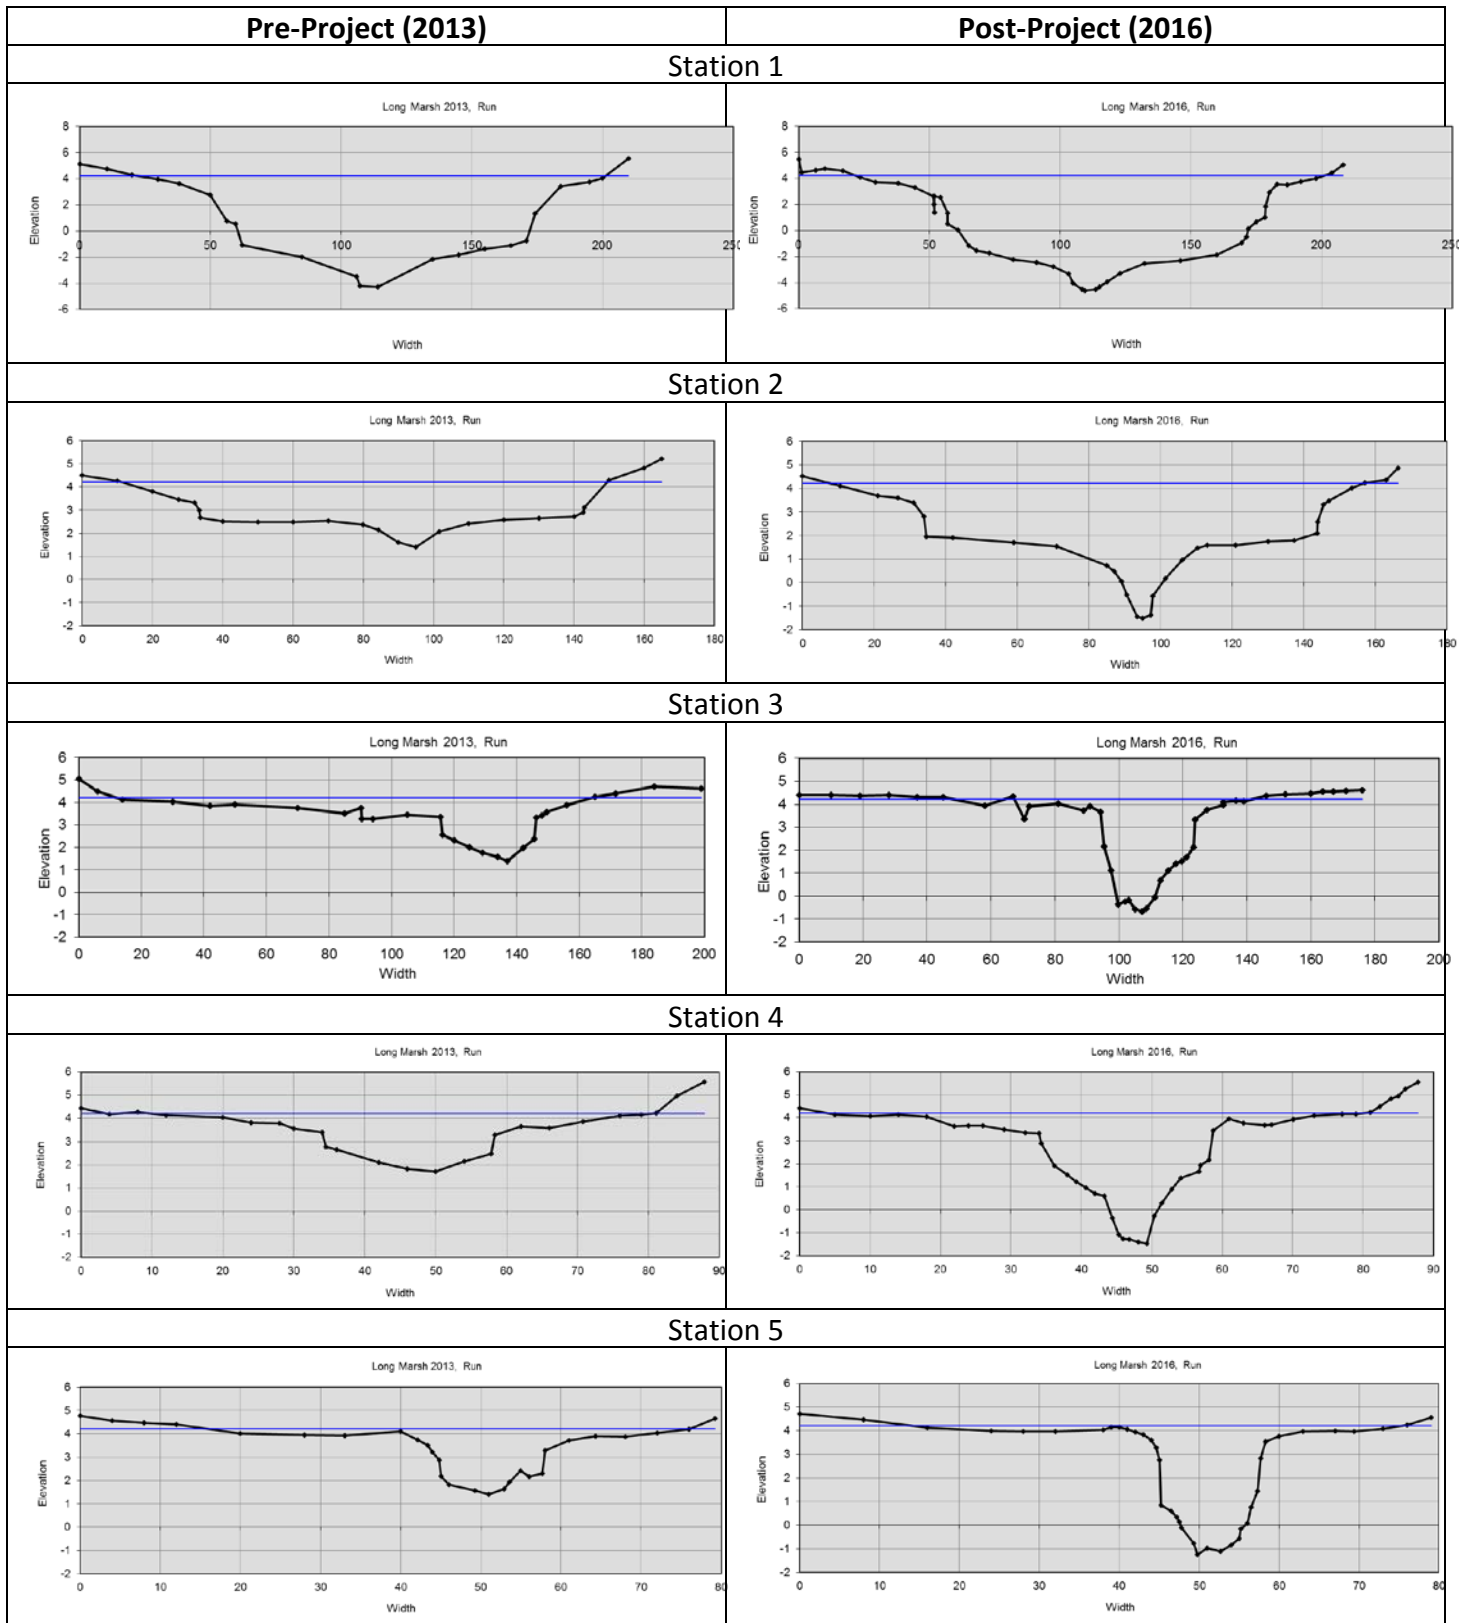
Figure 14. Plotted channel cross sections (Stations 1-5).

Figures 14 and 15 plot channel cross sections at Stations 1-10, with MHW (4.12' NAVD) at the Portland Tide Station for context. MHW was used in the Reference Reach Spreadsheet (Mecklenburg 2006) to calculate channel dimensions and cross sectional area, allowing for a standardized comparison of change in channel characteristics from one year to the next, which is particularly useful for looking at channel evolution in relation to increased inundation of the marsh surface. At each Station, the west side of the marsh is shown on the left side (0') of the transect. Elevations at Stations 1-5 are shown in feet relative to NAVD 88; elevations other Stations are approximated in NAVD. At most Stations, transects begin and end at fixed points that are higher than MHW, with the exception of Station 7. The location of cross section transects was identical each year, but slight differences in transect length occur due to conditions in the field, such as wind.

**St. 1** - Due to heavy wrack accumulation and loose peat deposition on the marsh surface at this station, we could not locate the stake, XS1E, marking the eastern start of the transect; therefore, the transect may have been in a slightly different location in 2016. A 3.7% increase in cross sectional area was observed this year whereas previously, cross sectional area has been nearly identical year to year. Surveys continue to show linear bank sloughing on the western channel edge at approximately 50 feet along the transect. Where sloughing had previously been documented on the eastern bank, at approximately 175' on the transect, the channel edge is now steeper and slightly wider.

St. 2 – Down cutting continues, with a V-shaped channel expanding between exposed mudflats with deep unconsolidated fine sediments. In 2016, maximum channel depth grew by .8’ over 2015, and overall, is now 2.9’ deeper than pre-project. Cross sectional area increased by 8.4% (26.5 ft<sup>2</sup>) over 2015. The mudflats are popular for shellfish harvest; softshell clams, quahogs, and an occasional native oyster have been observed.

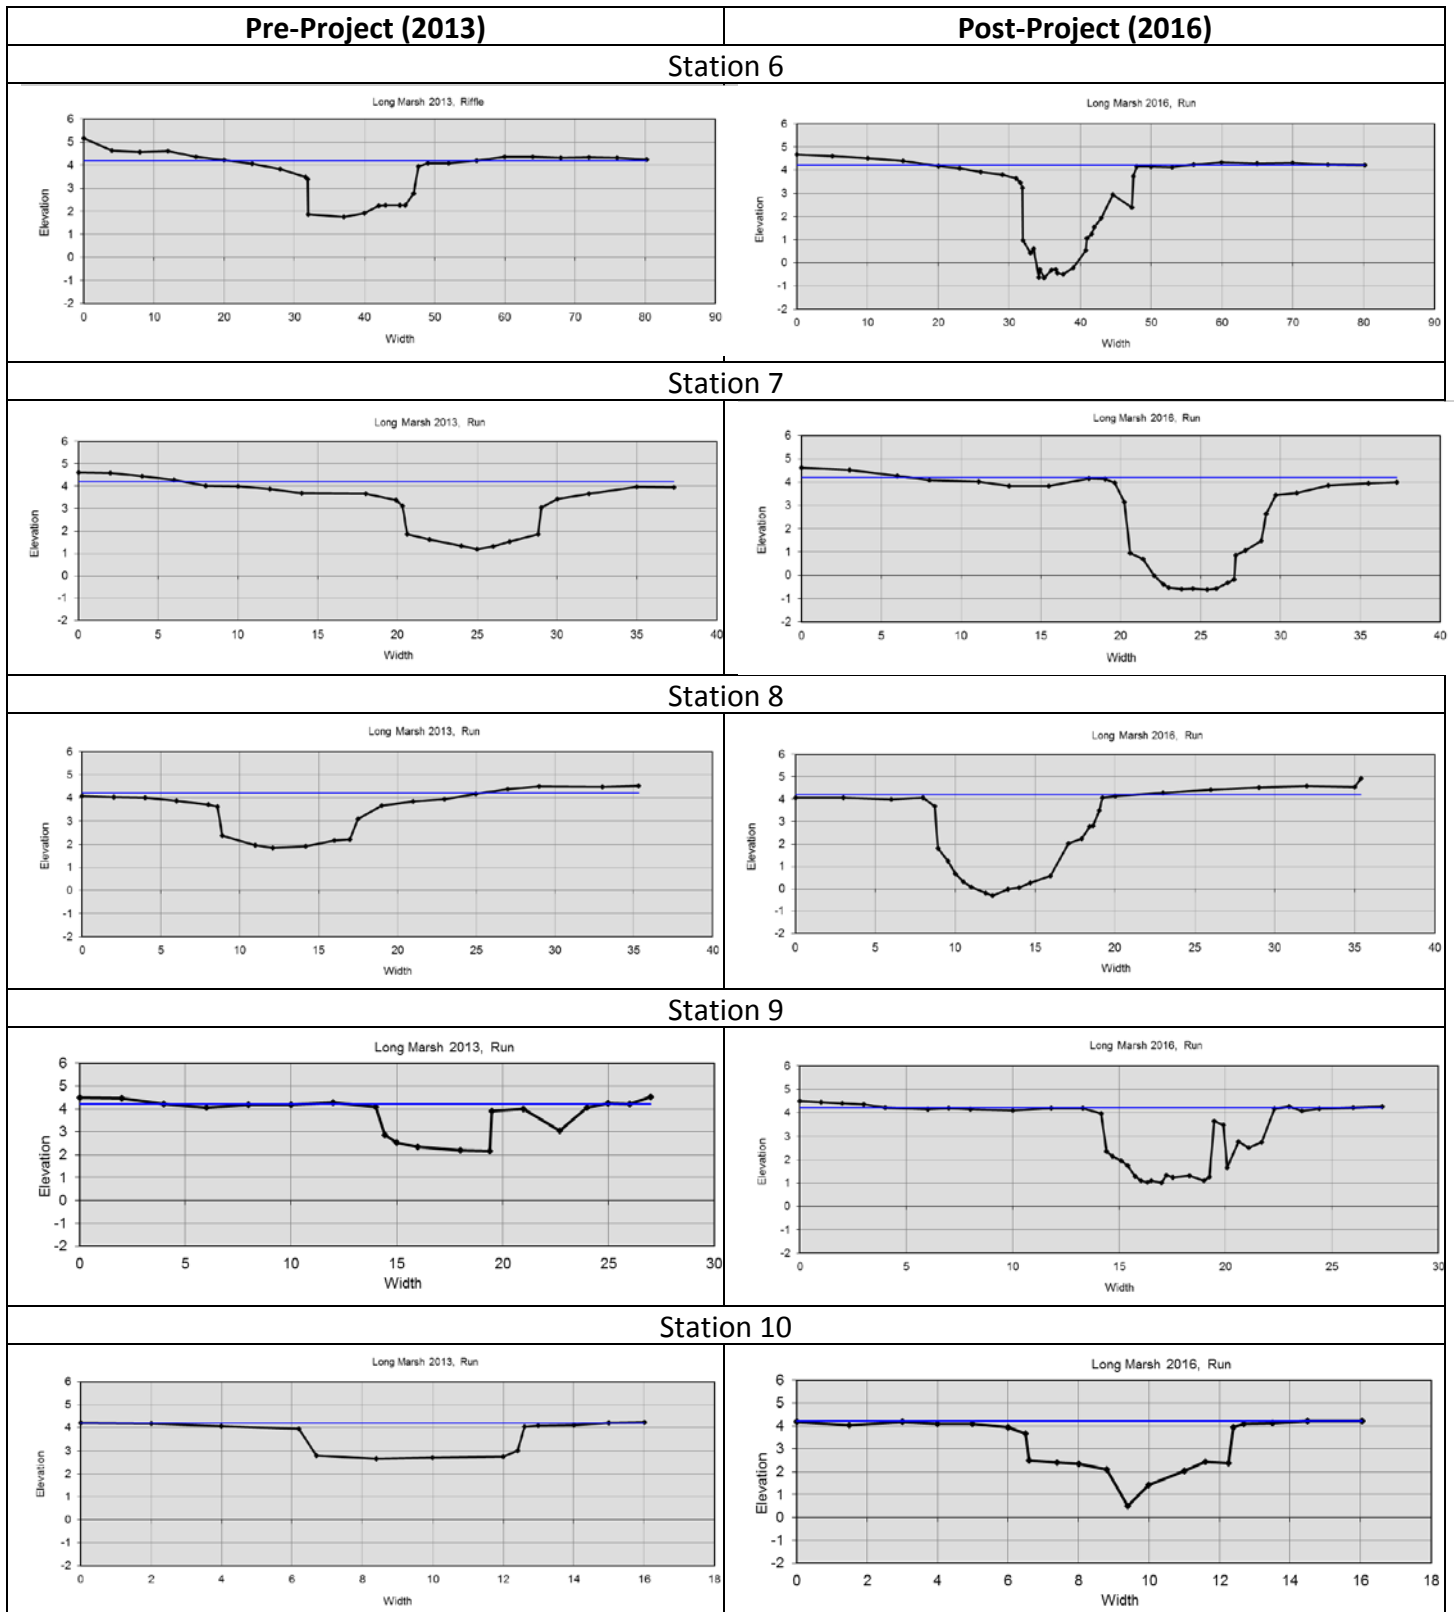
Figure 15. Plotted channel cross sections (Stations 6-10).

St. 9 & 10 – These stations are upstream of the “old road bed” crossing. Compared with other stations in the Project Area, the channel in this reach has experienced relatively little change. Sediment transport downstream is limited by the rock pile. Maximum channel depth was measured to have increased at Station 10 from 1.9’ in 2015 to 3.62 feet in 2016, but this may be partially attributed to the presence of unconsolidated organic material, and consequently, the lack of a stable base to hold the stadia rod at a constant depth.

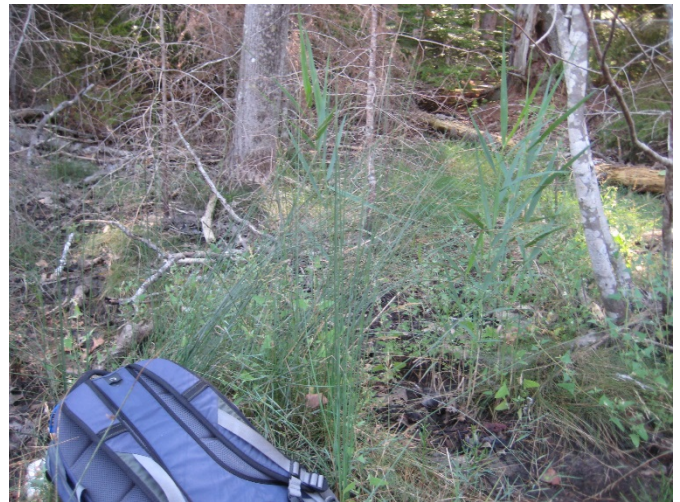
Invasive Common Reed (*Phragmites australis*) was found in the Project Area for the first time in 2016. During an invasive species meander survey in early August, CBEP's seasonal field crew observed a small new patch of *Phragmites australis* in a southeastern portion of the Project Area, approximately 15m away from the upland edge of the marsh near Station 9. At subsequent site visits, the patch was estimated to include 390 stems in an area of approximately 100m<sup>2</sup>. The patch was located amongst standing dead alder, cattails, and white pine, in an ecologically disturbed area of the marsh that now experiences regular tidal inundation, post-project. CBEP contacted Deane Van Dusen of MDOT to report the discovery. Van Dusen subsequently applied a mixture of Glyphosate and Imazapyr as a control agent in a fall application. Monitoring and spot treatment will continue in Years 4 and 5. Invasive *Phragmites* continues to grow in three distinct patches downstream (south) of Station 10 (visible on Figure 1). Anecdotal observations suggest that these stands are stressed by increased salt water delivery south of the "narrows". These stands were likely the source of the cloned *Phragmites* found in 2016.

One of two small adjacent *Phragmites* patches found in the Project Area during 2016 meander surveys.

Monitoring in 2016 documented that the marsh's vegetation communities, channel morphology, and habitat continues to adjust to the increased tidal exchange beneath Long Reach Lane. The discovery of invasive *Phragmites* within the Project Area reinforces the importance of monitoring of core parameters during the ongoing transition. CBEP will continue to intensively monitor the marsh for *Phragmites*, and continued spot treatment with herbicides is recommended on an as-needed basis.
