**Merepoint Boat Launch Facility Eelgrass Mitigation Measures:
2013 Monitoring Report**

MER Assessment Corporation

12 December 2013

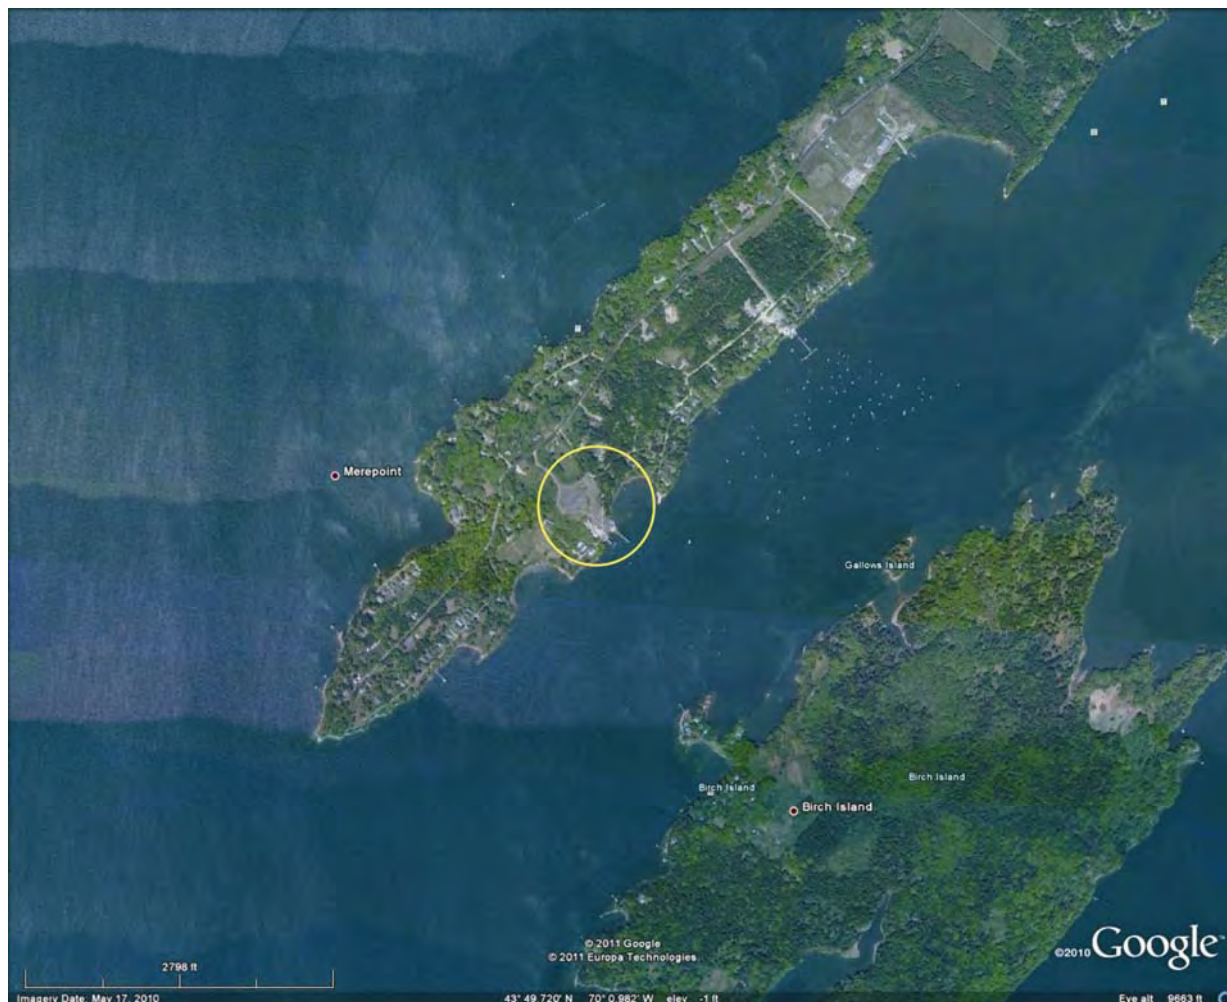
Figure 2 Completed Merepoint Boat Launching Facility (center) at Merepoint, Brunswick, Maine (Google Earth image)

The Maine Department of Inland Fisheries and Wildlife (IF&W) was issued a permit approval for the development and installation of the Merepoint Boat Launching (MPBL) facility at Merepoint, Brunswick, Maine on 13 April 2007. The location of the MPBL is shown in Figures 1 and 2, below.

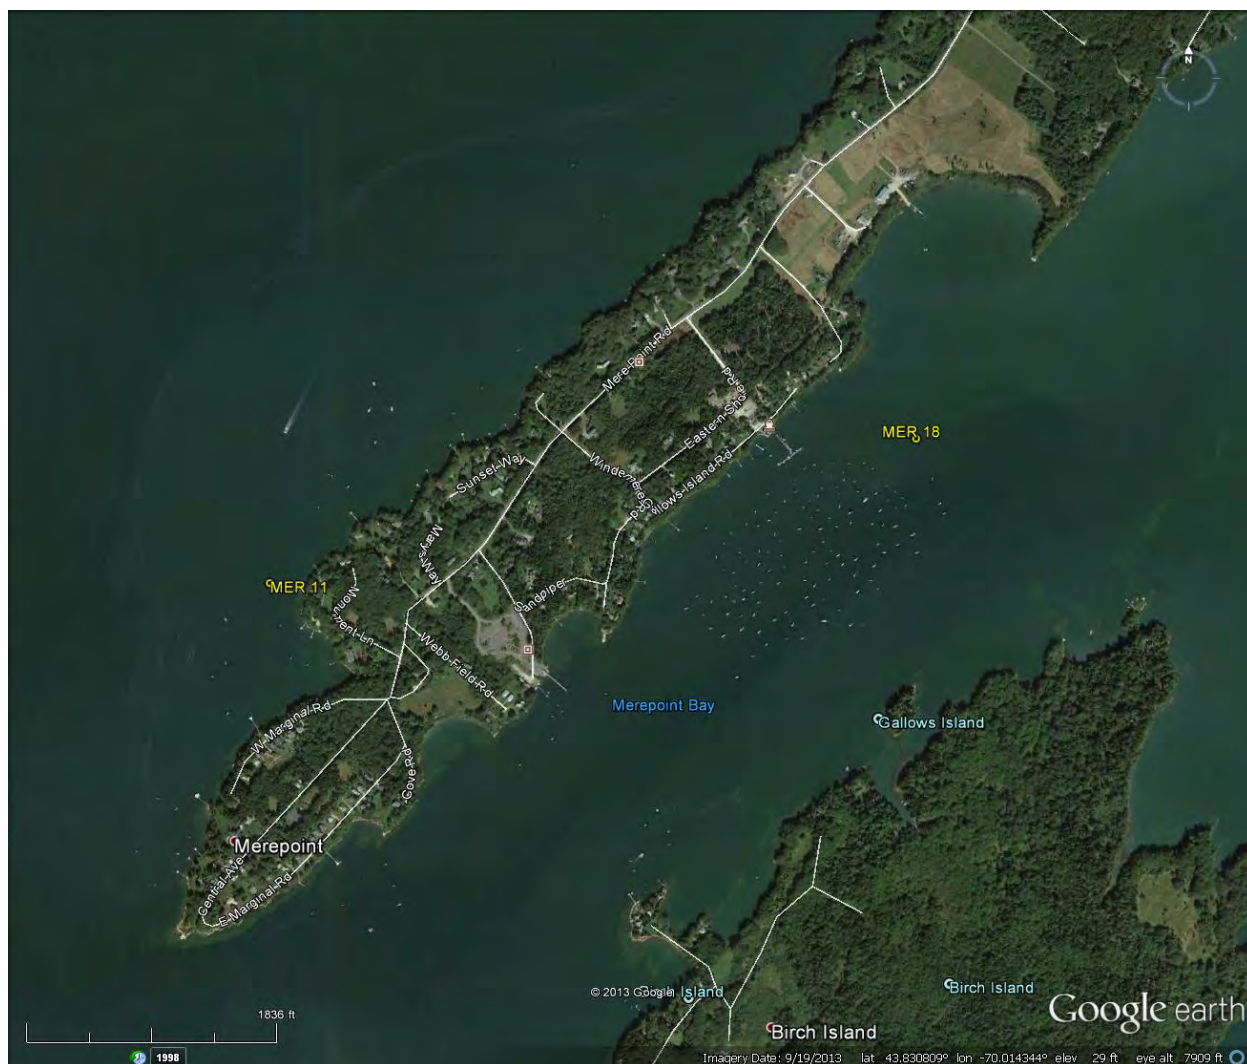
Figure 3 Location of the two (2) moorings selected for monitoring in 2013 (*Google Earth image*)

Mooring scar measurements were made on August 12, 2013 around the two (2) moorings selected for the 2013 monitoring effort. Both MER 11 and MER 18 moorings in Maquoit Bay and Merepoint Bay, respectively, are embedment helix mooring replacements for traditional mushroom/ block-chain moorings. The locations of the two moorings are shown in Figure 3.

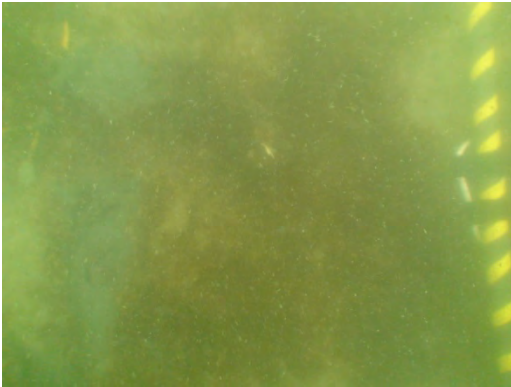
Transect 1 at 5m mark

The 2012 video survey showed a continuation of the thinning and general decline of the eelgrass within the meadow that appears to have begun in 2011; however, in 2013 as the photos below show, no eelgrass was found along the two transects and the bottom was generally covered with a brown epilithic diatom mat.

Still images taken with the Sony HDR-HC9 high definition digital camera of Transect 1 at 30m intervals are shown below; these locations correspond to the locations where sediment chemistry and eelgrass (below-ground) sampling was done, the sampling frame appearing in some photos.

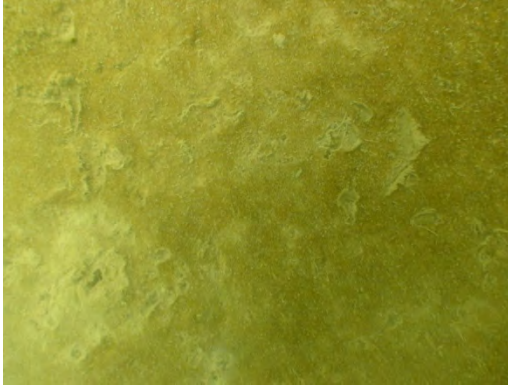
Transect 2 at 5m mark

Still images taken of Transect 2 at 30m intervals are shown below; as above, these locations correspond to the locations where sediment chemistry and eelgrass sampling was done.

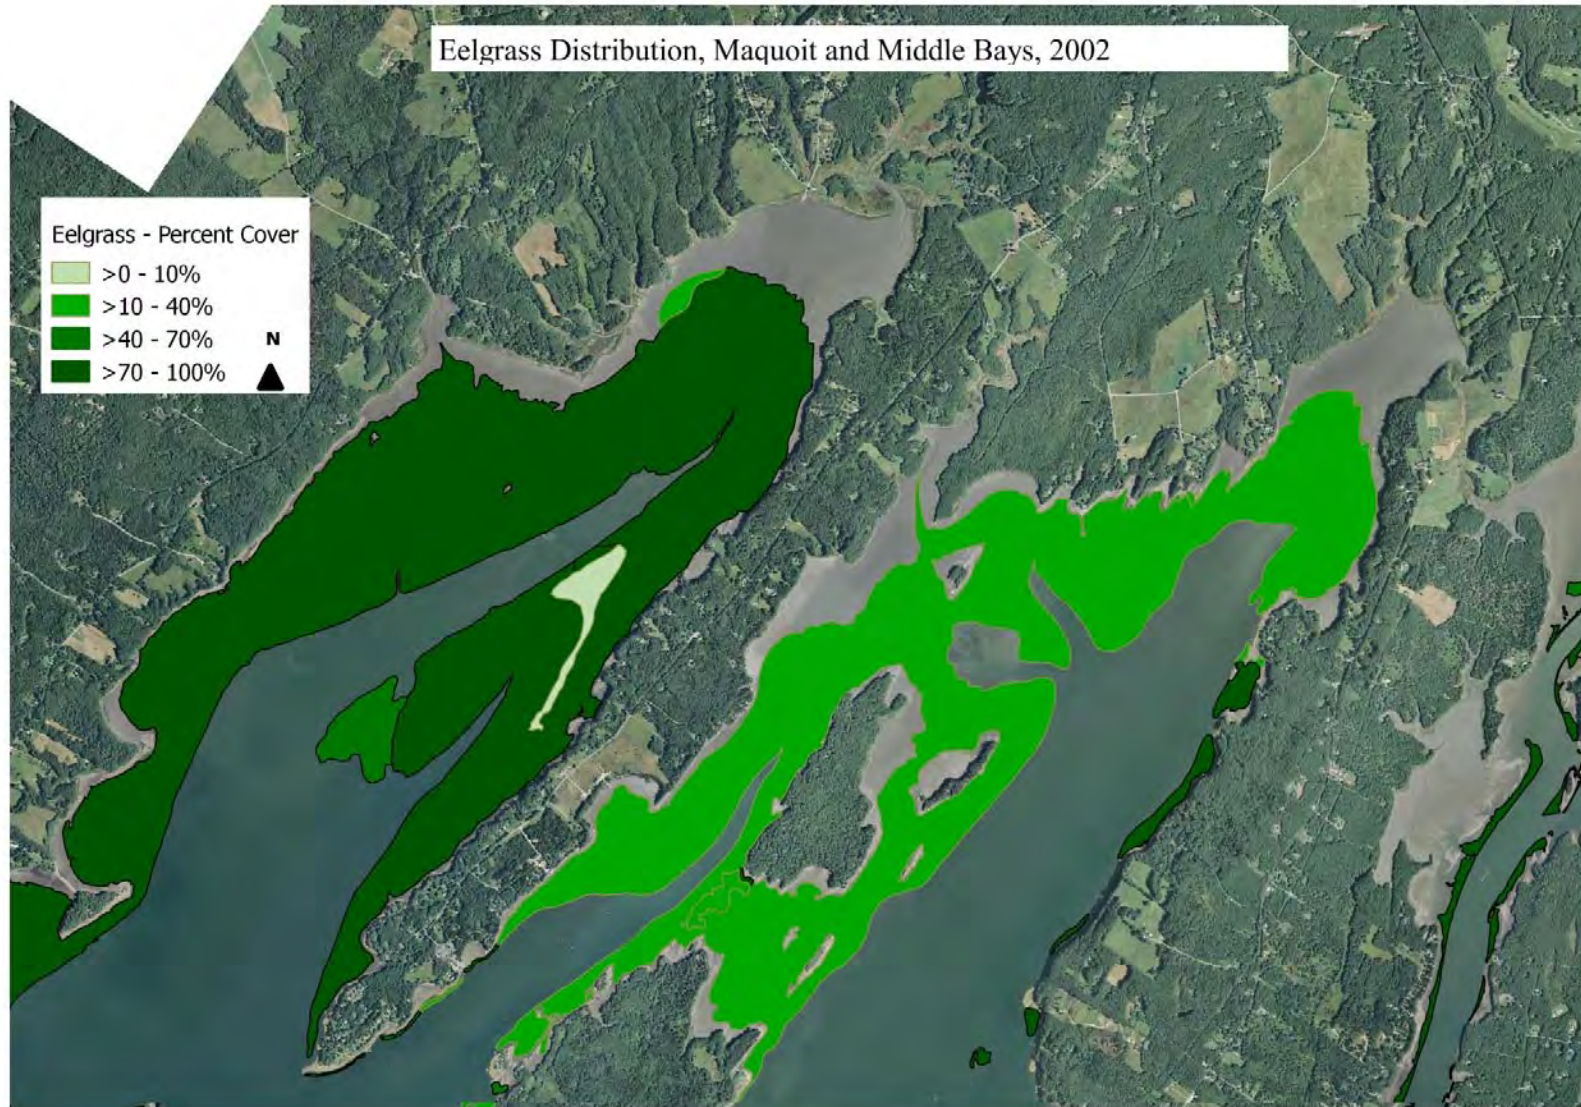
Figure 9. 2013 Sewall aerial photo Maquoit Bay and Middle Bay area in 2013 showing photo-interpreted eelgrass distribution in 2002 per Seth Barker (formerly with Maine DMR).

The video monitoring at the mooring scars and vicinity of Simpson Point revealed a near catastrophic loss of eelgrass in Maquoit and Merepoint Bay. These observations were confirmed by aerial photography conducted by Sewall as part of a collaborative effort by the Maine DEP and DMR and Casco Bay Estuary Partnership (CBEP) with photo-interpretation of eelgrass distribution done by Seth Barker, formerly with the Maine DMR.

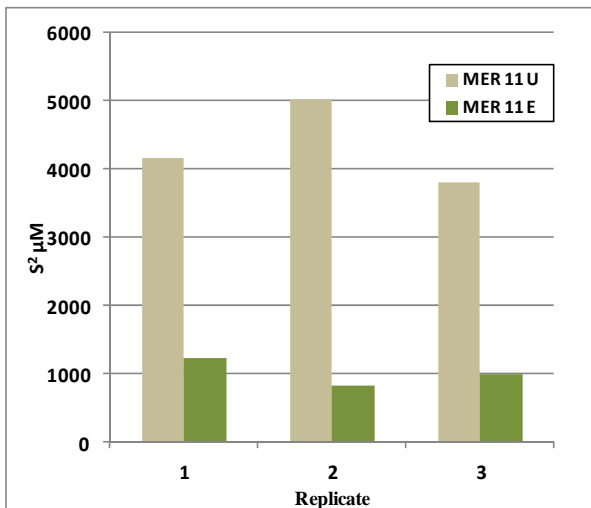
Figure 12 MER 11 sulfides (μ M)

It has been suggested that the lack of recovery of eelgrass within the mooring scars might be the results of unsuitable sediment conditions, specifically elevated sulfide and total organic carbon resulting from accumulation and decomposition of organic matter within the depression created by the sweeping chain. Goodman (1995) classified pore water sulfide concentrations in excess of 600 μ M as toxic to eelgrass, based on EC50 laboratory experiments for eelgrass photosynthesis. As Figures 12 and 13 show, sulfide concentration within the “unvegetated” (‘U’) scar area (tan bars), particularly at MER 11, are significantly higher than in the surrounding “vegetated” area (green bars). The sulfide concentration levels are significantly higher than the 600 μ M. These levels are clearly toxic to eelgrass and likely the reason for the lack of recovery of the scars, at least those areas toward the center of the scars.

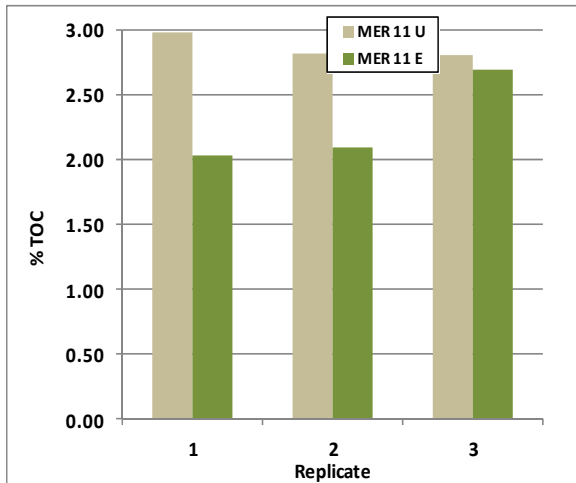
Figure 14 MER 11 TOC (%)

Total organic carbon is consistently higher within the scar area compared to the vegetated areas, but the difference is small compared to the sulfide results (Figures 14 and 15). These results are generally similar and only slightly higher than results obtained from soft bottom reference sites elsewhere along the Maine coast.

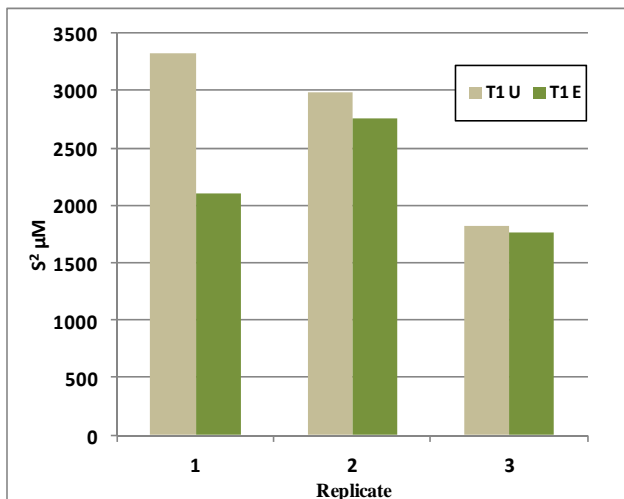
Figure 16. SP T1 sulfides (µM)

No eelgrass was found at Simpson Point and there is, therefore, no difference between the “unvegetated” and “vegetated” samples other than the “unvegetated ‘U’ ” samples were collected over the first 60 meters of the transect and consequently in shallower water (approx 1.5 feet depth at low water) compared to the “vegetated ‘E’ ” collected over the second 60 meters of transect in deeper (approx. 3.5 feet depth at low water). The Simpson Point sulfide concentrations are generally lower than those found in the mooring scar areas; however all are still well above the toxic level of 600µM, indeed all being above 1,000µM (Figures 16 and 17).

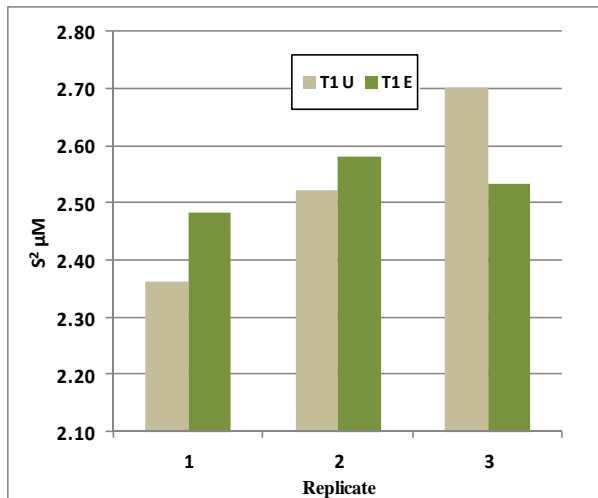
Figure 18. SP T1 TOC (%)

The Simpson Point total organic carbon results are similar to results obtained from soft bottom reference sites elsewhere along the Maine coast, that is, within the 2.00% to 2.50% range (Figures 18 and 19).

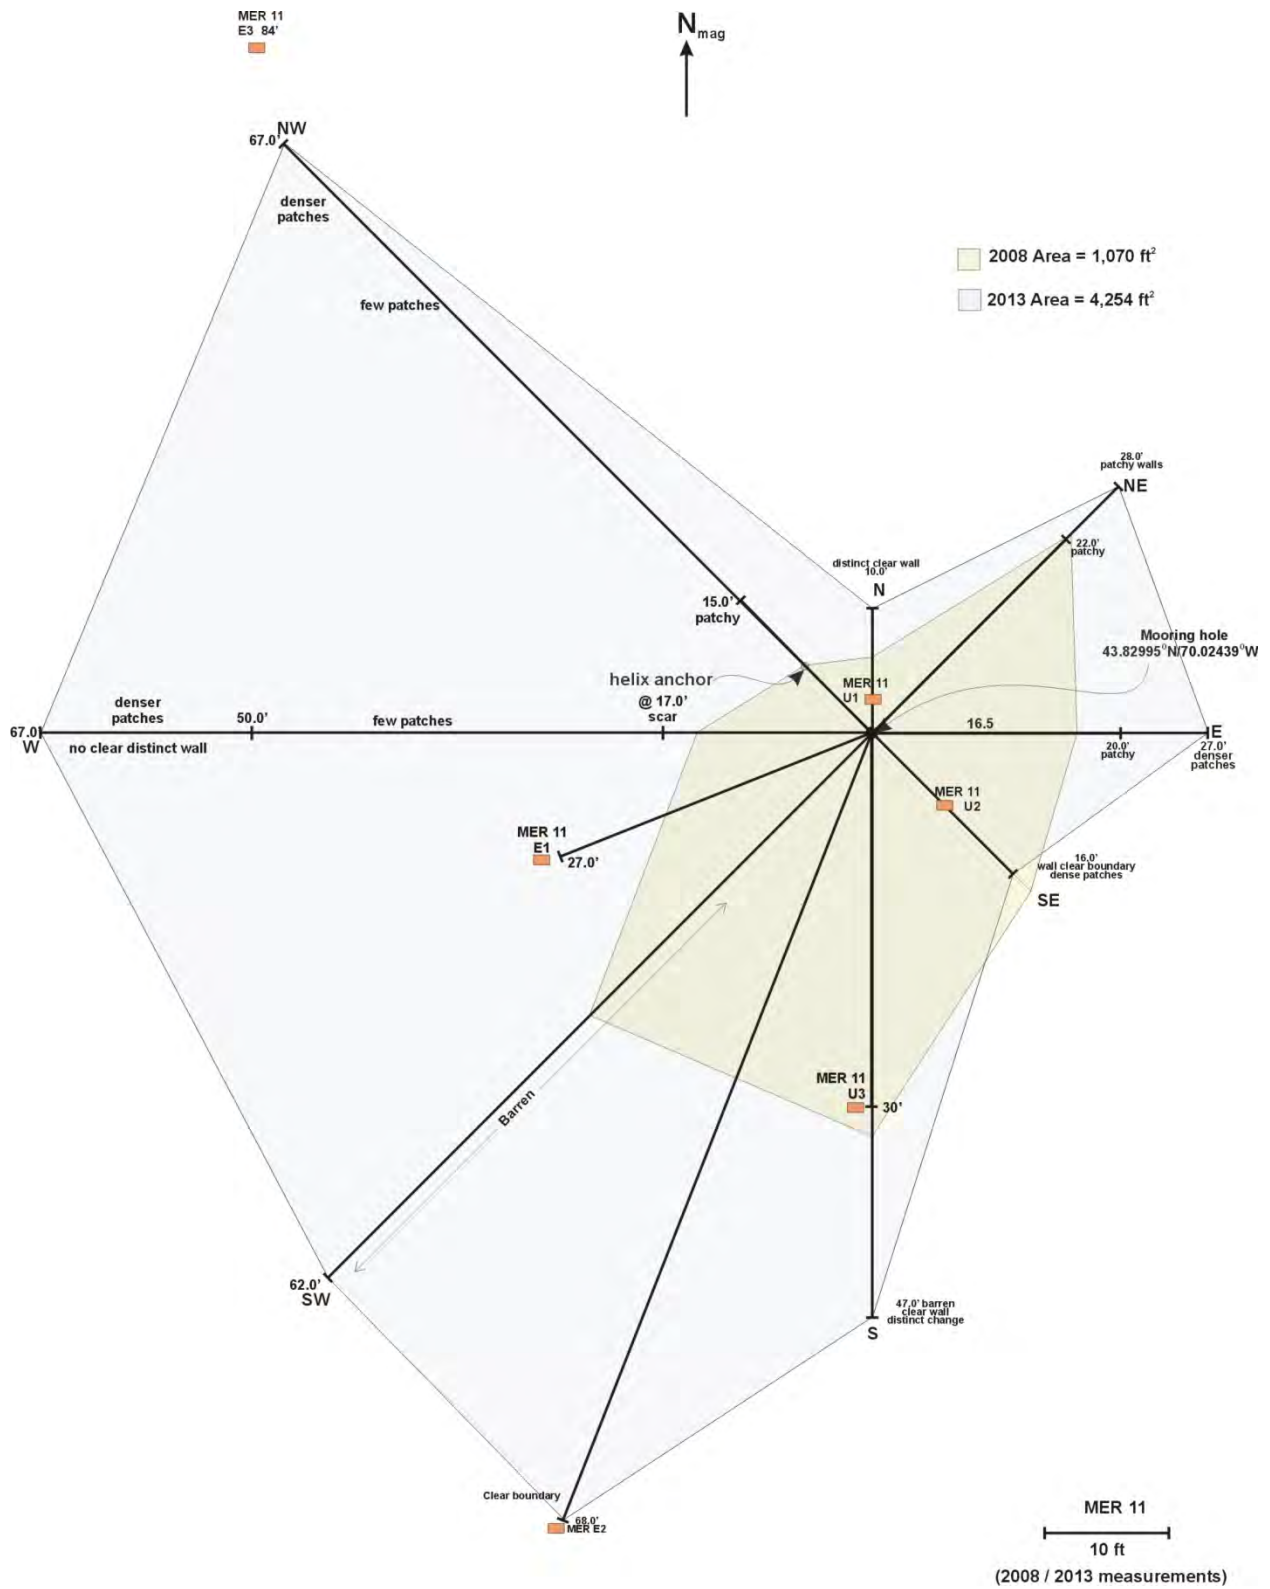
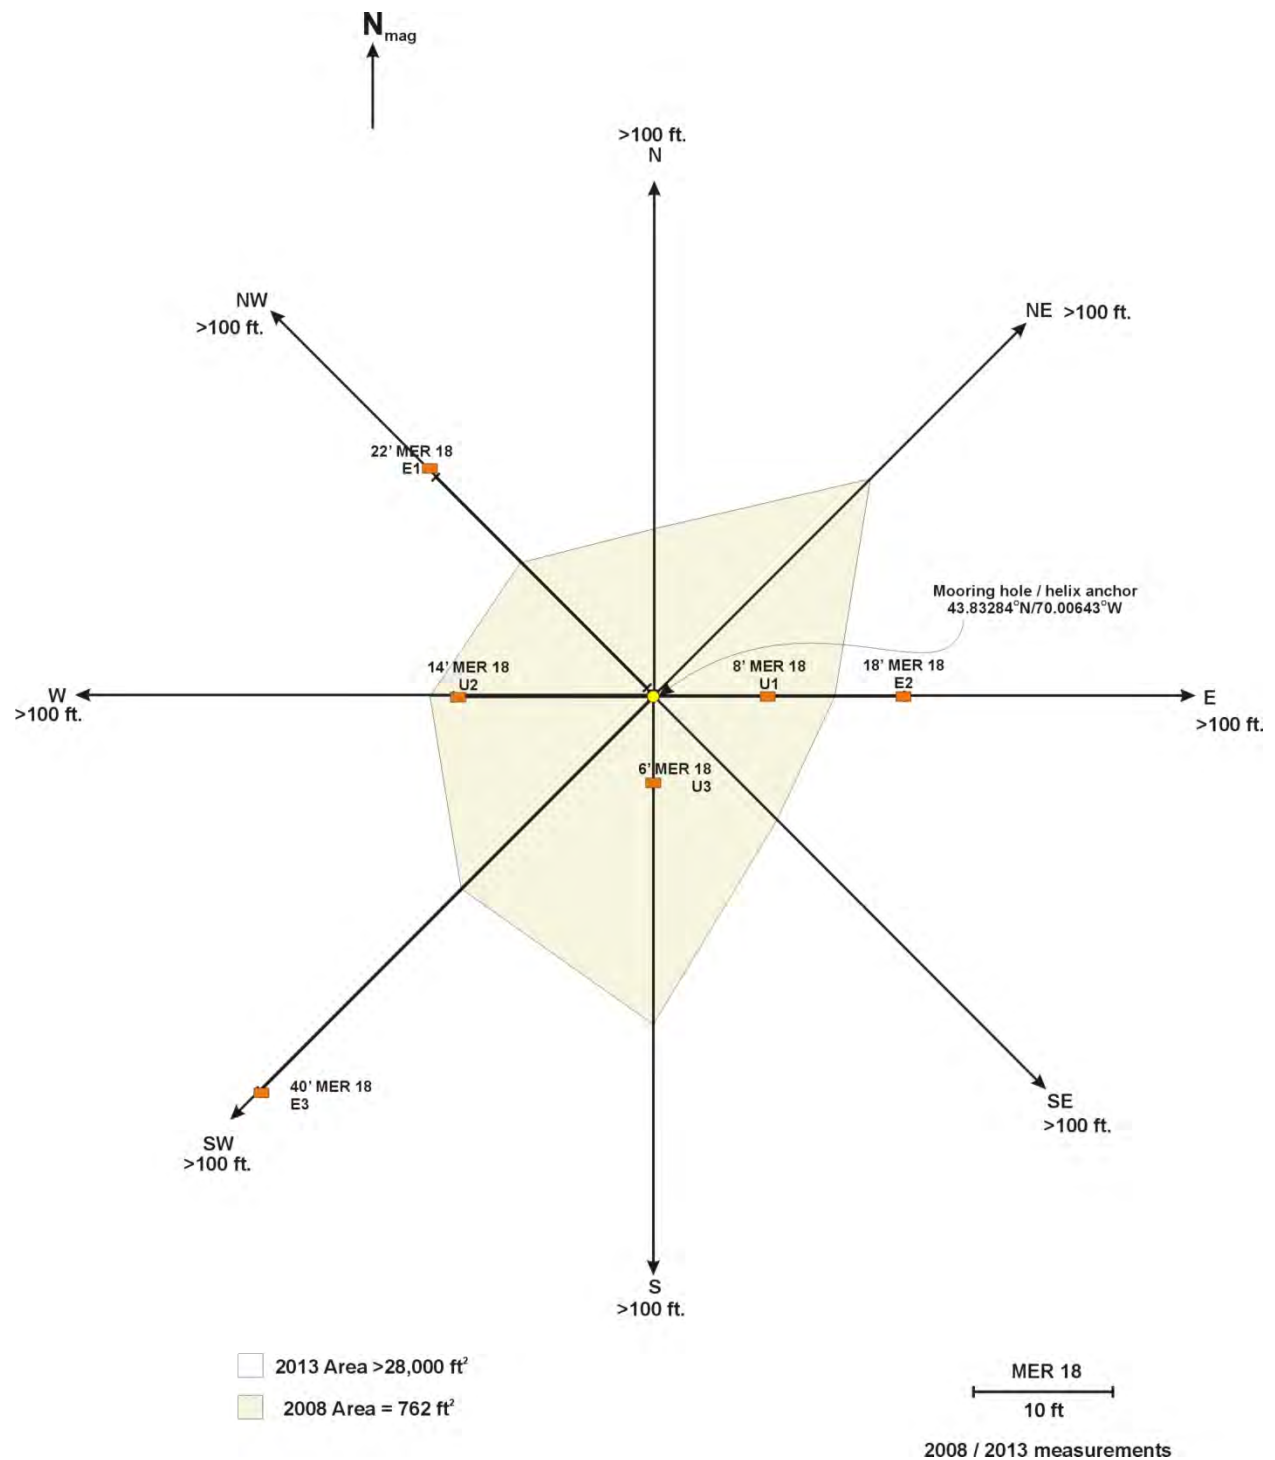
**Graphic representations showing 2008 and 2013 mooring scars area based
on eight *in situ* radii measurements**

These results clearly show that, following some moderate recovery of these two scars between 2008 and 2011, the trend towards increased scar area that began in 2012, presumably due to a general decline in eelgrass within the region, continued through 2013 to the extent that no eelgrass was observed in the vicinity of MER 18 indicating a complete loss of eelgrass within the area.
