## Thomas Bay Marsh, Brunswick, Maine, 2011 Post-Construction Monitoring Report

# Thomas Bay Marsh, Brunswick, Maine 2011 Post-Construction Monitoring Report

**Submitted To:**  
GOMC/NOAA CRP  
#10-03 Thomas Bay  
Marsh/Adams Road

**Date Submitted:**  
February 17, 2012

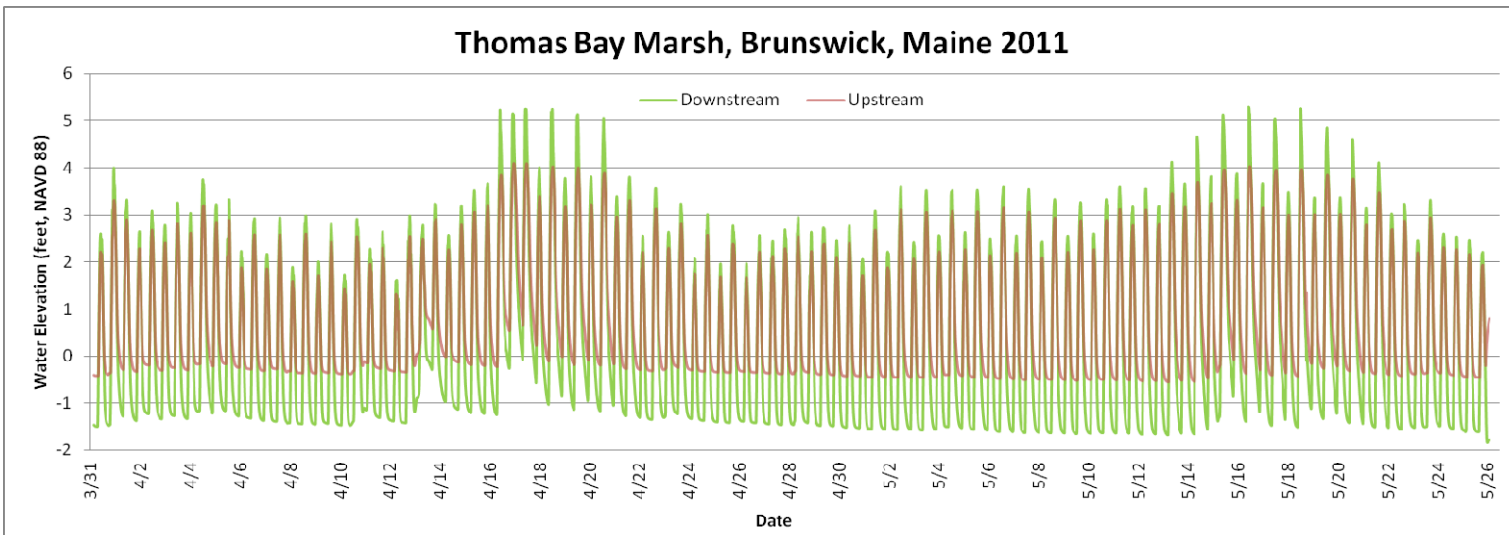
Figure 3. Thomas Bay marsh pre-construction data from March 31 to May 26, 2011.

Pre-construction tidal stage data were collected using In-Situ, Inc. AquaTroll 200 pressure transducer data loggers with vented cables between March 31 and May 26 by CBEP. Loggers were deployed horizontally, in porous/drilled PVC piping secured to concrete blocks, with the cable running out of the creek channel and posted several feet above the high marsh surface on a metal fence post. Water level was recorded at 15 minute intervals, spanning two spring tide cycles, including an 11.7 foot projected high tide event on April 19. Data were periodically downloaded onto a laptop in the field via the cable, and loggers remained submerged for the entire deployment period. Figure 3 is a

plot of pre-construction surface water hydrology data from March 31 to May 26. Figure 4 plots pre-construction data from May 1 to May 26. Figure 5 plots pre-construction data from May 16 to May 20 spring tide. Figure 6 is a plot of the pre-construction data on the April 19 spring tide. Surface water salinity was also recorded with the loggers. Figure 7 plots surface water salinity with 24 hour rainfall from April 1 to April 30.

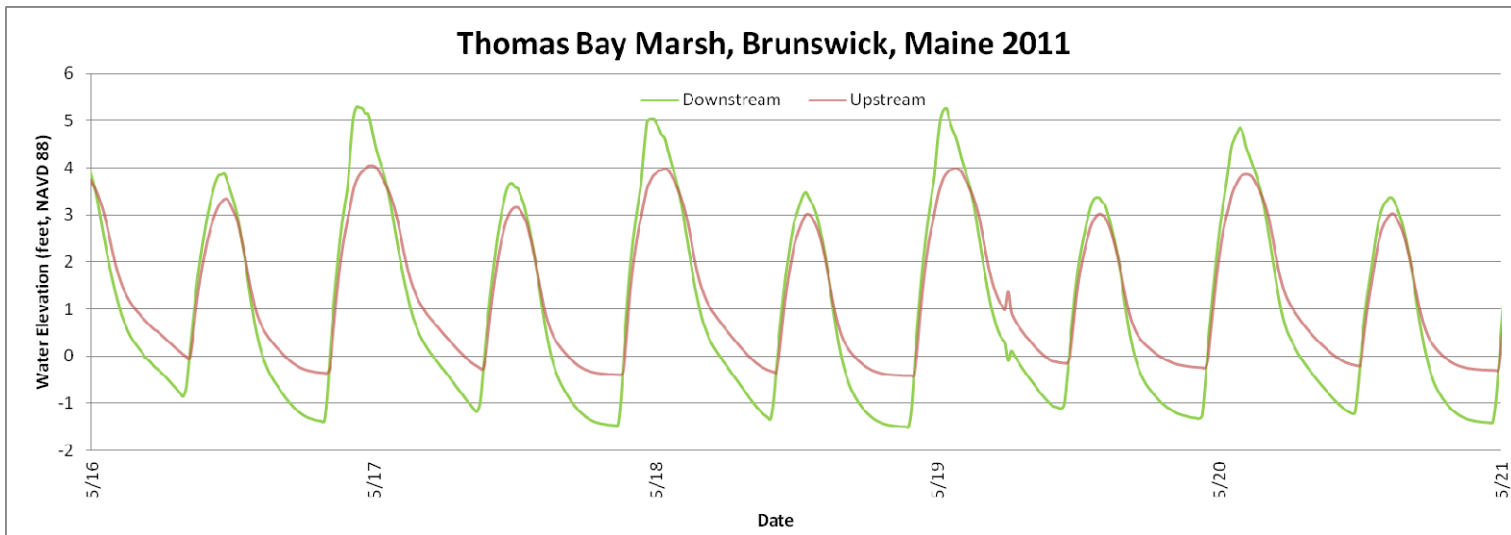
Figure 5. Thomas Bay marsh pre-construction data, May 16 to May 20, 2011.

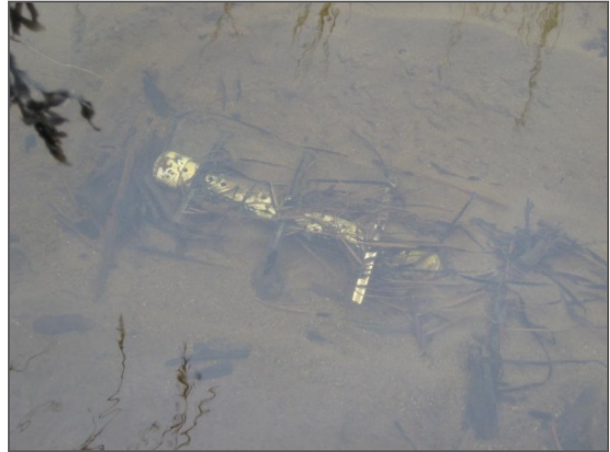
Additional pre-construction tidal stage and salinity data, as well as post-construction tidal stage and salinity data, were collected by CBEP using AquaTroll 200 loggers between July 25 and October 19. Loggers were deployed horizontally, in porous/drilled PVC piping attached to a flat concrete block (Photo 1), with the cable running out of the creek channel and staked above the high marsh surface. Water level was recorded at 15 minute intervals. Data were periodically downloaded onto a laptop. Loggers remained deployed during construction, which generated heavy in-stream sediment plumes on August 16 that lasted for several days afterward.

Photo 1. Upstream logger, post-construction.

- Equipment fouling. Particularly post-construction, both loggers were heavily fouled, as evidenced by Photo 1. Sediment build up within the PVC pipe and around the equipment sensors was clearly exacerbated by construction activities, as well as active channel adjustment post-construction.

- Change in logger elevation. Active channel adjustment post-construction may have changed logger elevations over the course of the deployment period. Although survey data do not indicate this occurred, the upstream concrete block was clearly buried into the channel bottom. Logger elevation could have also shifted during field cleaning.

- Switch to a more standard vertical deployment system/Stilling Well, in order to stabilize logger elevation, as well as to reduce fouling within casing and around sensors.
- Send loggers to manufacturer for factory calibration.
- Deploy equipment for a maximum of one month. Loggers will be calibrated and thoroughly cleaned in the office between deployments.
- Take multiple measurements of logger elevations at deployment and at removal to check measurement accuracy and consistency.

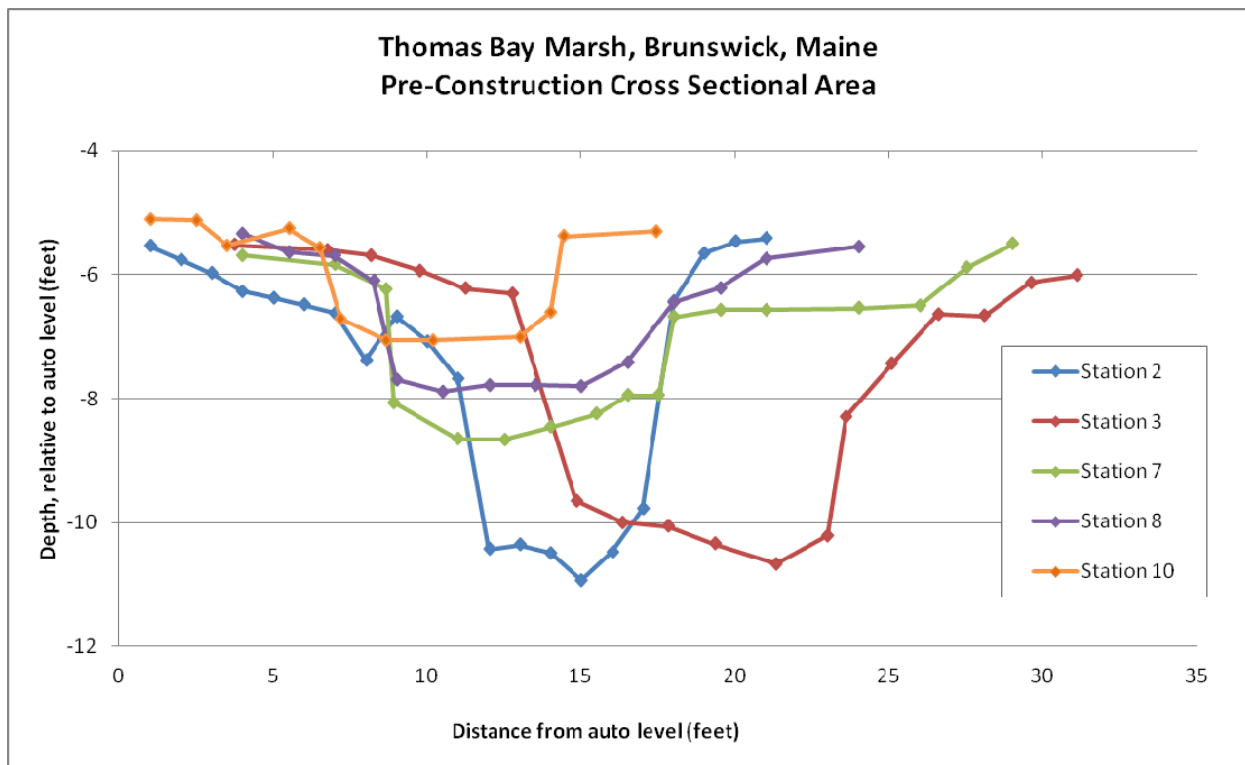
Pre-construction channel cross sections were surveyed on August 9 at Stations 2, 3, 7, 8, and 10. Generally, cross sectional area decreases moving from south to north.

Figure 8. Pre-construction cross-sectional area on 8/9/2011. Note: elevations are relative within a given transect, but not across transects.

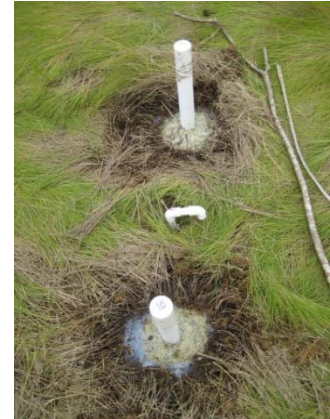
Pore water samples were collected from capped and vented PVC wells. Salinity was measured using handheld refractometers. Measurements were collected and recorded at Stations 2, 3, 7, 7a, and 10. Two pre-construction samples were collected at Stations 2, 3, 7, and 7a, and one pre-construction sample was collected at Station 10. Figure 9 plots pore water salinity measurements. Generally, pore water salinity measurements were observed to decrease moving northward/inland into the marsh system.

Photo 2. Typical cluster of Station wells.

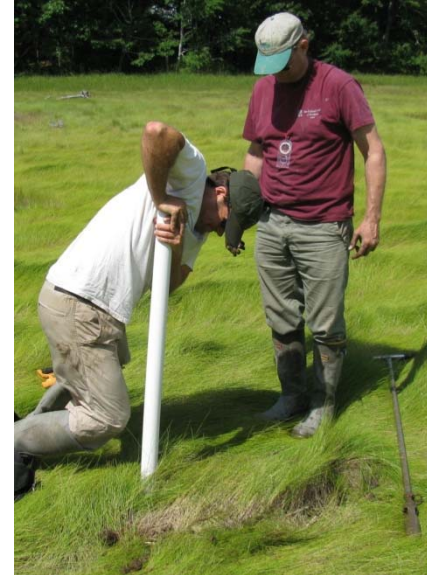
Photo 3. Installing a deep water monitoring well.
