# Urban Streams Nonpoint Source Assessments in Maine Final Report

# **Urban Streams Nonpoint Source Assessments in Maine**

## **Final Report**

**Maine Department of Environmental Protection**  
Bureau of Land & Water  
Division of Environmental Assessment  
State House Station #17  
Augusta, ME 04333

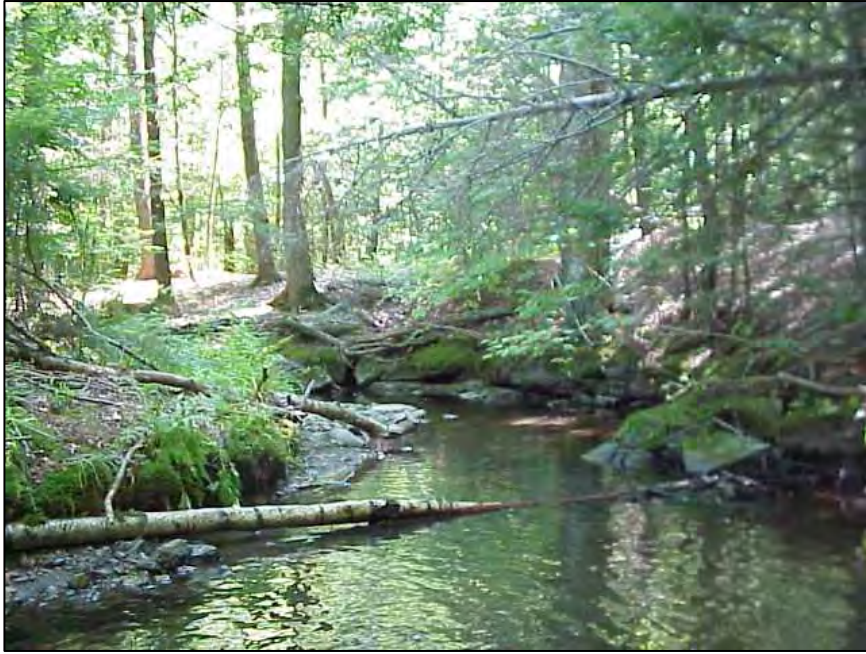
Non-urban Stream  
(Lambert Brook, Skowhegan)

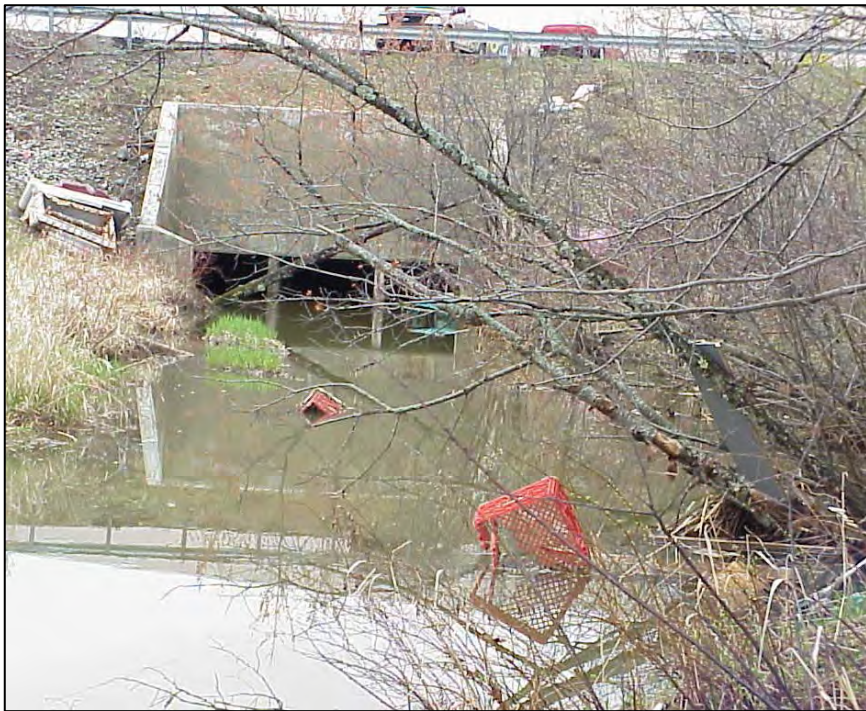
Urban Stream  
(Birch Stream, Bangor)

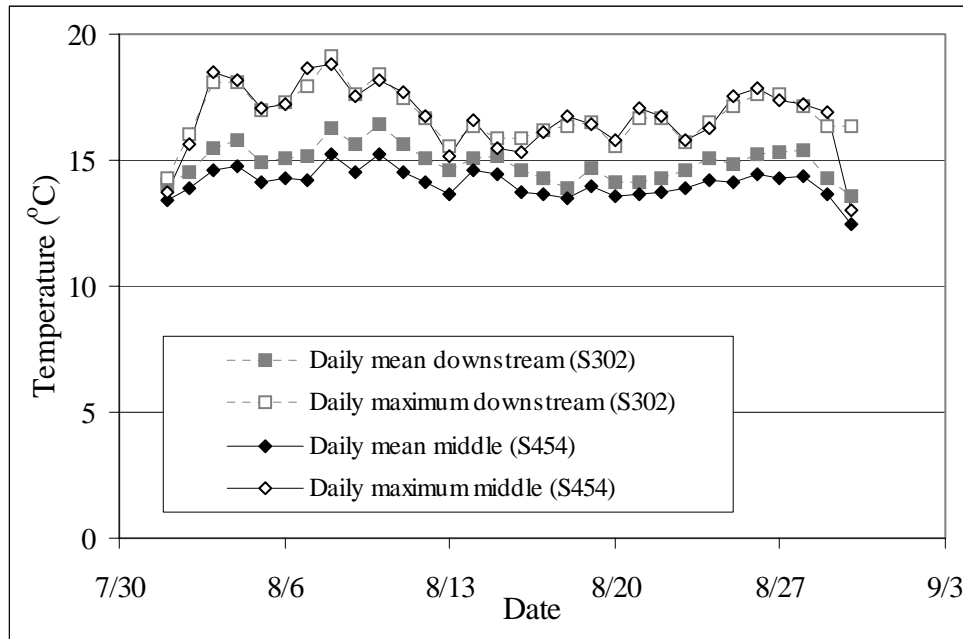
Fig. 3. Continuous water temperature at downstream and middle stations in 2000

For the middle station, model results indicated that macroinvertebrates did not meet Class C aquatic life criteria in the single sampling year (2000) with the dominant organisms consisting of tolerant crustaceans (amphipods) and a few worms (oligochaetes) (Table 1). The number of organisms found was intermediate (387) while the percentage of non-insects was very high (82 %). No dissolved oxygen data are available, but the conductivity level was high (693  $\mu\text{S}/\text{cm}$ ) and water temperature low (14.4 °C). Continuous water temperature data collected August 1 to 30, 2000 (measurements taken every 15 min) were very similar to those recorded at the downstream station (Fig. 3). No water chemistry parameters were sampled at this station.

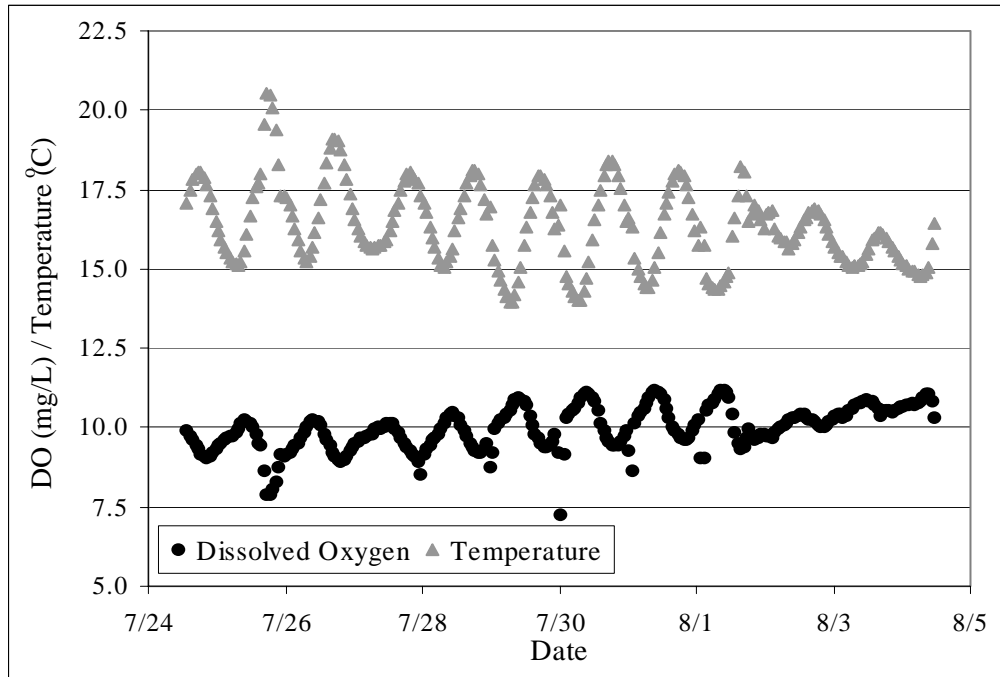
Fig. 9. Continuous dissolved oxygen and water temperature at downstream station (12 days)

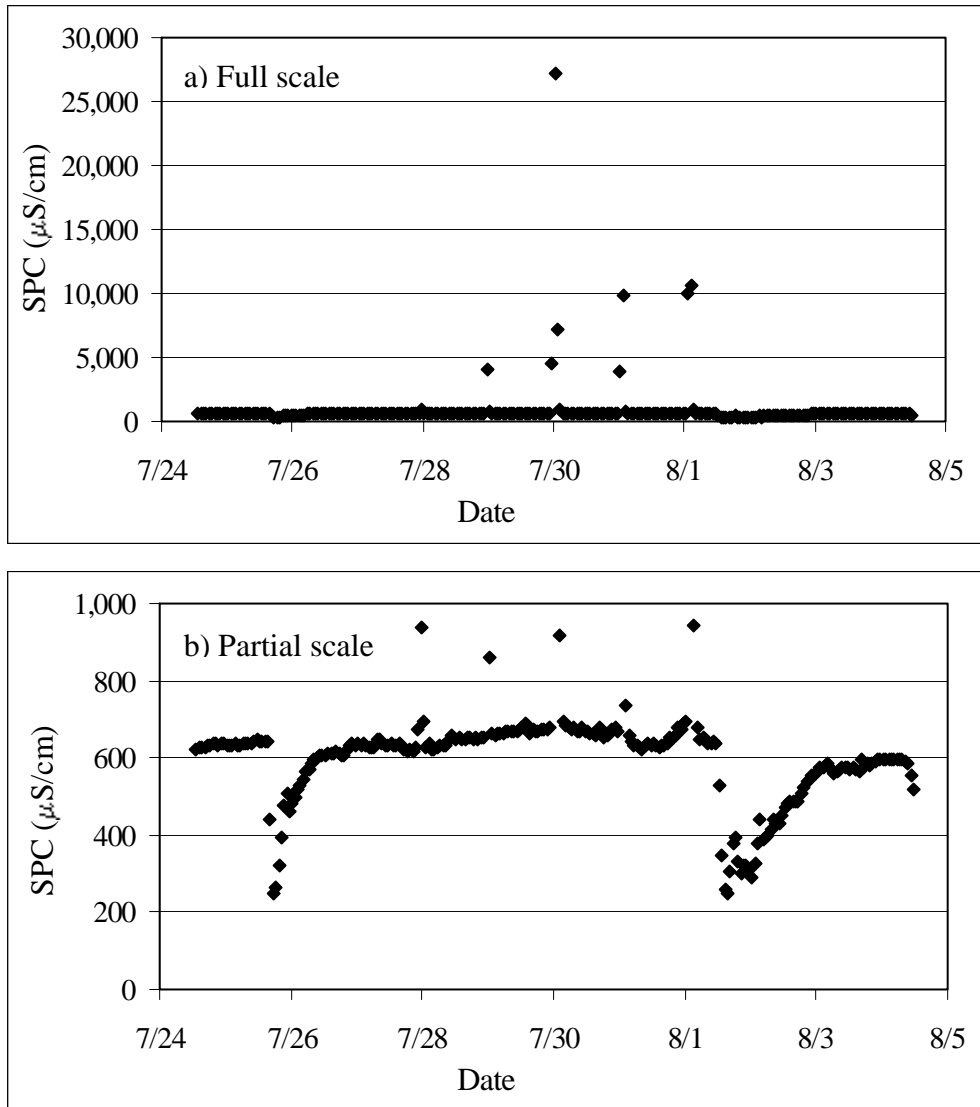
Fig. 10. Continuous specific conductance at downstream station (12 days)

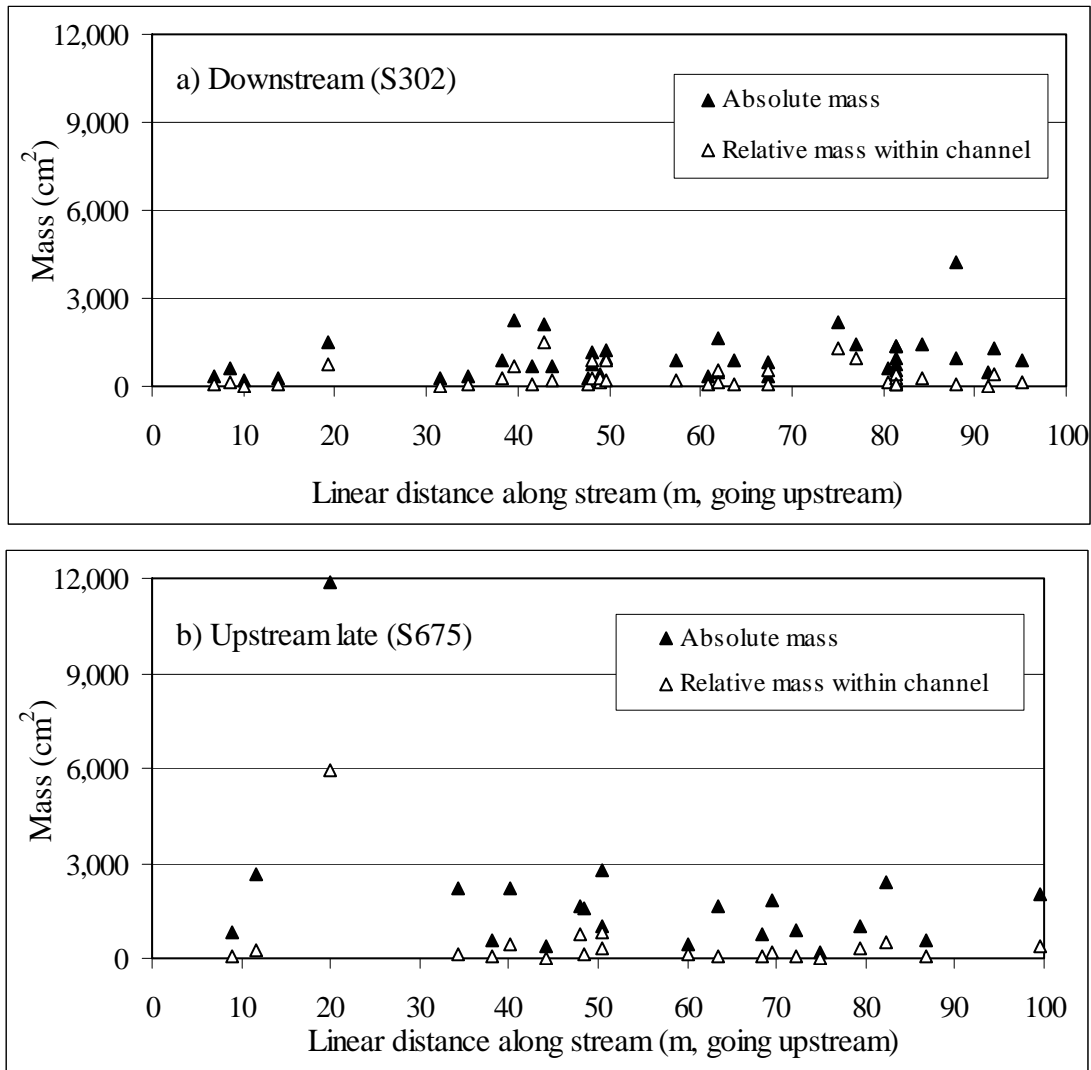
Absolute mass of LWD pieces (mean diameter \* length) was similar at both stations, ranging largely from ~200 - 3,000 cm<sup>2</sup>, with one outlier at each station (4,200 cm<sup>2</sup> downstream, 11,900 cm<sup>2</sup> upstream; black triangles in Figs. 19 a and b, respectively). Relative mass of LWD pieces (absolute mass \* % spanning channel) was greater at the downstream station (23 - 1,470 cm<sup>2</sup>, mean of 319 cm<sup>2</sup>, open triangles in Fig. 19 a) than at the late upstream station (18 - 825 cm<sup>2</sup>, with one outlier at 5,950 cm<sup>2</sup>, overall mean of 512 cm<sup>2</sup>, open triangles in Fig. 19 b). The decrease from absolute to relative mass was smaller at the downstream than at the late upstream station (Figs. 19 a and b), reflecting the higher mean percent of the channel spanned by pieces of LWD at the downstream station (30 versus 18 %).

Fig. 19. Absolute and relative mass of large woody debris

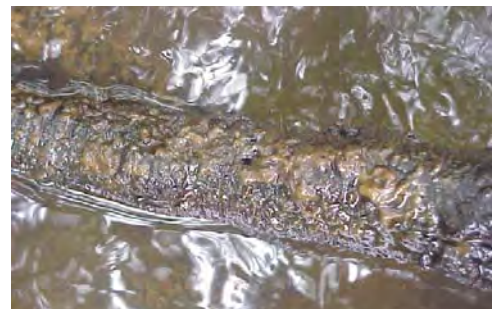
Fig. 2. Growth on log at upstream (algae) station (June 2004)

sampled for algae statewide, similar mats have been observed only at Blood Brook, which drains historic iron deposits in Katahdin Iron Works TWP. A revisit to the site in early July 2004 showed the same conditions.

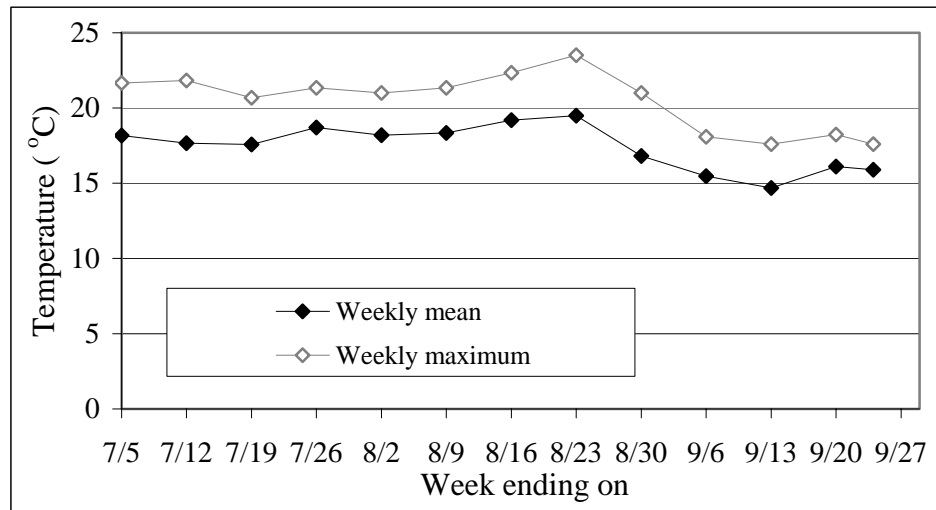
Fig. 11. Continuous water temperature (85 days)

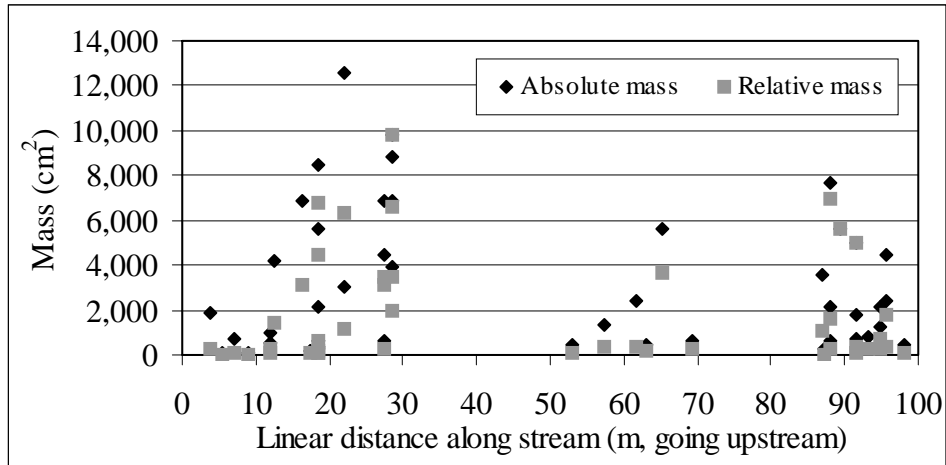
Fig. 18. Absolute and relative mass of large woody debris

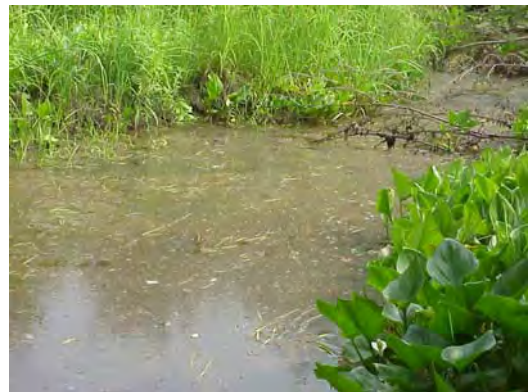
Fig. 19. Barberry Creek as it emerges from wetland (June 2003).

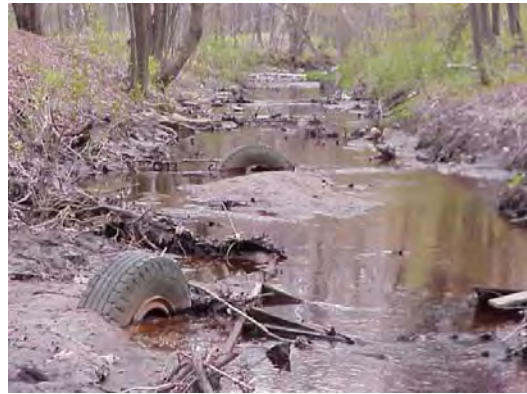
Fig. 22. Sedimentation problems at upstream station (May 2004)
