New Meadows River Watershed and Shoreline Surveys

Maine Department of Environmental Protection
Non-point Source Program Grant Project #2000P-13

Watershed and Shoreline Surveys Final Report

Christopher S. Heinig
MER Assessment Corporation
14 Industrial Parkway
Brunswick, Maine 04011
207-798-7935
mer@maine.com

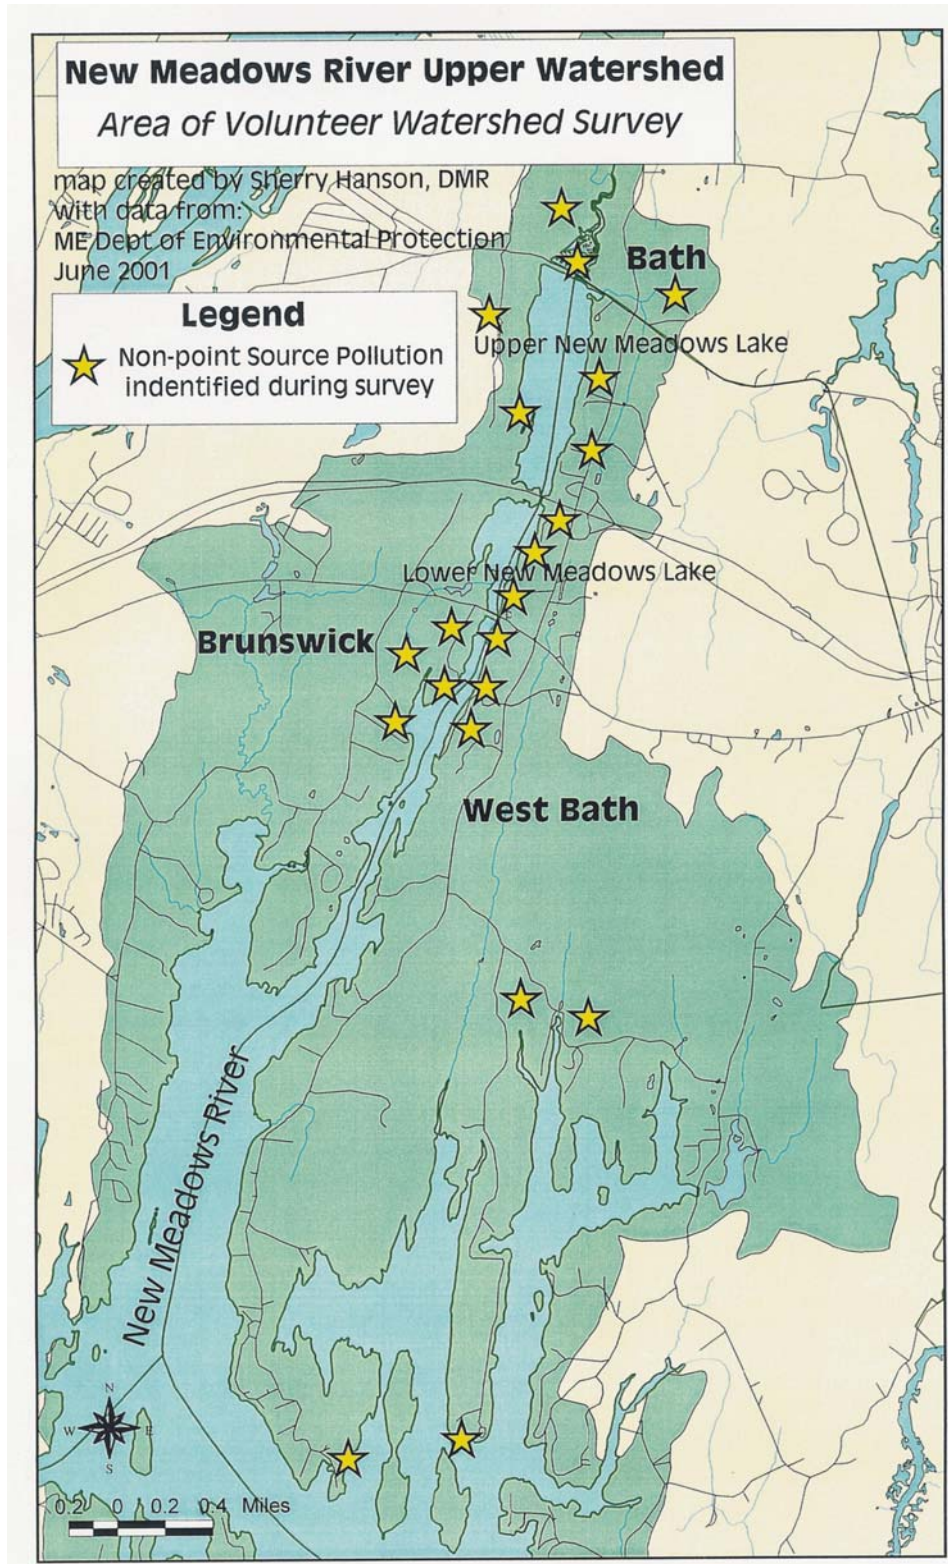
Figure 2. New Meadows River watershed and shoreline survey area and potential non-point source pollution source locations

The survey resulted in the identification of twenty-six (26) actual or potential non-point pollution sources at twenty-two (22) sites, the raw data and accompanying maps for which is included in Appendix II, and include erosion and/or sedimentation in the following categories:

- seven (7) on town roads
- five (5) on state roads
- four (4) on private roads
- one (1) at a town boat ramp
- five (5) on residential property
- three (3) on commercial property
- one (1) on agricultural property

The location of each of these identified problems is shown on the Geographic Information System (GIS) map on the following page. Table 1 provides a tabulation of these results which are also summarized graphically on the following pages, first as percentage of identified problems by type, second by land use categories in which they are found, and third by point of impact.

Table 2., on the following page(s), provides some suggested remedies to these observed problems and rates the remedies on the basis of both technical difficulty and cost. The NMRWP town-coordinators may wish to review these tables with the appropriate officials in their respective towns to determine the best course of action.

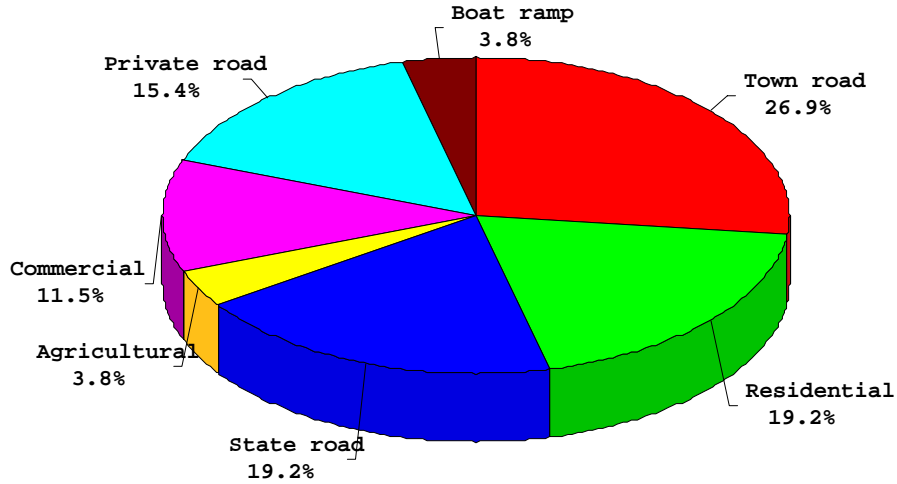
Figure 3.

Percentage of Problems by Land Use

It is interesting to note that 61.5% of the erosion sites found in the watershed survey are located on state, local or private roads. This is typical of many other watersheds across the state. Fortunately, most of the problems identified during the survey are of either low or moderate impact. Unfortunately, some of the problematic sites drain directly into the River. Many low impact erosion sources, when added together, can cause as much of a problem as one high-impact site, so all sites need to be fixed at some point. Problems found typically include road shoulder, ditch and surface erosion. Simple best management practices, that is, conservation measures that stop or prevent non-point source pollution or polluted runoff, can be used to correct the soil erosion problems the volunteers found. They include such simple activities as: seeding and mulching the sides of ditches, re-shaping road surfaces and ditches, stabilizing culvert inlets and outlets, armoring the steep slopes with heavy rock. More complicated problems would require more complex solutions, but we are fortunate that most problems found so far do not require expensive solutions. It is hoped that the Steering Committee will be able obtain additional funds in the next few years to assist in the correction of existing problems as well as conduct education at the town and individual level on the need for proper road construction and maintenance to prevent or minimize new ones.

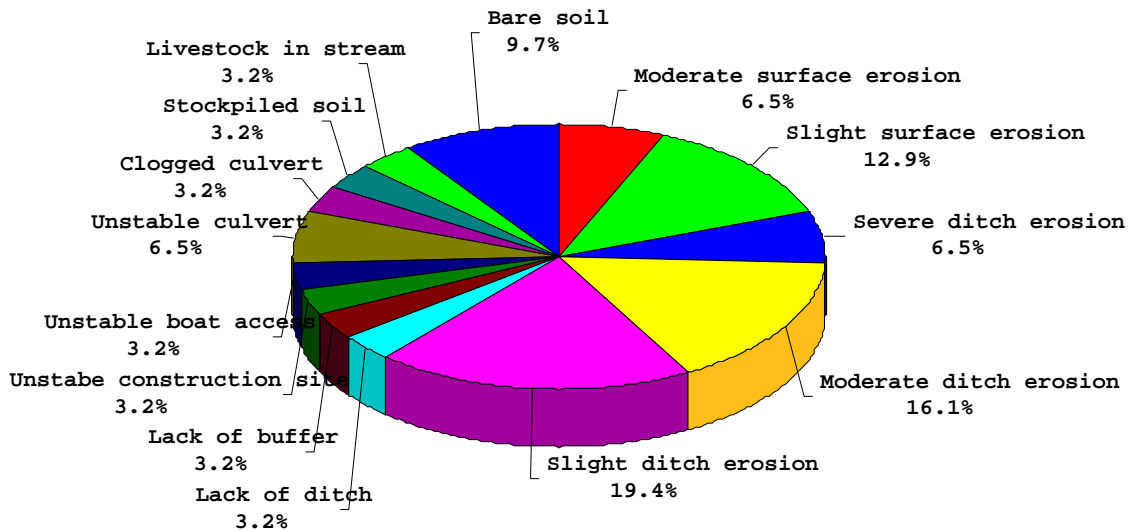
Figure 4.

Percentage of Problems by Type

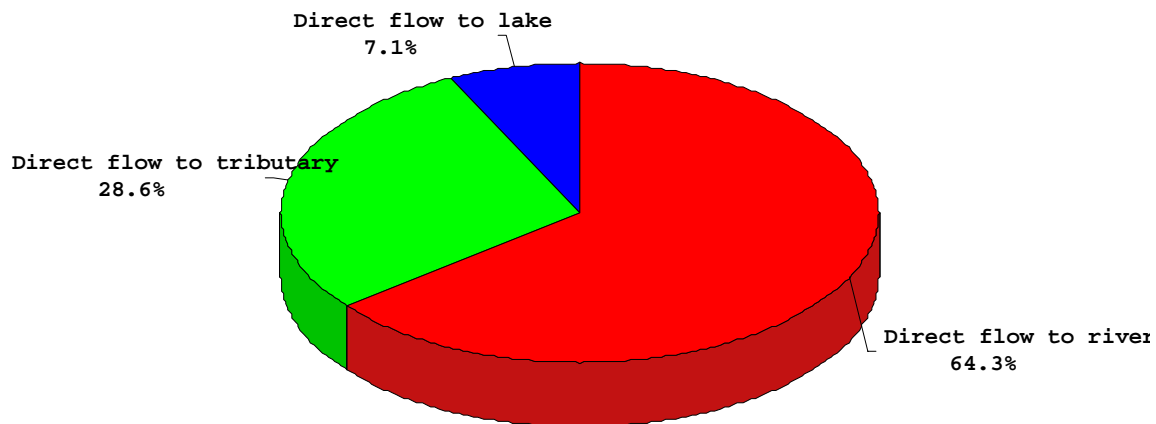
Figure 5.

Percentage of Problems by Point of Impact
