**Fisheries & Aquatic Habitat Restoration Feasibility Study, Royal River Restoration Project Yarmouth, Maine**

Stantec Consulting Services, Inc.

November 2010

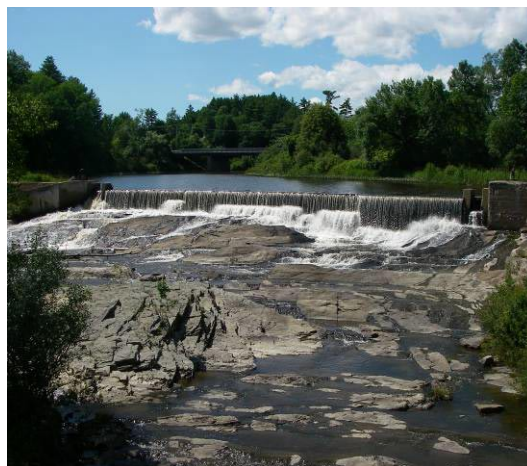
*Bridge Street Dam as viewed from north side of the Bridge Street bridge*

The Bridge Street Dam is located approximately one-quarter mile upstream from the head-of-tide at a site known as the Second Falls of the Royal River in Yarmouth. The dam is a reinforced concrete, gravity-type, run-of-river structure spanning the river approximately 250 feet northeast of Bridge Street. The dam, which is founded on visible bedrock, measures approximately 275 feet in length and has a 10-foot structural height. It has a sloped upstream face and a vertical downstream face. The dam's spillway is located near the center of the dam and is approximately 75 feet long. Low-flow sluiceways are cast into the concrete at either end of the spillway and controlled by removable weir planks. A concrete Denil-type fishpass is situated at the southwest end of the spillway. Water flow into the fishpass is controlled by a vertical lift gate mounted on a steel I-beam frame; however, the gate was severely damaged in the spring floods of 2010 and is currently inoperable. An intake forebay constructed on a triangular plan measuring 40 by 60 feet is located on the northeast end of the dam. This substructure is surrounded by a chain link fence and is protected on its upstream side by a metal trash rack mounted on a rolled steel I-beam frame. The frame also supports a maintenance catwalk. A vertical lift gate is located on the downstream side of the forebay with a wood and timber frame and wood plank gate leaf. This gate is still operable and controls water into an approximately 200-foot-long welded steel penstock (a.k.a. flume) that supplies water to an operating micro-hydroelectric plant in the basement of what is now commonly referred to as the Sparhawk Mill. Due to additional topographic relief drop between the dam and the Sparhawk Mill tailrace, approximately 18-feet of head are assumed to feed the micro-hydroelectric plant. A granite retaining/training wall constructed of split-faced tabular block lines the river channel behind the penstock. Fish passage facilities were not part of the original dam configuration.

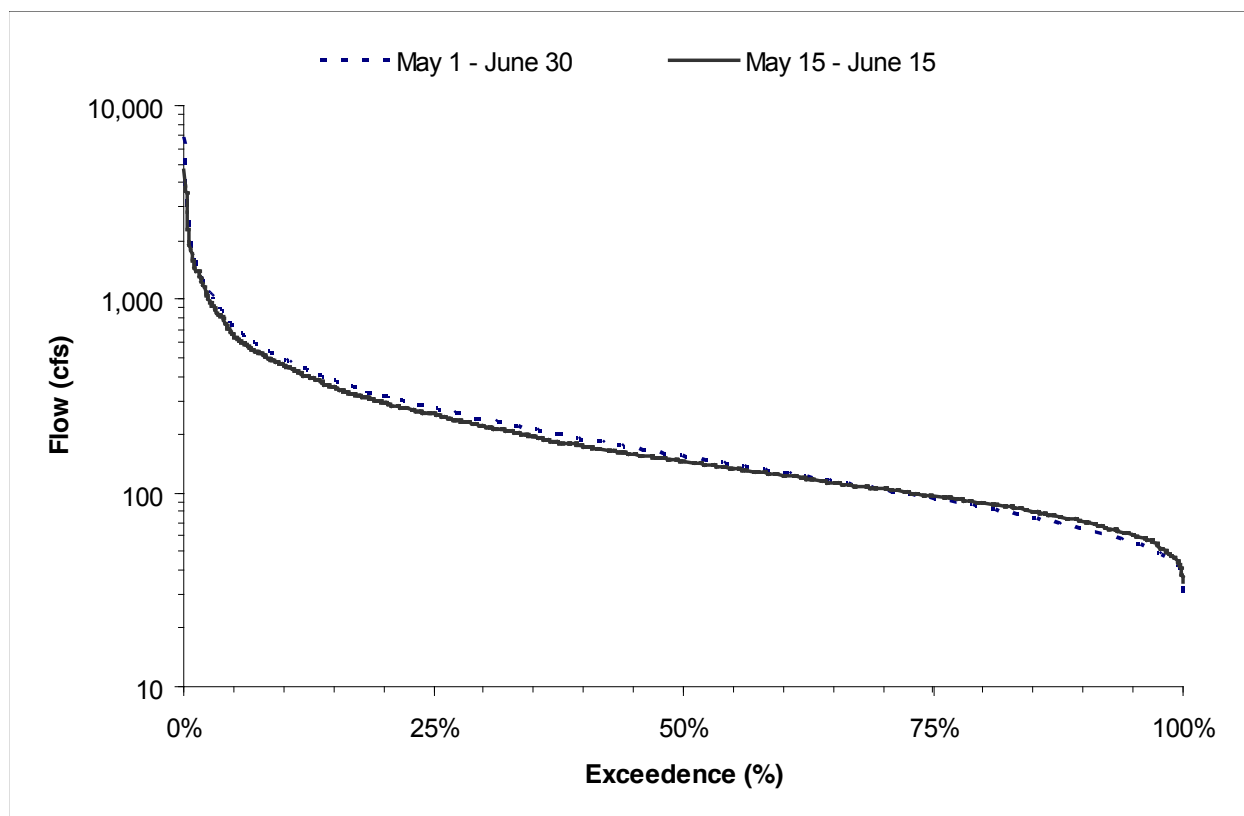
**Figure 4: Flow-Duration Curves during Target Fish Migration Periods**

Flow-duration statistics were developed for the target fish species using daily average flow data collected by the USGS gaging station for the period from October 1949 through September 2004. Daily average flows were extracted from the data set for two upstream fish migration windows defined as May 15 – June 1 and May 1 – June 30. The resulting flow-duration curves are shown in Figure 4. Extracted 10<sup>th</sup>, 25<sup>th</sup>, 50<sup>th</sup> (median), 75<sup>th</sup>, and 90<sup>th</sup> percentile exceedance flow statistics are presented in Table 5.

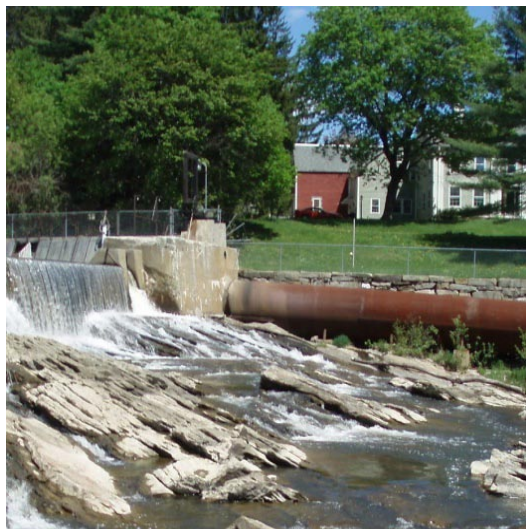
*Bridge Street Dam Head Gate Structure and Sparhawk Mill Penstock*

The use of the use of the penstock during periods of moderate to low flows (i.e., flows less than 100 cfs), such as those commonly encountered during the warmer months of the year, shifts water that would otherwise spill over the Bridge Street Dam to be largely diverted around the reach of river immediately downstream from the dam (utilizing a penstock diversion maximum diversion capacity of 90 cfs). Water remaining in the channel during such periods is largely passed through the fishway, with minor leakage occurring along the face of the dam. The impact of rapidly wetting and drying this reach of river has a detrimental effect on the fish community, as fish trapped in isolated pools as the water recedes face asphyxiation and/or predation as the isolated pools warm and shrink with evaporative water losses.

Flows through the Bridge Street Dam fishpass typically vary between 20 and 30 cfs during periods of upstream migration (May 1 and June 31) for numerous diadromous fish species. However, flows may dip lower when the penstock is drawing water from the impoundment or debris accumulates on the intake trash rack. A mechanical gate structure was formerly used to reduce flow through this fishway but it is currently inoperable due to damage sustained during high flow events in the spring of 2010.
