# Eight years of experience with windowless housing for poultry

**Eight Years  
of Experience with  
Windowless Housing  
for Poultry**

# Eight Years of Experience with Windowless Housing for Poultry

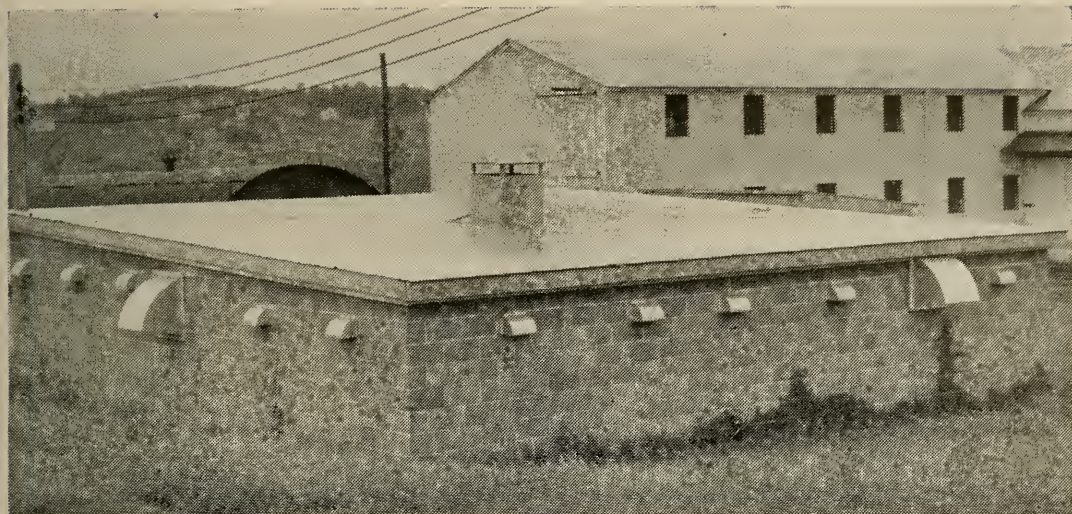
**FIGURE 1.** Windowless house showing original ventilation system of 24-inch exhaust fan in center of roof and small, hooded intake openings. This system was discarded in favor of a pressurized system. The large hoods in the walls cover the intake fans and exhaust openings.

Many changes were made in the ventilation system of this 30 x 30-foot house. Initially, a 24-inch propeller fan with a capacity of approximately 7,500 cfm was mounted in the center of the ceiling to exhaust air through the roof (Figure 1). The cores of blocks placed on their side at regular intervals in the wall served as inlets for the air. Various hoods, baffles, and ducts were used in an attempt to direct the air where it would do the most good (Figures 2 and 3). Ducts were erected within 15 inches of the litter to exhaust the air at bird height (Figure 4). All

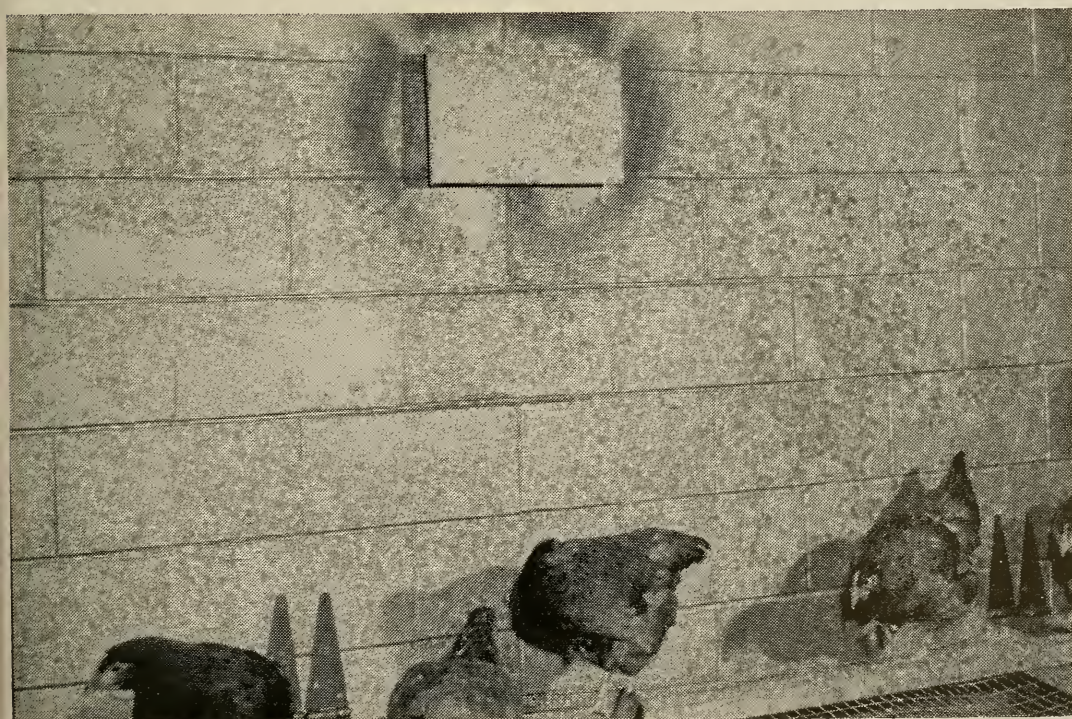
**FIGURE 2.** Flat plate baffle over the inlet of the wall helped to keep the wall dry, but did not direct the air over the birds and litter.

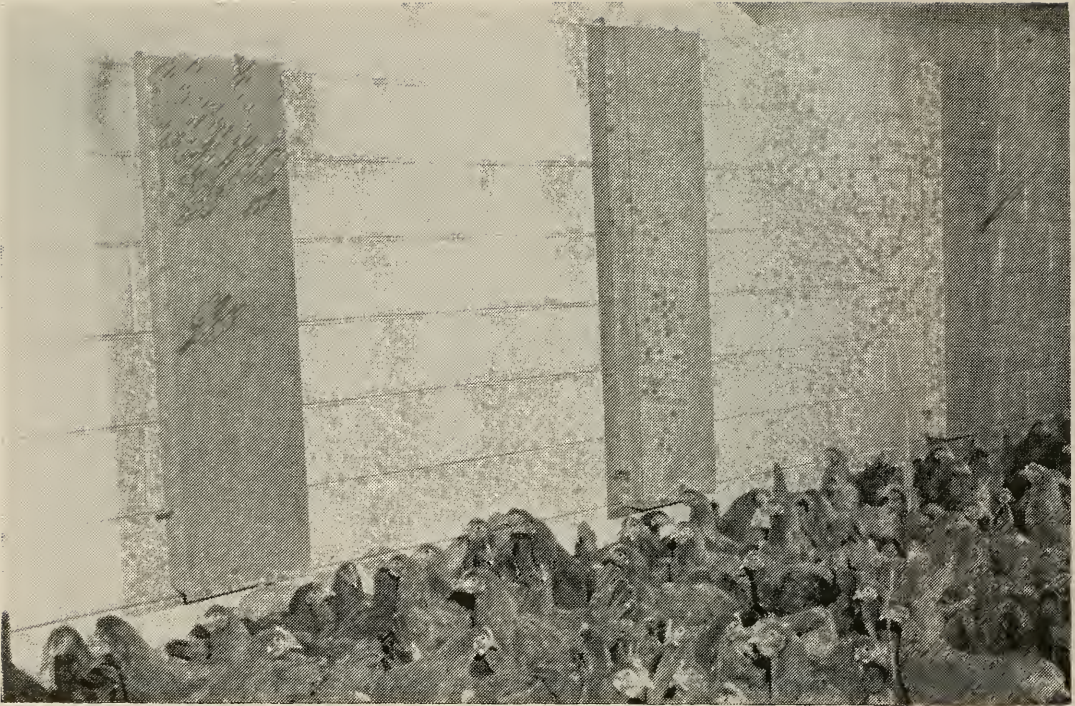
**FIGURE 3.** This baffle directed air to the floor, but the birds crowded around the base and they prevented good circulation.

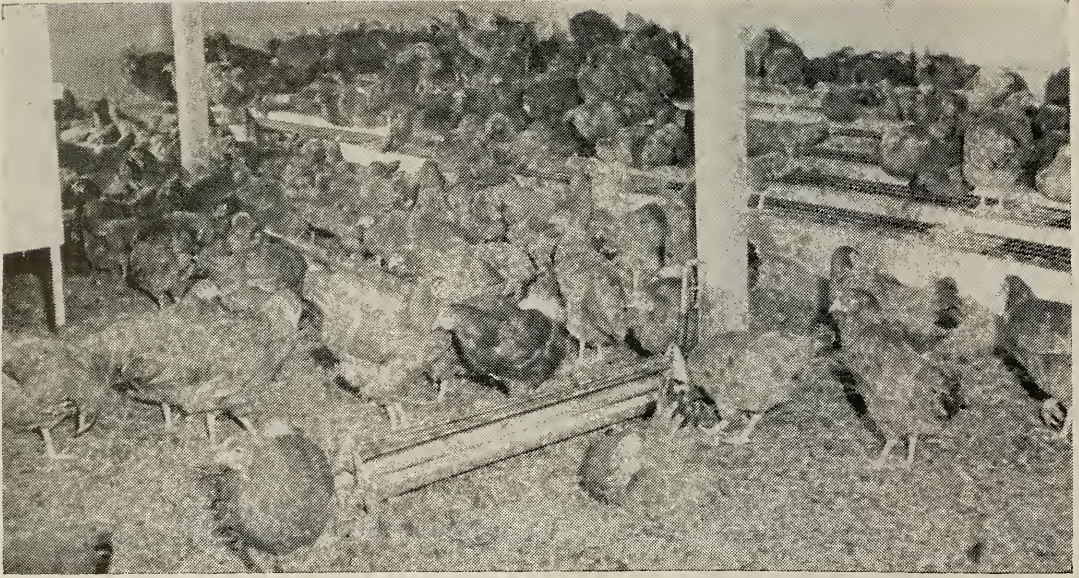
**FIGURE 5.** Old style single-tiered roosts over dropping pit. Feeders and water fountains were on the litter.

Equipment for 300 Rhode Island Reds the first year was placed on a dirt floor with built-up litter. Single-tier roosts were placed along the back wall over a dropping pit (Figure 5). The birds received their water from automatic equipment, but feeding was done by hand. There was practically no control of the moisture build-up in the litter and the ammonia concentration became quite irritating.

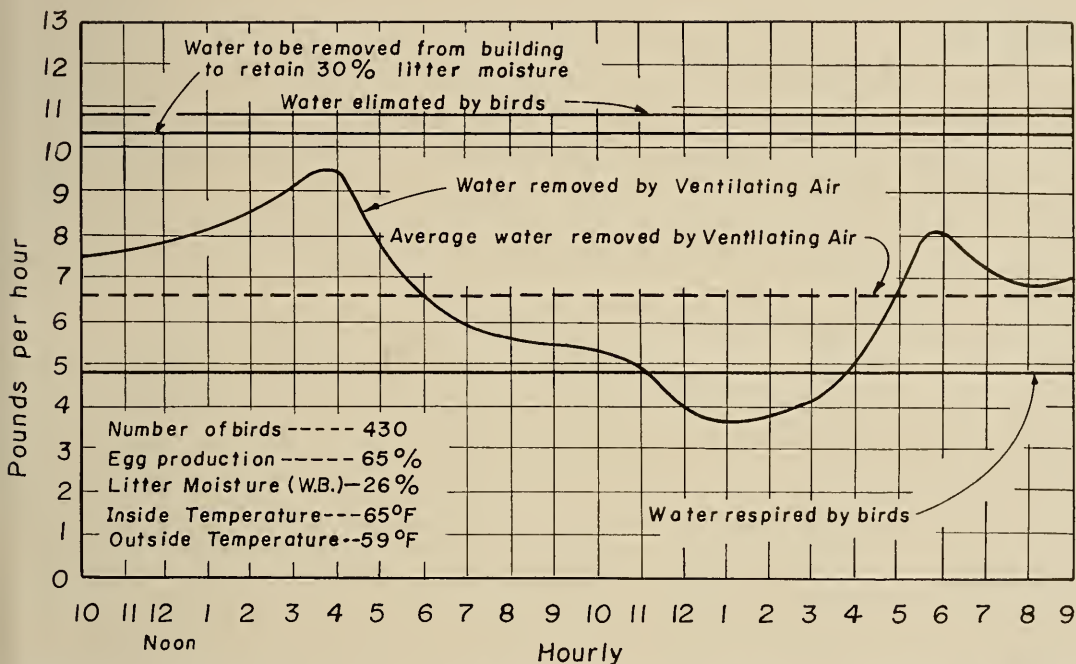
FIGURE 7. Water produced by birds and water removed by ventilation system and mechanical pit cleaner.

The value of the pit cleaner can best be demonstrated by making a calorimeter-psychrometric analysis of a week's data for the house. The calorimetric information was obtained from published data for poultry.\* Hourly readings of temperature, humidity, and air flow obtained with potentiometers and operations recorders provided the psychrometric data (Figure 7). The data were recorded beginning at 9 a.m., for 24 hours, seven days each week. The solid curved line indicates the average amount of water removed by the ventilating air each hour of the day every day for one week.

The ventilating air should remove the required moisture as fast as it is produced in order to maintain good environmental conditions in the poultry house. It is also important to use a mechanical pit cleaner to remove the water in the droppings before it evaporates into the room. Litter should serve as a temporary reservoir for moisture—giving it up on good drying days, absorbing it on poor drying days. During this particular week, it failed to do so between 11 p.m. and 4 a.m., but the average rate of removal was 6.6 pounds of water per hour, whereas the rate of respired moisture was 4.84 pounds per hour.

be removed by the combined use of the ventilation system and pit cleaner in order to hold the litter moisture content at approximately 30 per cent (wet basis). Actually, the litter moisture content dropped 2 per cent during the week. As shown in Figure 7, the water removed by the pit cleaner was 10.35 pounds minus 6.6 pounds or 3.75 pounds per hour or 88 pounds of water per day. This was the same amount of water in 75 per cent of the droppings excreted by the birds estimated to be removed by the pit cleaner. Without the pit cleaner, moisture accumulation would have occurred in the litter.
