Long Reach Lane at Long Marsh, Harpswell, 2018 Post-Project Monitoring Report; Year 5 of 5

2018 Post-Project Monitoring Final Report: Long Reach Lane at Long Marsh, Harpswell

Year 5 of 5

Compensation for the Martin's Point Bridge Project, Falmouth-Portland
(PIN 16731.00)

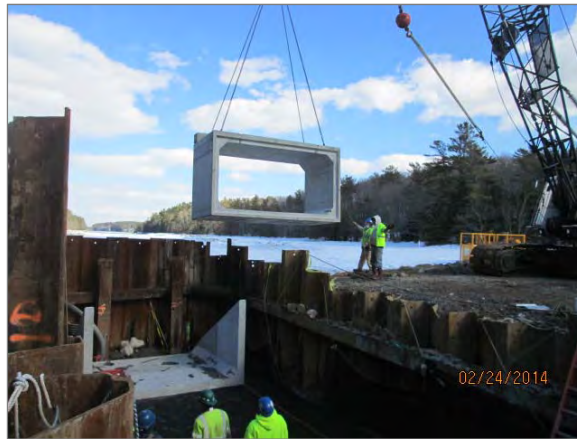
In 2012, the Maine Department of Transportation (MaineDOT) proposed a mitigation project at Long Reach Lane (LRL) in Harpswell to compensate for the functional impacts to marine wetlands associated with the construction of the Martin's Point Bridge between Falmouth and Portland. The mitigation project was implemented in January and February 2014, and resulted in the successful replacement of a 36" (7.1 ft² flow area) round concrete pipe beneath Long Reach Lane with a larger 6' x 12' concrete box culvert (72 ft² flow area) in February 2014 (photo MaineDOT, below).

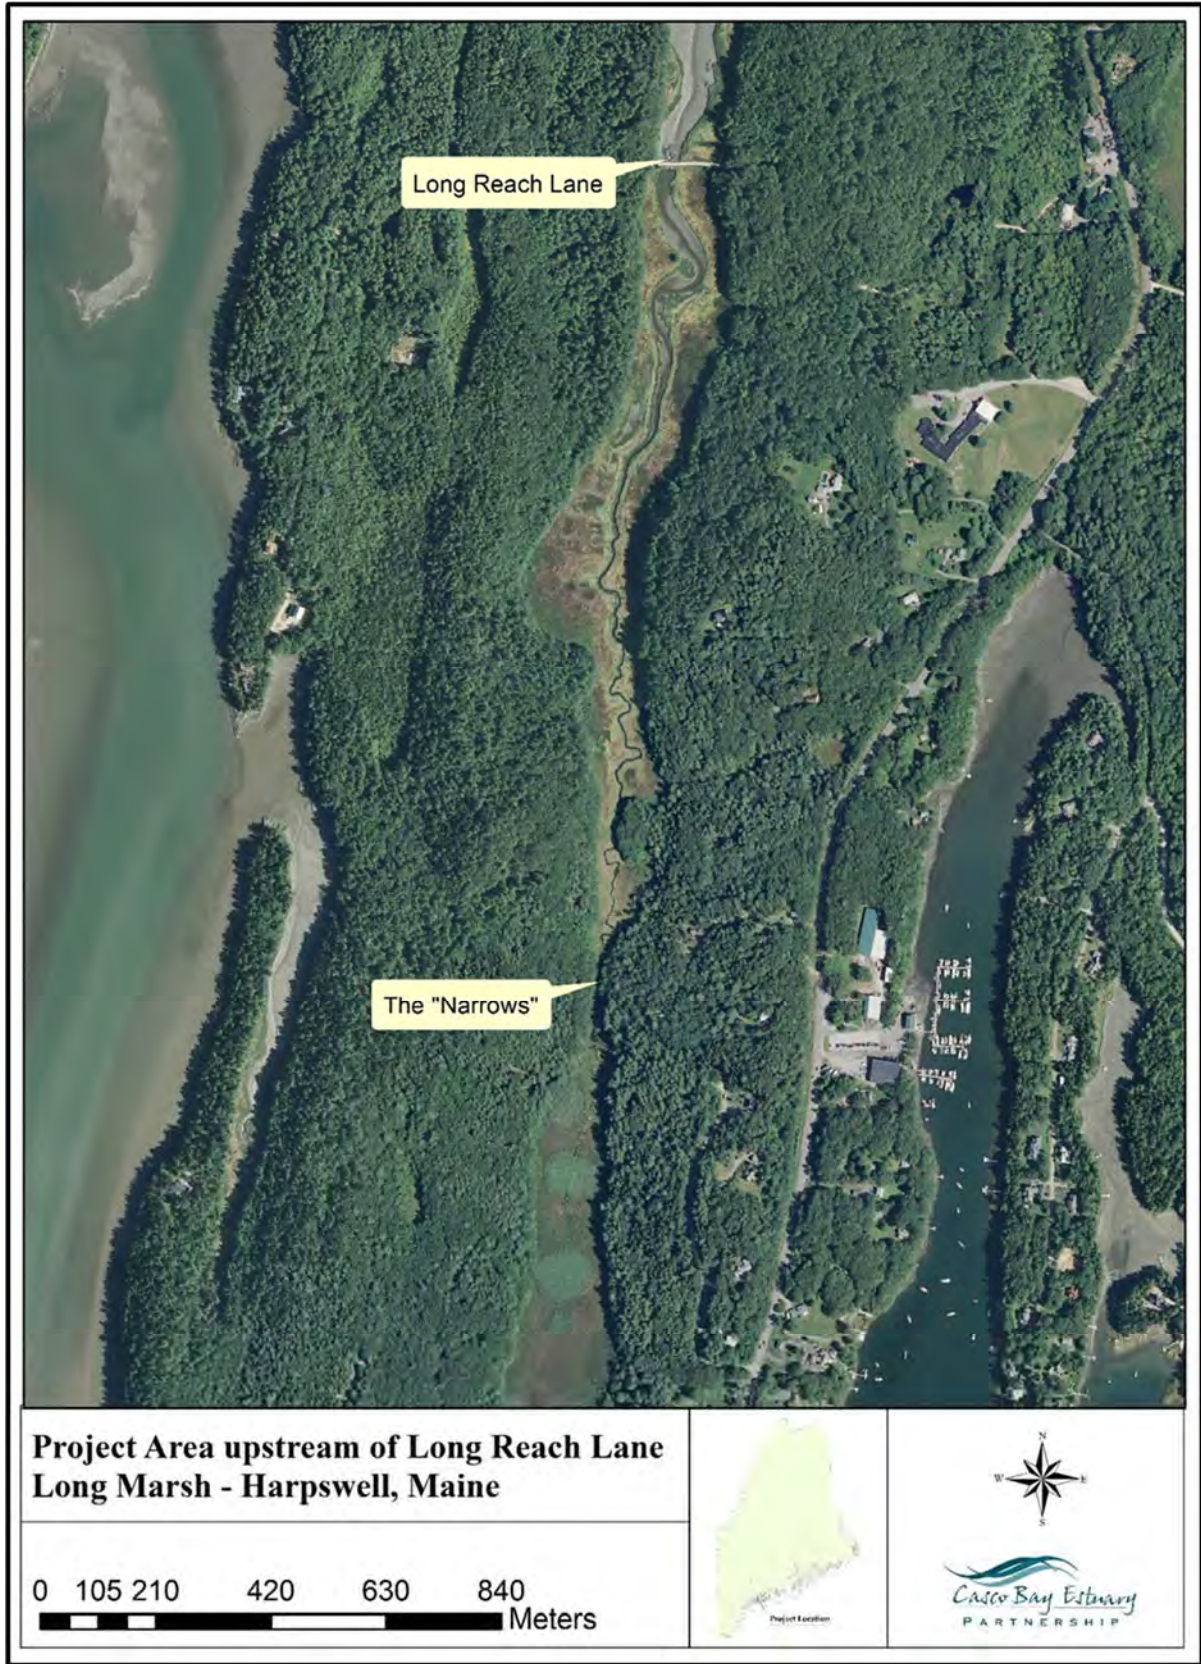
Figure 1. Map of Project Area.

The *Martin's Point Bridge Wetland Mitigation Plan (Mitigation Plan; MaineDOT 2012)* describes the mitigation site Project Area as the marsh area upstream (south) of Long Reach Lane, and north of a bedrock feature locally known as "the narrows" (Fig. 1). The *Plan* also states:

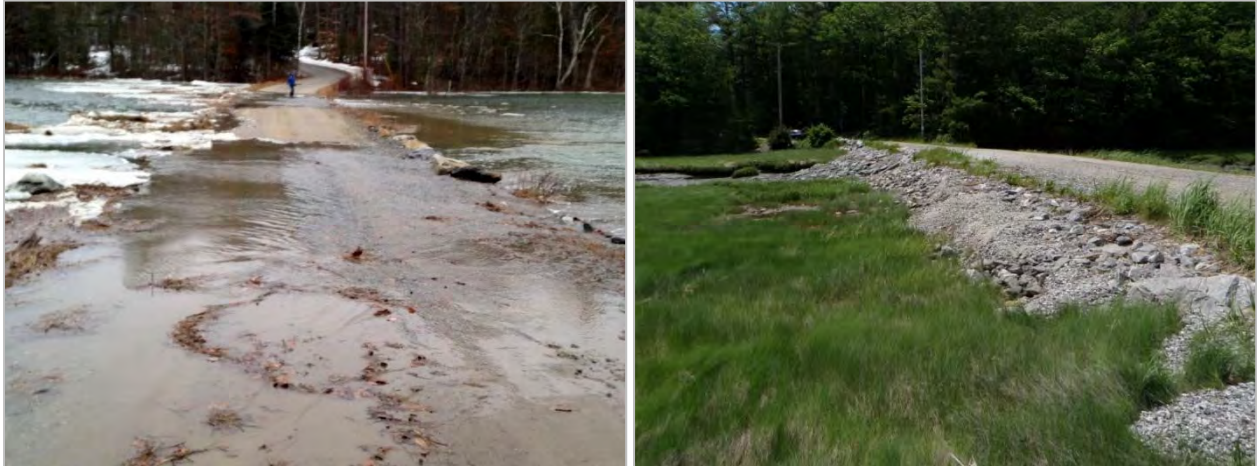
Figure 3. Photo-documentation of road overtopping and associated erosion of road material.

2017, overtopping resulted in minor erosion of road fill off of the road and onto the upstream road bank and high marsh (Fig. 3, right; photo at bottom).

Subsequent road repairs by local residents, including additional fill and regrading, had fully re-stabilized the roadbed by the time CBEP directly observed the site. In 2017 CBEP observed areas of newly regraded fill over the culvert (photo below), suggesting erosion of fill occurred at this location, but had been addressed. Residents reported that they are concerned about the recent frequency of overtopping, and are investigating options to address the issue.

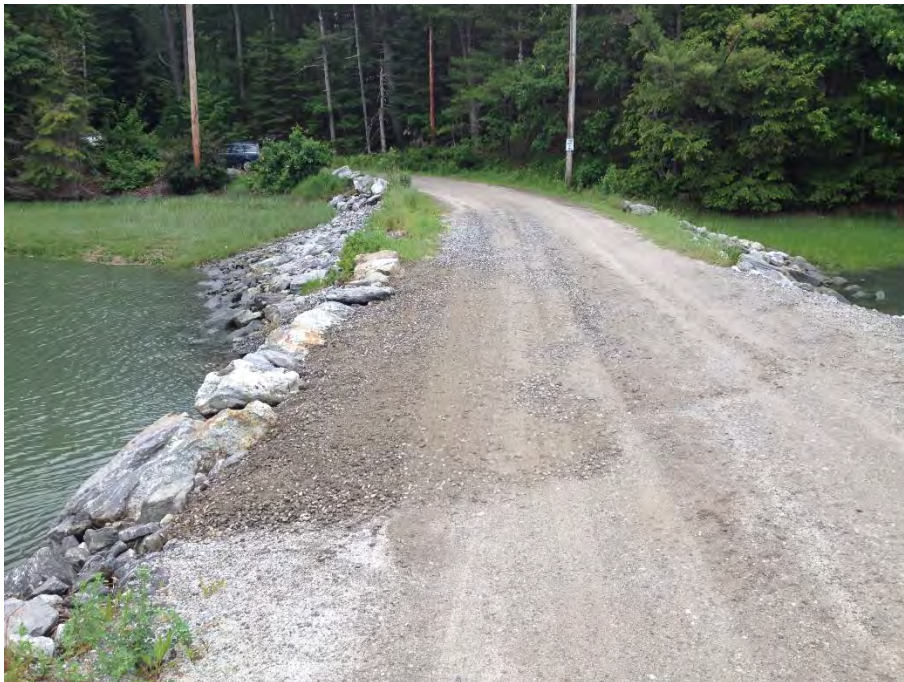
CBEP observed that rip-rap scour protection at the culvert inlet and outlet were stable. Rip-rap along the downstream road bank was also stable.

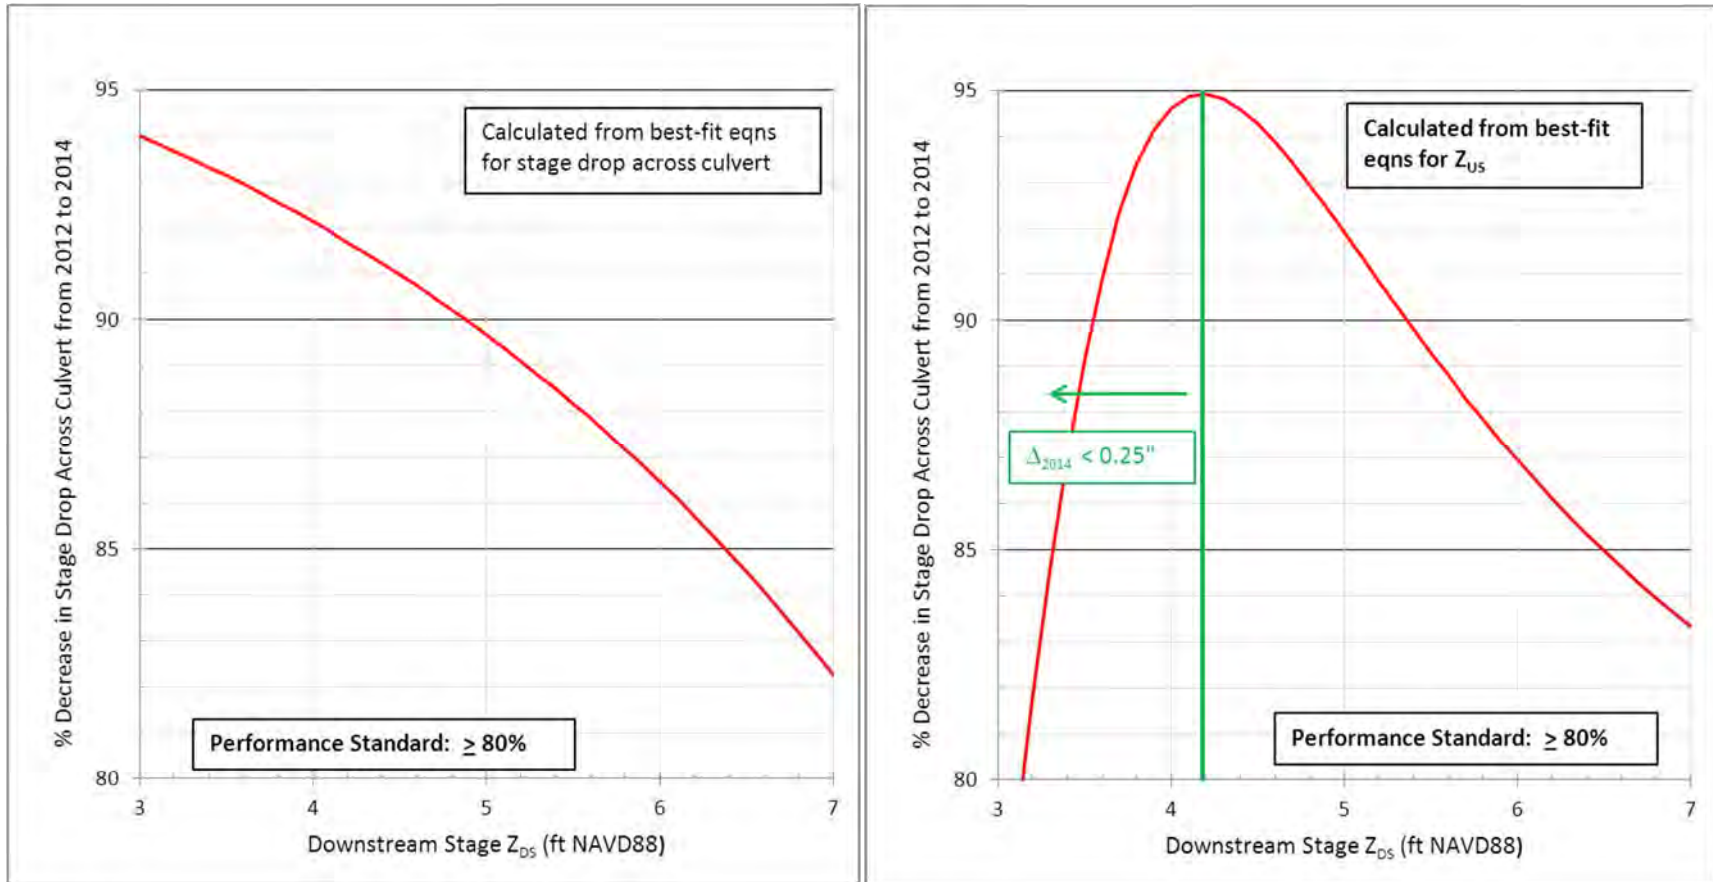
Figure 15. Percent Decrease in Stage Drop Across Culvert (by two different sets of best-fit equations).

Based on this analysis, we conclude that the performance objective of reducing the head drop across LRL by at least 80% has been achieved.

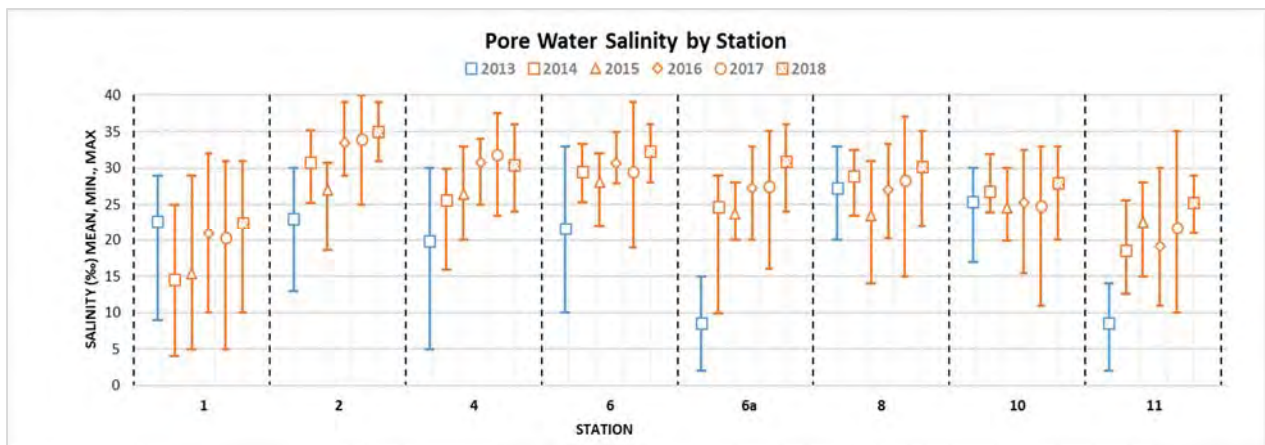
Fig. 18 plots mean, minimum, and maximum pore water salinity levels by year for each station. In 2018, observed pore water salinity in the Project Area ranged from a low of 20‰ at St. 10 to a high of 39‰ at St. 2. Other than St. 4, observed mean pore water salinity levels were higher throughout the Project Area in 2018 than any prior year, although this may be partially due to the fact that there were no samples collected in April or October (comparatively wetter months). The greatest post-project change in pore water salinity was at St. 6a. St. 6a was placed near the upland edge, and is furthest from the creek channel of all the wells. The dramatic increase in salinity is consistent with observations from vegetation monitoring that generally, the biggest shifts in vegetation community type were at locations further from the creek channel. A similar increase was observed at St. 11, outside the Project Area. St. 11 is adjacent to stands of invasive *Phragmites australis*, which shows signs of stress in response to the new hydrological regime. The impact of the culvert replacement extends well south of the Project Area and the Narrows, into the southern reach of the marsh.

Figure 18. Mean (symbol), min. (low bar), and max. (high bar) pore water salinity readings, 2013-2018.

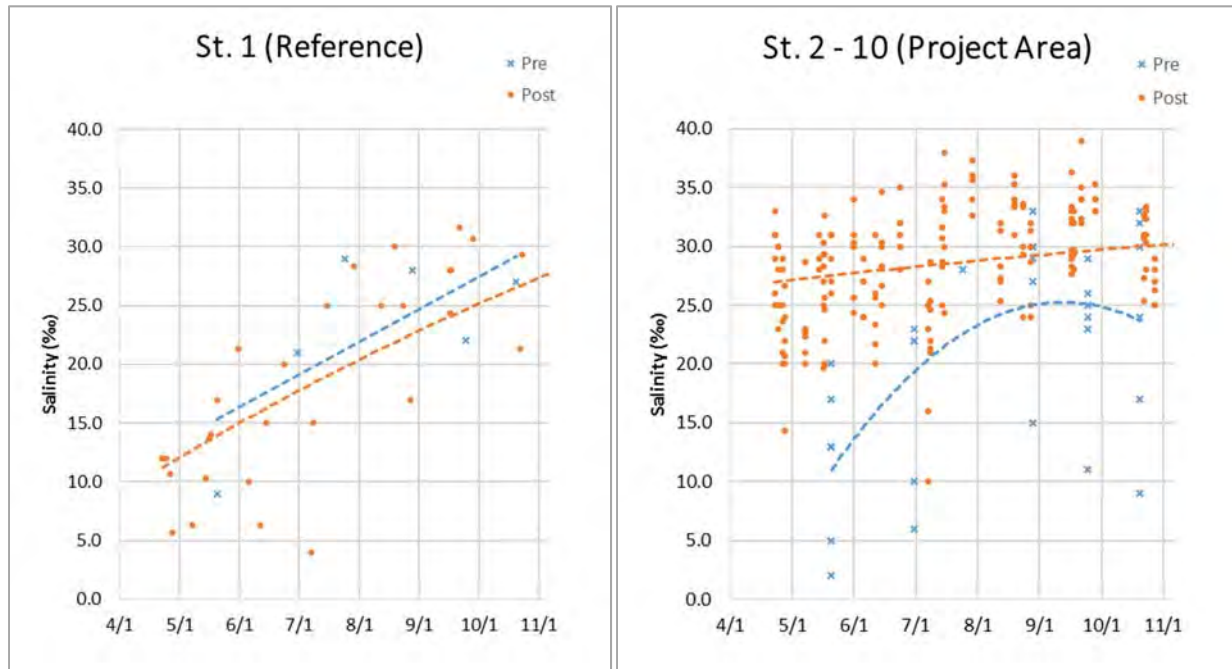
Figure 19 plots individual salinity readings from samples collected in the Project Area with best-fit trendlines for pre- and post-project data. Although there aren't enough pre-project samples to make statistically significant observations, pore water salinity levels appear to be higher post-project, earlier in the growing season, than pre-project. The post-project mean of pore water salinity samples (28.6‰, 2014-2018) is higher than pre-project levels (20.9‰, 2013).

Figure 19. Pore water salinity comparison between Reference Area and Project Area. .

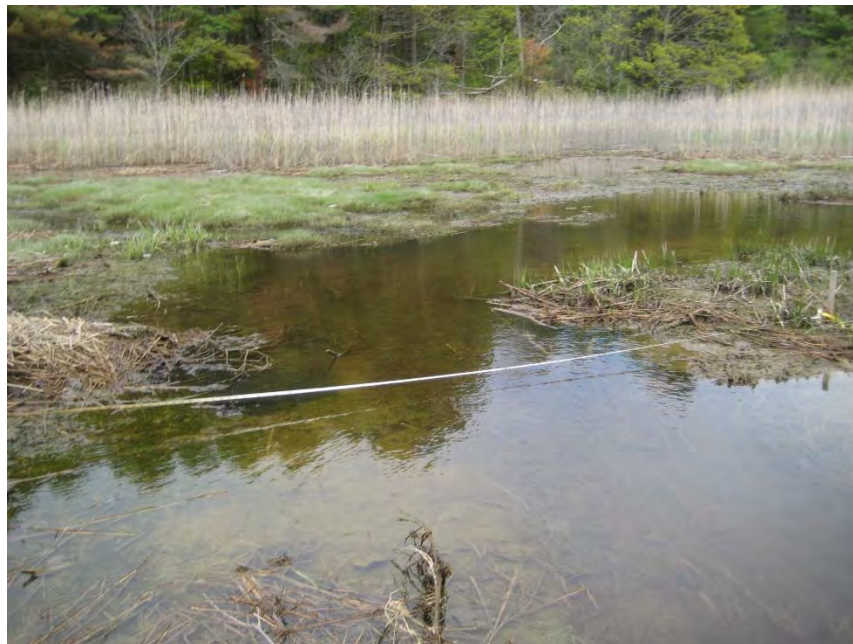
Surface water impounded at St. 11, May 2018. Phragmites stand in the background.

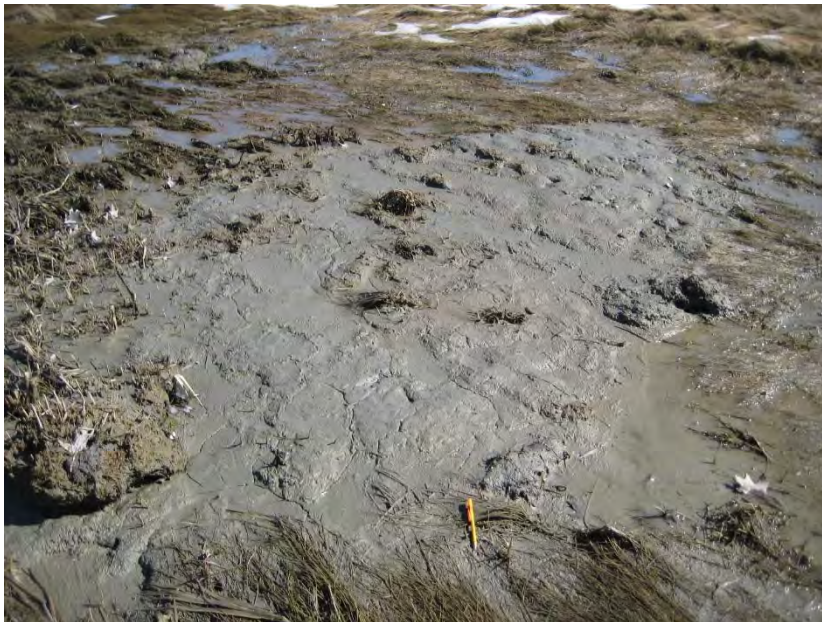
Example of sediment deposition onto marsh surface following winter ice rafting. Spring 2016.

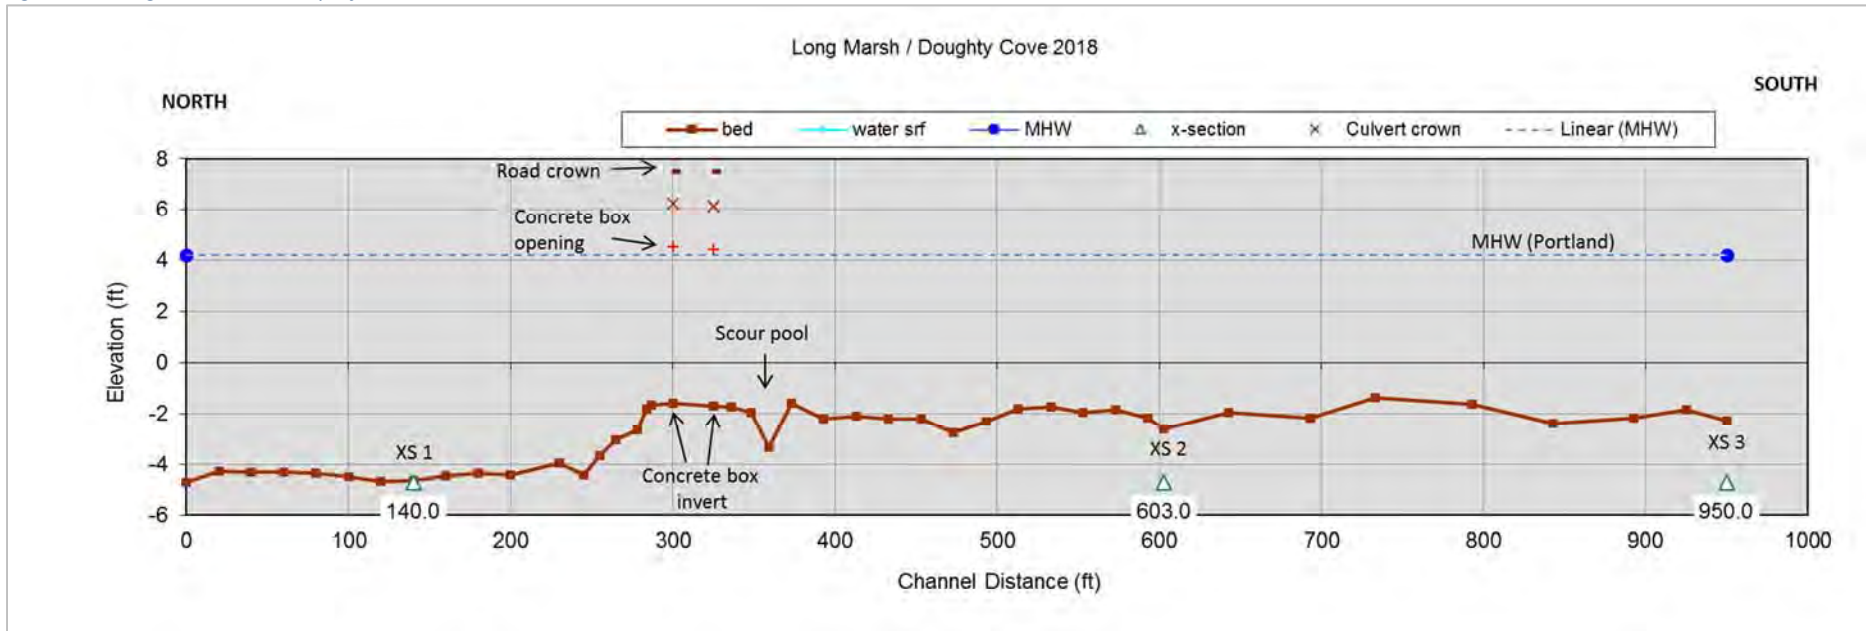
The 2018 profile shows mudflat downstream of the road, with elevations comparable to 2013. Rip-rap at the base of the outlet remains, but the invert of the new culvert is lower. A series of sediment deposits are evident upstream of the culvert inlet, resulting in a series of shallow ripples and pools in the former upstream scour pool. A head cut migrated up the channel, evident all the way to St. 8 (not shown). The thalweg elevation is two feet lower than pre-project, indicating significant sediment mobilization.

Figure 32. Longitudinal channel profile, 2018. Elevations shown in NAVD 88.

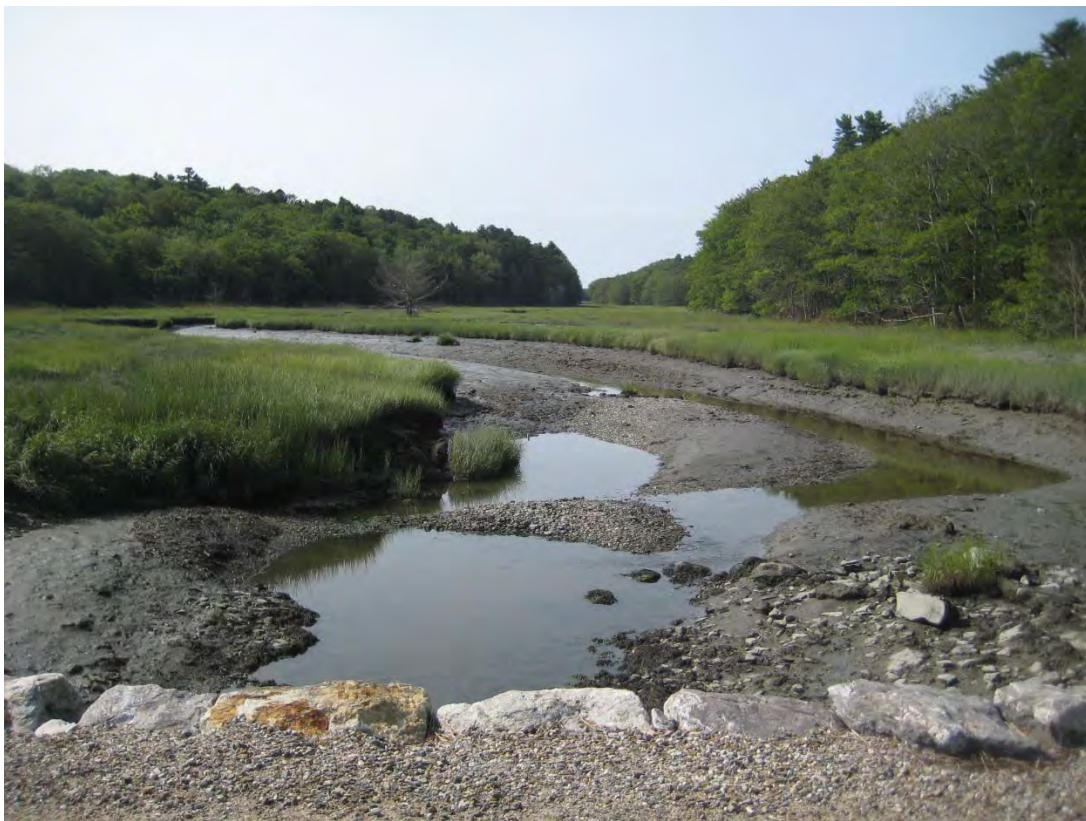
View of channel and scour pool upstream of culvert inlet.

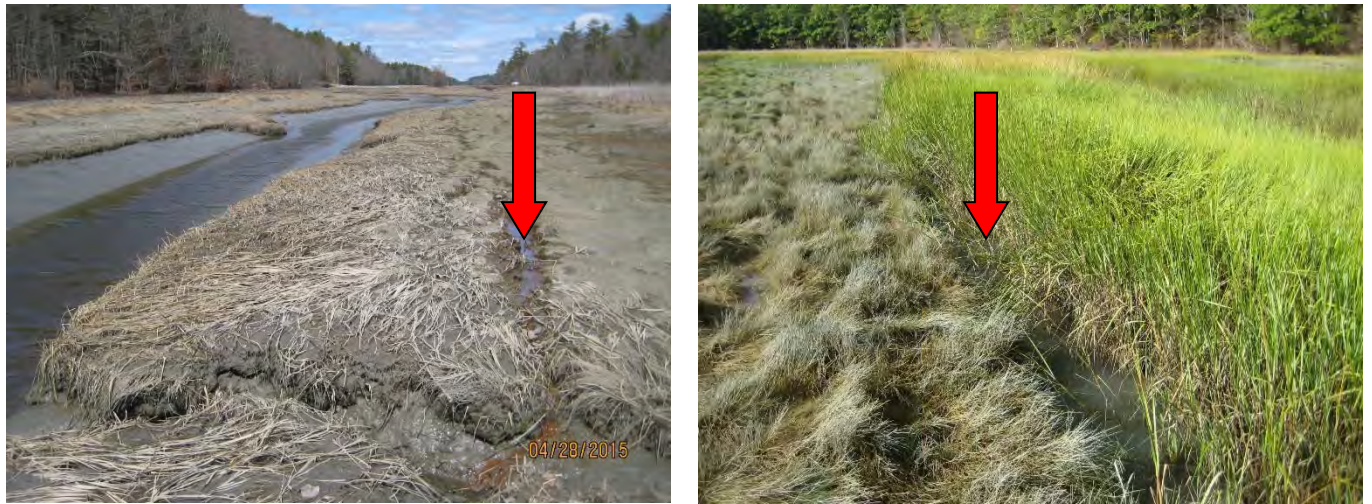
St. 4 – The cross section transect at St. 4 is located in a straight section of the channel, and has evolved more quickly than the channel at St. 3. A U-shape is increasingly evident (Fig. 33). The maximum channel depth at the thalweg seems to have stabilized at a depth close to that of the culvert invert, which is about 3.5' deeper than it was in 2013 (Fig. 36). Cross sectional area increased from 66 ft.² in 2013 to 109 ft.² in 2018 (Fig. 37), an increase of 65%. The photos in Fig. 35 below point out a rill forming near St. 4, resulting in pooled standing water parallel to the eastern creek bank, even at low tide. The rill may be becoming more pronounced as a result of freezing and thawing, and may indicate that a substantial bank slough will occur.

Figure 35. Photos: channel edge near St 4 showing expanding rill, indicative of ongoing channel erosion.

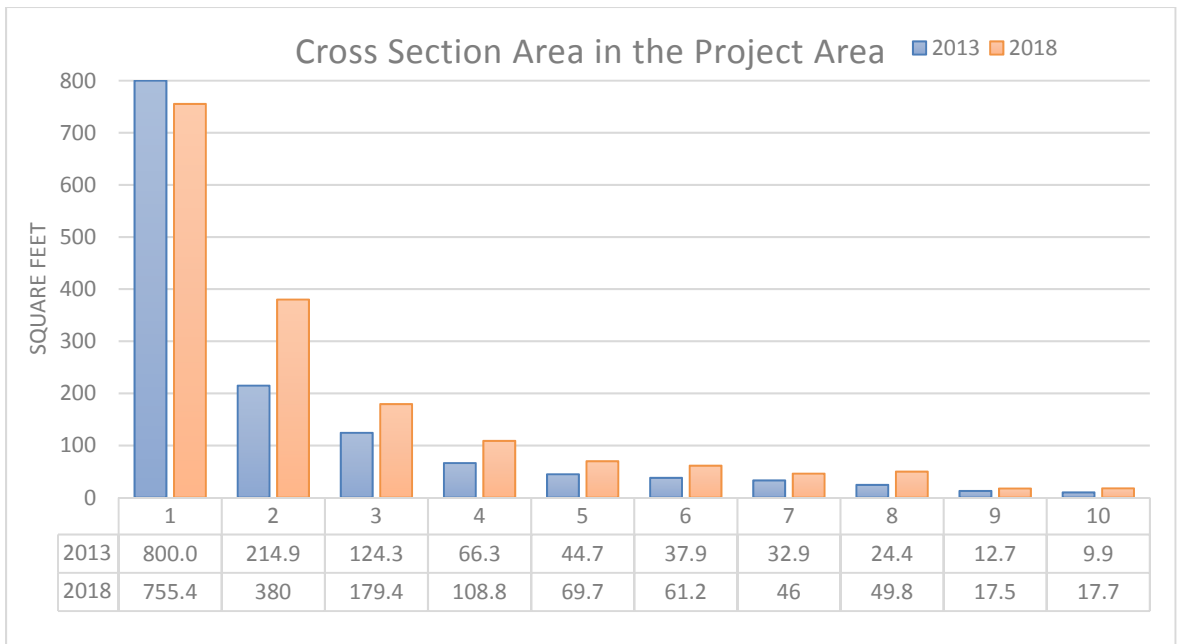
Figure 37. Comparison of channel cross sectional area 2013-2018.

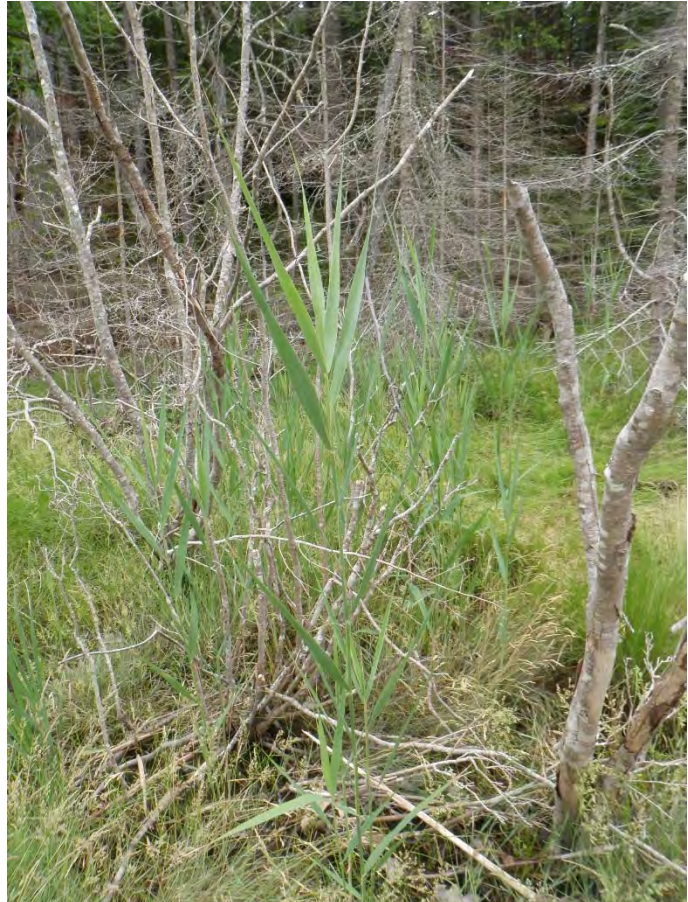
One of two clonal patches of *Phragmites australis* observed near St. 9 in 2018.

Recommendation: Continue to monitor for colonization by Phragmites australis within the Project Area for an additional 3 year period.

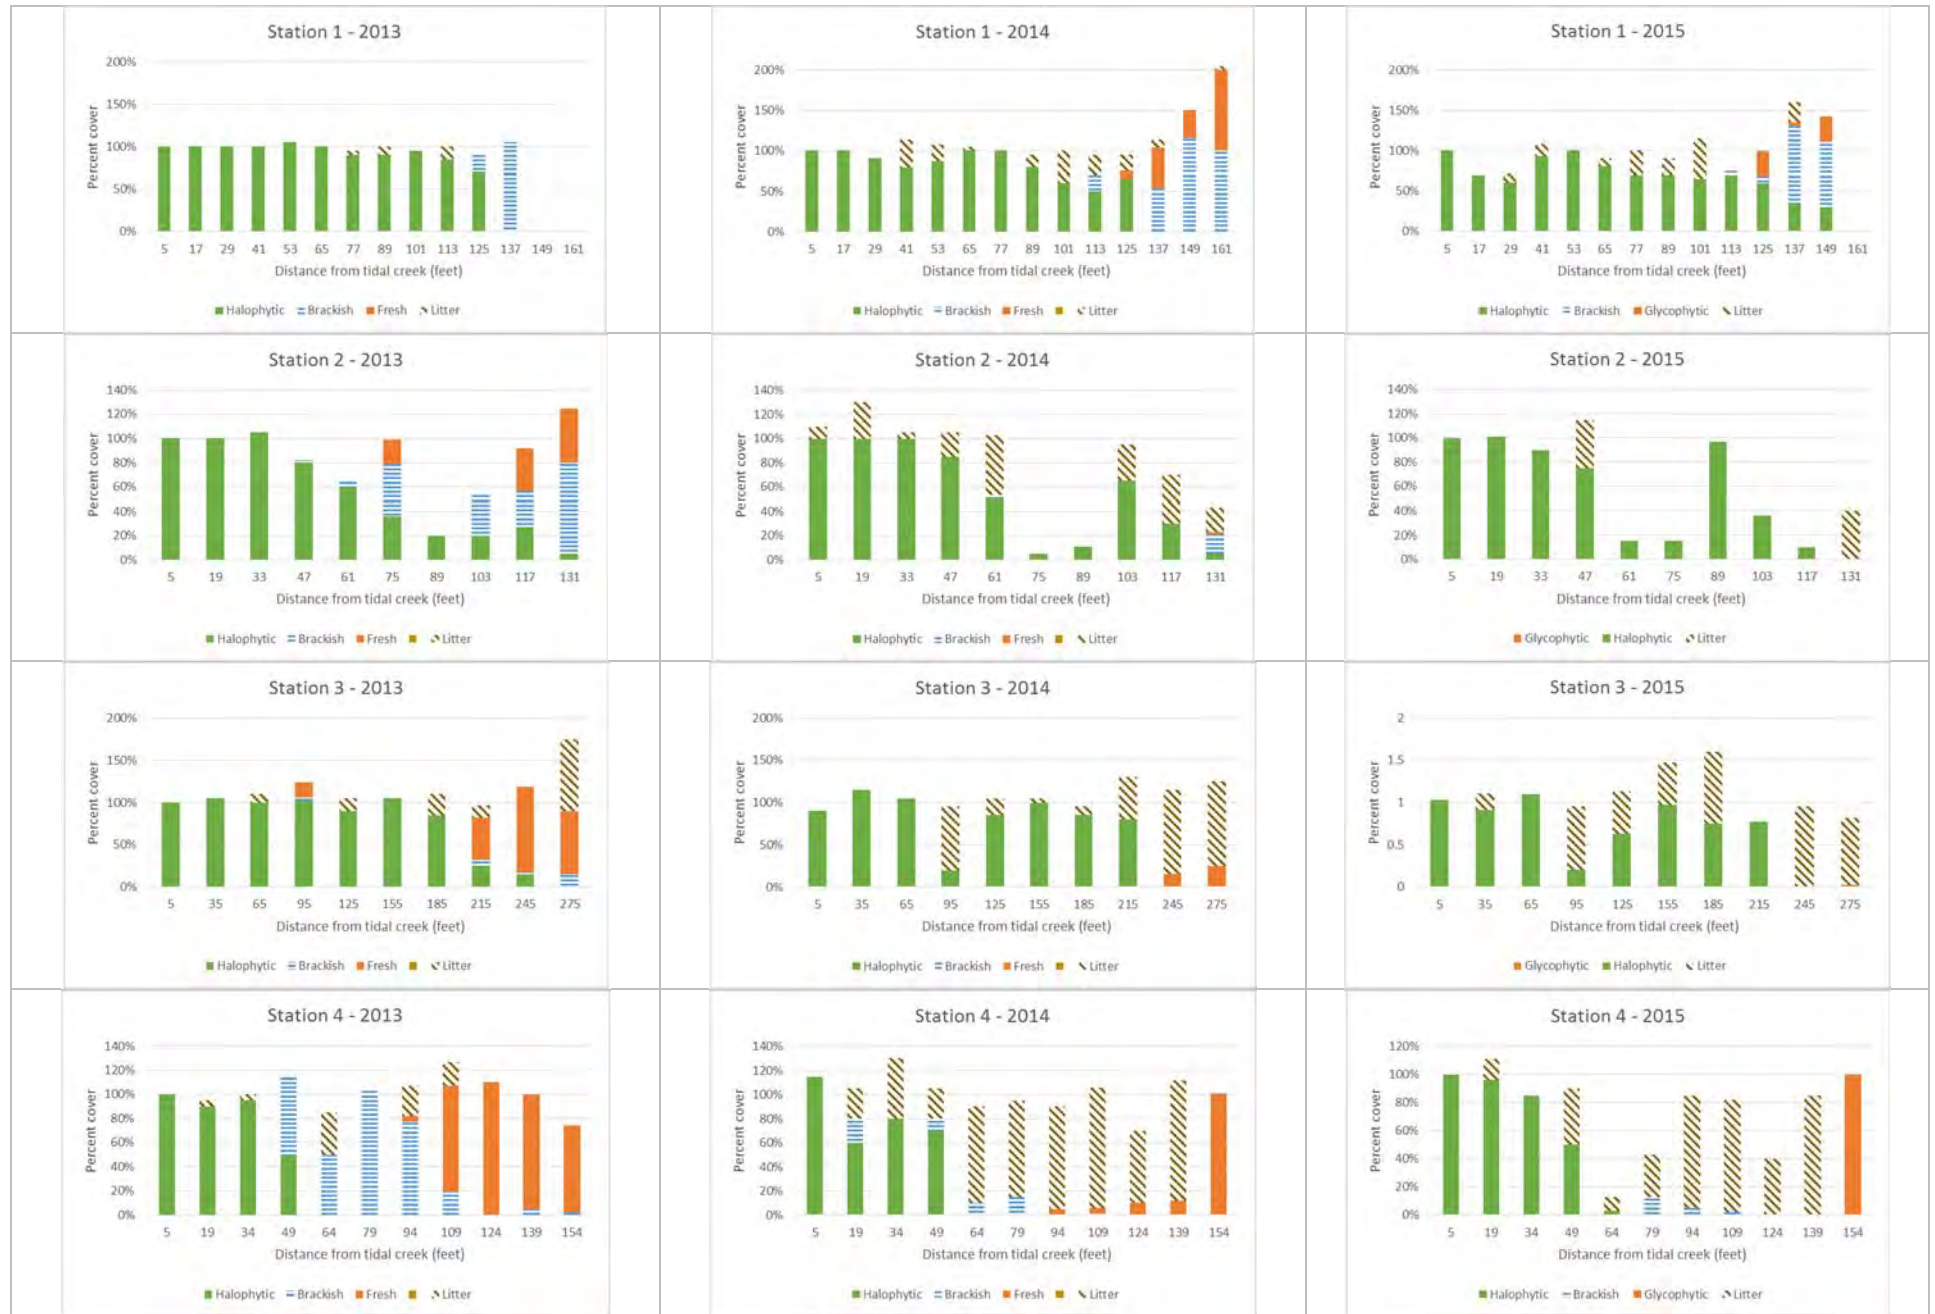
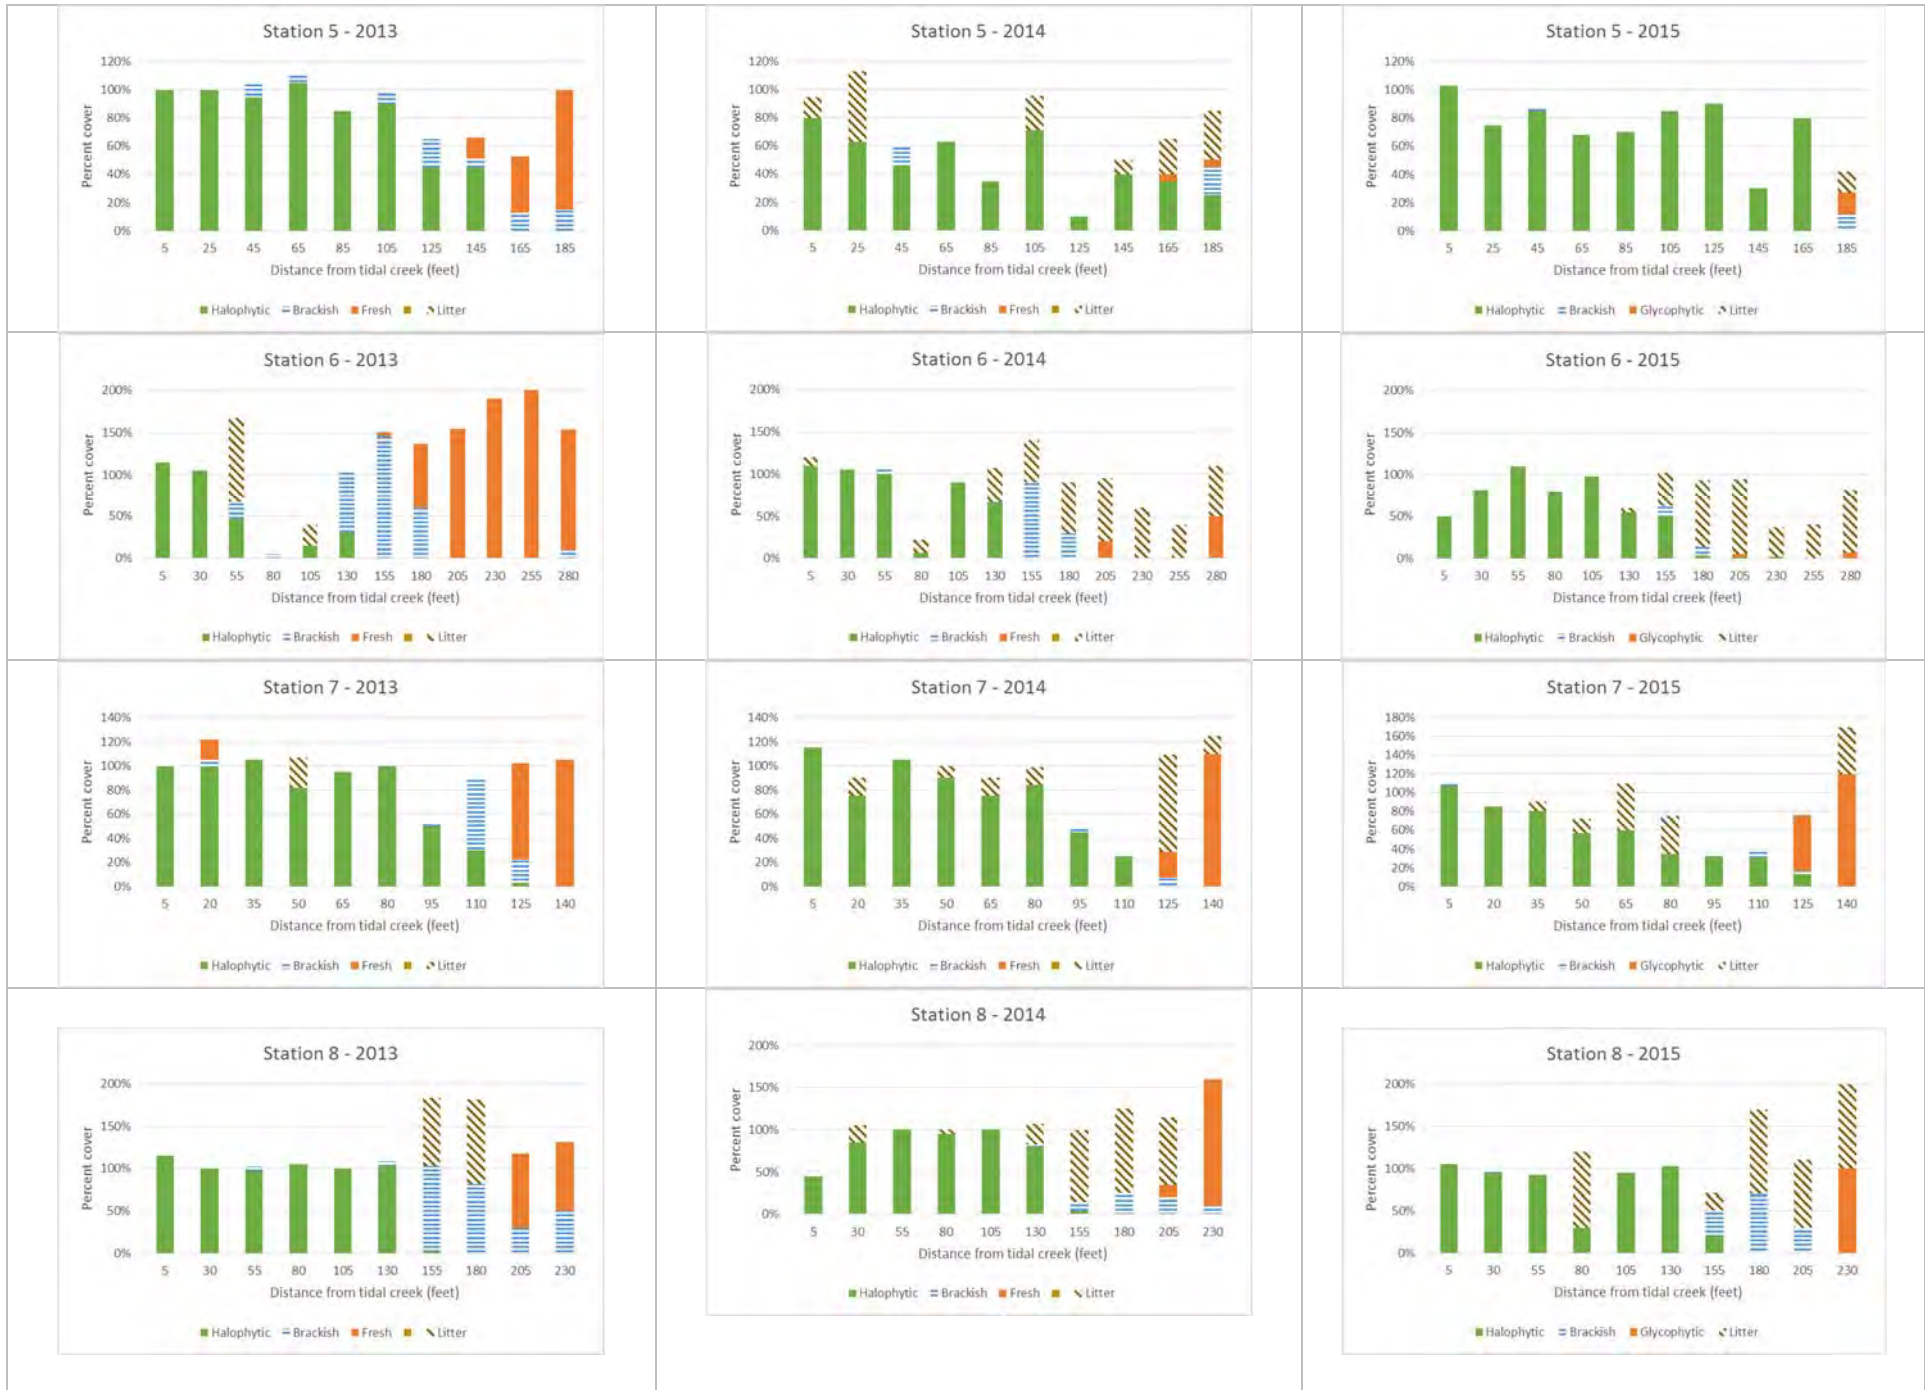
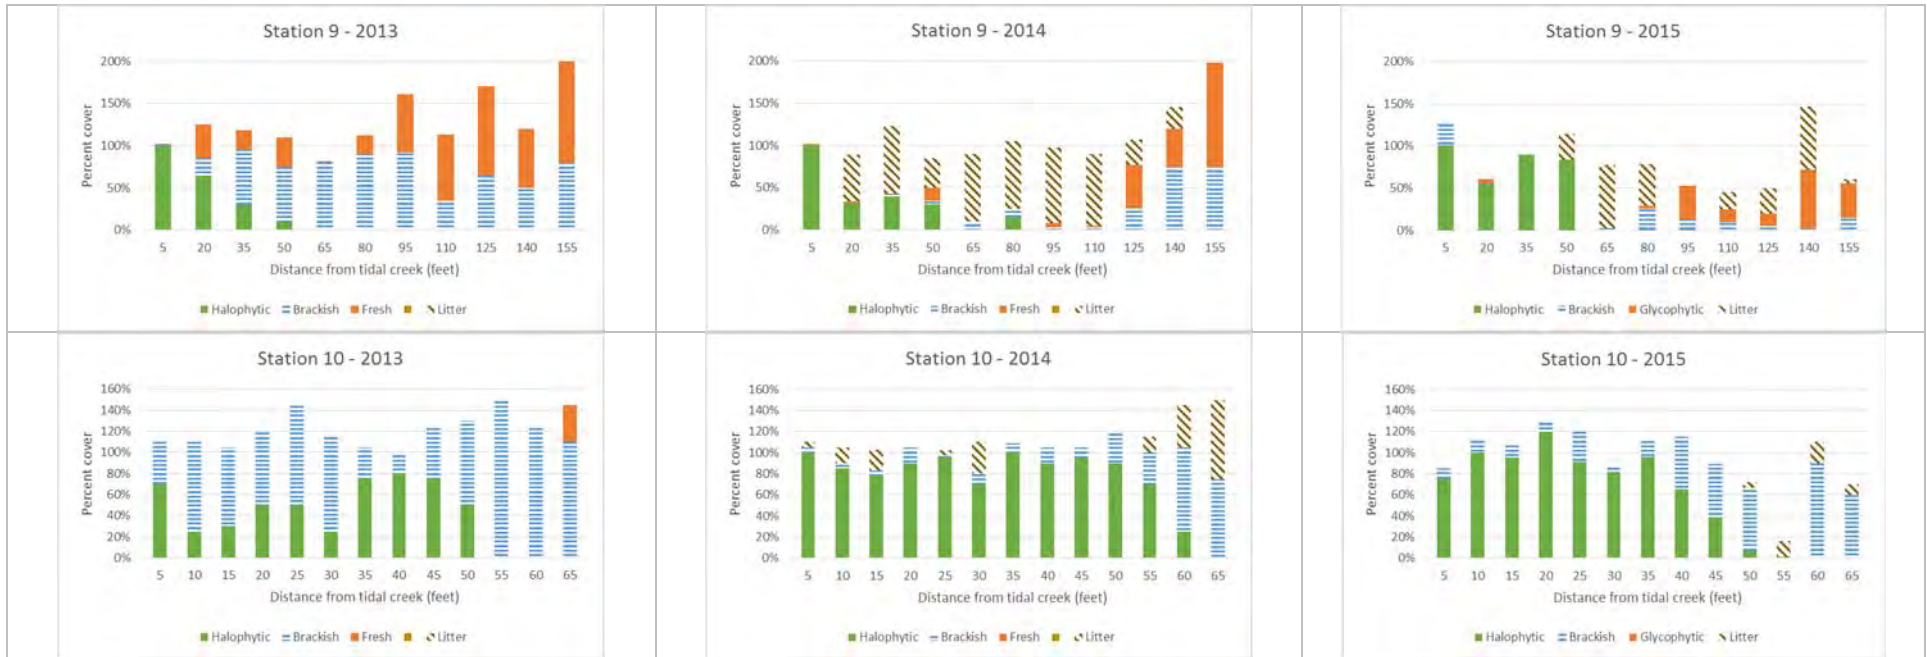
Table 13. Bar graphs of community type (% cover) for Stations 1-10, by transect distance, 2013 - 2015.
